East Buffalo Creek Mitigation Project

Year 3 Monitoring Report - Final Graham County, North Carolina

Monitoring Firm: Michael Baker Engineering, Inc. (Baker)

Prepared for: North Carolina Ecosystem Enhancement Program (NCEEP)

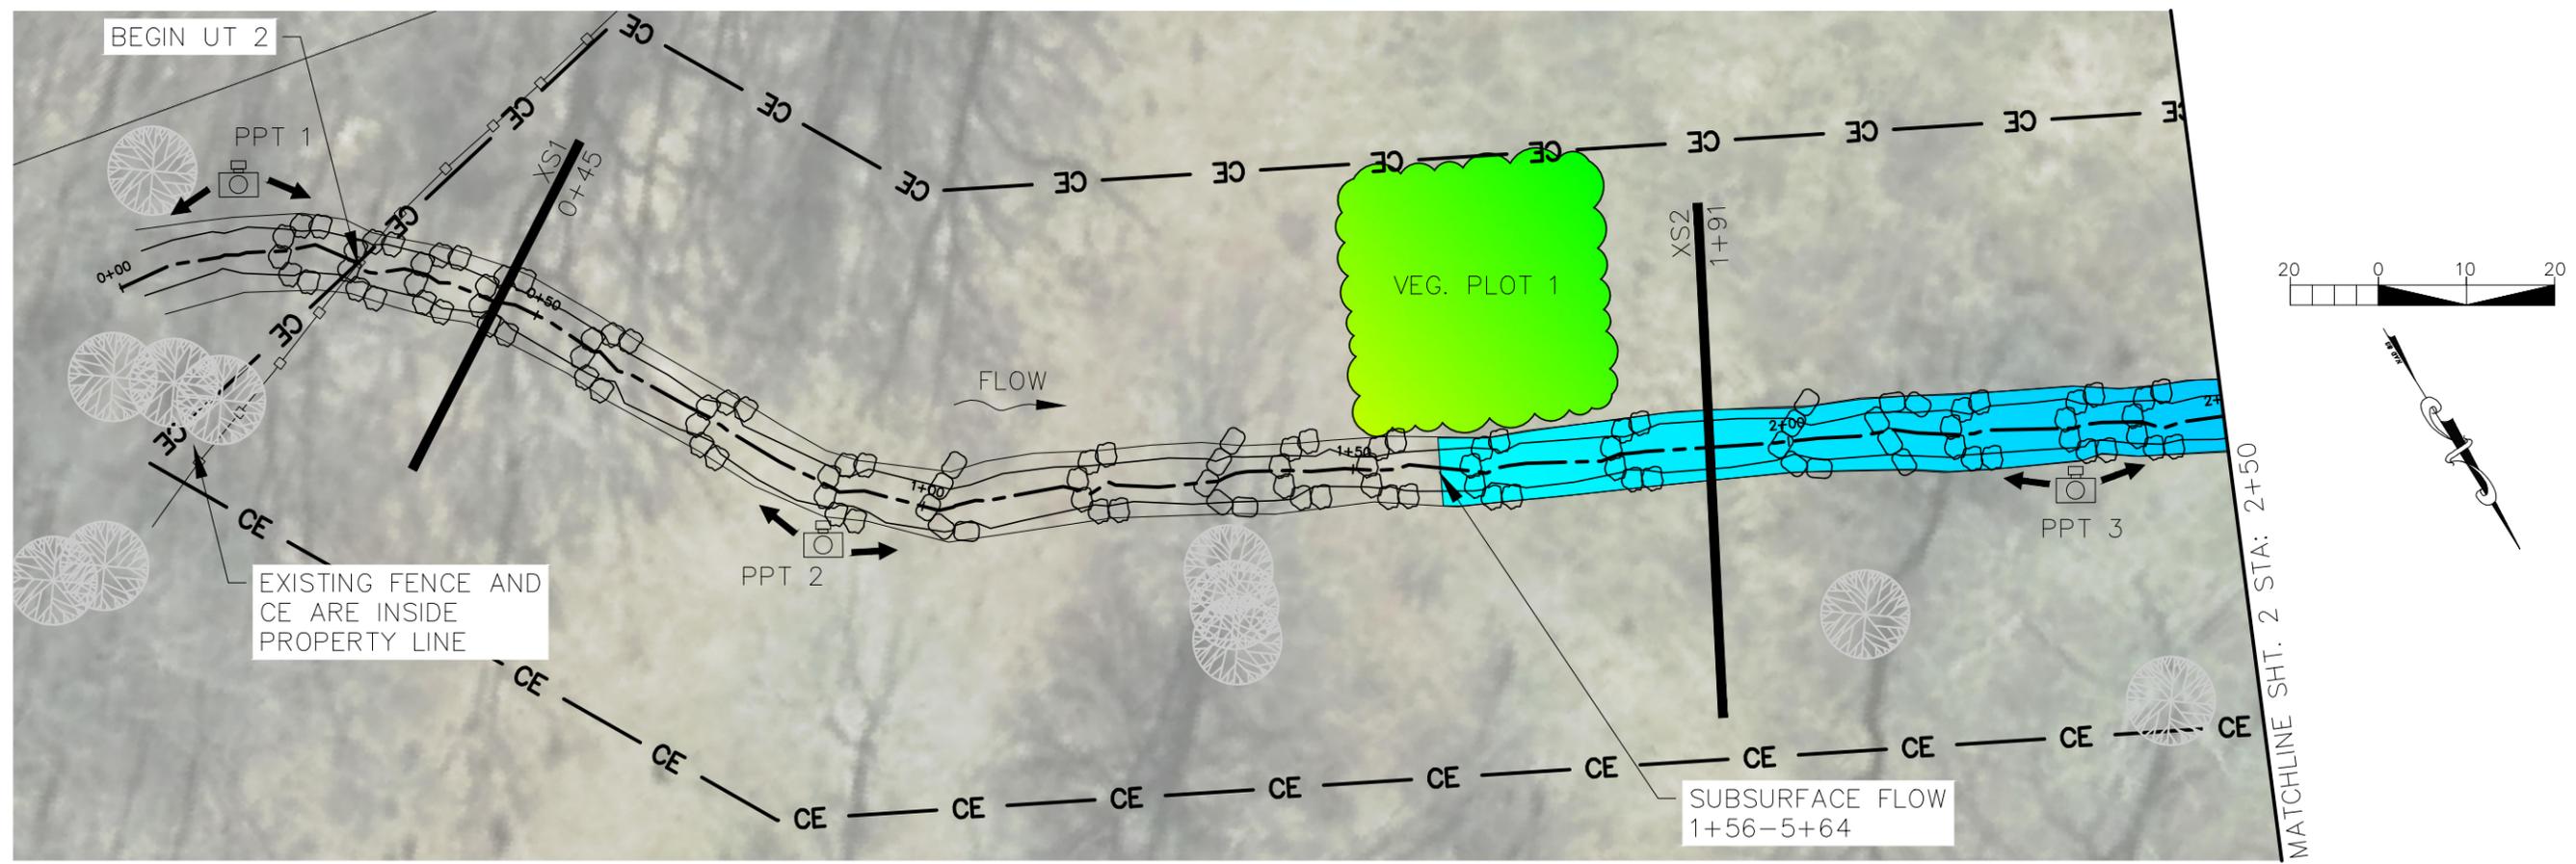
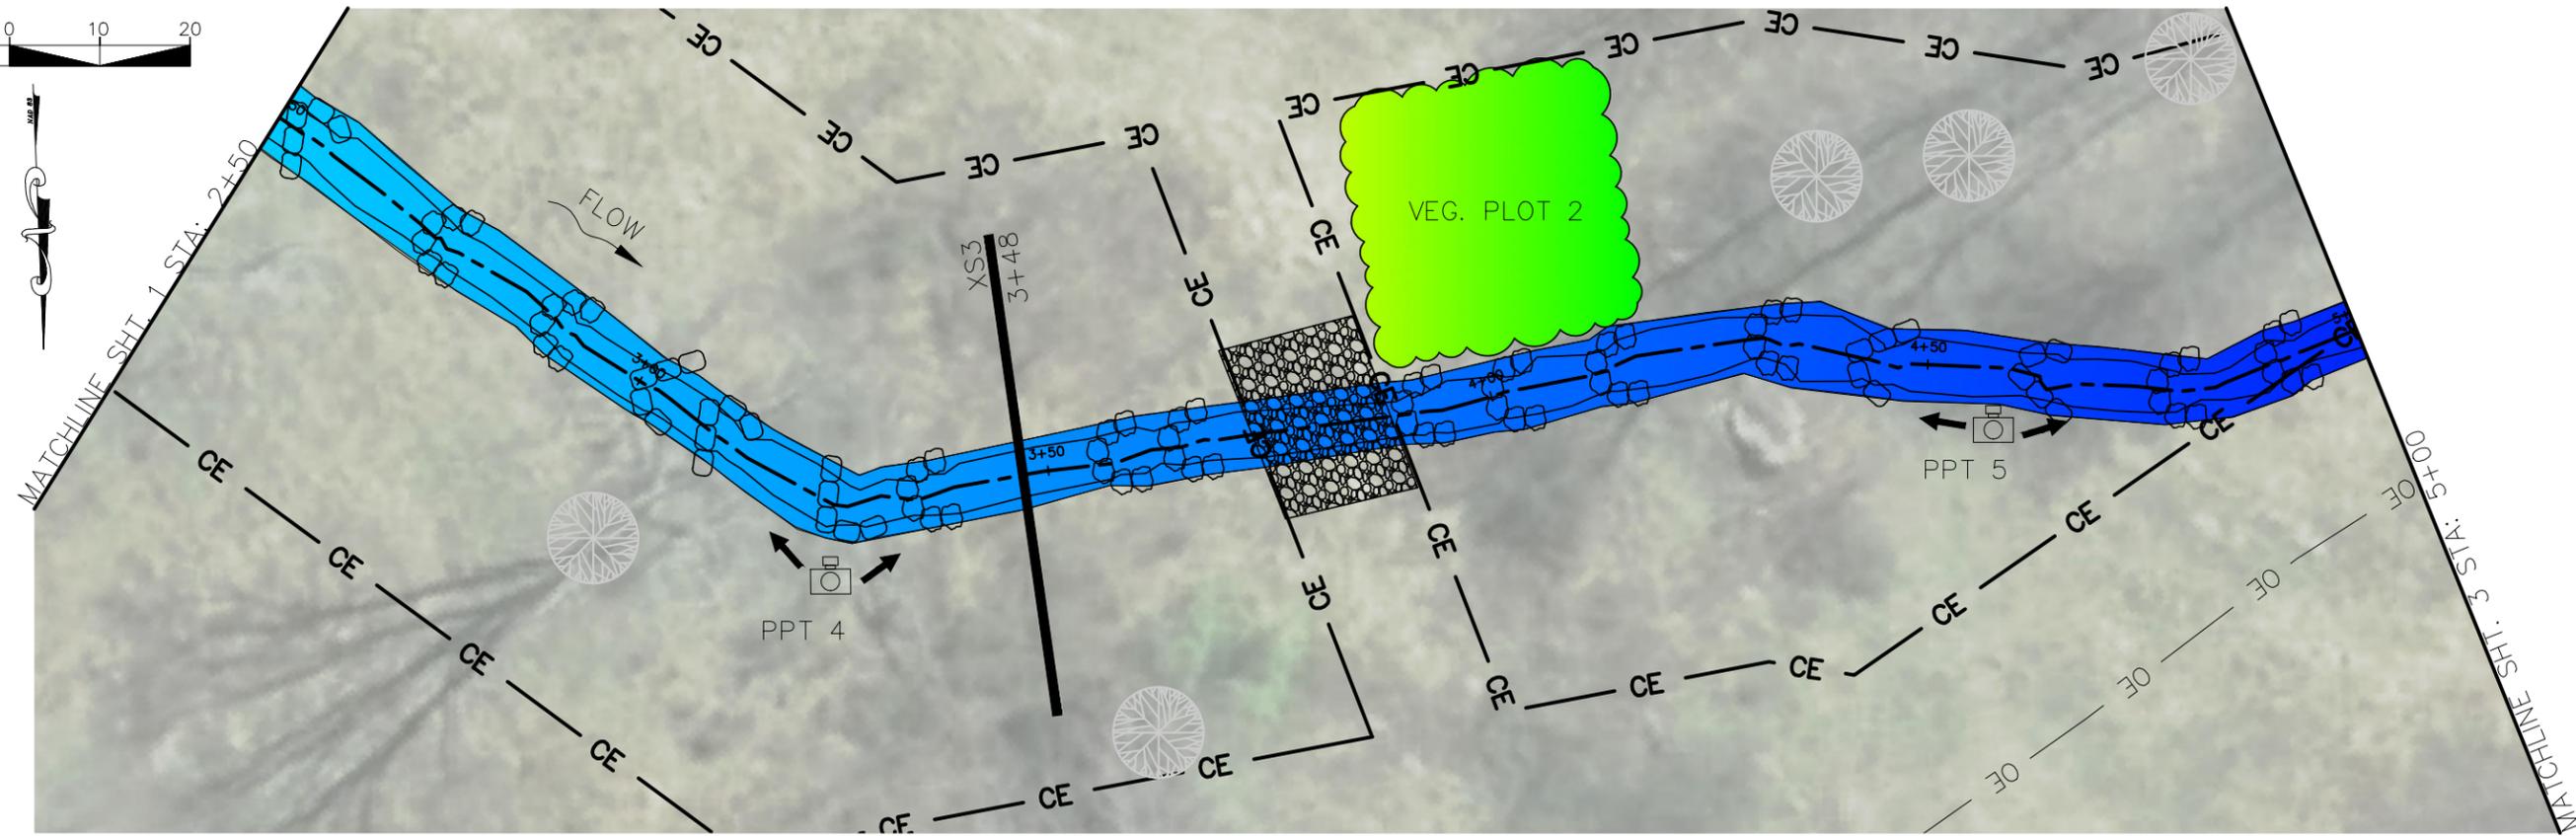
EAST BUFFALO-UT2
CURRENT CONDITION
PLAN VIEW
YEAR 3 MONITORING

There was also little to no change in the profile of UT2 to East Buffalo Creek. Although the profile appears stable, there is a section of UT2 where the stream flow goes subsurface; this section is illustrated on the current condition plan view and documented in Tables 11 and 12 in Appendix F. Given the steepness in slope and the relatively large riffle material used to construct the step-pool channel system, it is likely that the flow will remain surface until interstitial spaces between the stones of the constructed channel bed become filled by smaller particles and organic material. Particle sorting was observed in the channel during the Year 3 survey, indicating that there is flow in the channel at times. However, the presence of rooted plant material indicates that

the baseflow remains under the bed material most of the time. During the 2013-2014 monitoring period, it was observed during at least 3 different visits to the site that surface flow was continuous over approximately half of the restored reach. This distance that flow is at the surface appears to be increasing and we believe that in time it will continue across the reach. The subsurface flow condition on UT2 will be monitored and managed as we assess the progress of this surface flow condition. No areas of instability were noted during Year 3 monitoring.

Feature Issue	Station No.	Suspected Cause	Photo Number
Other	1+56 to 5+64	Flow is subsurface	----

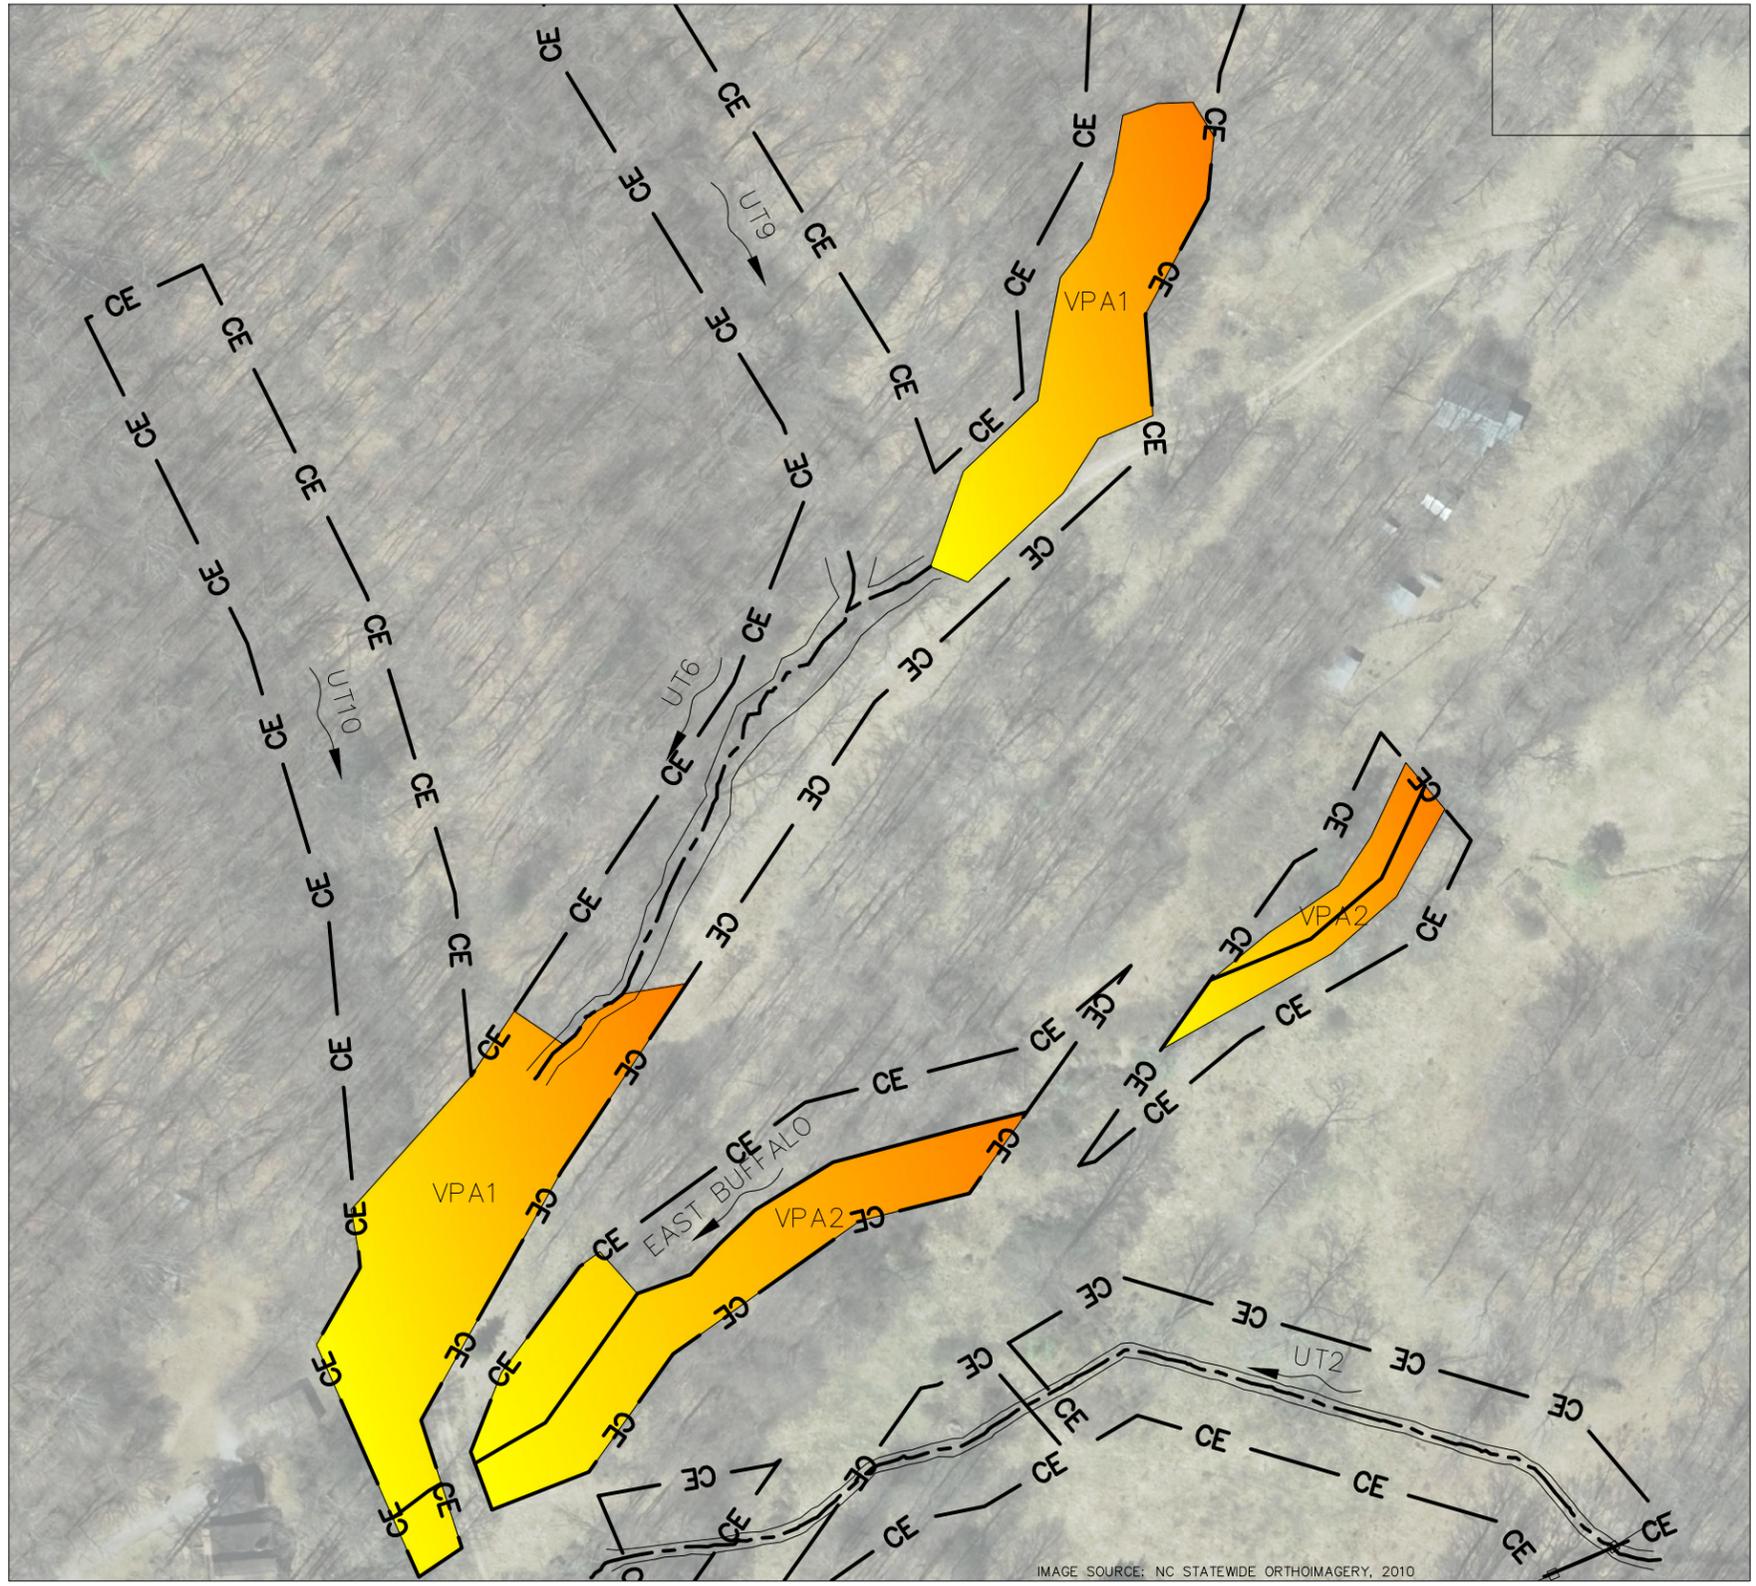
EAST BUFFALO
CURRENT CONDITION
PLAN VIEW
YEAR 3 MONITORING

There were three vegetation problem areas identified during Year 3 monitoring that related to the presence of invasive vegetation along Reaches 2 of UT5, UT6, and East Buffalo Creek. Multiflora Rose and Chinese Privet found along portions of these reaches appear to primarily be a result of invasives that have persisted after prior treatment (and not from new growth) as evidenced by the similar age of these species to those in close proximity that have been effectively treated which have withered and died. The large area of withered and dead Muliflora Rose and Chinese Privet observed along these reaches, especially along UT5 Reach 2, is indicative that prior spray treatment was effective for much of the cover. However, the current extent of persistent invasives (CCPV in Appendix F) warrants immediate follow-up treatment to limit potential proliferation and will be scheduled with the contractor in spring of 2014; an updated status of these vegetation problem areas will be provided in the Year 4 monitoring report.

UT6 Reach 2 (565 LF)			
Feature Issue	Station No.	Suspected Cause	Photo Number
Invasive/Exotic Populations	See Plan View	<i>Rosa multiflora</i> , and <i>Ligustrum sinense</i> : persisting after treatment	NA
East Buffalo Reach 2 (932 LF)			
Feature Issue	Station No.	Suspected Cause	Photo Number
Invasive/Exotic Populations	See Plan View	<i>Rosa multiflora</i> , and <i>Ligustrum sinense</i> : persisting after treatment	NA
UT5 Reach 2 (607 LF)			
Feature Issue	Station No.	Suspected Cause	Photo Number
Invasive/Exotic Populations	See Plan View	<i>Rosa multiflora</i> , and <i>Ligustrum sinense</i> : persisting after treatment	NA
