Elk Branch Restoration Project

Year 4 Monitoring Report

Mitchell County, North Carolina

Date Submitted: November 2015

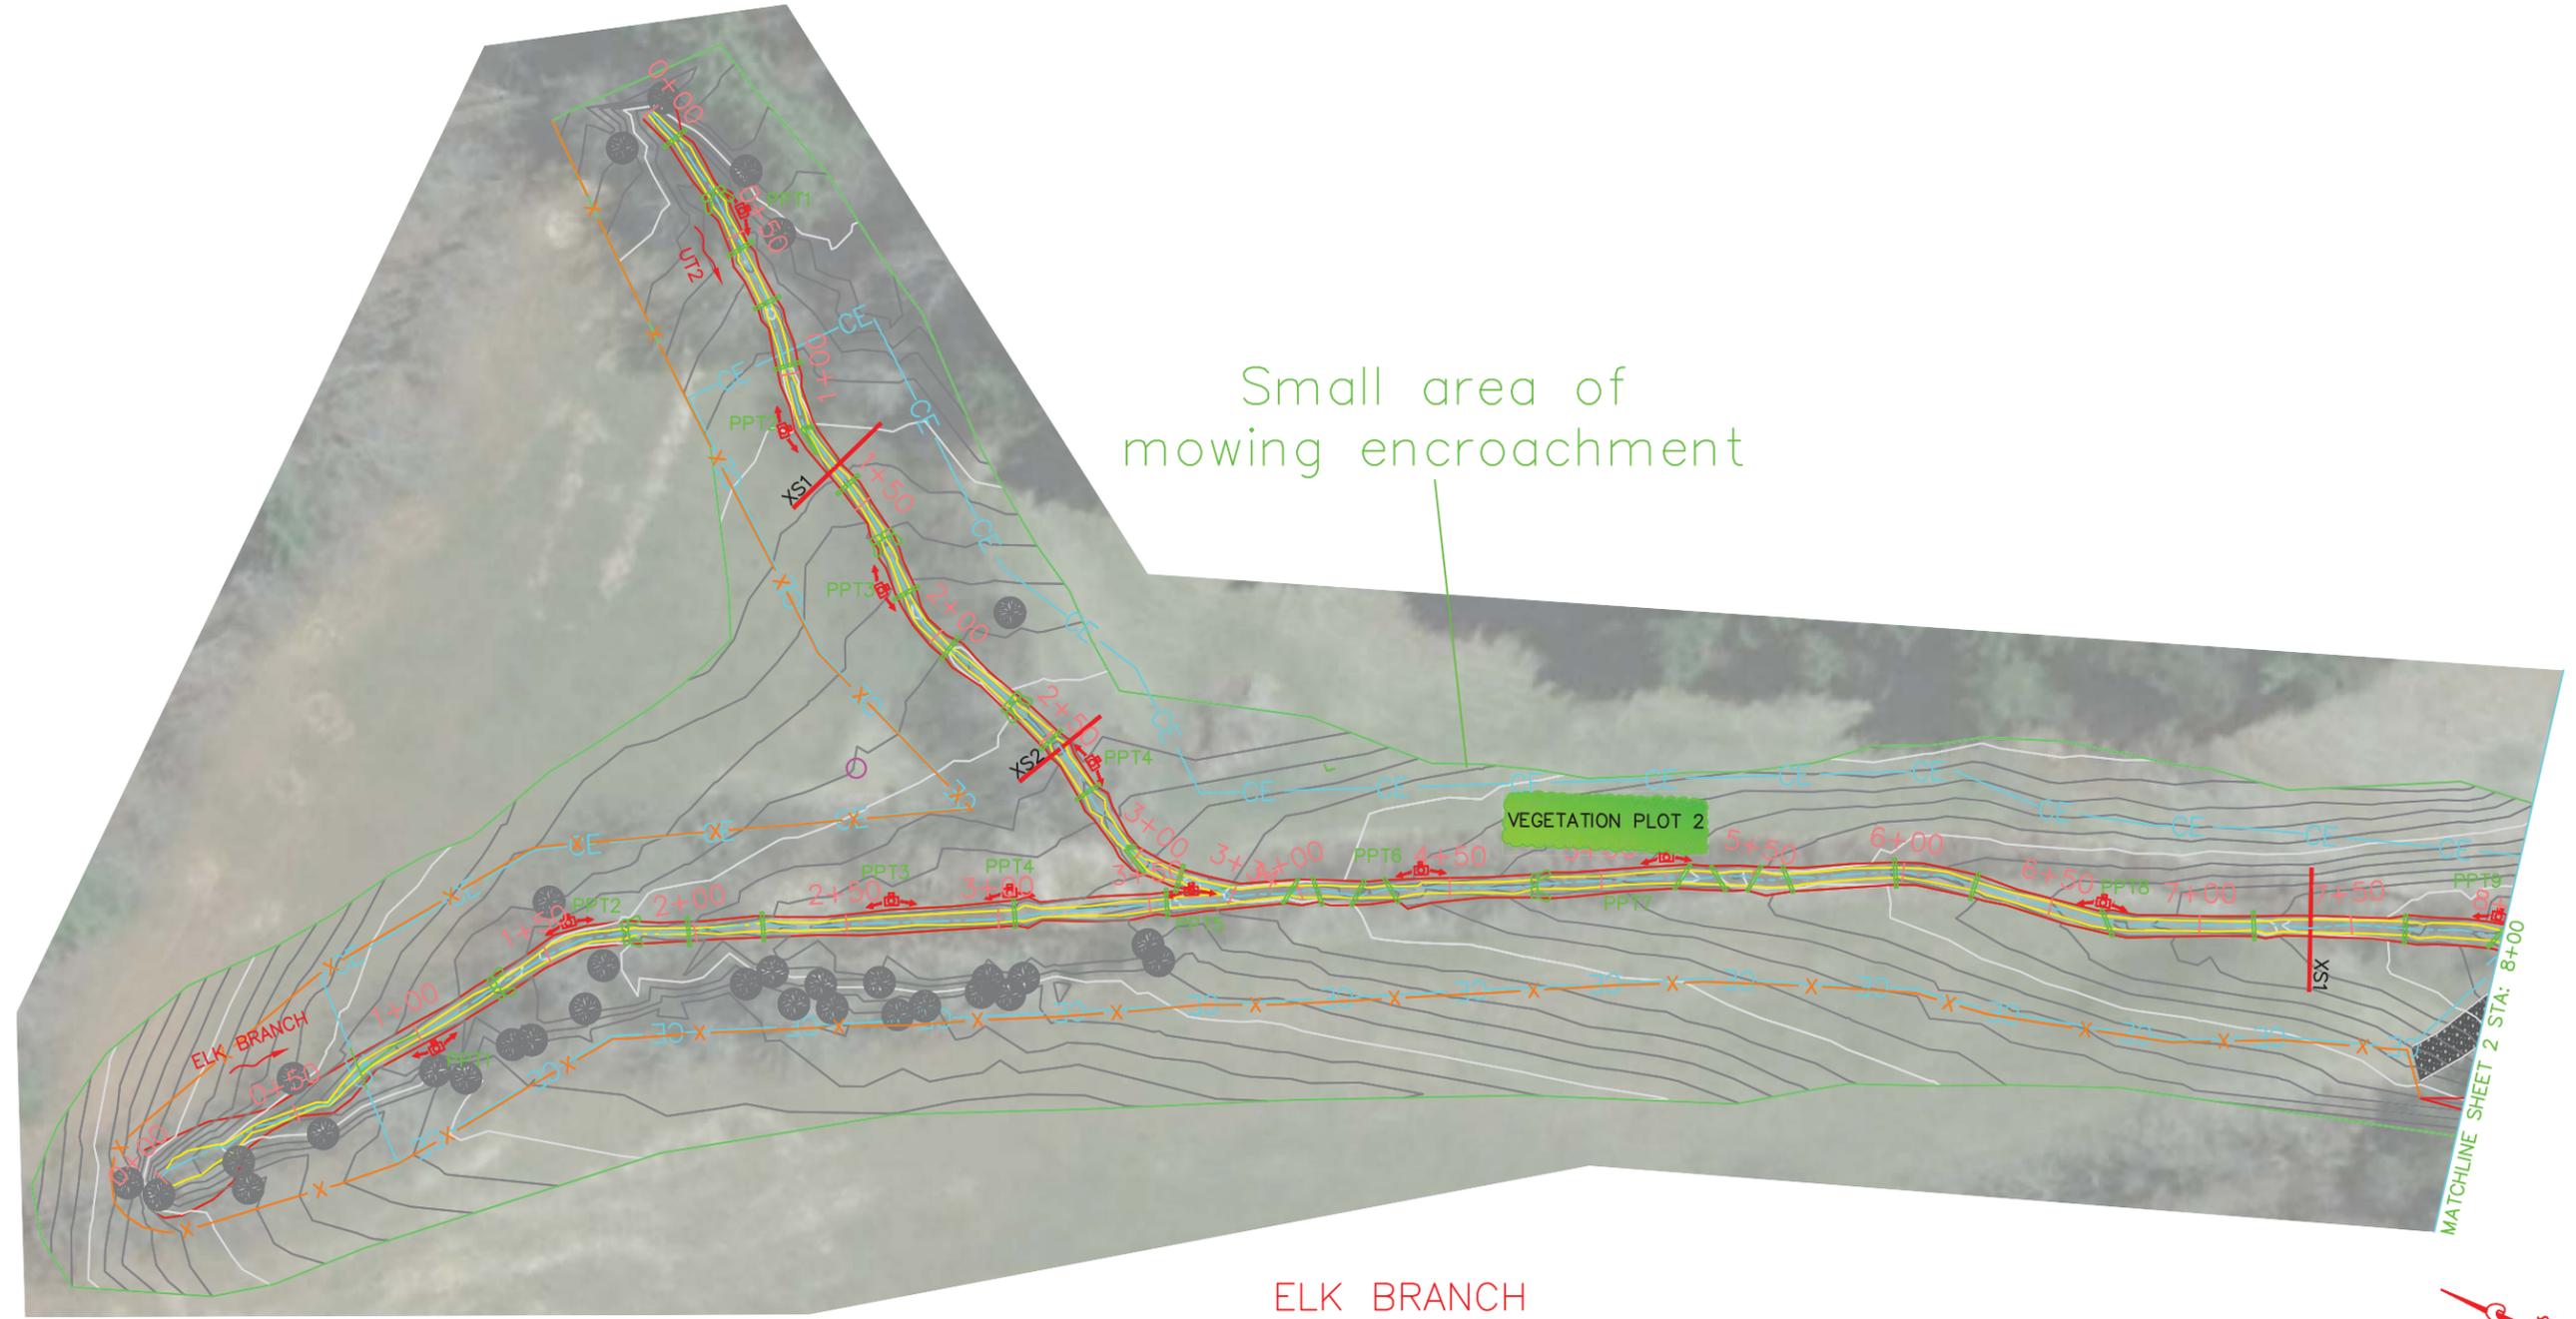
ELK BRANCH
 CURRENT CONDITION PLAN VIEW
 YEAR 4 MONITORING
 STA. 0+00-8+00

There is only one small area of concern due to a mowing encroachment, as shown on page 1 of the current condition plan view. This is at an area along the easement line where the marking posts cannot be seen very well due to a small hill and thick vegetation. We believe this was an accidental encroachment as there are no other similar areas. We plan to add two additional posts to more visibly mark the line in this area.
