# Baseline Monitoring Document and As Built Baseline Report

Five-Mile Branch Stream and Wetland Restoration, Iredell County

NCEEP IMS ID# 92185 DENR Contract # D05013S

Prepared by:
ARCADIS G&M of North Carolina, Inc.
801 Corporate Center Drive
Suite 300
Raleigh
North Carolina 27607
Tel 919.854.1282
Fax 919.854.5448

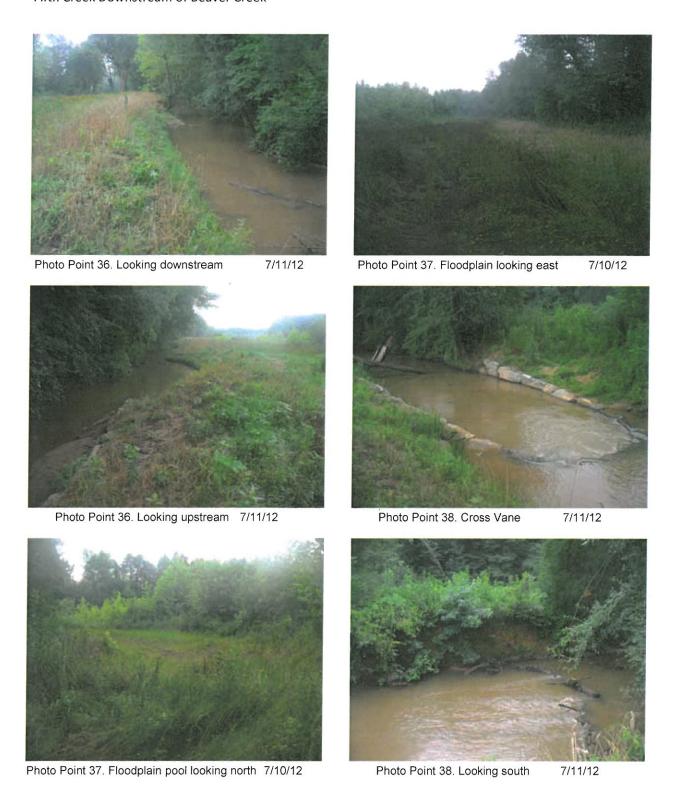
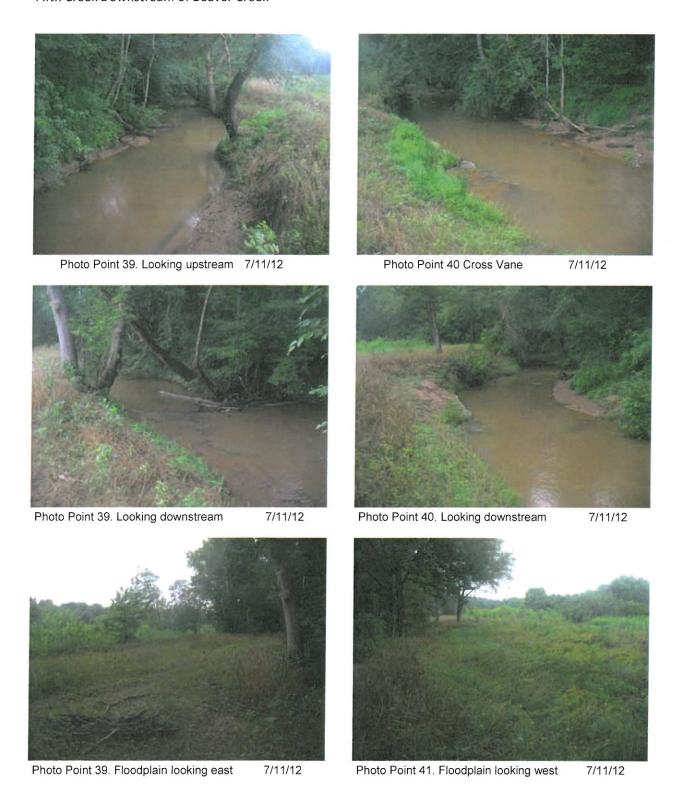
Rack line on floodplain
