Gregory Wetland and Stream Restoration As-Built Report Halifax County, NC

May 2005

EXECUTIVE SUMMARY

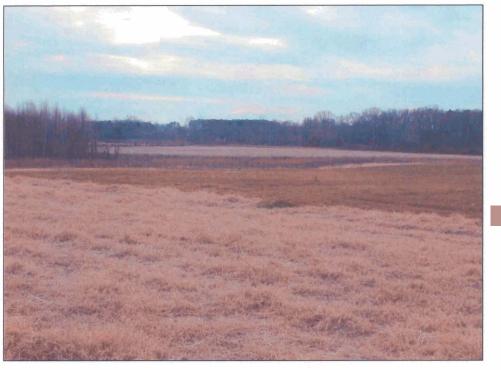
Photo PC1. Restoration area before construction activities began.

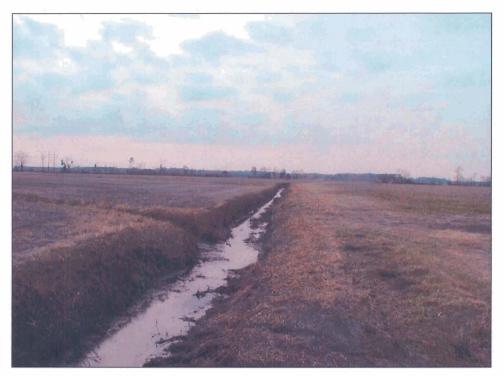
Photo PC2. Lateral field ditches before construction activities.

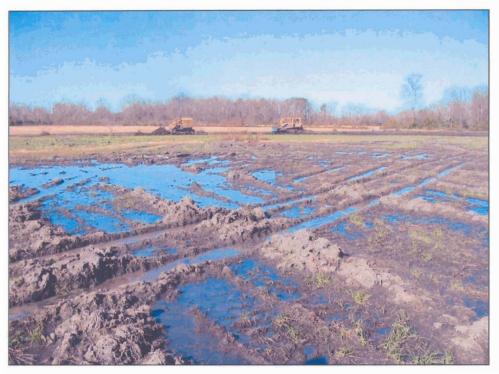
Photo C1. Restoration area during initial grading to design elevations.

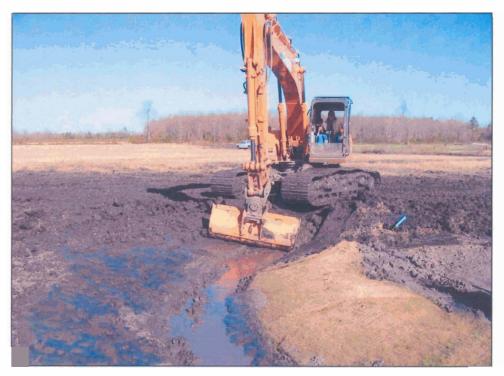
Photo C2. A new section of stream channel (Reach 2) during excavation.

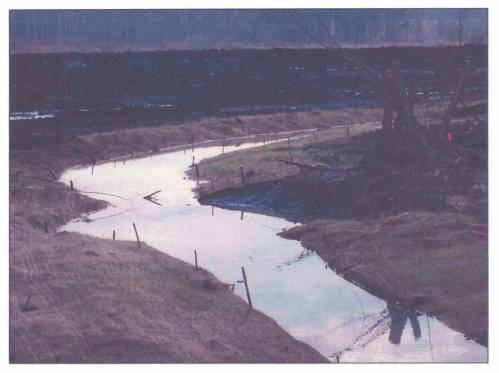
Photo P1. Transplants installed at a log weir.

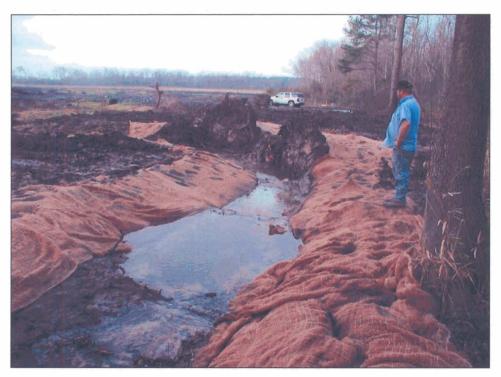
Photo P2. Root wads and coir fiber matting installed around a meander bend for bank stabilization and habitat improvement.

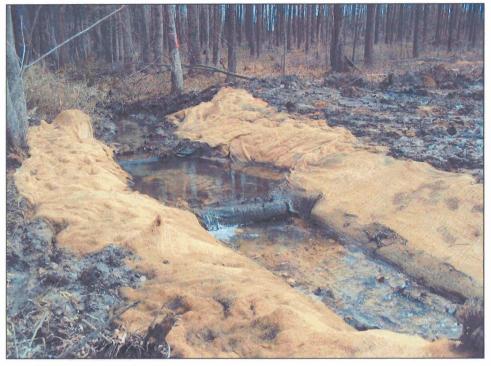
Photo P3. A log weir at the beginning of Reach 1.

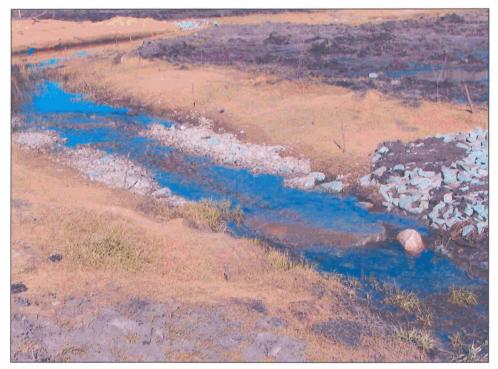
Photo P4. A constructed riffle near the end of Reach 1.

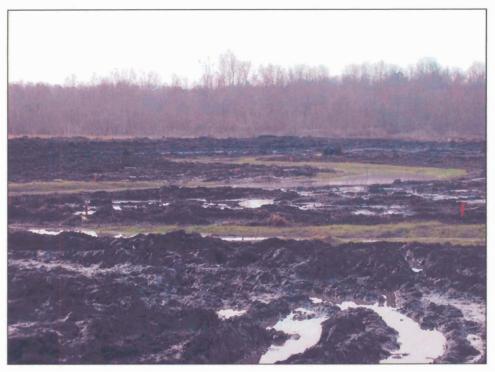
Photo P5. Middle portion of the project. Scarification and minor grading resulted in a diversity of hydrologic wetland conditions.

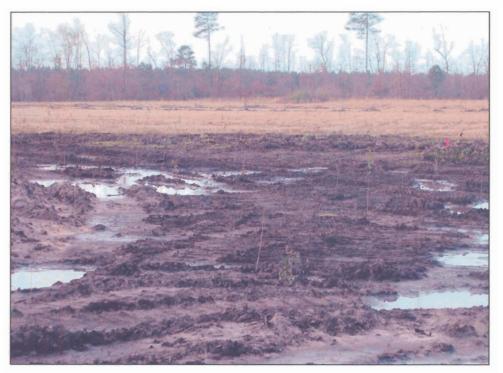
Photo P6. An area in the middle of the project after planting was completed.
