MONITORING YEAR 3 ANNUAL REPORT

HOLMAN MILL MITIGATION SITE

Alamance County, NC
NCDEQ Contract 005795
DMS ID No. 96316

Data Collection Period: January 2018 - October 2018
Draft Submission Date: November 7, 2018
Final Submission Date: December 10, 2018

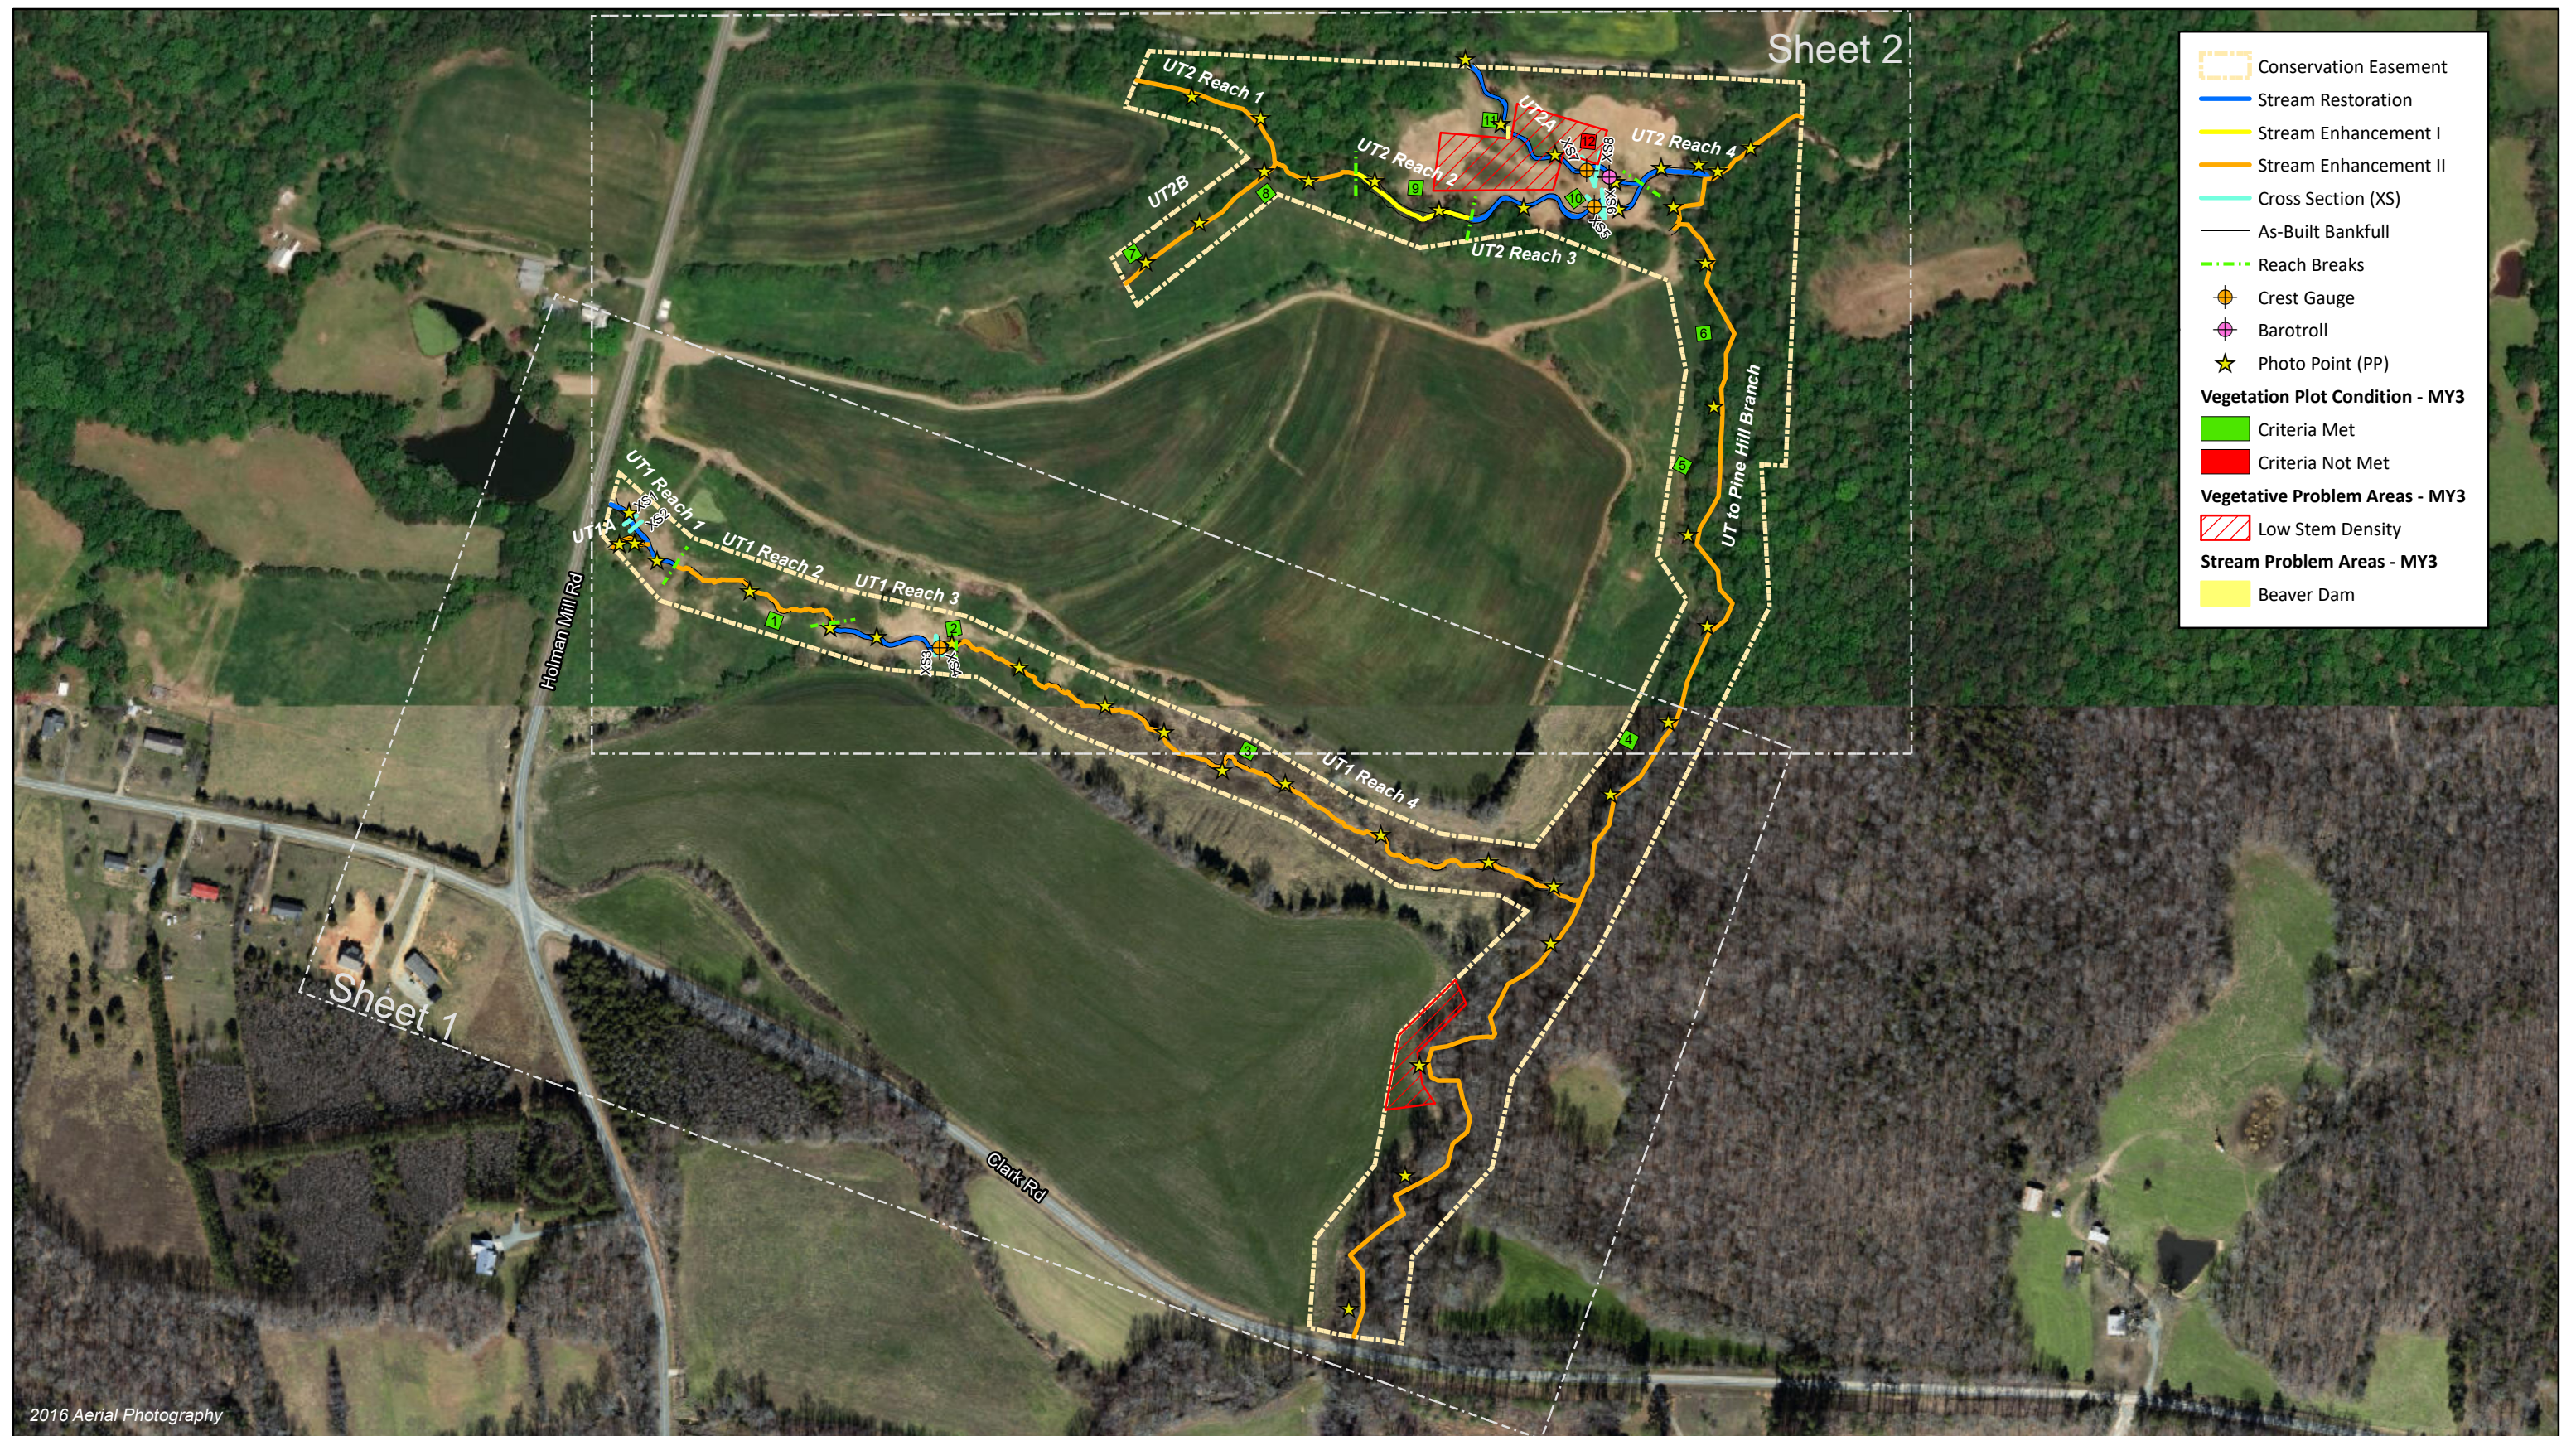
During MY3 two areas of low stem density were observed totaling 1.5 acres (Figure 3.0). Vegetation plot 12 is located in one of the areas and did not meet the MY3 interim success criteria of 320 planted stems per acre. The low stem density along UT2A was graded during construction, resulting in poor soils. This accompanied with dense herbaceous competition has resulted in poor growing conditions for planted trees. In the low stem density area along UT to Pine Hill Branch thick herbaceous competition has caused a high tree mortality rate. Supplemental planting will take place in these two areas during the winter of 2018/2019.

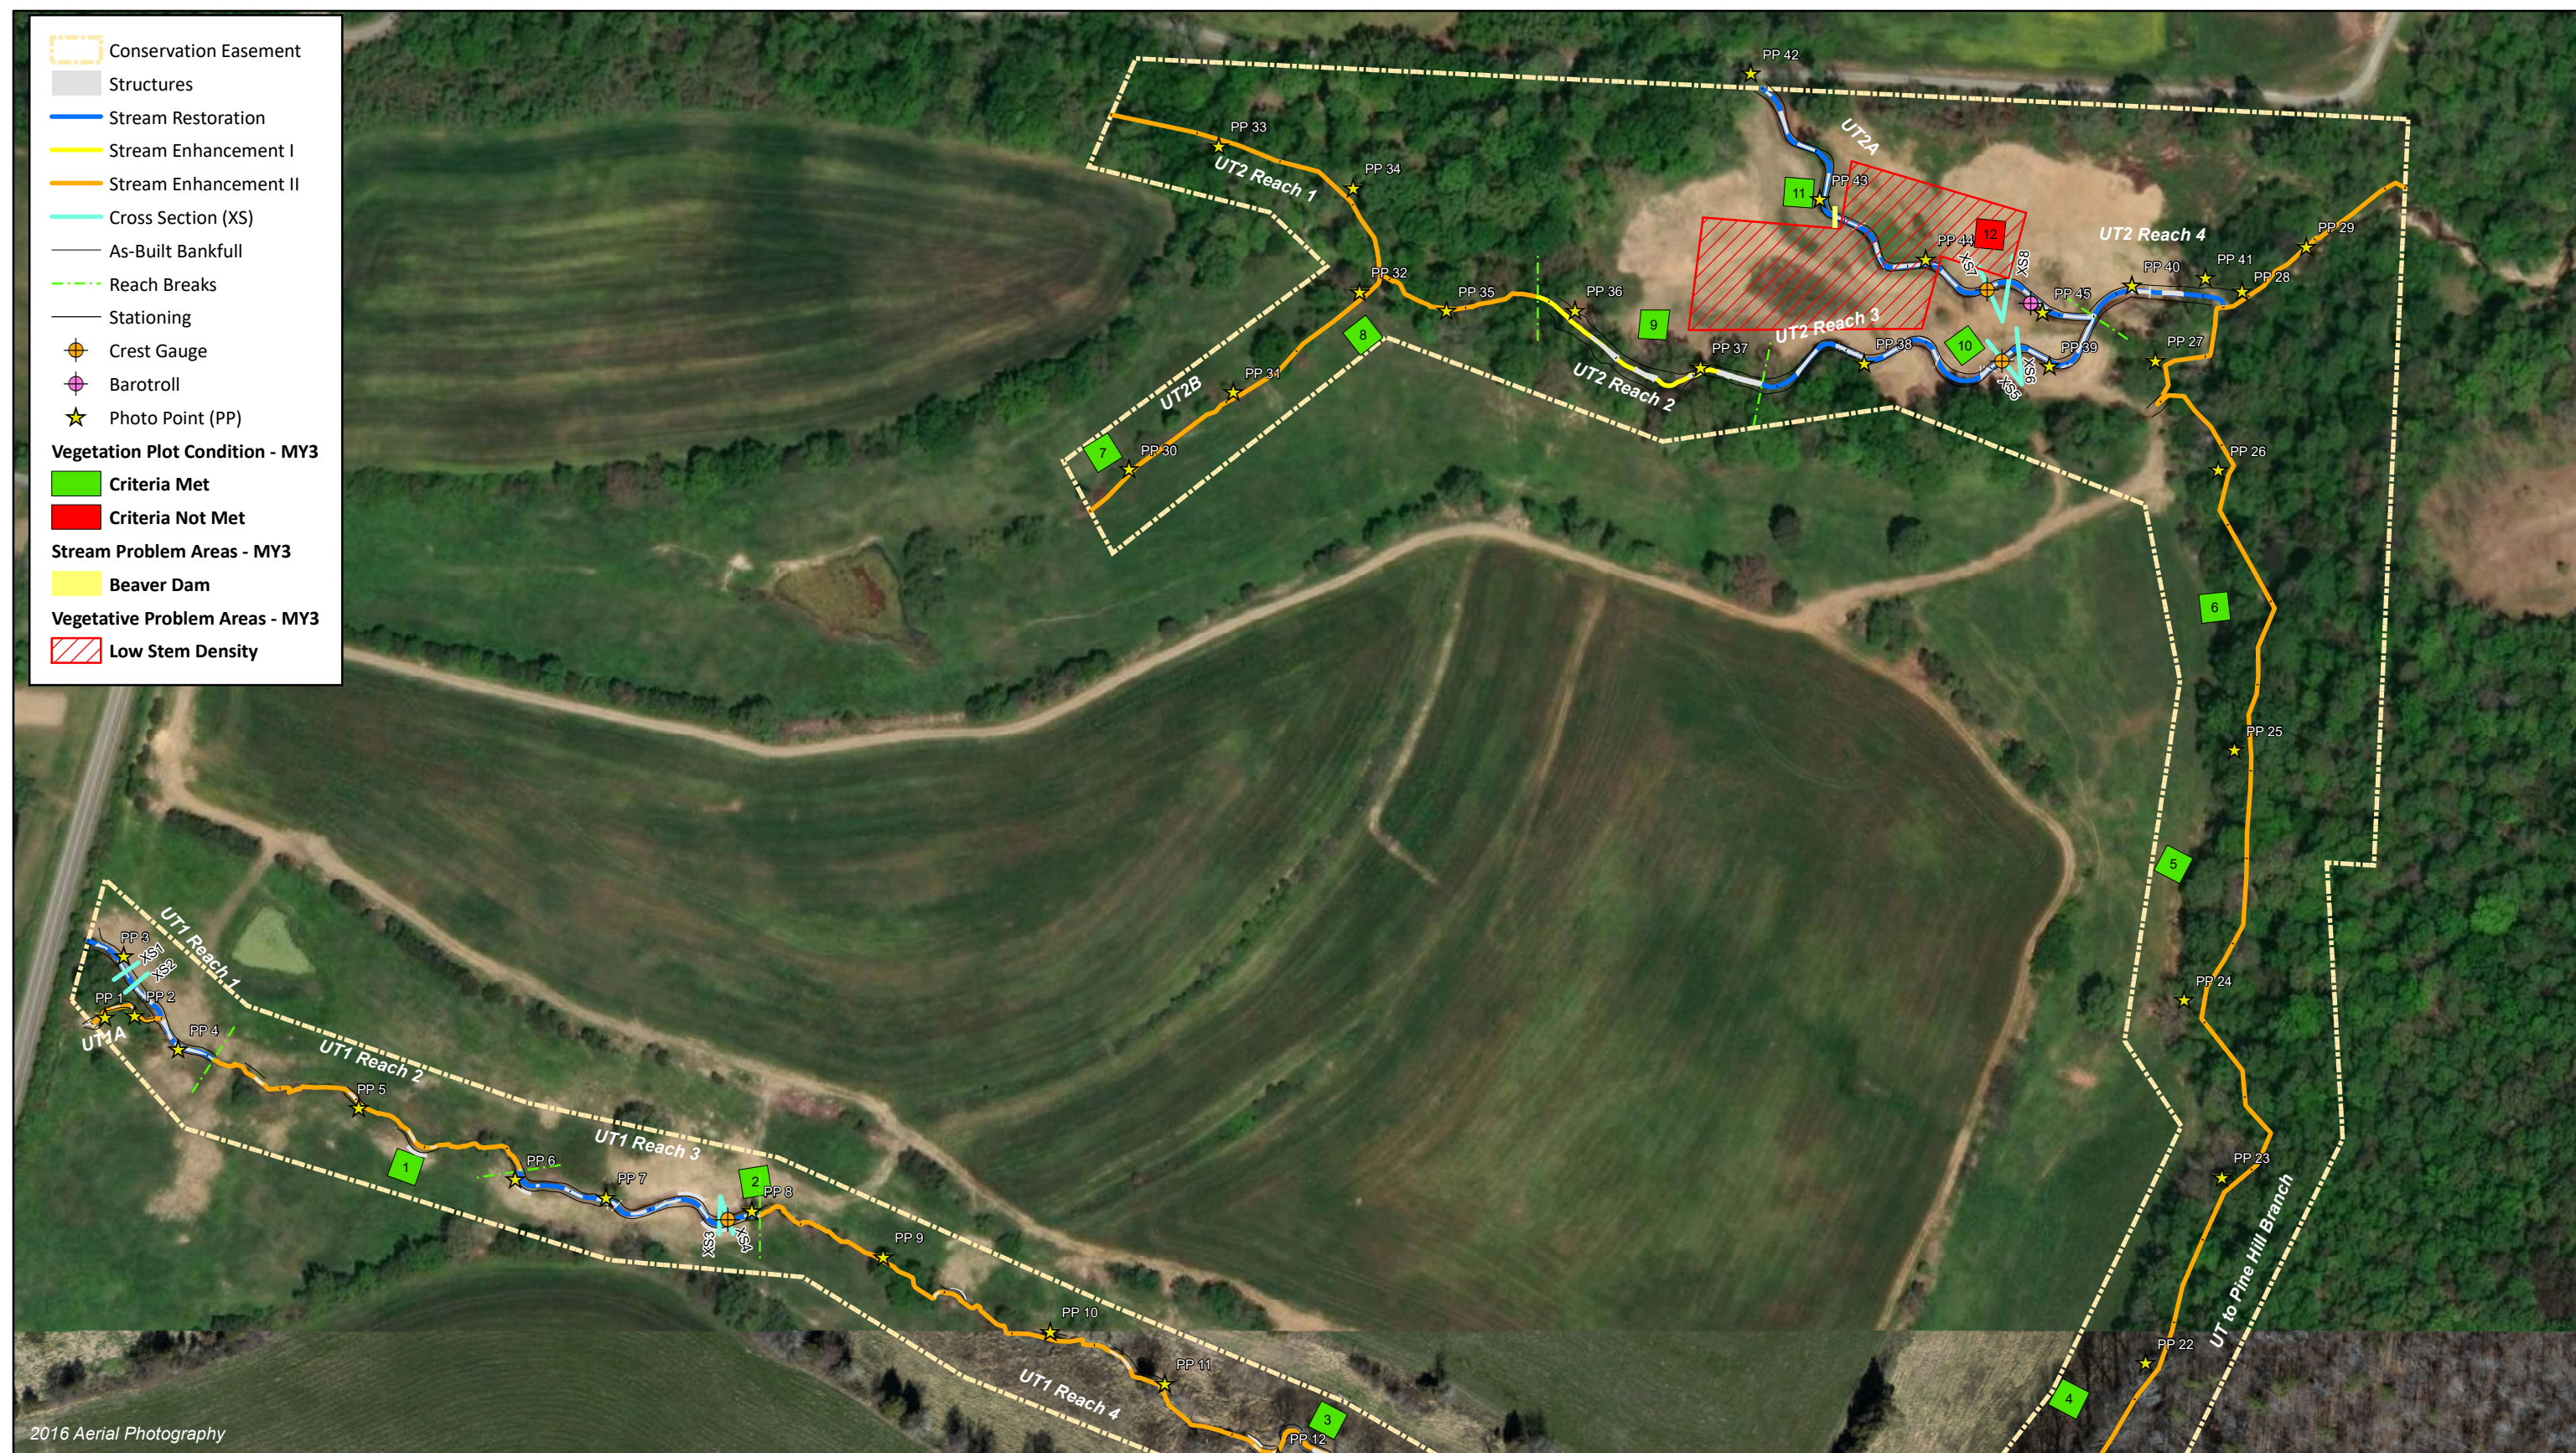
One beaver dam was found along UT2A in October 2018 (Figure 3.2) backing water onto the floodplain. The beaver dam was removed and no damage was observed. Beaver activity is believed to occur during times of high flow on UT to Pine Hill Branch. When water levels reach baseflow, beaver activity is not observed within the UT2A area. The Site will be monitored during subsequent monitoring years for beaver activity.
