Monitoring Report
FINAL VERSION
Horne Creek Tributaries Mitigation Project
Monitoring Year 2
Calendar Year of Data Collection: 2021

NCDEQ DMS Project Identification # 100026
NCDEQ DMS Contract # 7181
Yadkin River Basin (Cataloging Unit 03040101)
USACE Action ID Number: SAW-2017-01510
NCDEQ DWR Project # 2017-1156
Surry County, NC
Contracted Under RFP # 16-006993
Data Collection Period: October 2021
Submission Date: December 2021

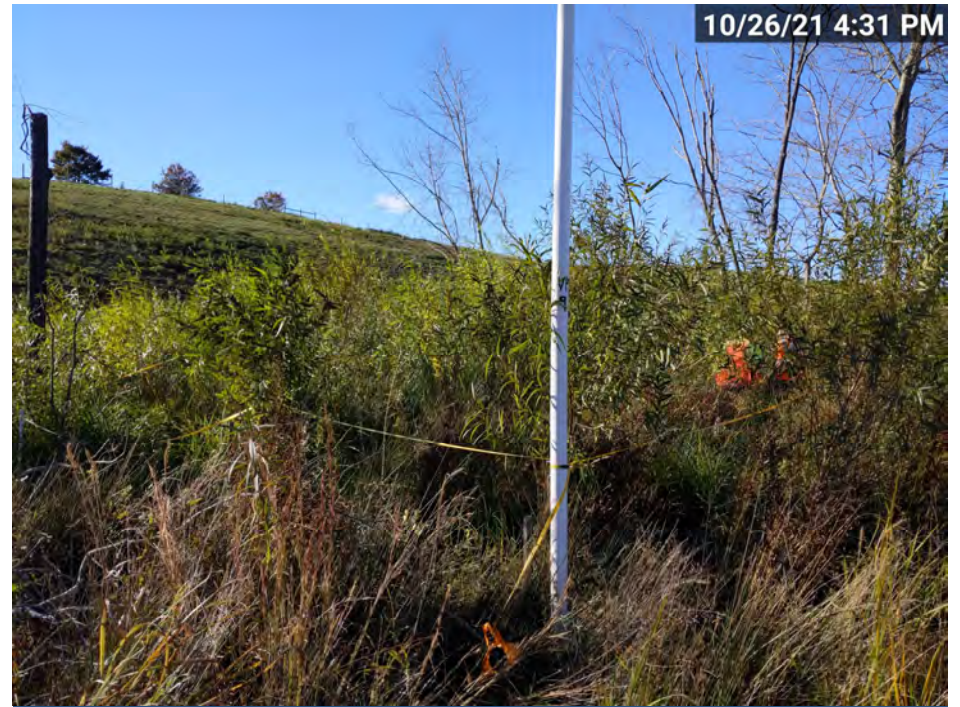
Veg Plot 9 (MY-02)

- **3.3 Vegetation: Add short discussion regarding plots 9 and 10. These plots fail to meet the interim success criteria, but with the addition of the black willow (approved mit plan species), both plots meet.** Response: The following language was added to section 3.3, “Plots 9 and 10 did not meet interim success criteria with planted stems, but both plots do meet criteria with the addition of volunteer stems (black willow). Both plots are in the old channel area, have increased hydrology, and dense herbaceous vegetation. Volunteer black willow is doing well in these areas”

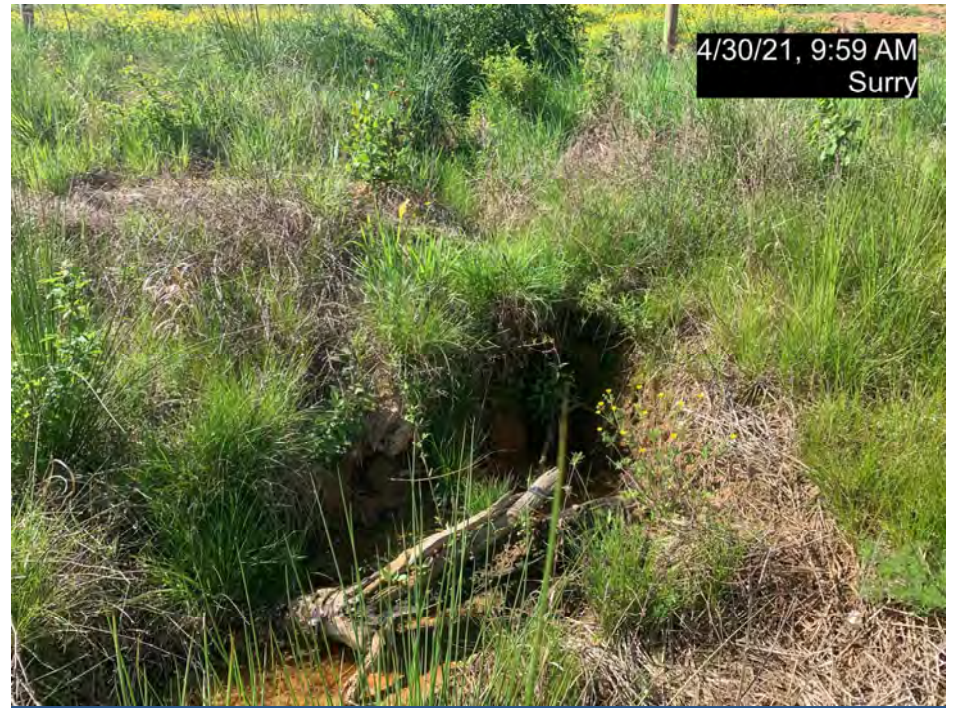
SPA1, R1 Right Floodplain, Minor Slumping (MY-02)

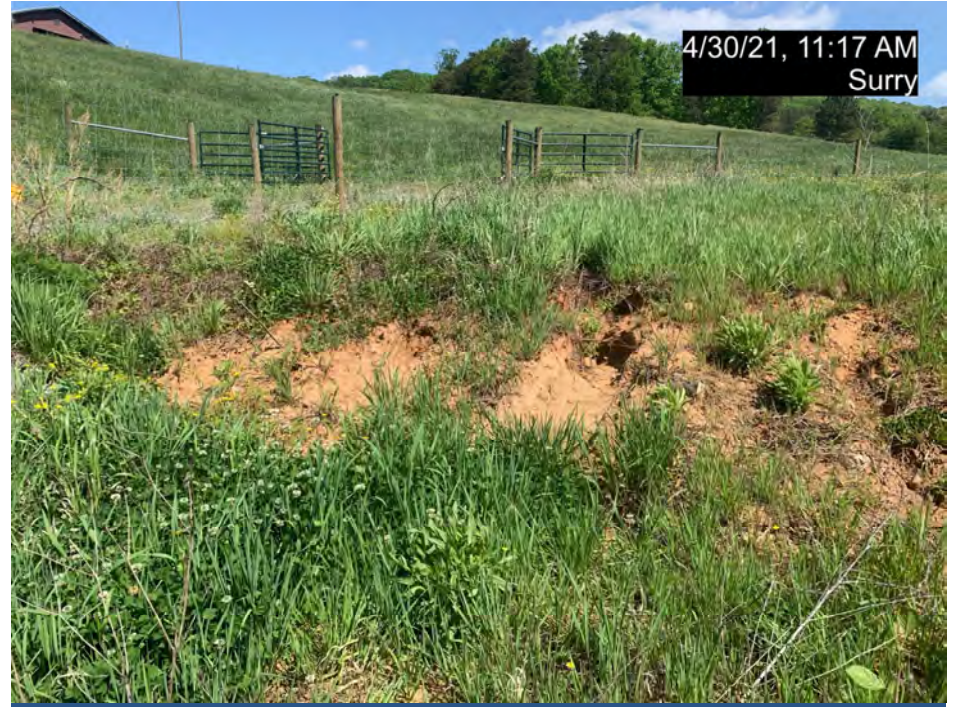
SPA4, R2 Left Floodplain, Minor Erosion (MY-02)

- **SPA4-** On R2, minor erosion was observed on both the right and left bank side slopes at approximate station 15+75, above the culvert crossing.
 - **MY2 Action:** Planted livestakes to stabilize soils in February 2021. Vegetation cover is improving in these areas and WLS will continue to monitor them closely in MY3.

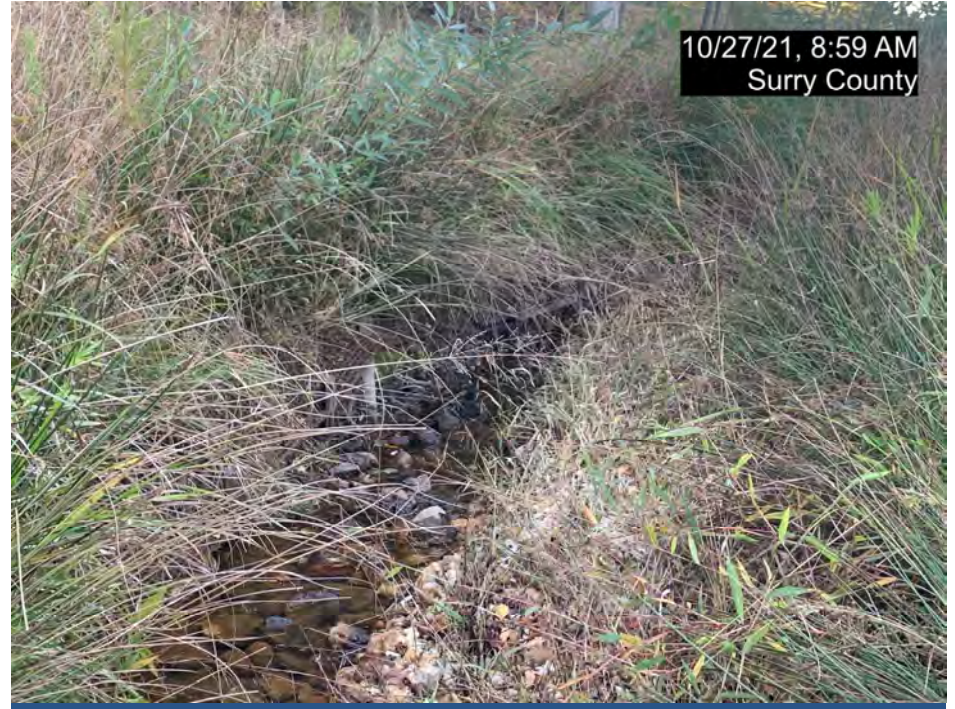
SPA8, R4, STA 20+75, Channel Bed Erosion (MY-02)

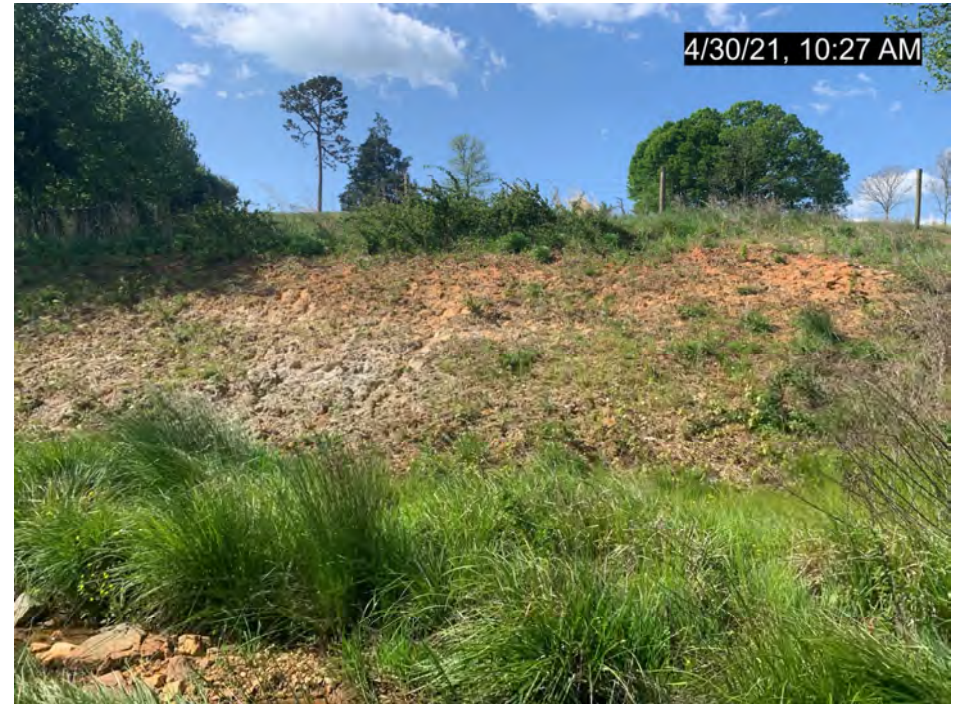
Bare Area, R1, Right Floodplain (MY-02)
