FINAL ANNUAL MONITORING REPORT IRWIN CREEK

RESTORATION SITE MECKLENBURG COUNTY, NORTH CAROLINA (EEP Project Number 192, Contract Number 004502)

Monitoring Year 4 of 5 (2014)

Prepared by:
Axiom Environmental, Inc.
218 Snow Avenue
Raleigh, North Carolina 27603

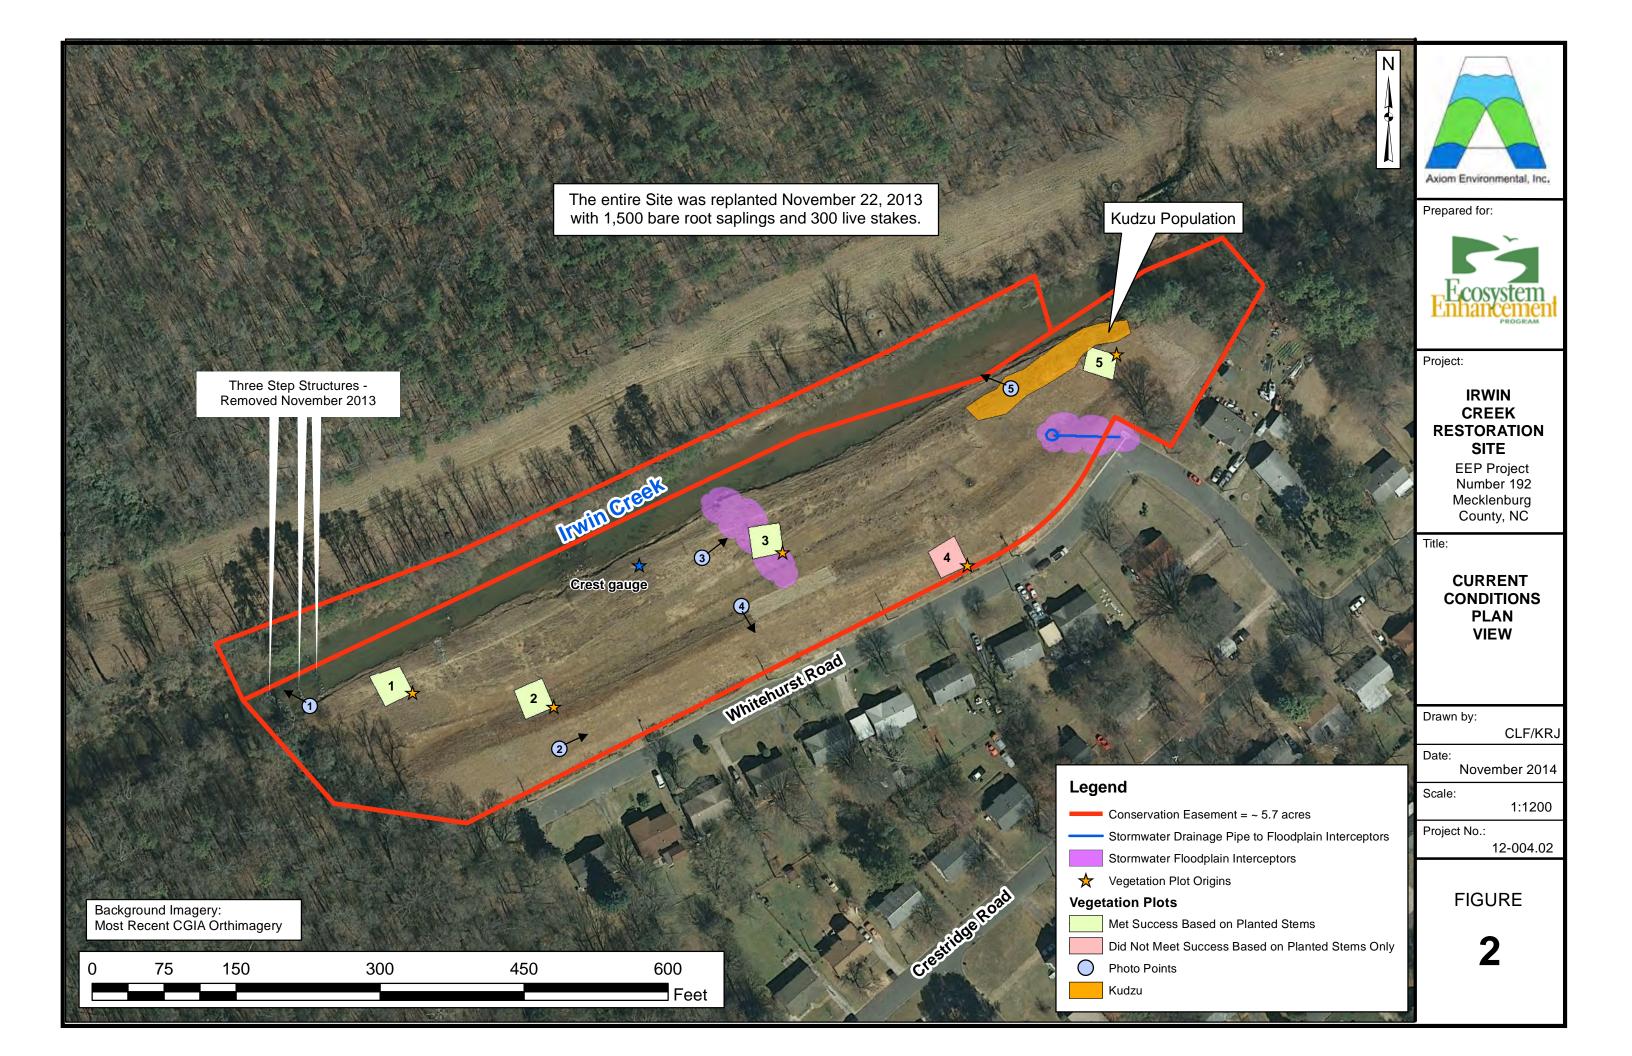
Figure 2. Current Conditions Plan View
Table 5. Vegetation Condition Assessment Table

One small patch of kudzu (*Pueraria lobata*) was observed in the streamside assemblage on the left bank of Irwin Creek in the upstream portion of the Site (Figure 2, Appendix B).

Vegetation Category	Definitions	Mapping Threshold	CCPV Depiction	Number of Polygons	Combined Acreage	% of Easement Acreage
4. Invasive Areas of Concern ⁴	Invasive Areas of Concern ⁴ Small patch f kudzu on the left bank of Irwin Creek in the upstream portion of the Site.				0.11	0.8%
5. Easement Encroachment Areas ³	NA	NA	NA	NA	NA	NA

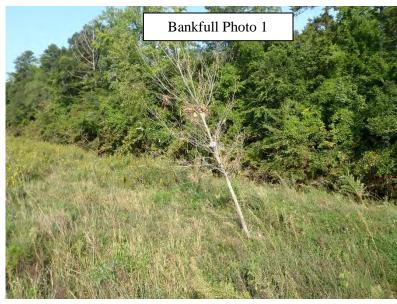
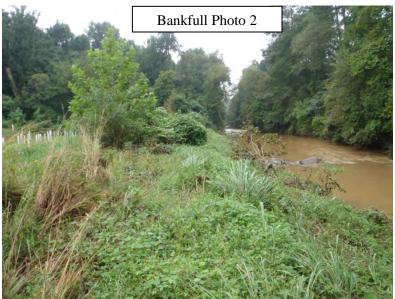
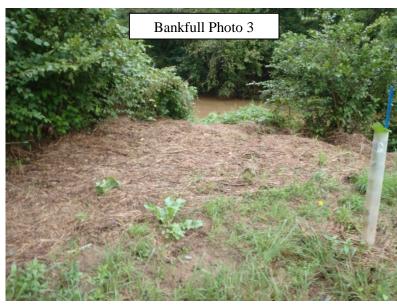
Table 9. Verification of Bankfull Events

May 12, 2014	January 19, 2014	Bankfull event likely occurred after a total of 2.80 inches** of rain reported to fall over two days (January 18-19, 2014).	
September 17, 2014	August, 1 2014	Bankfull event documented after a total of 3.85 inches* of rain reported to fall over two days (July 31-August 1 2014).	2, 3
