**Jones Creek Mitigation Project
Anson County, North Carolina
DENR-EEP Contract No. D04020-1
FINAL Year 5 Monitoring Report**

April 2011

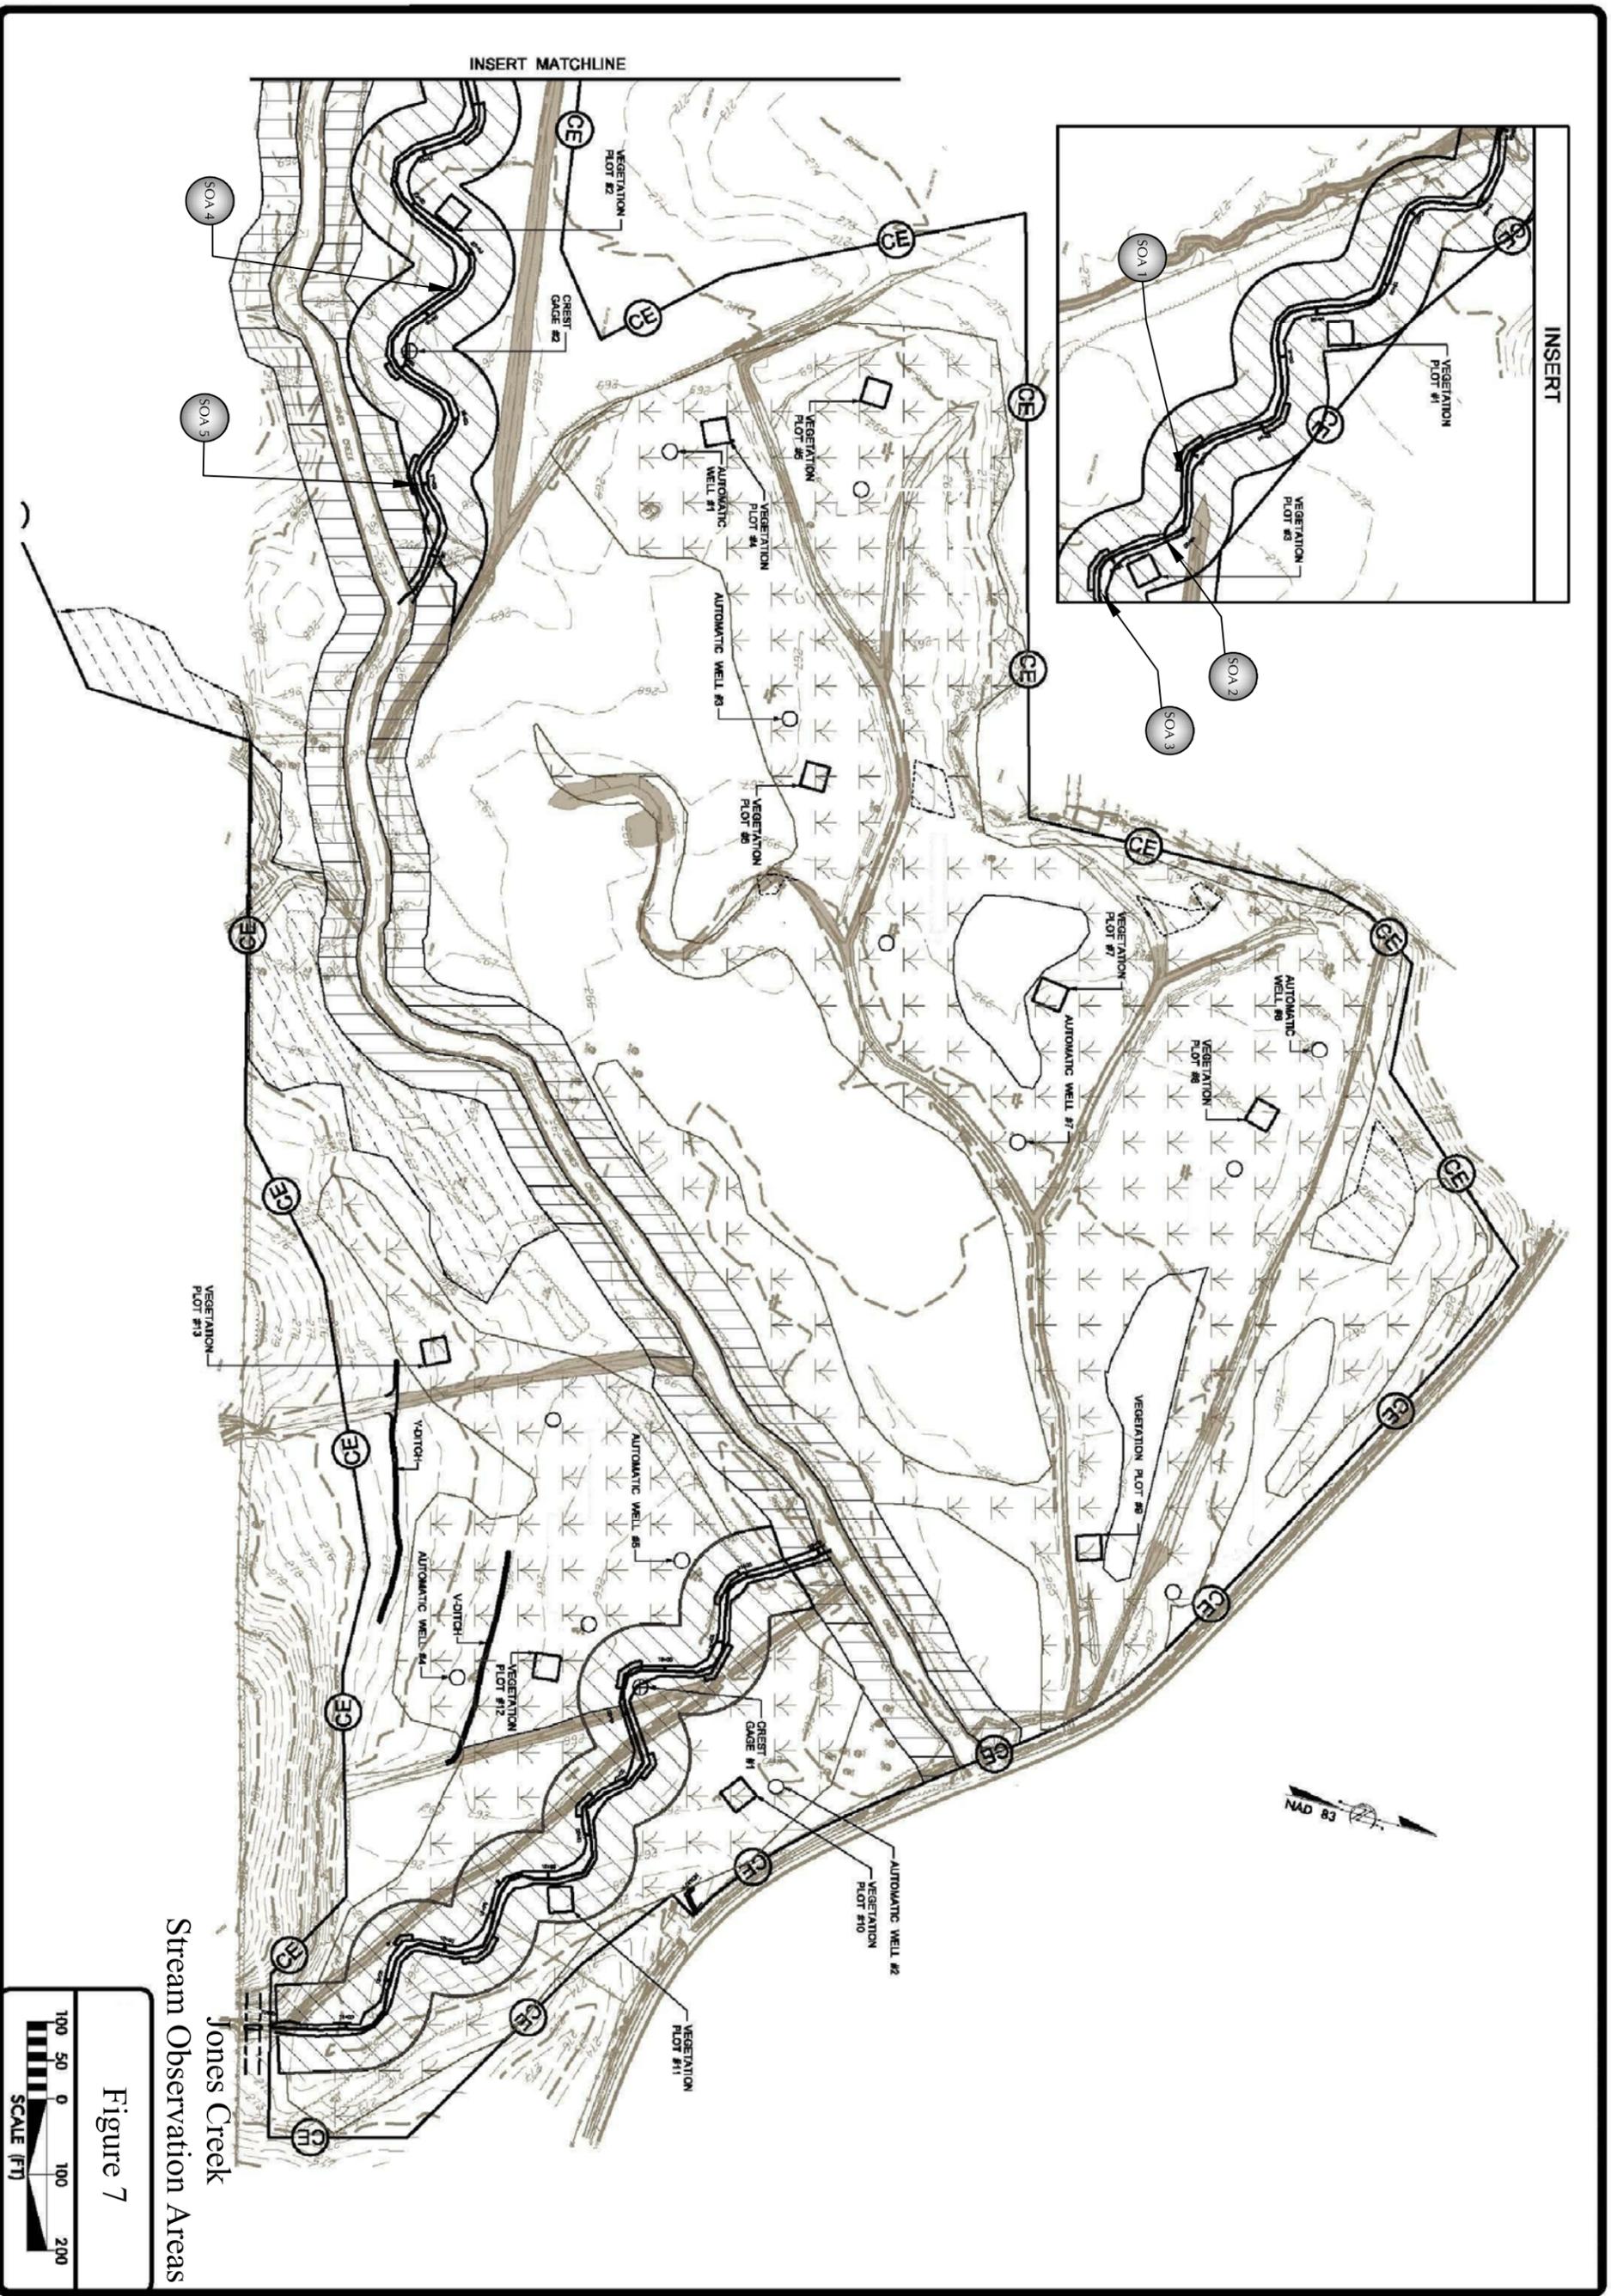
Figure 7

In-stream structures installed within the restored stream included constructed riffles, log vanes, log weirs, rock step pools, J-hooks, rock cross vane, and root wads. Visual observations of structures throughout the 2010 growing season indicated that most structures are functioning as designed. Five beaver dams were located throughout the Mill Branch reach restricting stream flow. These beaver dams have been removed; however, they were not affecting the streams stability or the success criteria of Mill Branch.

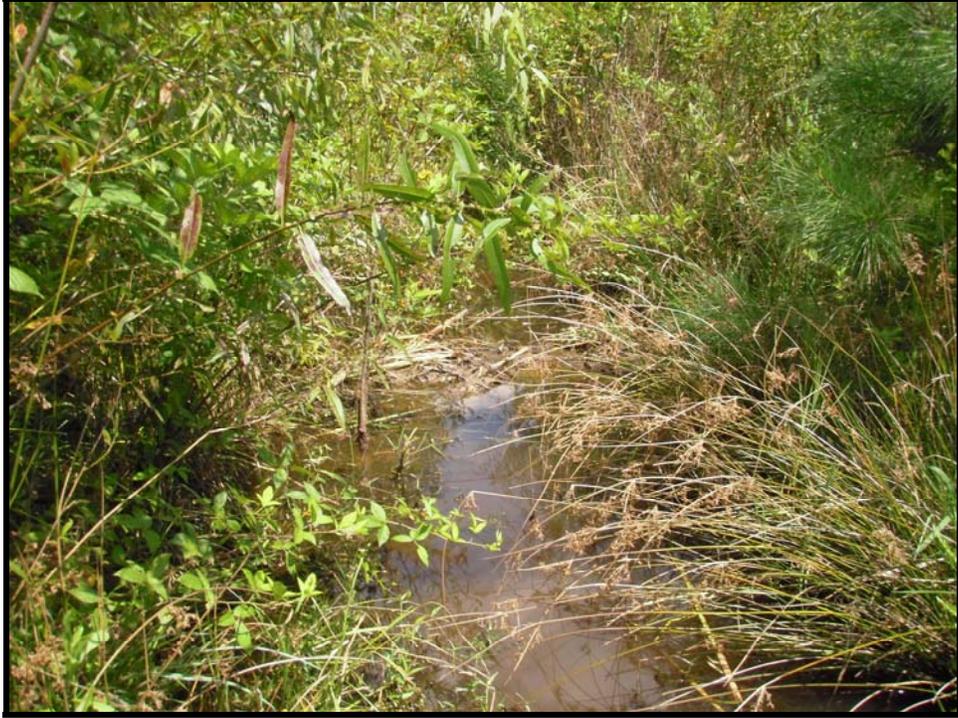
SOA 1, Mill Branch Station 17+25 – Beaver Dam

S0A	Station	Description/Recommendation
1	Mill Branch 17+25	Beaver Dam / Removal of the dam is recommended.
2	Mill Branch 18+20	Beaver Dam / Removal of the dam is recommended.
3	Mill Branch 19+50	Beaver Dam / Removal of the dam is recommended.
4	Mill Branch 23+50	Beaver Dam / Removal of the dam is recommended.
5	Mill Branch 27+00	Beaver Dam / Removal of the dam is recommended.

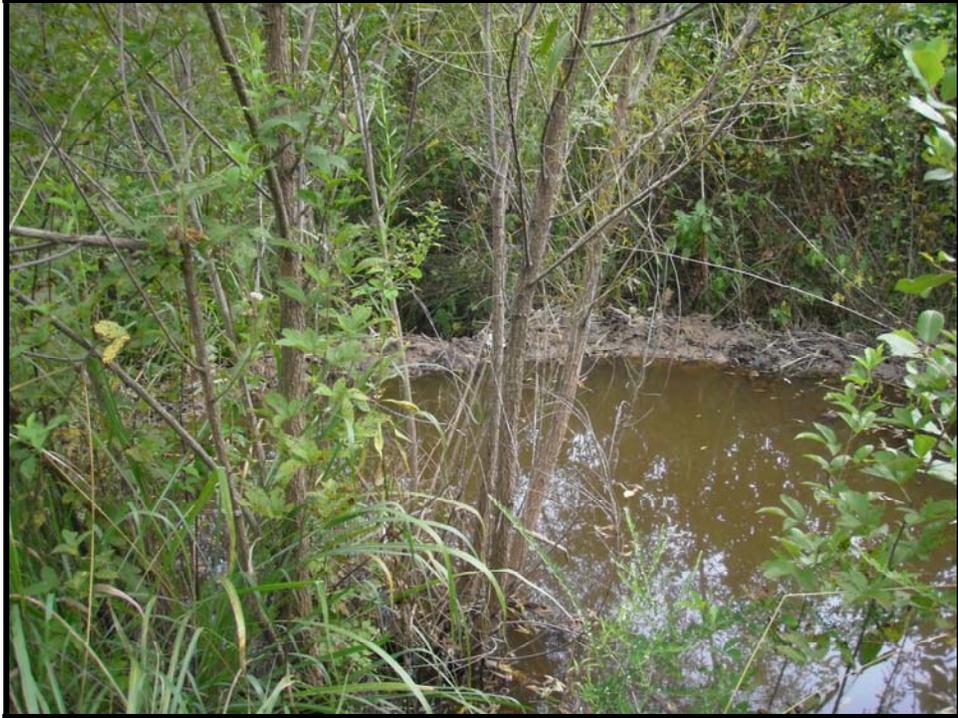
SOA 2, Mill Branch Station 18+20 – Beaver Dam

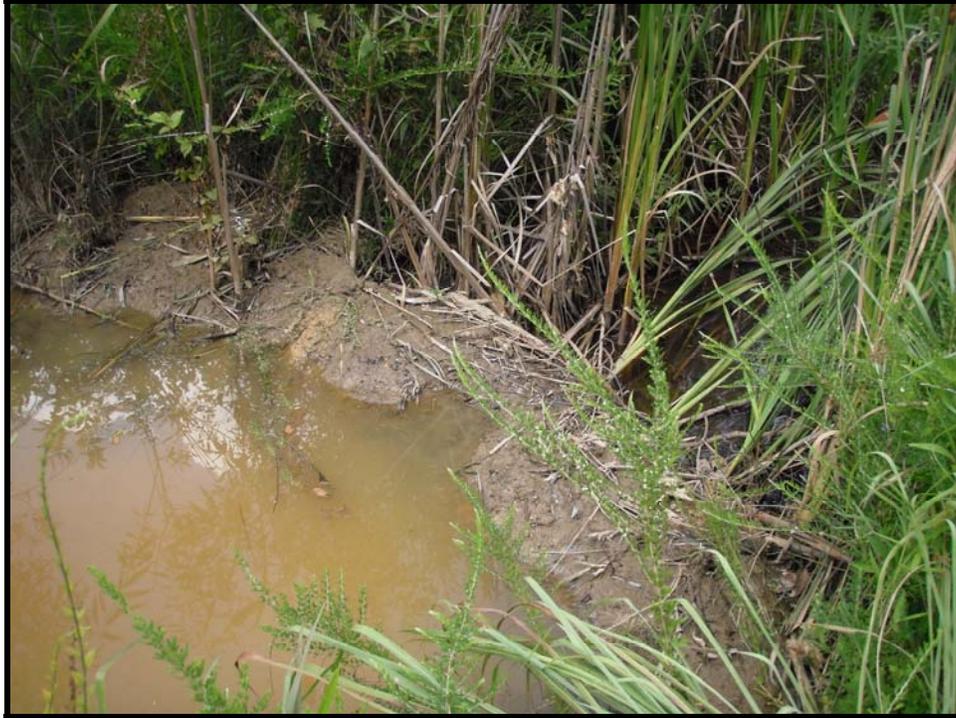
SOA 3, Mill Branch Station 19+50 – Beaver Dam

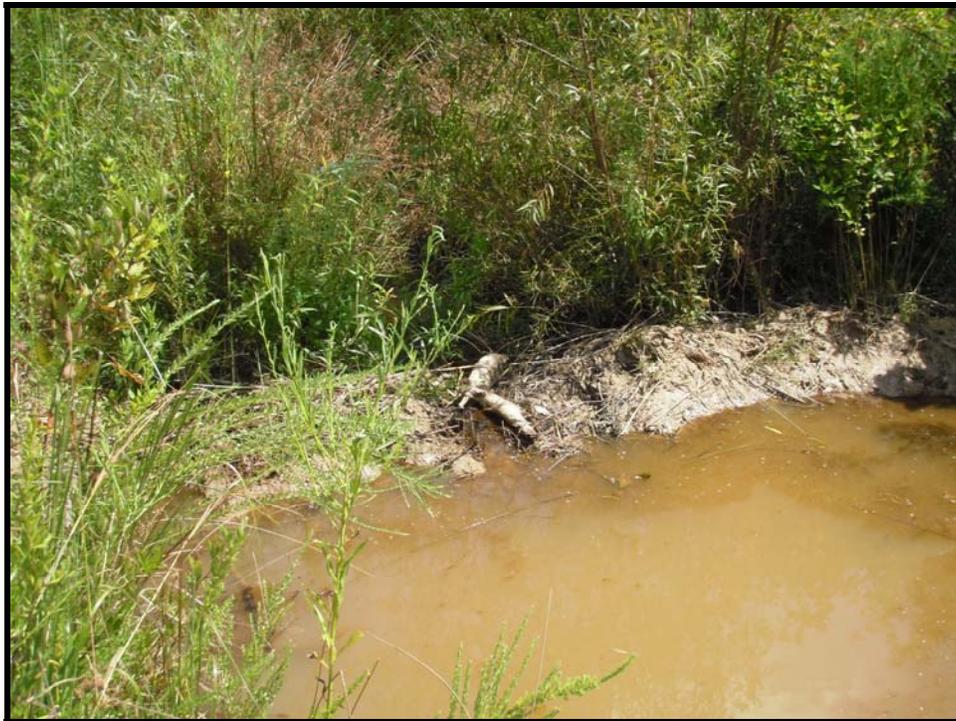
SOA 4, Mill Branch Station 23+50 – Beaver Dam

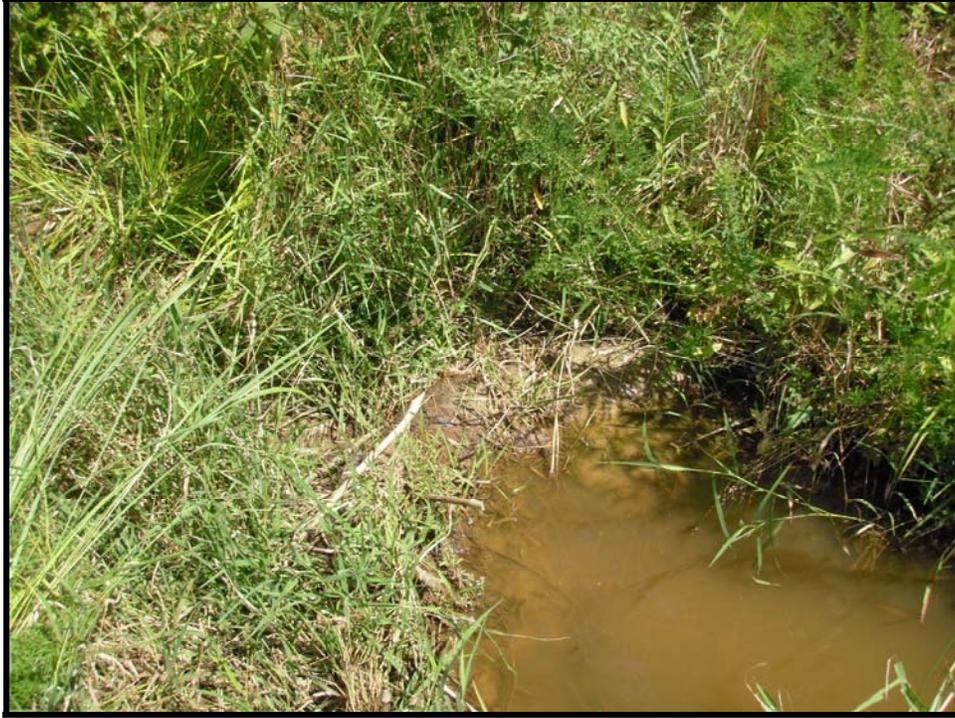
SOA 5, Mill Branch Station 27+00 – Beaver Dam

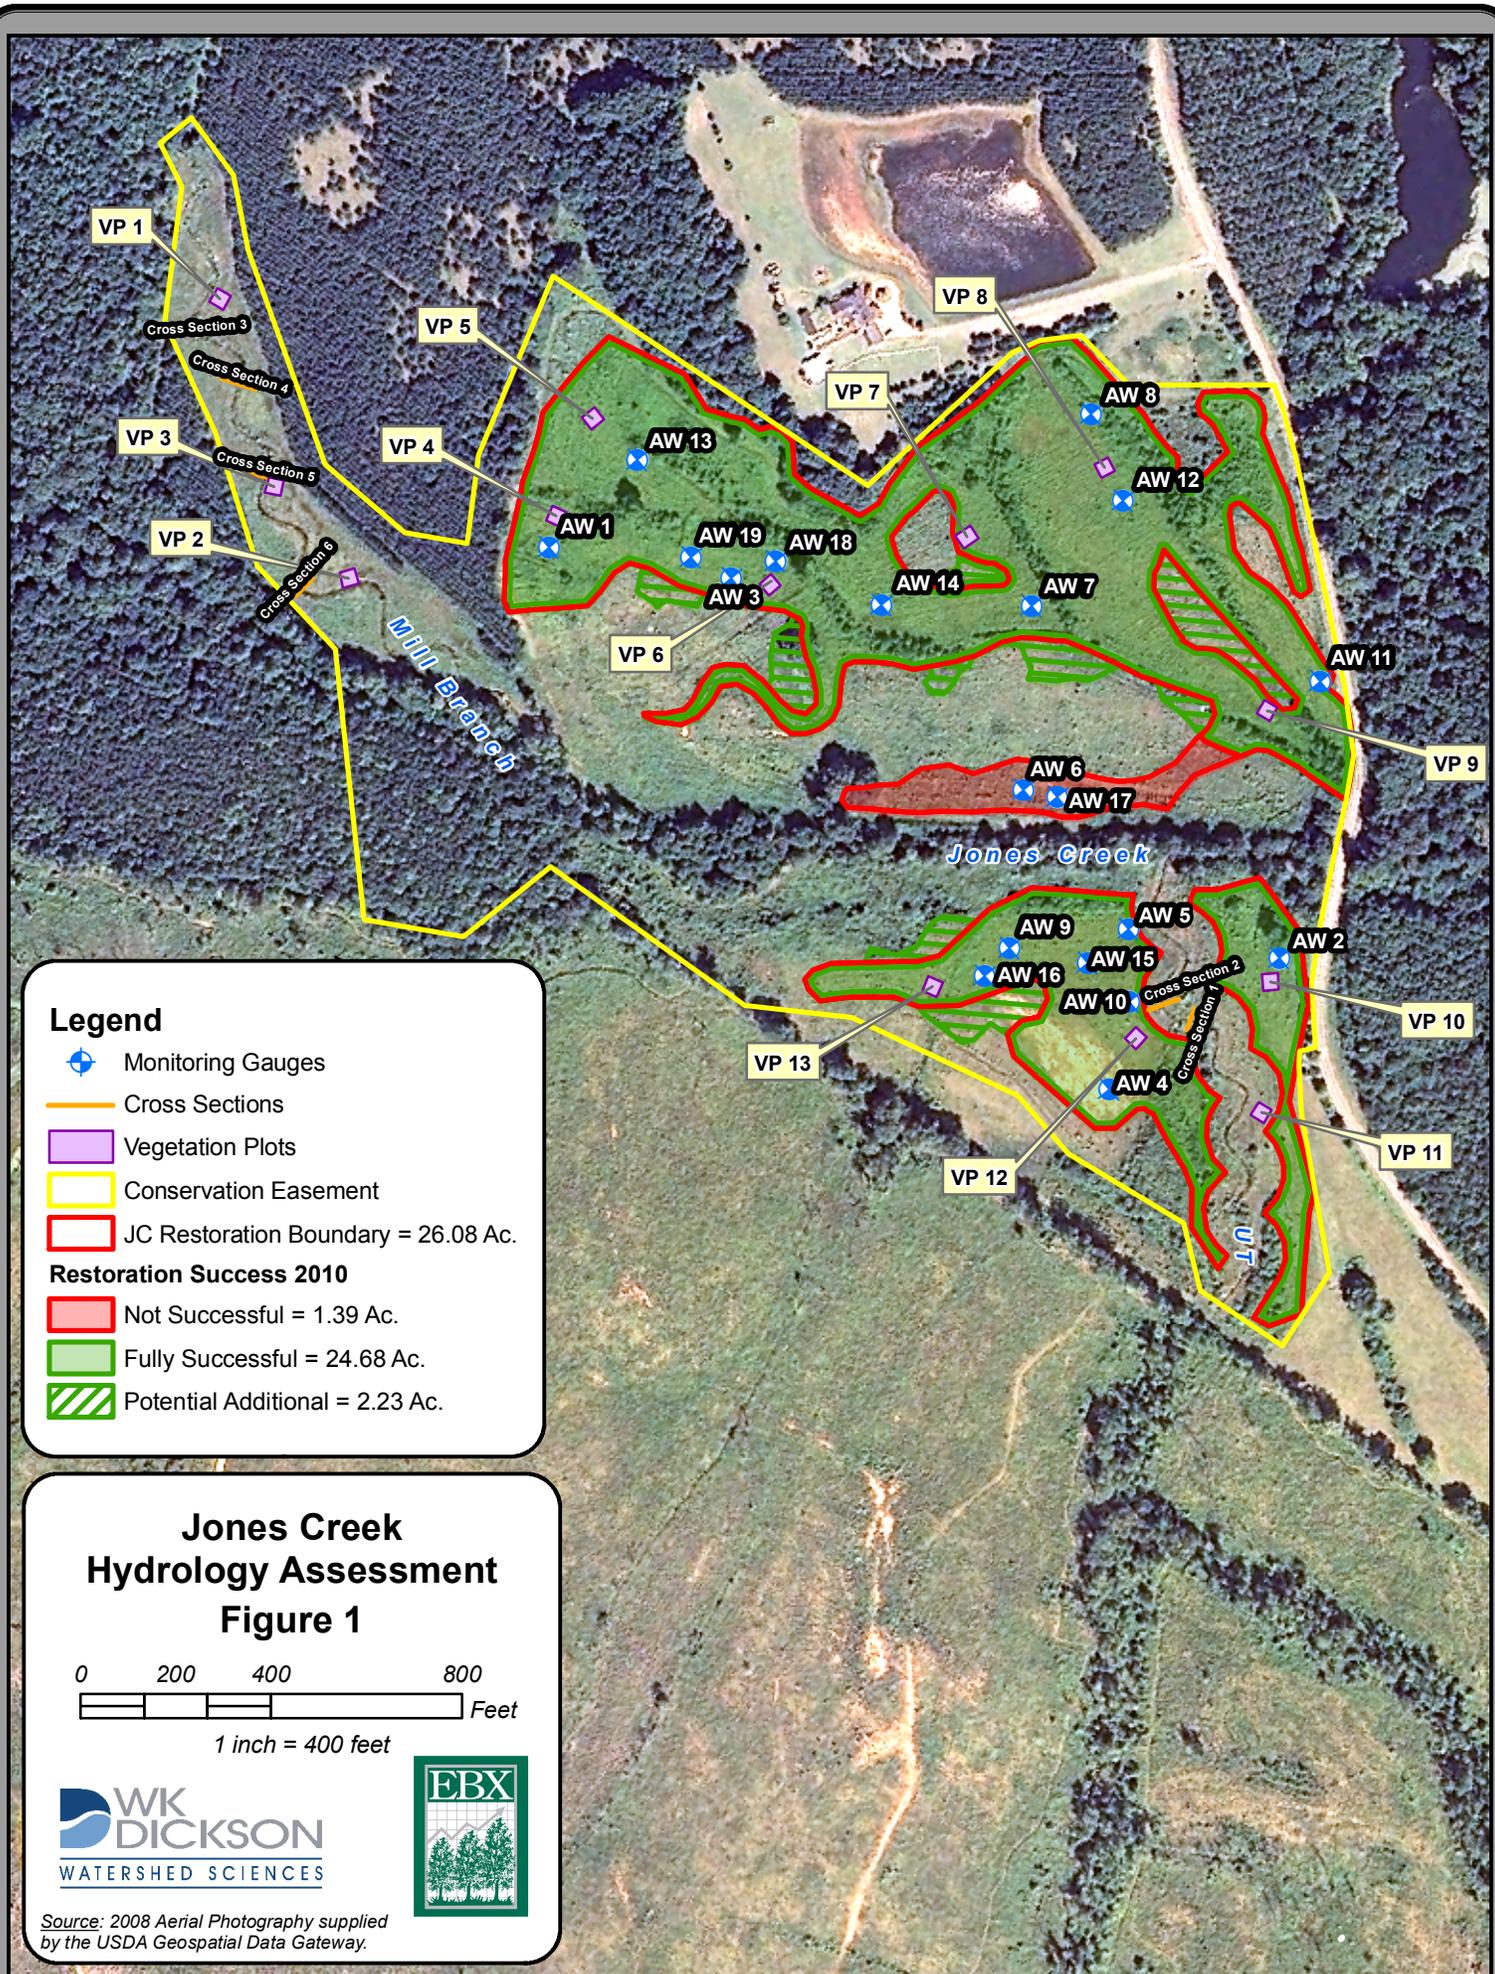
- Monitoring Gauges
- Cross Sections
- Vegetation Plots
- Conservation Easement
- JC Restoration Boundary = 26.08 Ac.
- Restoration Success 2010**
- Not Successful = 1.39 Ac.
- Fully Successful = 24.68 Ac.
- Potential Additional = 2.23 Ac.

For the gauges AW6 and AW17 that failed to meet the 7 percent wetland hydroperiod within 12 inches of the surface, a linear hydraulic gradient was developed with an adjacent successful gauge (AW11). For the successful AW11, the minimum depth at which 7 percent hydroperiod was achieved ranged from -0.77 to 3.35 inches from the surface (**Table 2**). For gauges AW6 and AW17, the minimum depth at which 7 percent hydroperiod was achieved ranged from -21.56 to 26.11 inches and from -20.86 to 25.16 inches from the surface.
