**Juniper Bay Wetland Mitigation Site**  
**Robeson County, NC**

**2006 Annual Monitoring Report**  
**Year 1 of 5**

NCEEP Project Number 201

Date: January 2007

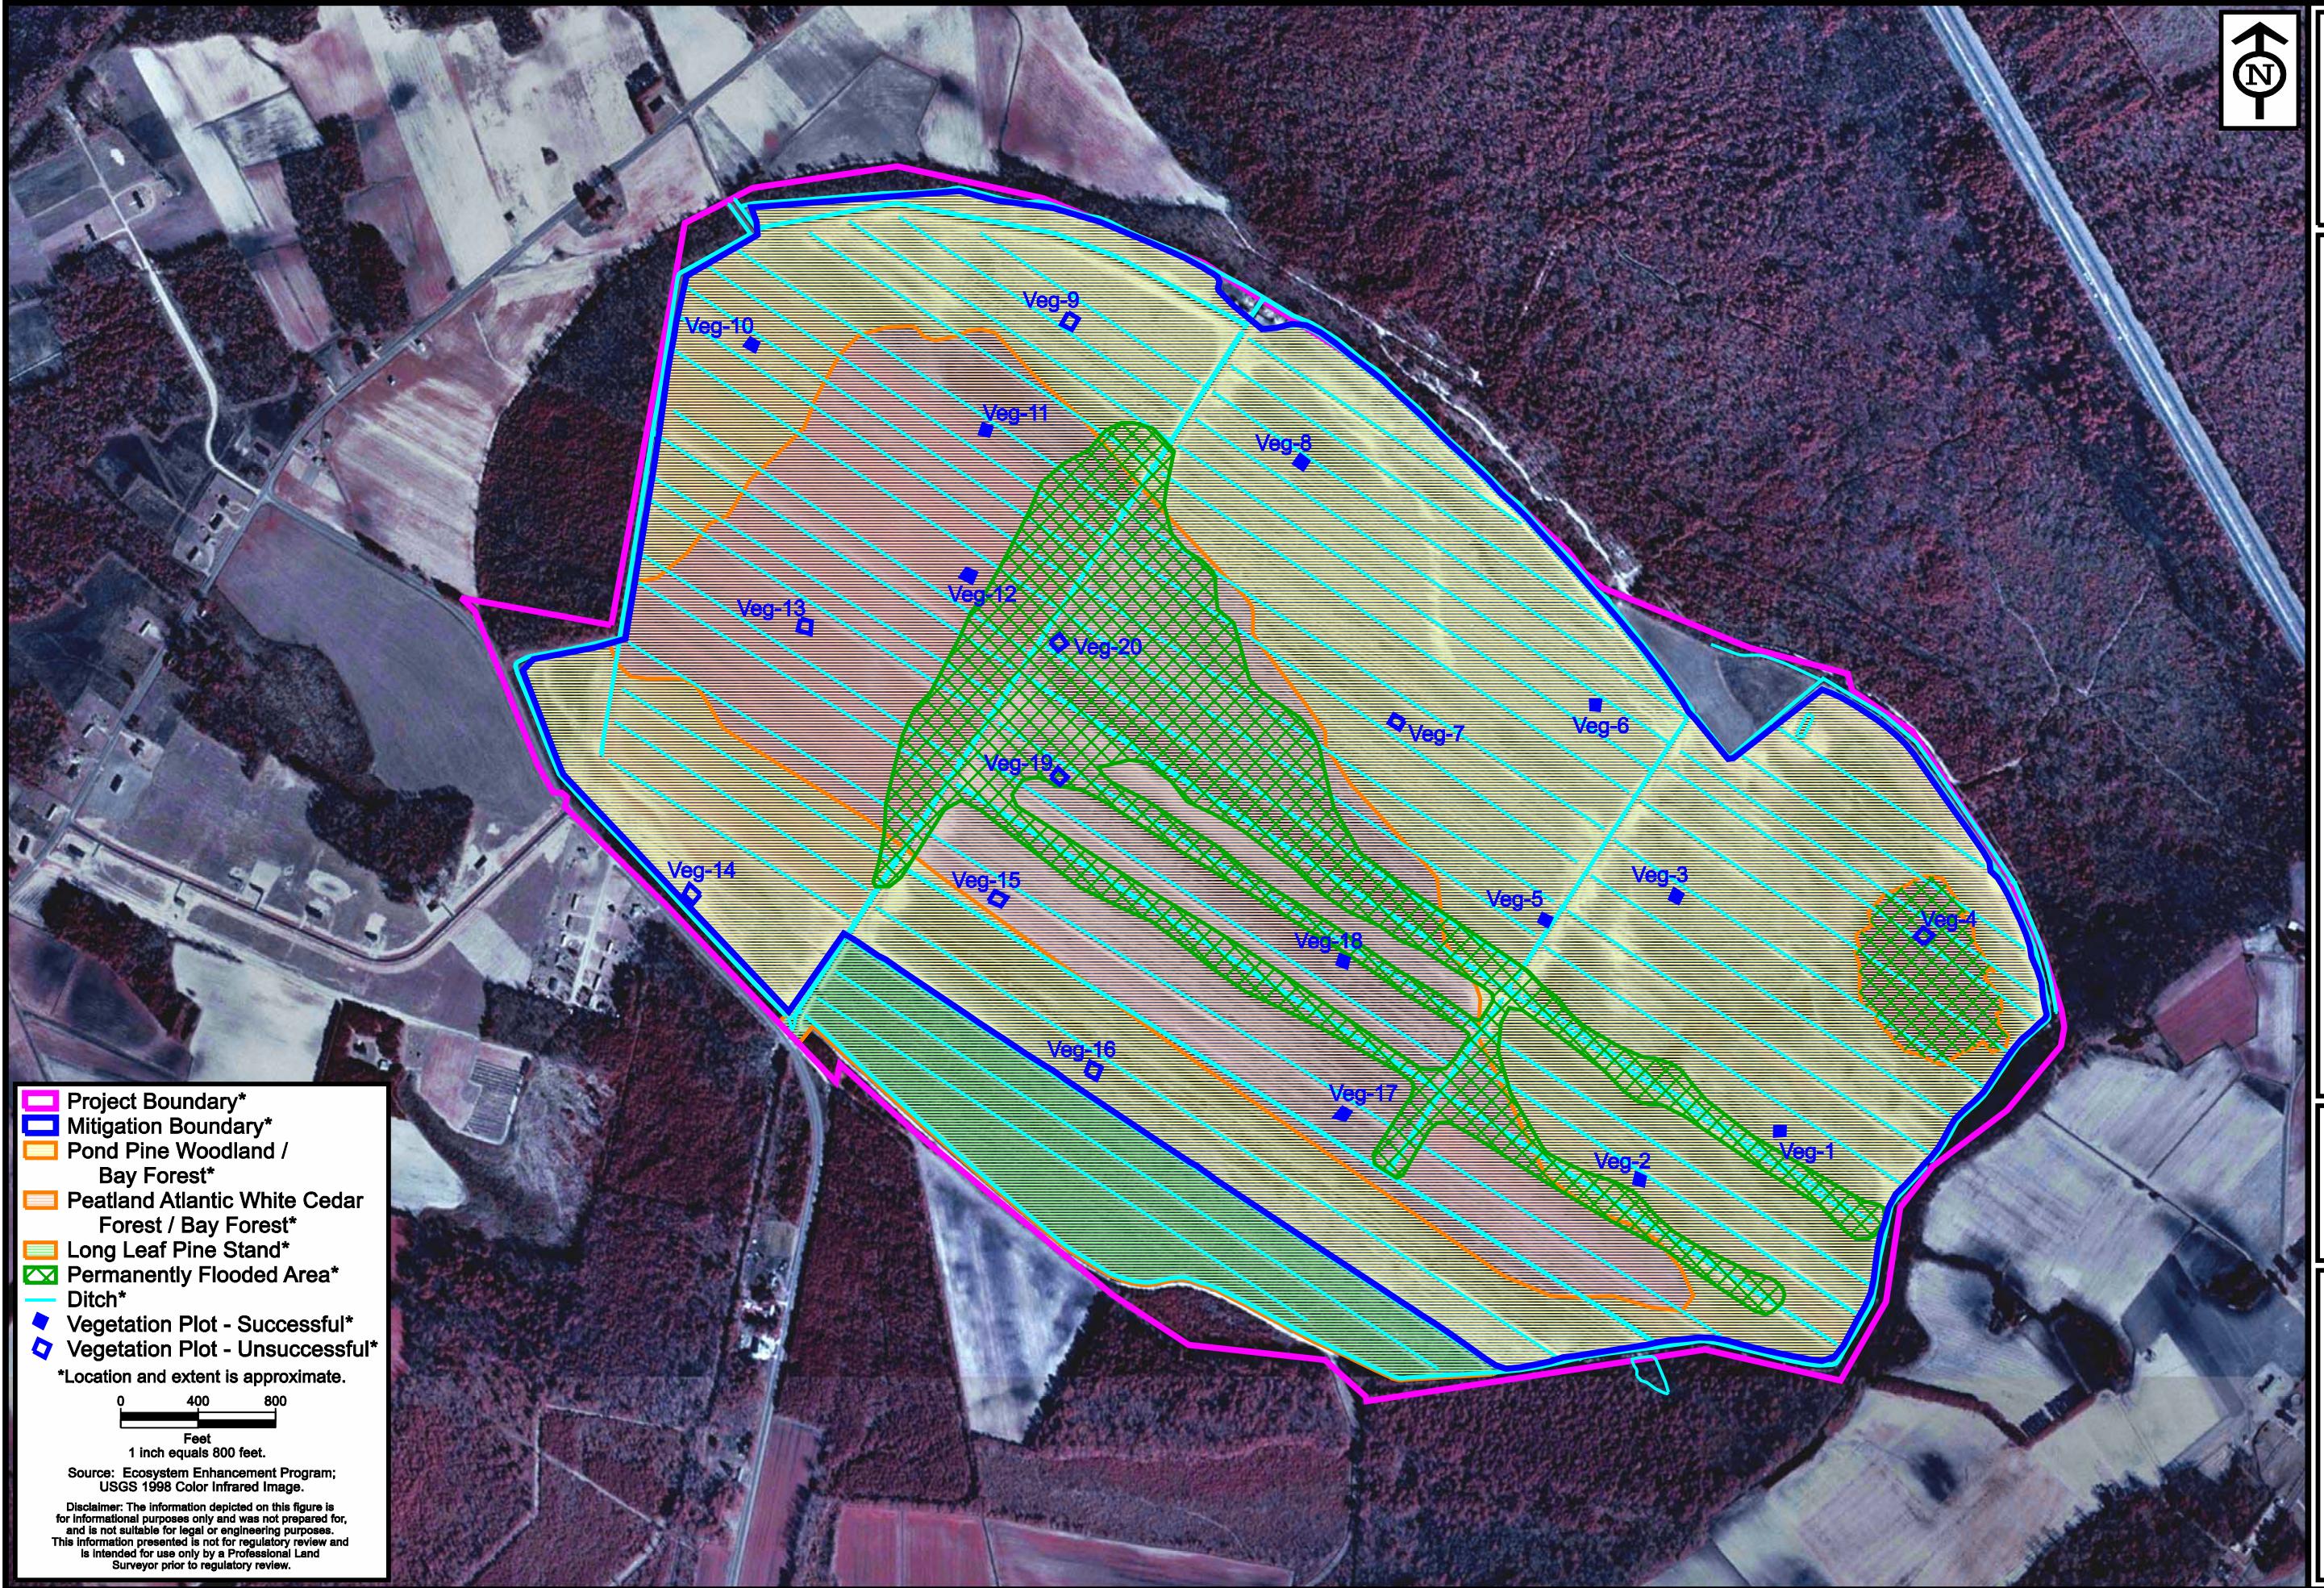
Project: ER06040.00  
Date: Dec 2006  
Drwn/Chkd: AJS/GT  
Figure: 3a

Figure 3a depicts a hand-drawn approximation of the areas that are permanently flooded. These areas account for approximately 115 acres, which includes plots 4, 19, and 20. These

plots had water levels greater than one foot, which could negatively affect species survival. These three plots are located in the Peatland Atlantic White Cedar Forest/Bay Forest community. This community type occupies the wetter portions of the site thereby increasing the likelihood of high water contributing to sapling mortality. Plot 4 is located in a topographic depression underlain by a clayey subsoil and is located too far from a primary ditch outlet to receive drainage increasing potential high water conditions.

Plots, 7, 9, 14, and 16 are located in the Pond Pine Woodland/Bay Forest community. The soils within this community type are sandy soils with low organic matter content, which may inhibit survival.

Plots, 13 and 15 are located in the Peatland Atlantic White Cedar Forest/Bay Forest community. These plots may be adversely affected by the dense growth of pioneer herbaceous vegetation, primarily dog fennel (*Eupatorium capillifolium*) and goldenrod (*Solidago* spp.). This herbaceous growth may result in competition-induced mortality or may block sunlight to the saplings due to the dense midstory.

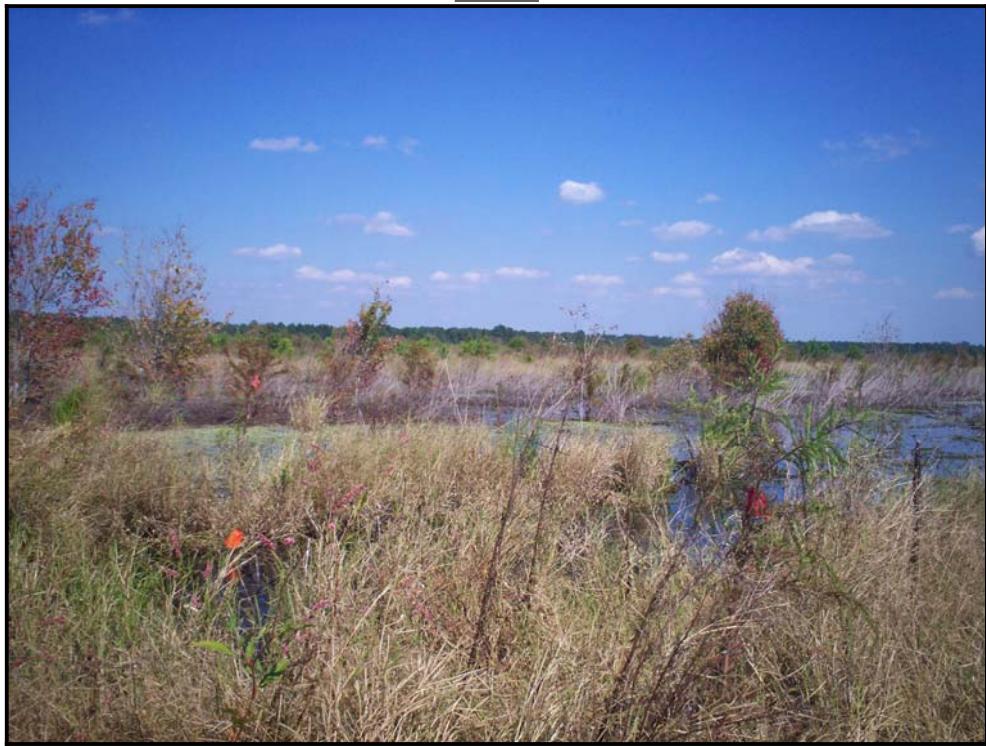
Plot 19

Feature/Issue	Plot	Probable Cause	Photo #
Submerged	19	Adjacent to drainage ditch with overtopped bank. >25% of plot submerged > 1 ft.	VPA 1
Submerged	20	Low area in center of site adjacent to drainage ditch. 40% of plot submerged > 1 ft.	VPA 2
Submerged	4	Low area in eastern portion of site. Approximately 1 ft. water across plot.	VPA 3
Herbaceous growth	15	Dense herbaceous midstory.	VPA 4

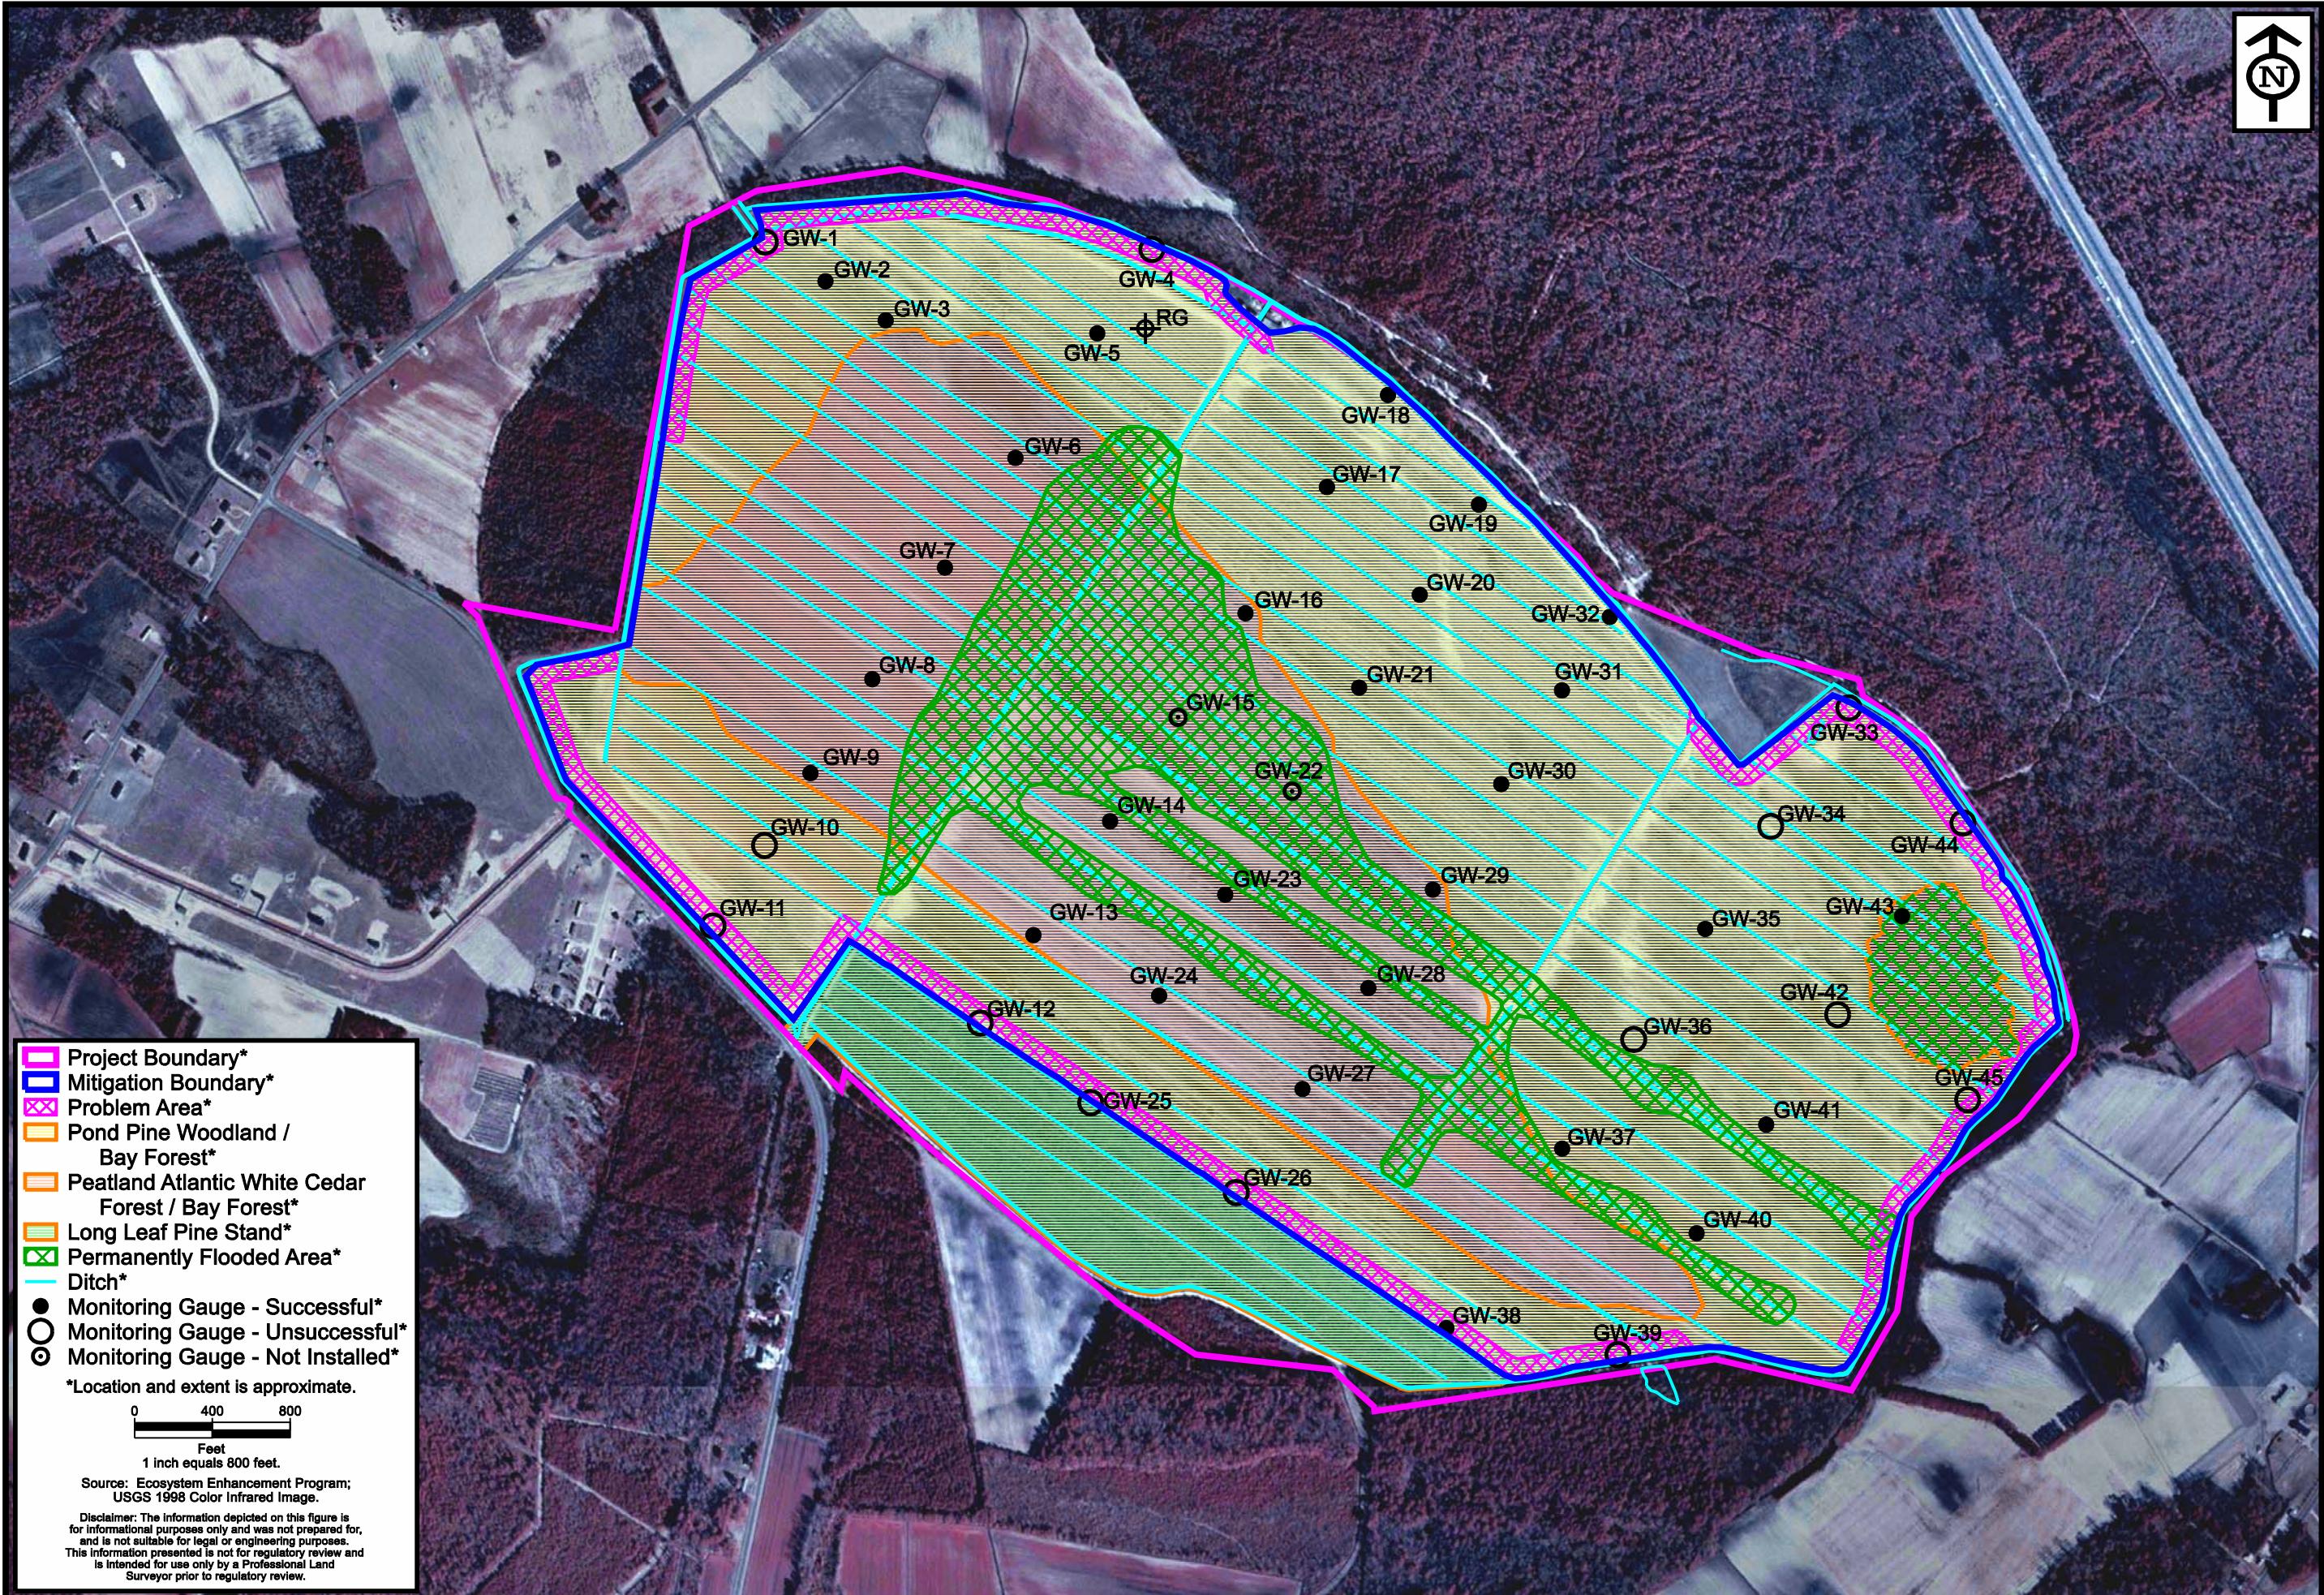
Project: ER06040.00  
Date: Dec 2006  
Drwn/Chkd: AJS/GT  
Figure: 4

During the 2006 monitoring period, 29 of the 43 monitoring gauges met the hydrology success criteria (Table VI.), a 67.4% success rate. However, based on the JBMS Mitigation Plan, there are 13 gauges located adjacent to the perimeter ditch that are not expected to be restored to jurisdictional status. Only three of the 13 perimeter gauges met jurisdictional hydrology. Of the remaining 30 interior gauges 26 met the hydrology success criterion, an 86.6% success rate. Hydrographs for the individual monitoring gauges can be found in Appendix B.

There are 13 perimeter gauges that are located adjacent the perimeter ditch in the Pond Pine Woodland/ Bay Forest community. The perimeter ditch remains open in order to avoid hydrologic trespass issues. The location of these 13 gauges represents portions of the site which are not expected to meet the wetland criterion due to the adjacent ditch's zone of influence. Additionally, Carolina bay topography is somewhat bowl shaped. The center of the mitigation site has a lower elevation, but slopes outward to a dry sand ridge, which encloses the bay. These 13 gauges are all located in this drier sand ridge area. Ten of the 13 perimeter gauges did not meet the hydrologic success criterion.

Of the 17 remaining gauges in the Pond Pine Woodland/ Bay Forest community, 13 (76.5%) met the hydrological success criterion. Gauges GW-10, GW-34, GW-36, and GW-42 did not meet the hydrologic success criterion. The soils within this community type are sandy with higher infiltration rates than those in the Peatland Atlantic White Cedar Forest/ Bay Forest community. Additionally, the Pond Pine Woodland/ Bay Forest community was designated for areas of the site with higher elevations in the bay. The sandy soils and higher elevations may explain why these gauges did not meet the success criteria, although further observation is warranted.
