**Kings Creek
Stream Restoration
NCEEP Project Number: 208
Monitoring Project Number: D09082S
Monitoring Year 4
2012 Final Report**

**Submitted to
North Carolina Ecosystem Enhancement Program
North Carolina Department of Environment and Natural Resources
November 2012**

Kings Creek Stream Restoration 2012 Monitoring Report (MY 4)

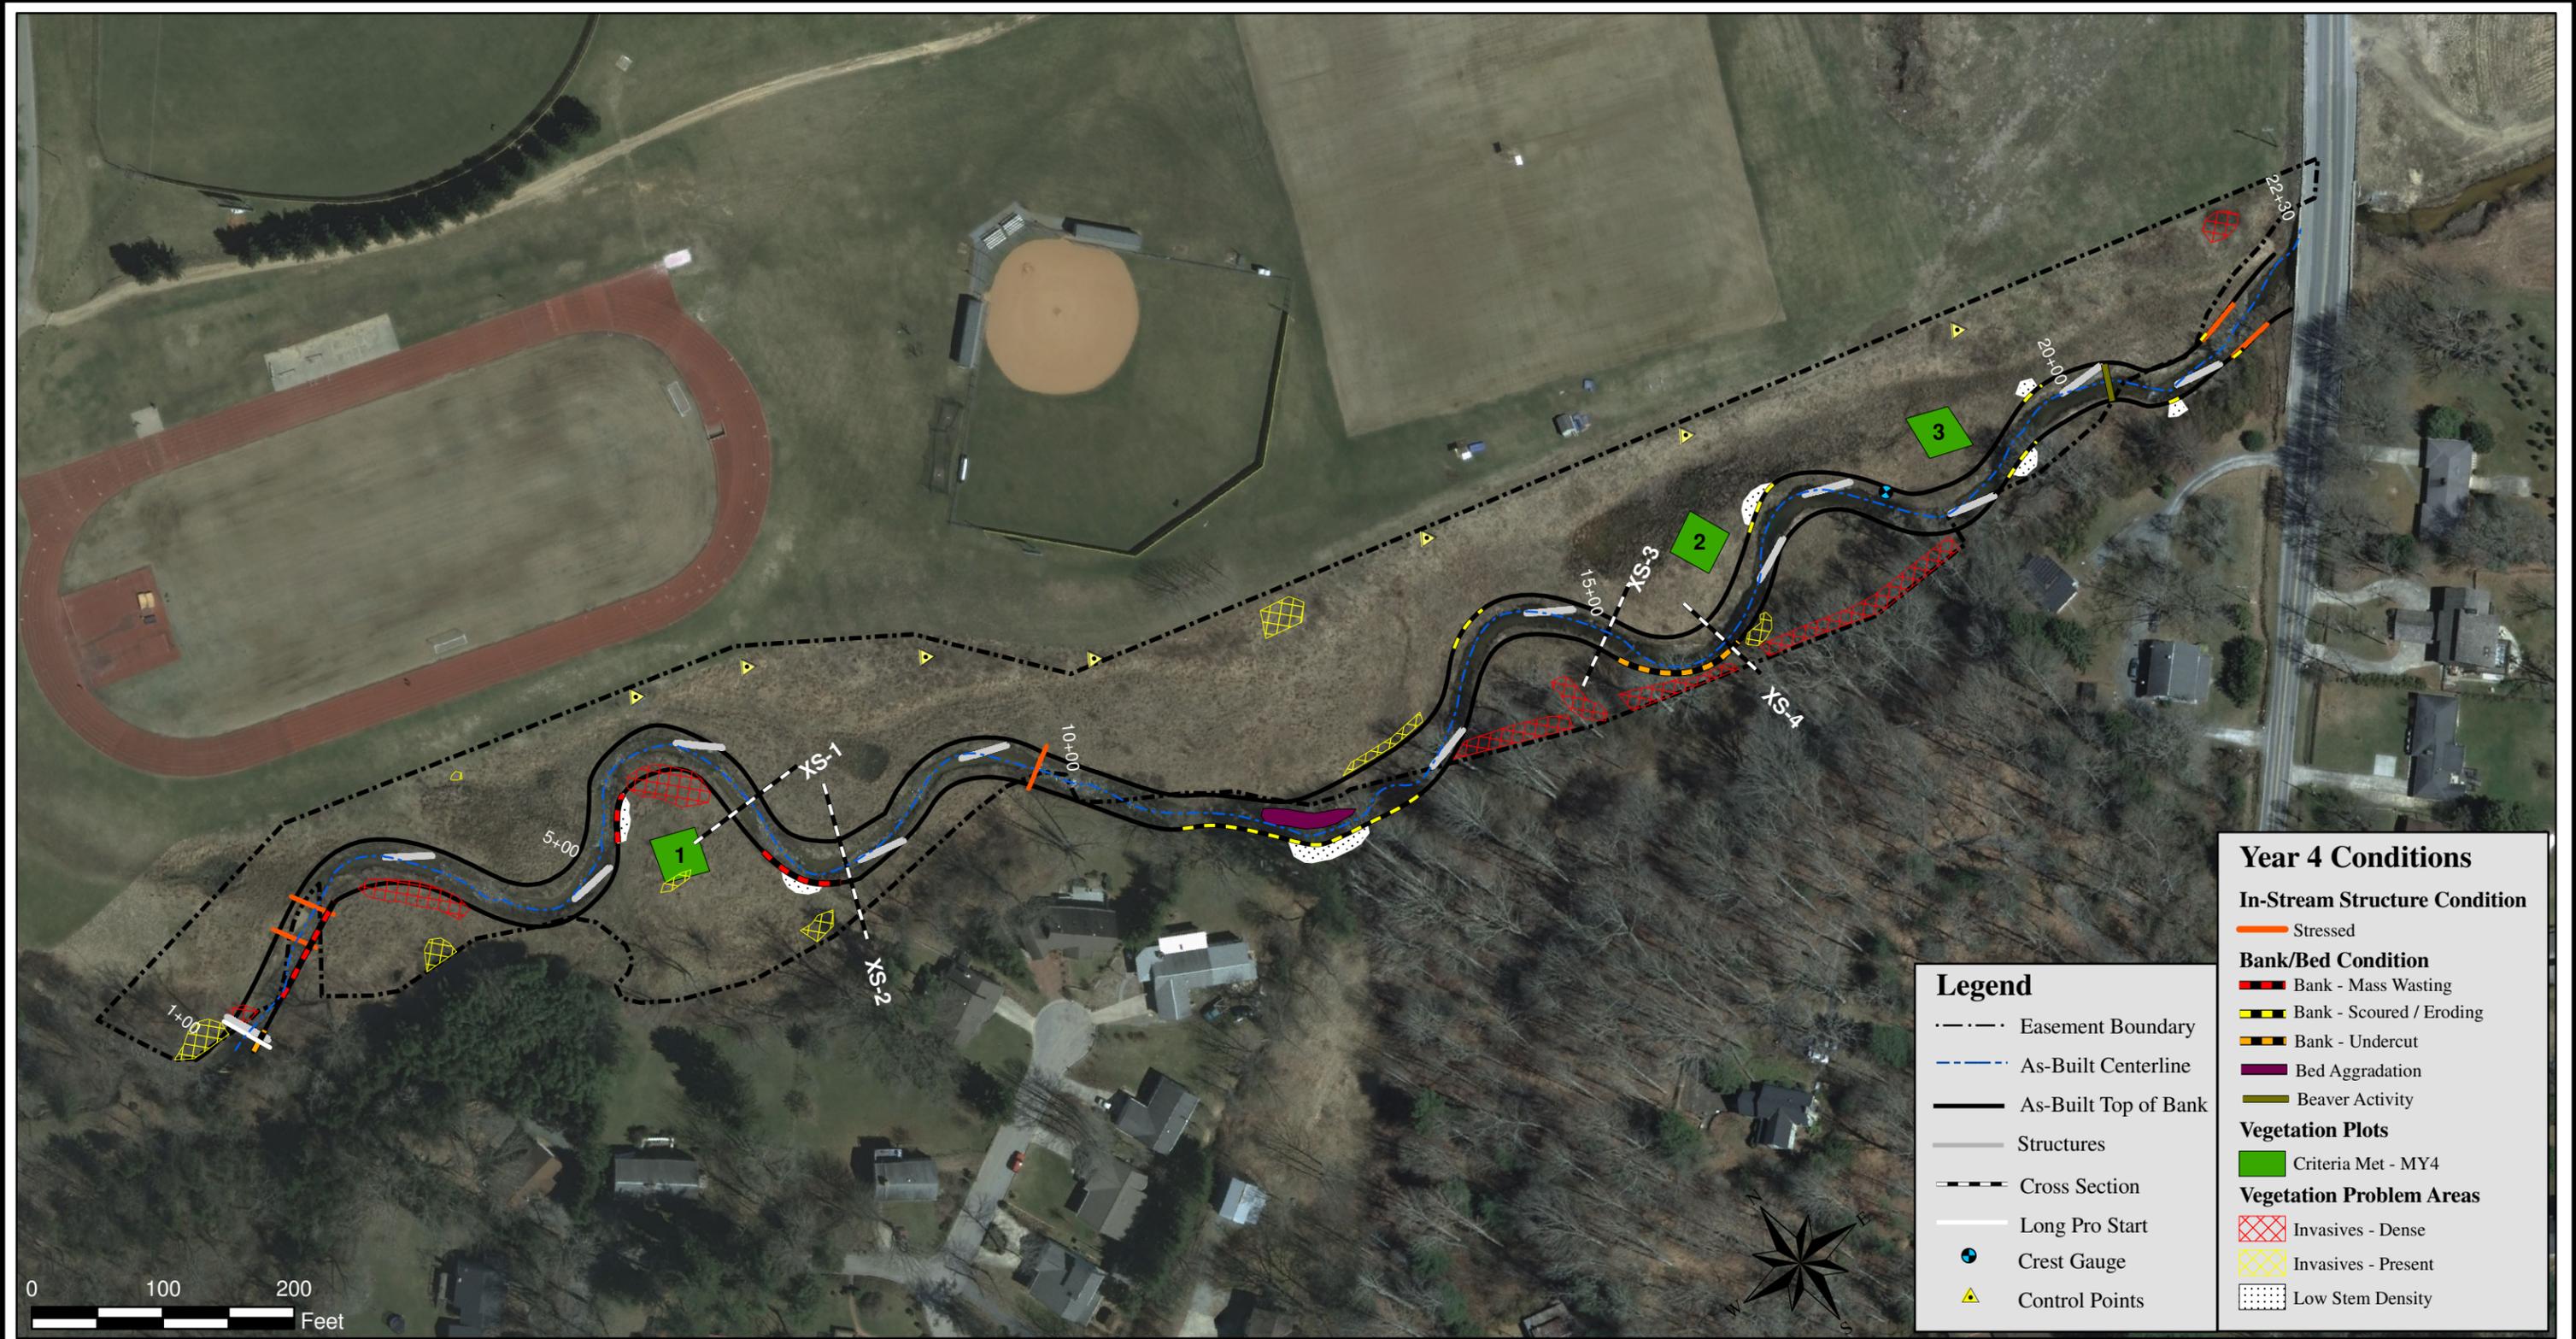
Figure 2. Integrated Current Condition Plan View Final

Stream longitudinal profiles have remained relatively stable among monitoring years. The primary stream issue observed during MY4 was bank erosion resulting from thalweg migration and low woody stem densities. In particular, thalweg migration has continued at station 2+00 (83 feet) and 5+25 (38 feet) causing further bank erosion. These two areas of concern have continued to actively erode between monitoring years. All other morphological metrics indicated performance percentages averaging between 88 and 100%. One beaver dam was noted at the lower end of the reach during separate monitoring visits. EEP was informed and a beaver removal request form was submitted to the Animal and Plant Health Inspections Service's (APHIS) on both occasions. APHIS removed the beaver dam and two beavers from the lower reach of Kings Creek on October 29, 2012. Based on the presence of wrack lines and crest gauge monitoring two bankfull events were documented in MY4.
