# Lick Creek Stream Restoration Site MONITORING REPORT 2008 (Year 3)

Cataloging Unit: 0303004 EEP Contract #: D04013-1

**November 20, 2008**

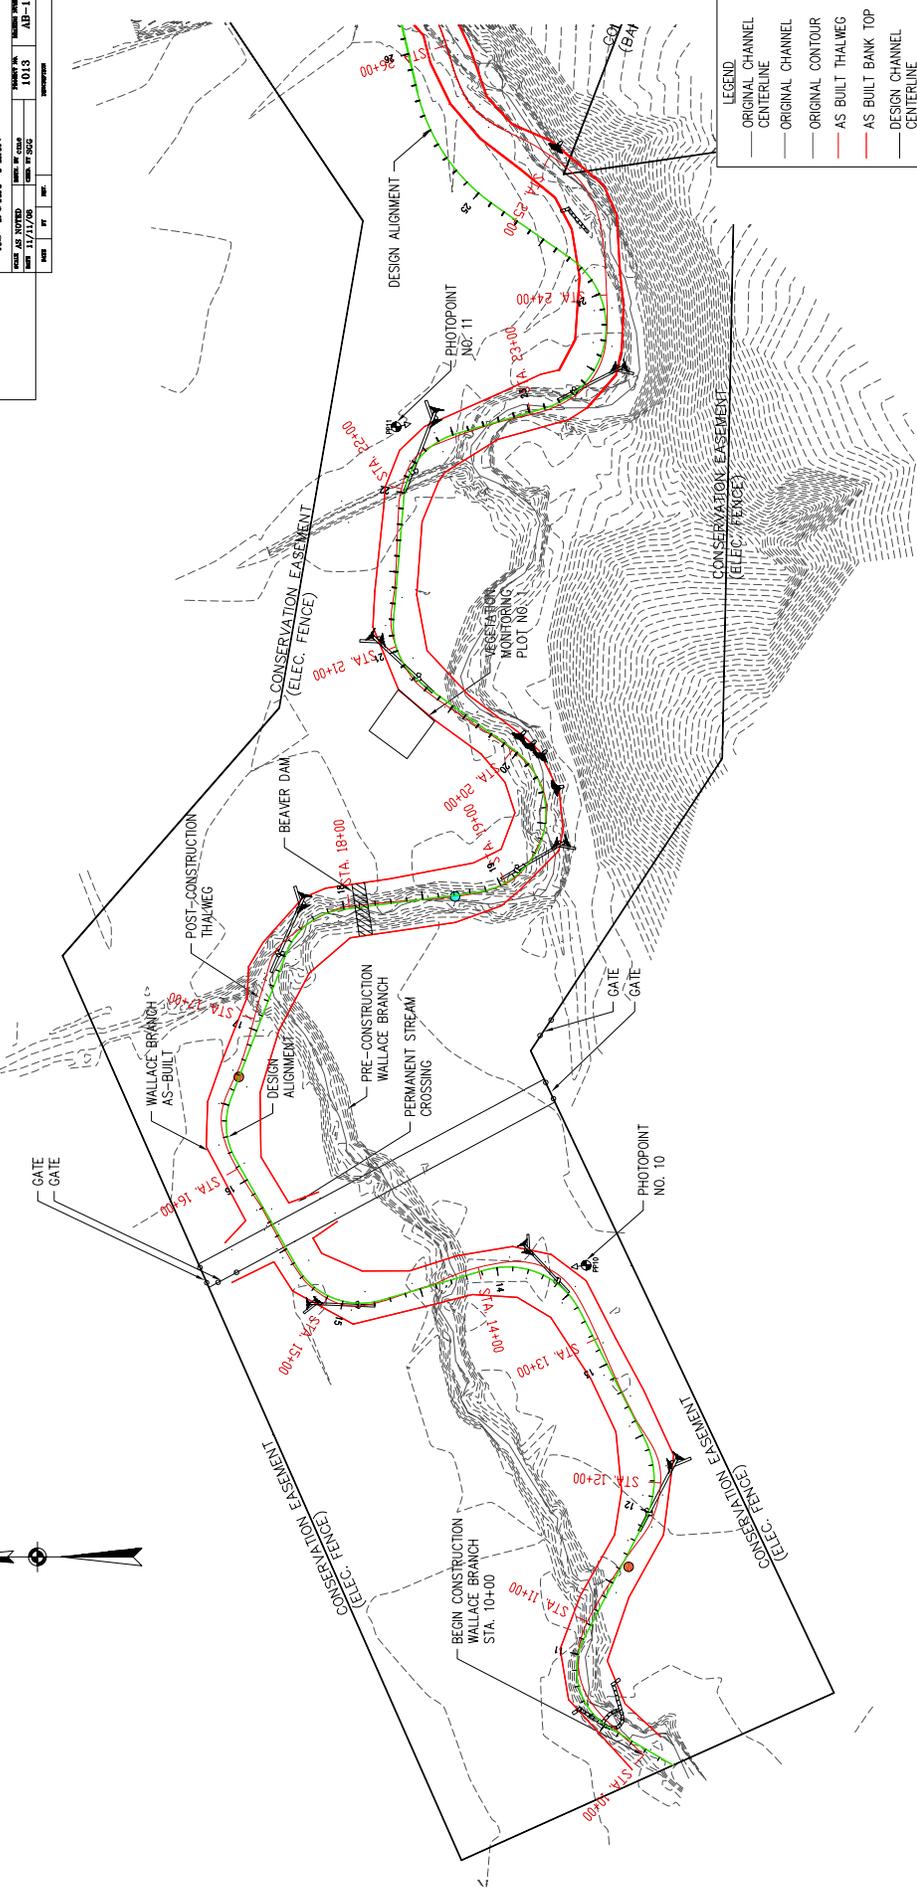
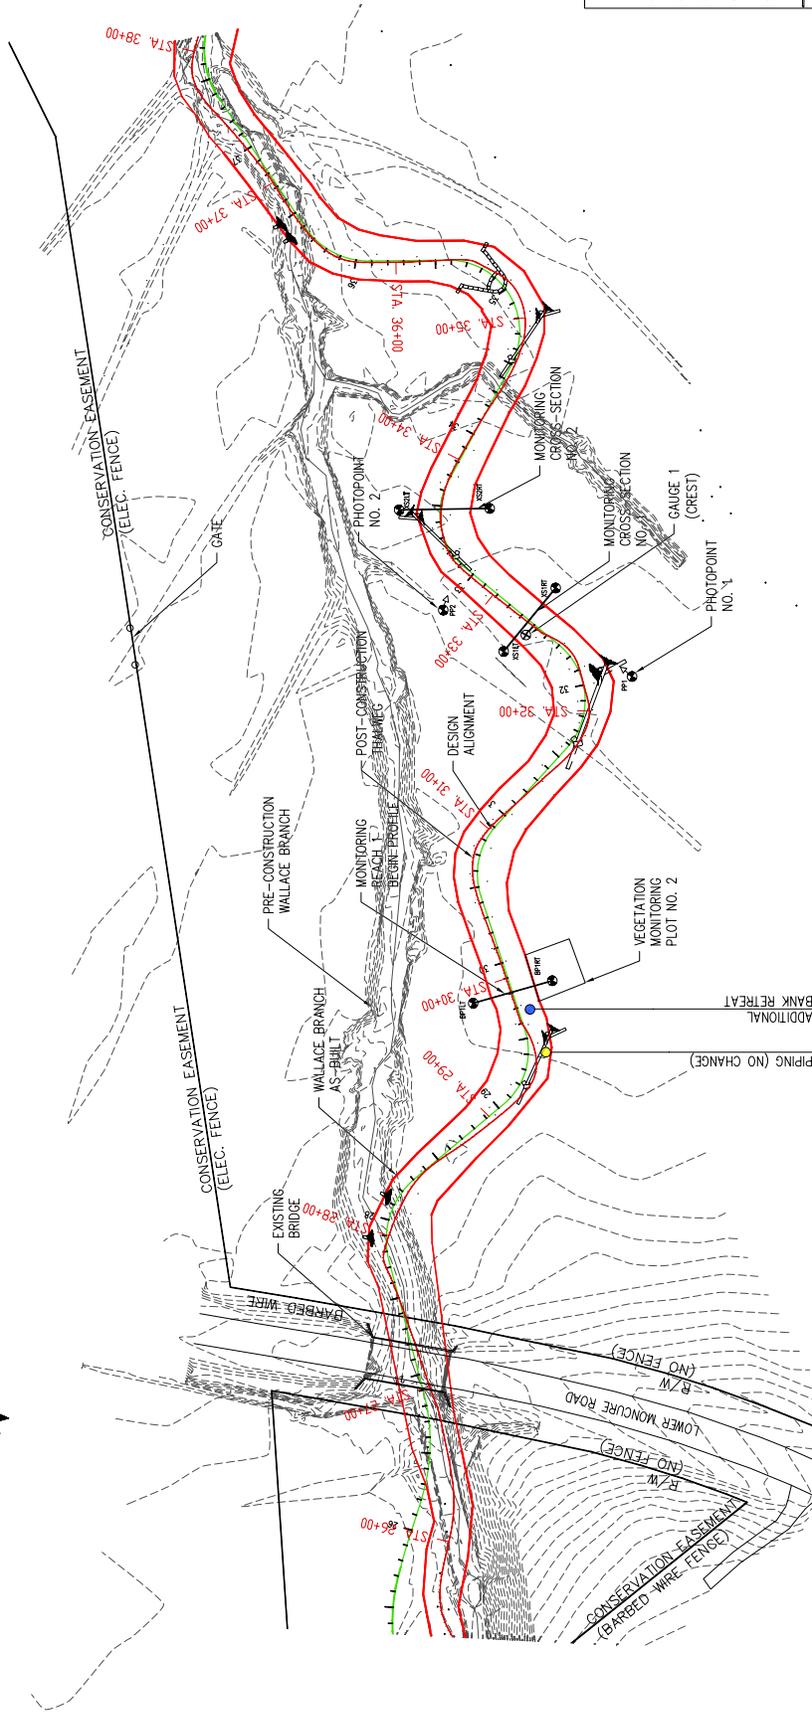
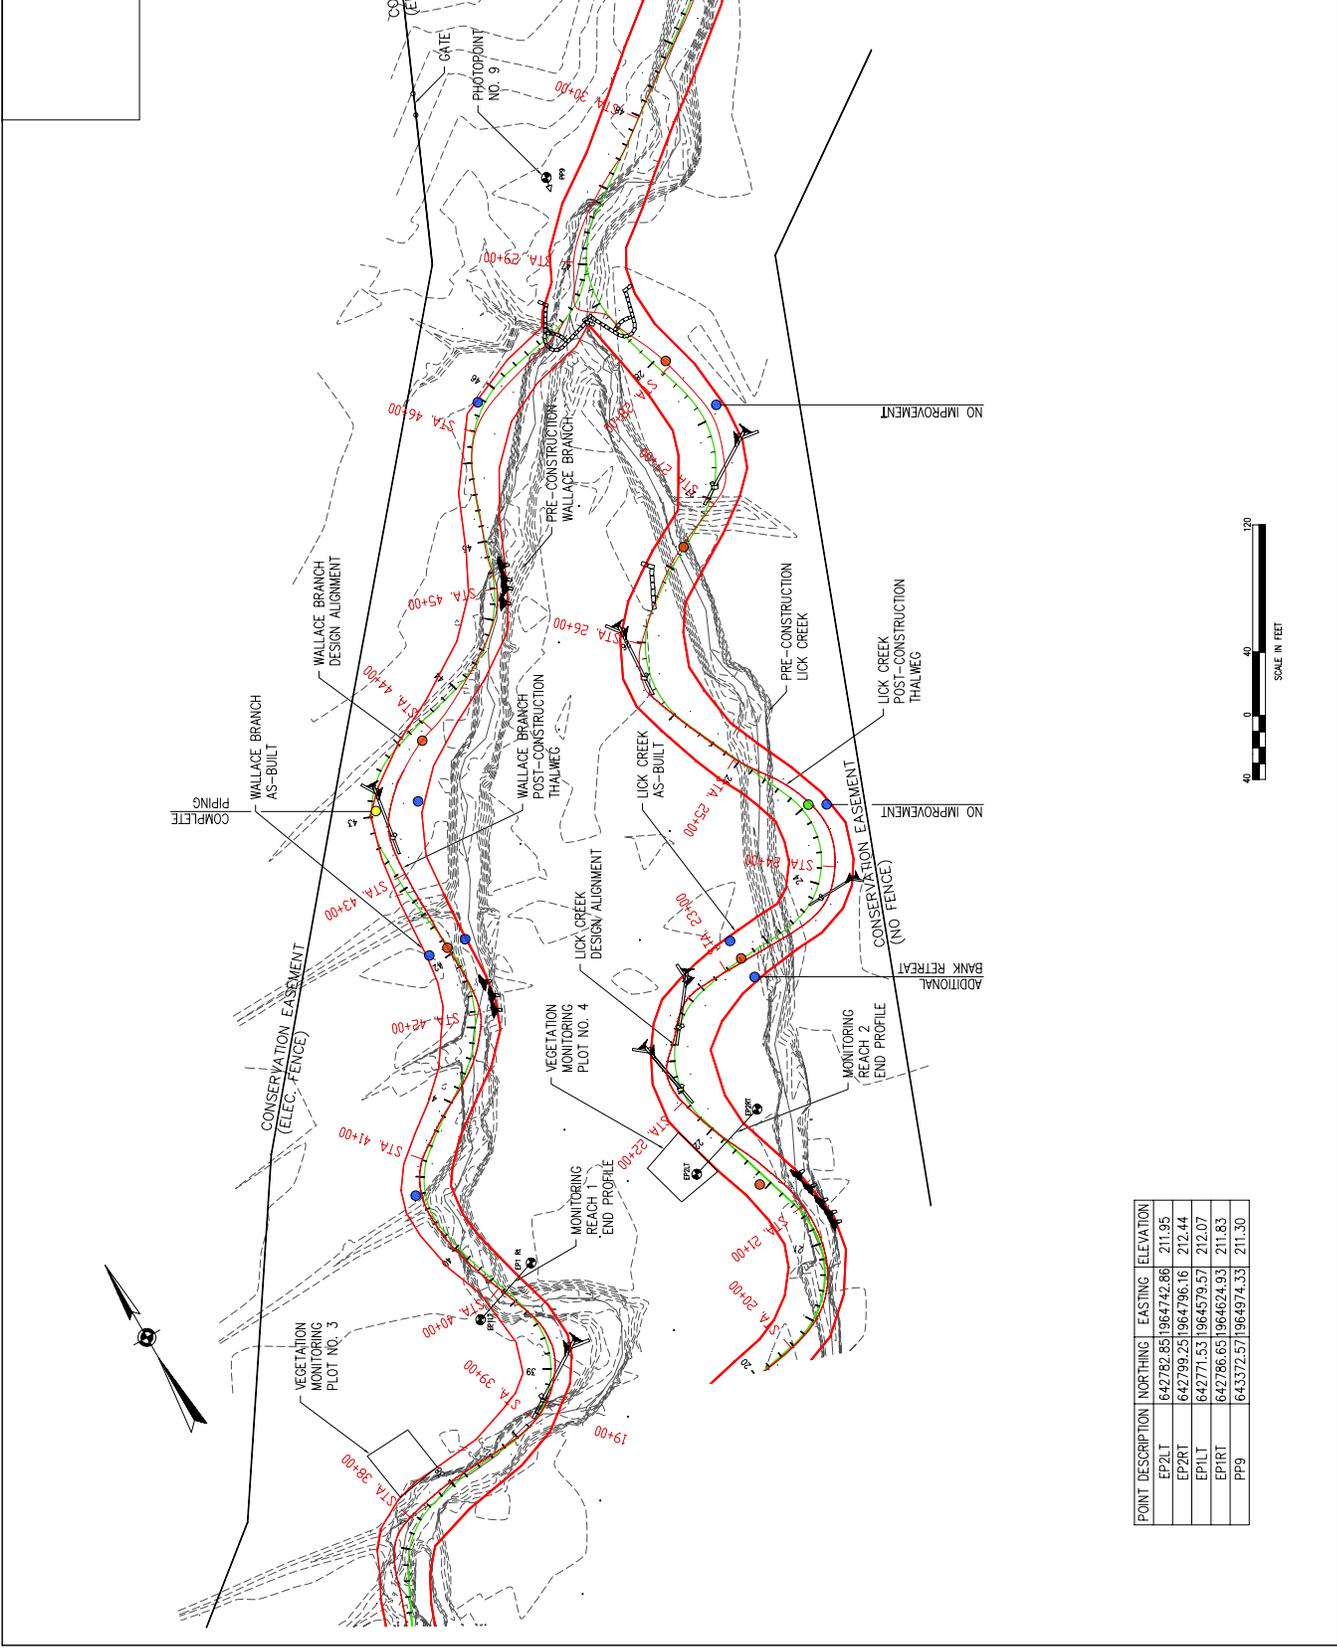
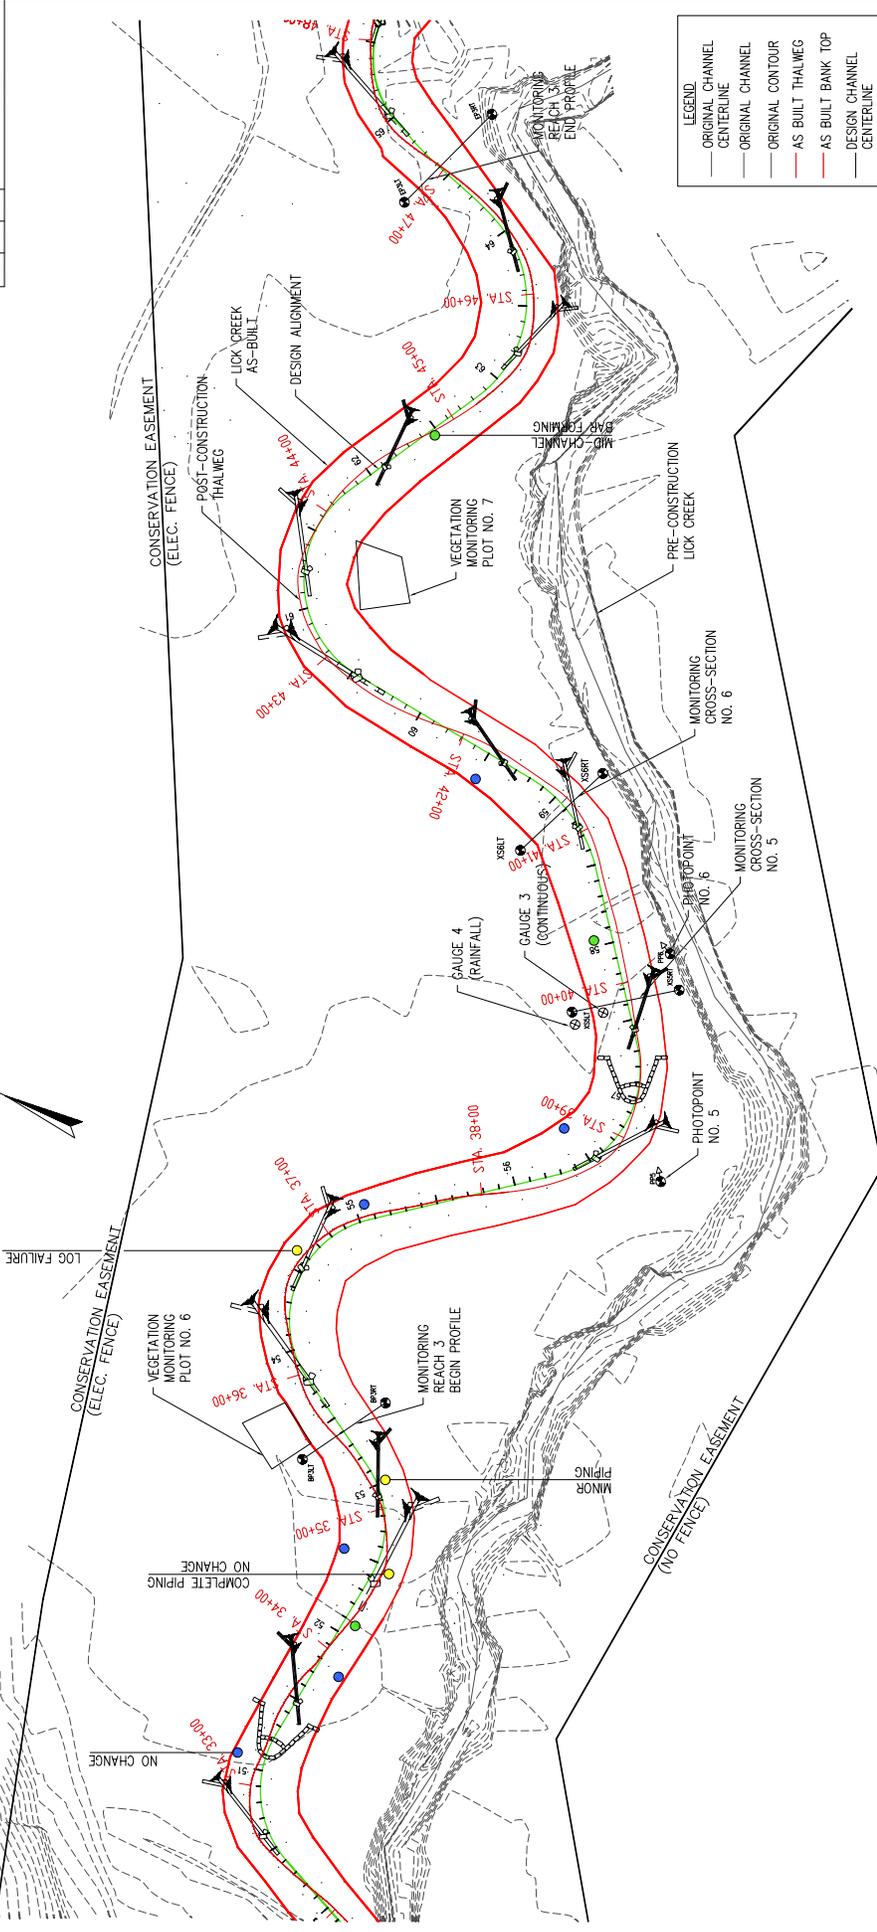
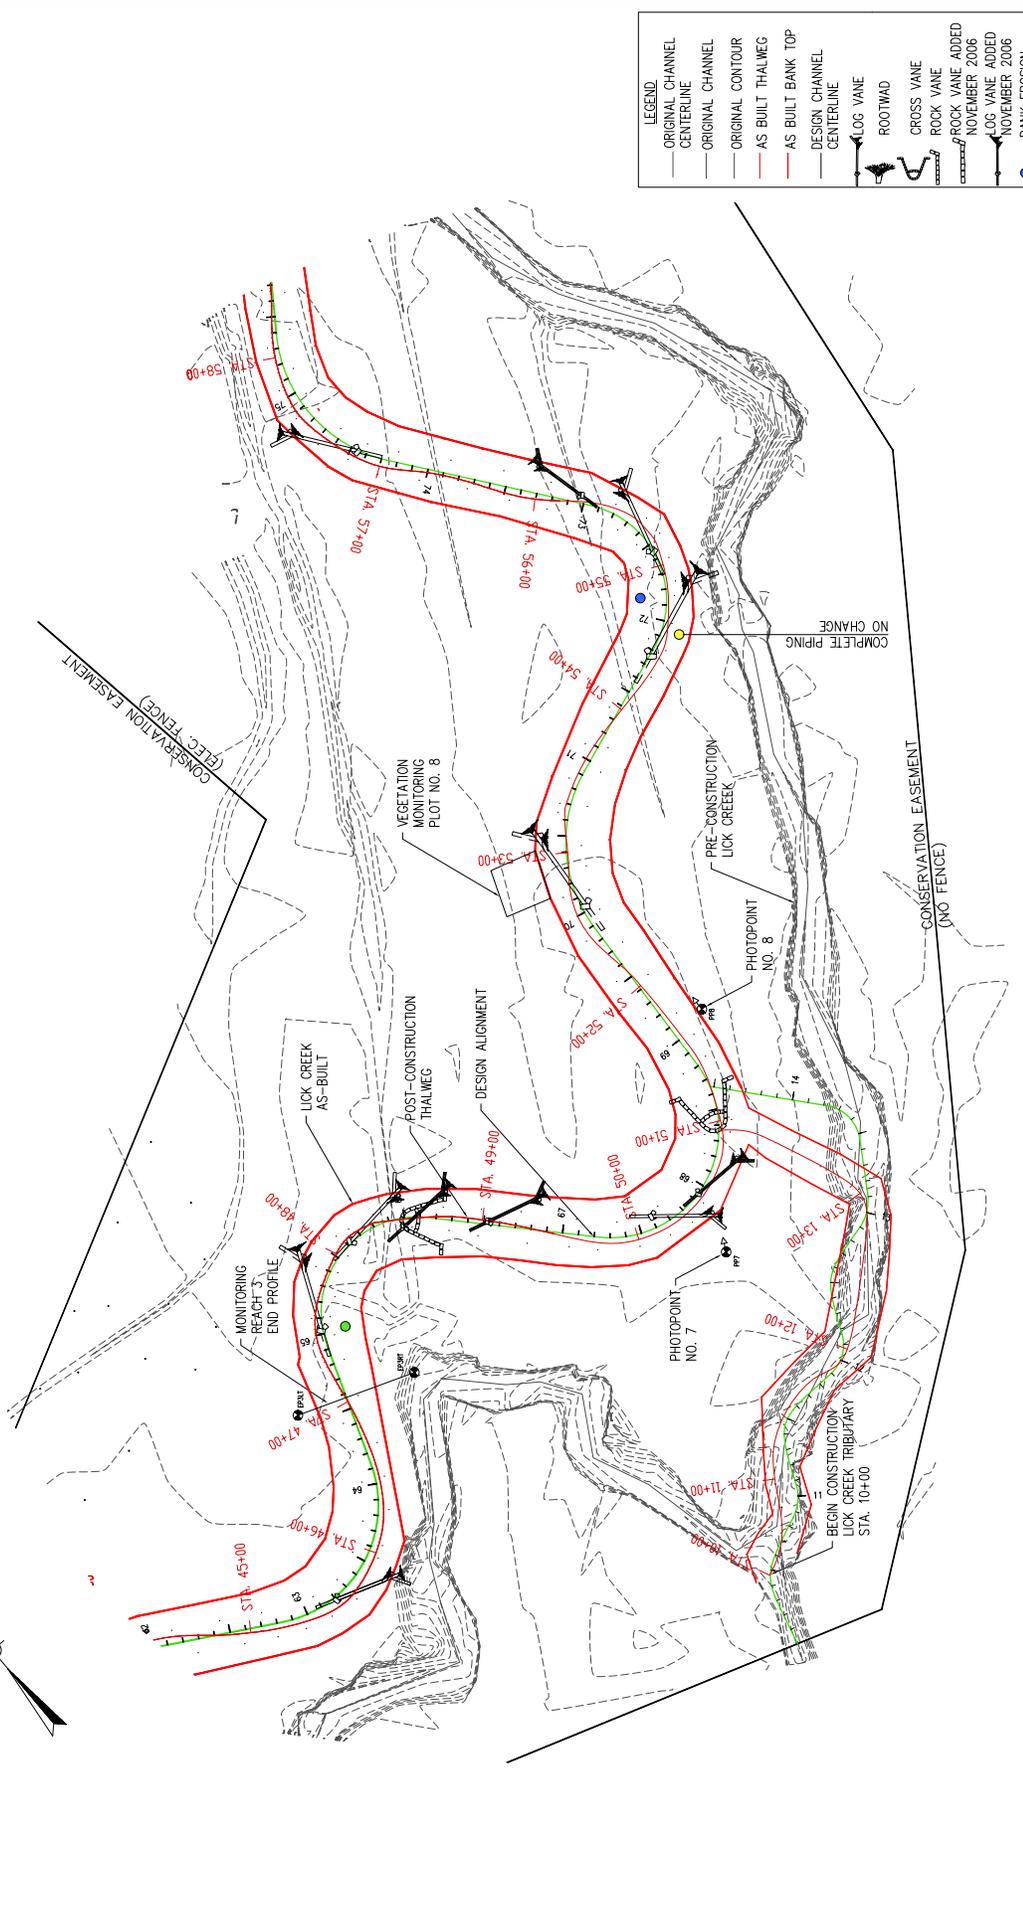
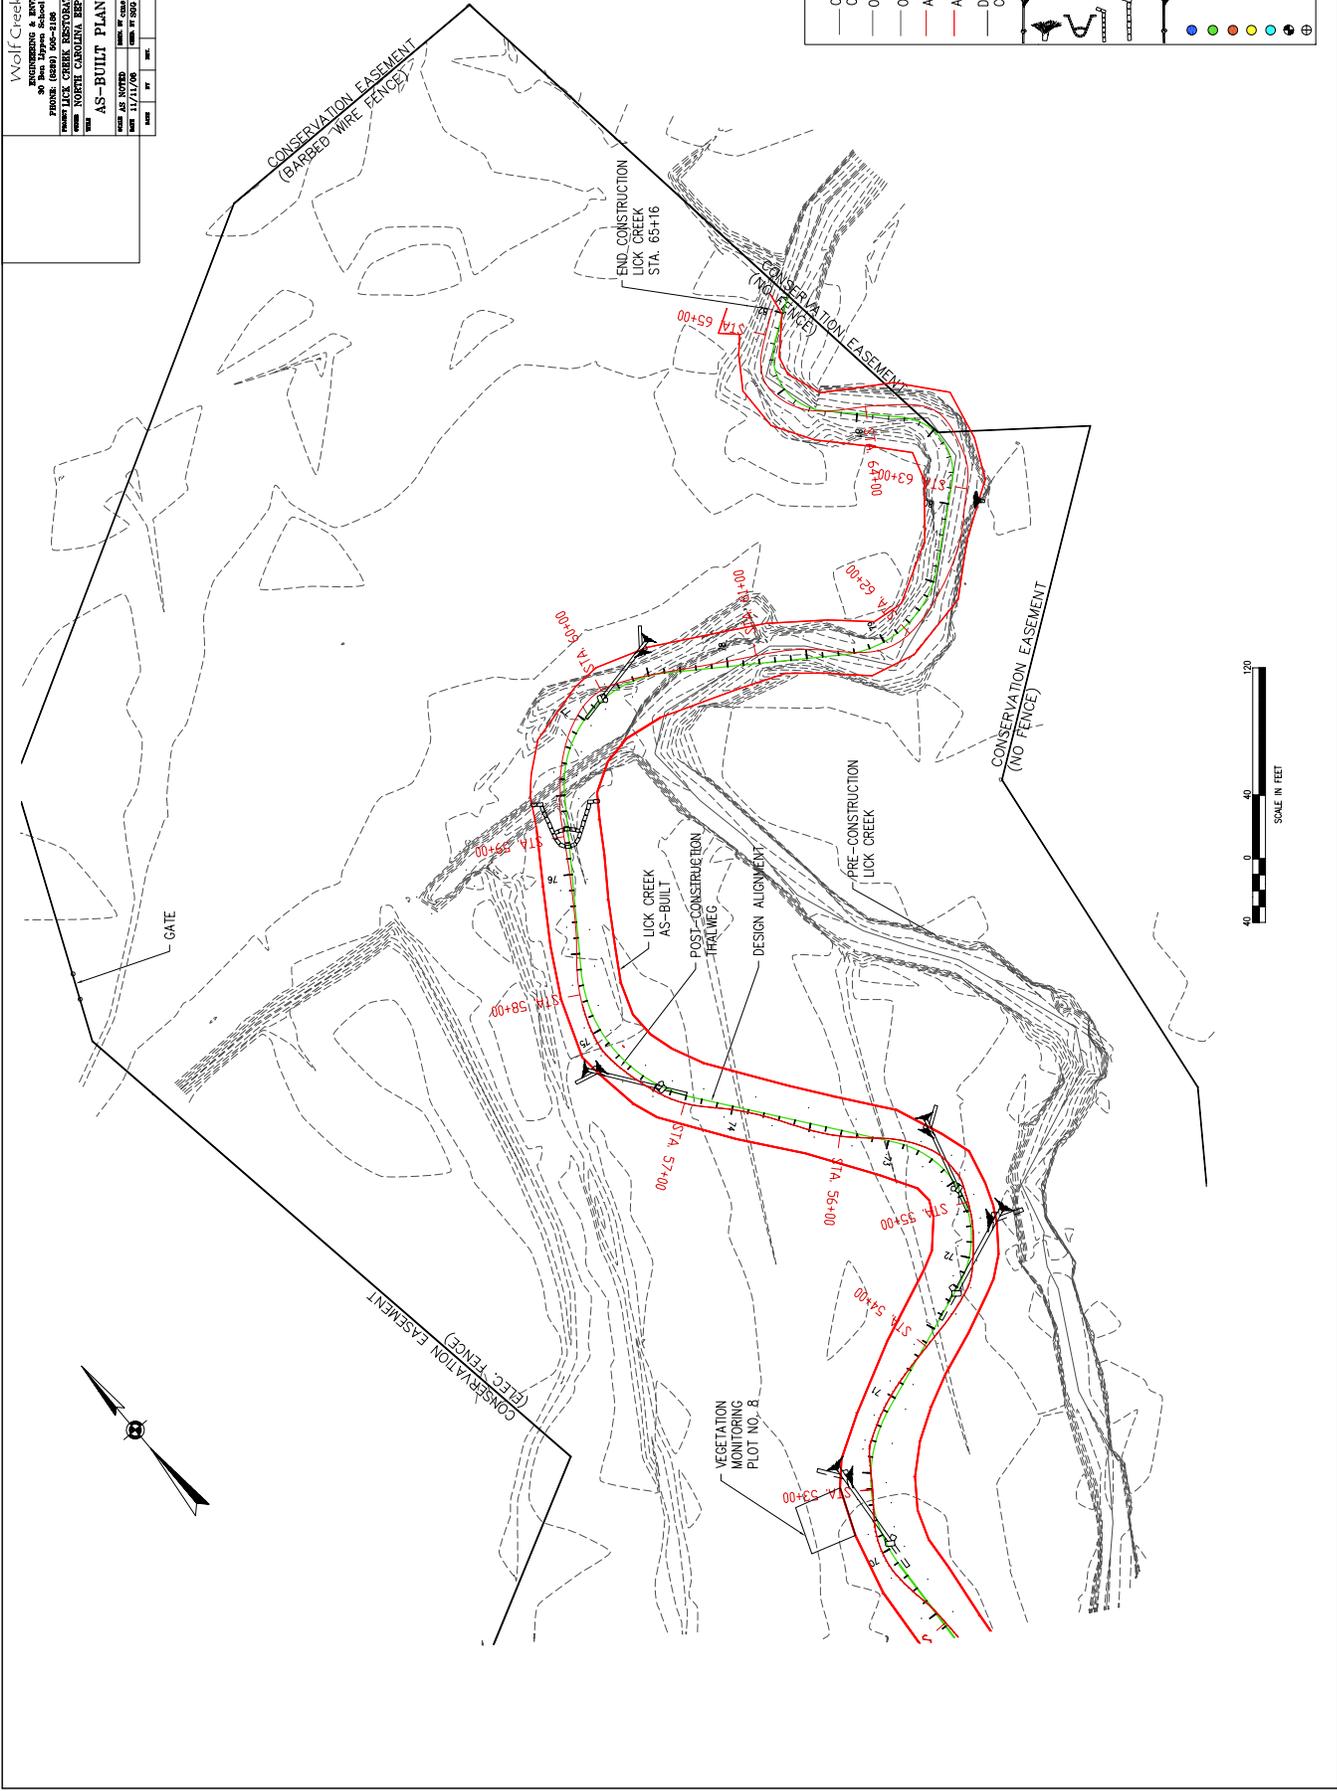
Plan drawings of the Lick Creek Stream Restoration Site detailing stream problem areas requiring additional observation and/or remediation can be seen in Figures AB-1 through AB-7. Representative photos of these areas can be found in Appendix B.

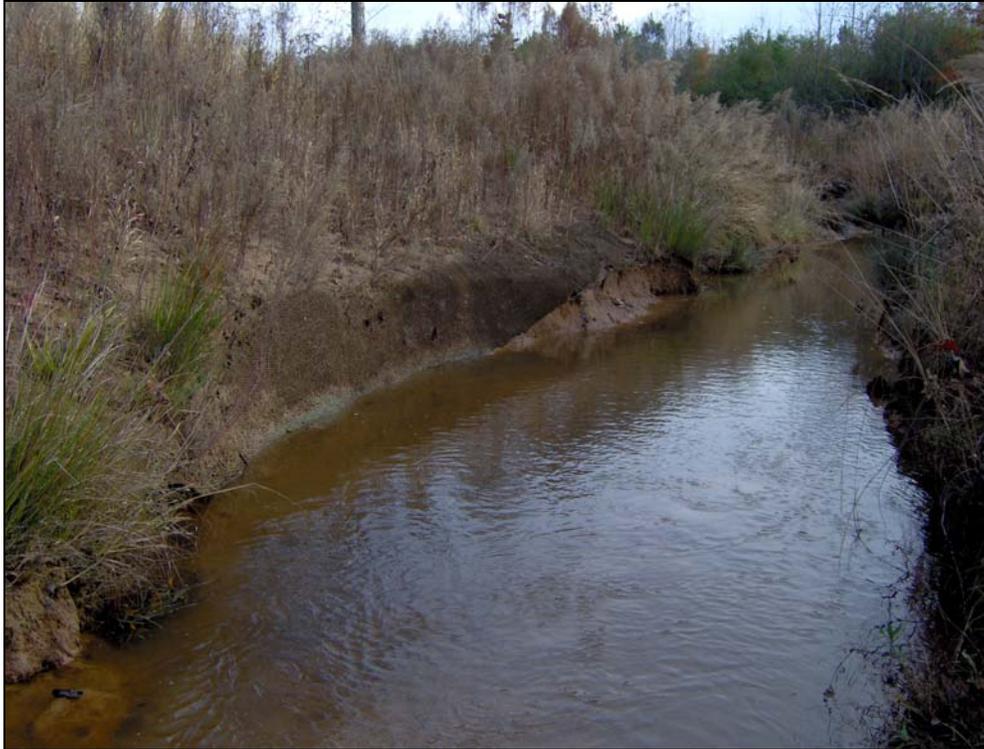
Toe Scour on Lick Creek, STA 23+00 11/27/07  
Photo No. 17

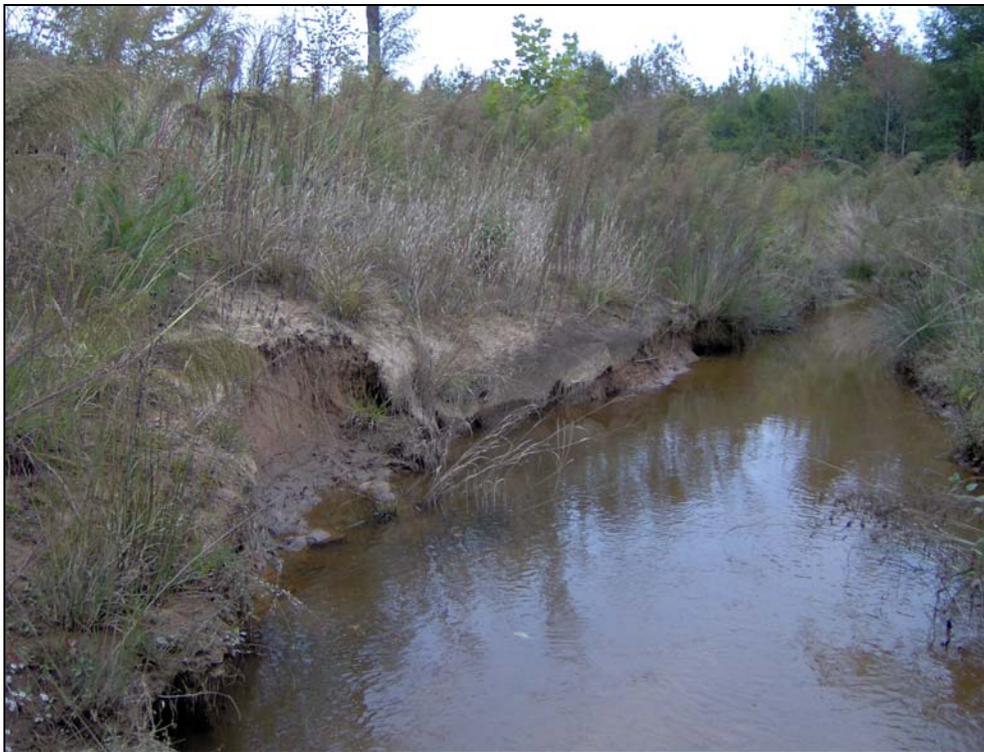
Toe Scour on Lick Creek, STA 23+00 10/24/08  
Photo No. 18

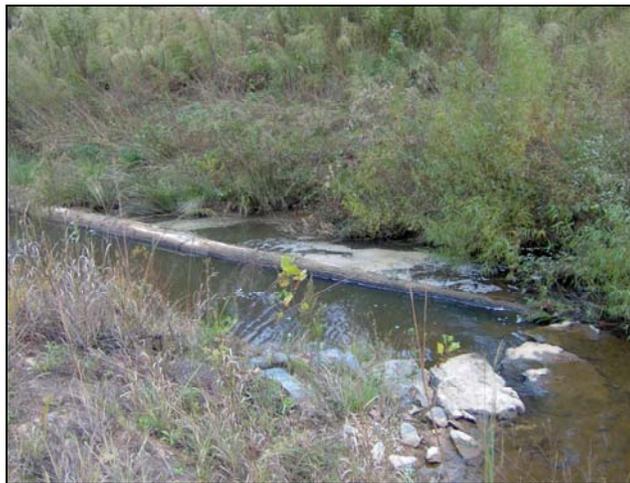
Piping at Log Vane on Lick Creek, STA 34+40 10/24/08  
Photo No. 23

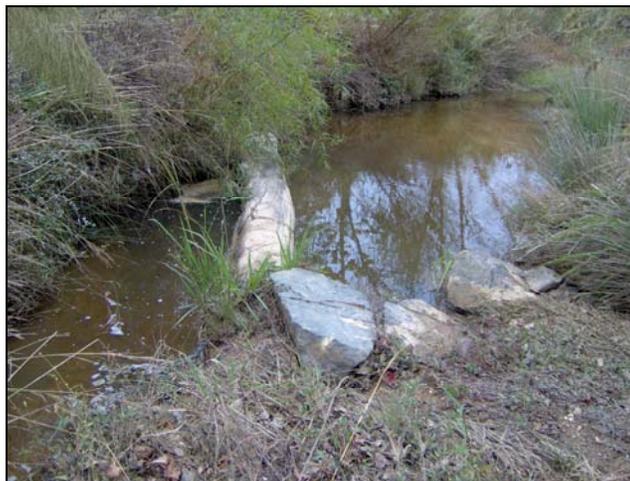
Piping at Log Vane on Lick Creek, STA 18+50 10/24/08  
Photo No. 24

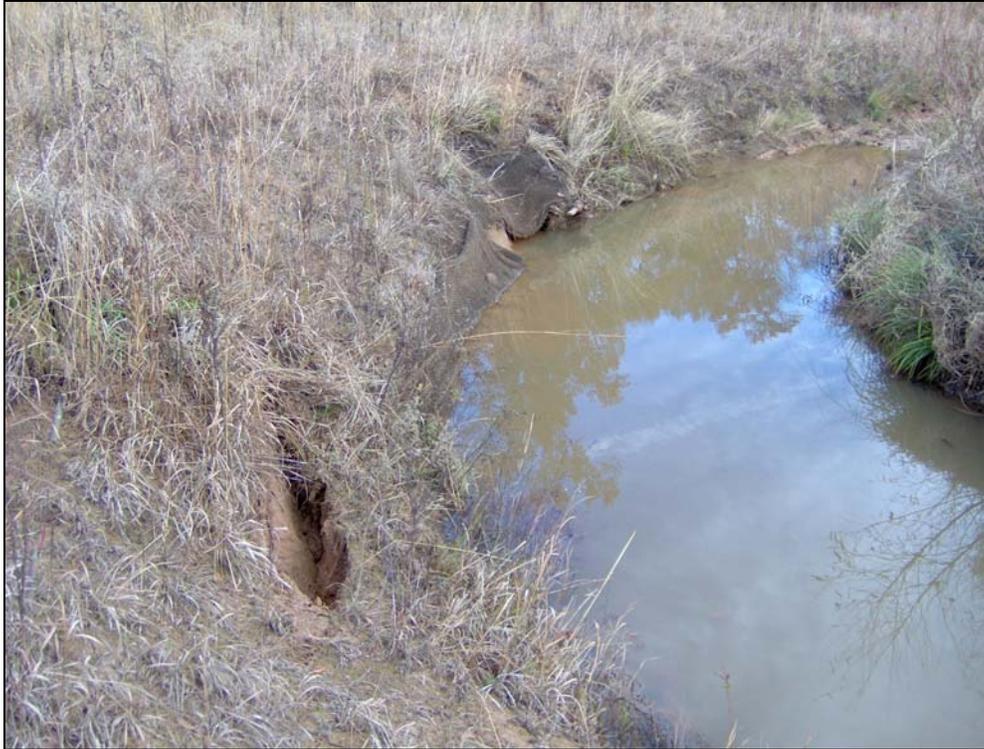
Bank Failure, Wallace Branch STA 40+50 11/27/07  
Photo No. 25

- 1) Repair areas of bank failure with brush toe and brush mattress installation.
- 2) Continued visual monitoring of areas of concern.
- 3) Install supplemental live staking in select areas of weak or nonexistent bank vegetation.
- 4) Removal of emergent Chinese privet.

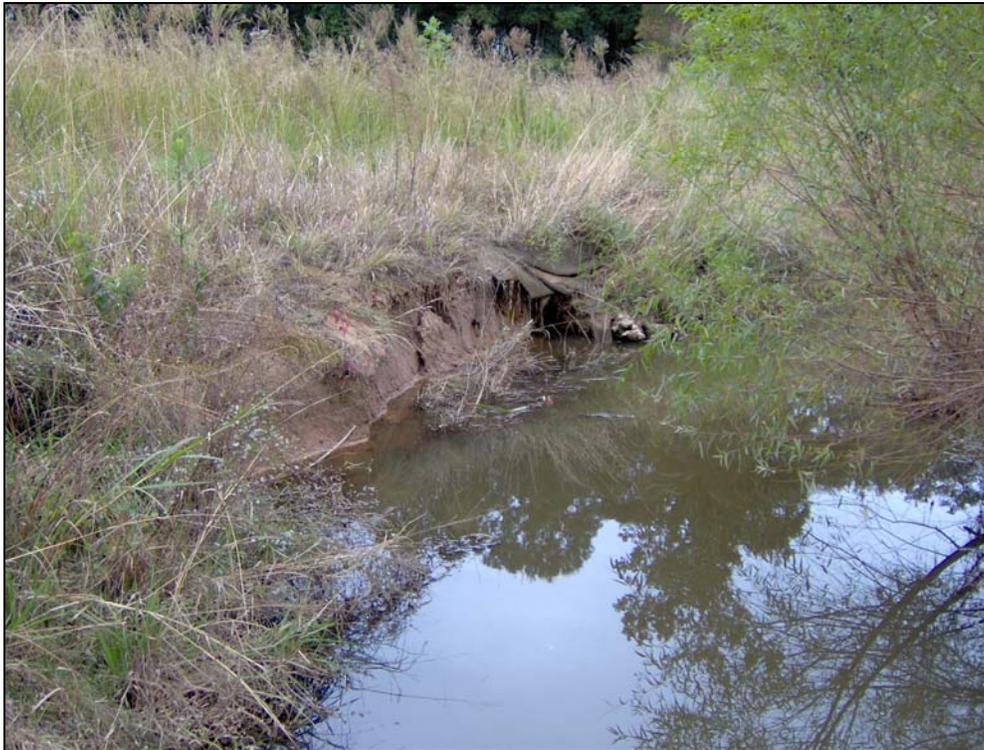
Bank Failure, Wallace Branch STA 40+80, 10/24/08  
Photo No. 26
