# Little Beaver Creek (DMS #221) Stream and Wetland Restoration Site

2015 Annual Monitoring Report (MY5)

**Wake County**

Division of Mitigation Services Project No. 221
Design Firm: Earthtech
Construction Completed: February 2007
Construction Repairs Completed: May 2013

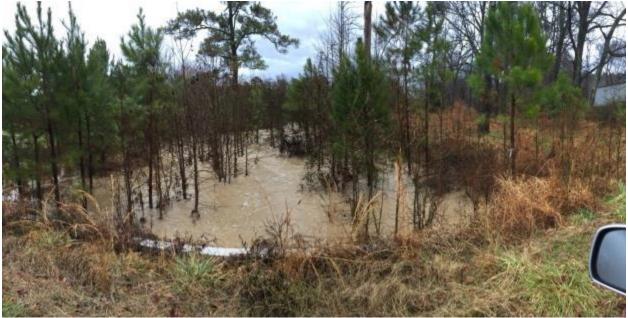
View of stream bankfull event on Little Beaver Creek.
