Monitoring Report Year 2 FINAL Little Buffalo Creek Stream Mitigation Project

NCDEQ-DMS Project Number: 94147 Contract Number: 2029 USACE Action ID: 2014-0386 DWR Permit: 14-0129 Cabarrus County

Data collection: September 2016 Submitted: March 2017

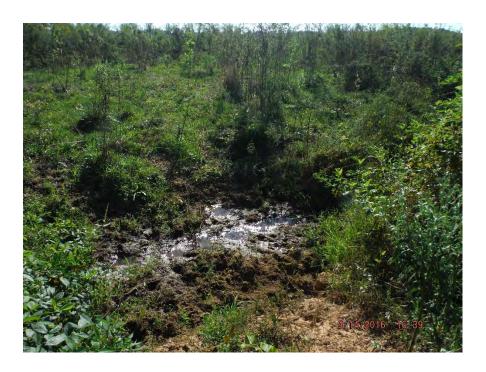
UT2 – Damage done by cattle crossing stream at bottom of trib.

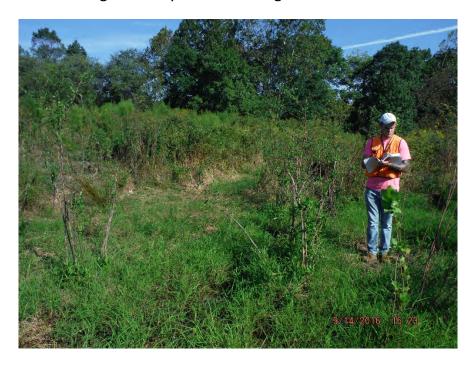
UT2 – Lower trib filled in with mud due to cattle trampling.

Downstream view.

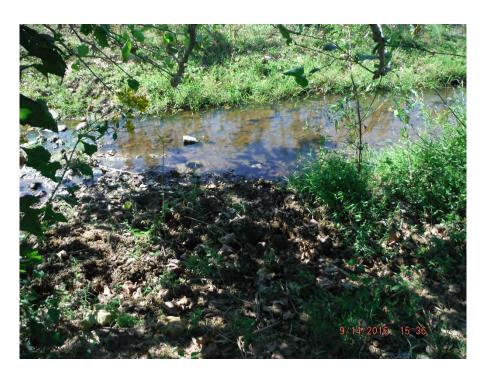
Damage from cattle crossing lower mainstem.

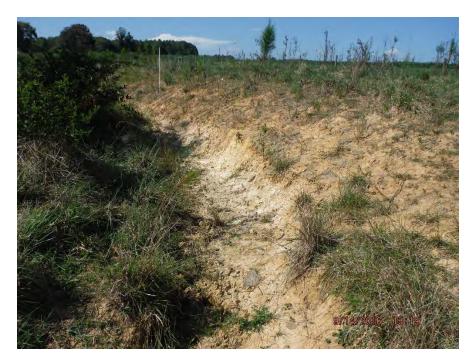
In early winter 2016, DENR representatives conducted a site visit to observe site conditions following a significant flow event. As part of this visit, a segment of UT3 was identified with a severe entrenchment and headcut in a portion of enhancement level II. Additionally, the restoration section in Reach 3 showed aggradation in both the riffle and pool sections connecting the restored channel to the existing channel at the upstream and downstream connection points. In spring of 2016, Louis Berger staff observed signs of an overflow chute forming in the Reach 3 restoration section as a result of the aggradation and high backwater caused at the upstream connection to the existing channel.

UT3 – Large headcut forming in bank. Heavy cattle damage in streambed. Upstream view.

As part of the September 2016 maintenance and monitoring work, the aggradation was removed on both the upstream and downstream connections of the restoration portion of Reach 3. The material removed was placed on the left bank to fill in the overflow chute, and the more extreme backwater condition immediately upstream of the site work was reduced to a more suitable level. This work simultaneously patched the minor cattle damage caused in the Reach 3 work area. Additionally, the entrenched banks identified in a portion

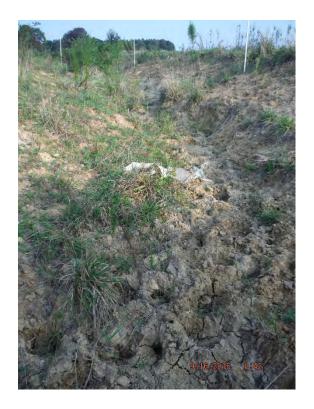
UT3 – Heavy cattle damage in streambed. Upstream view.

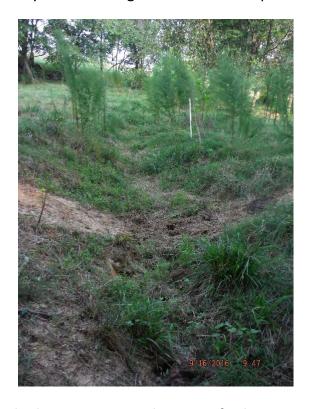
UT3 – Cattle damage crossing bottom of trib. Upstream view.

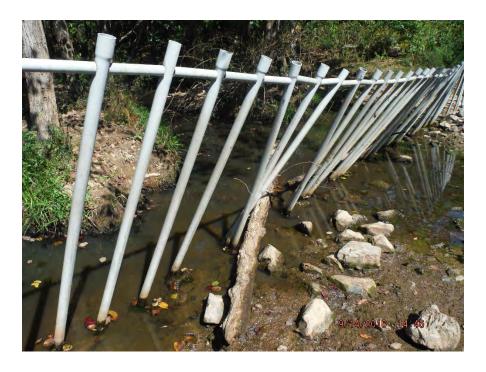
A number of site boundary issues were discovered during the Year 2 monitoring and maintenance period. A corner of fence where UT 3 joins the mainstem was found to be cut and reassembled, presumably by the land owner to remove escaped cattle. The electric wire of the cattle crossing fence in Reach 5 was broken, likely due to storm debris and flows, and no longer providing an electrical charge. The larger portions of the cattle crossing fence are up and functioning and the gates to the crossing are closed. The fence next to the northwestern gate of the cattle crossing has also been cut and hastily repaired as well as a corner of fence where UT 2 meets the mainstem. These damages are also likely the result of landowners moving cattle into or from the easement. The barbed wire has been broken on a small section of fence along the northeast edge of UT 7, possibly due to a tree fall in that area. The fence at the top of UT 1 has been completely knocked down due to the accumulation of vegetation and log debris from the adjacent fields causing enough force to push it over during a flood event.

Wires cut leaving slack in cattle crossing. Fence not electrified.

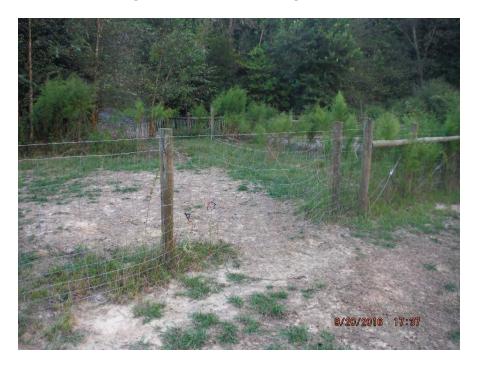
Fence has been cut and hastily repaired adjacent to cattle crossing.

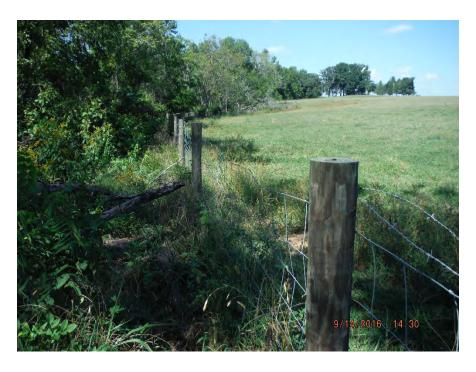
UT7 – Barbed wire broken. Cattle jump over the fence.

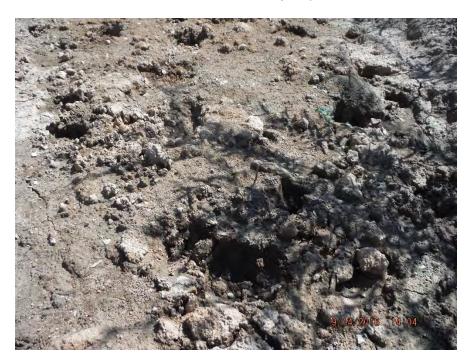
UT7 – Cow prints in banks and streambed.
