## MONITORING YEAR 5 ANNUAL REPORT

### LONE HICKORY MITIGATION SITE

Yadkin County, NC DEQ Contract No. 6897 DMS Project No. 97135 DWR No. 20161044 USACE Action ID No. SAW-2017-00100 Yadkin River Basin HUC 03040101

Data Collection Period: February – November 2023 Draft Submission Date: November 29, 2023 Final Submission Date: January 4, 2024

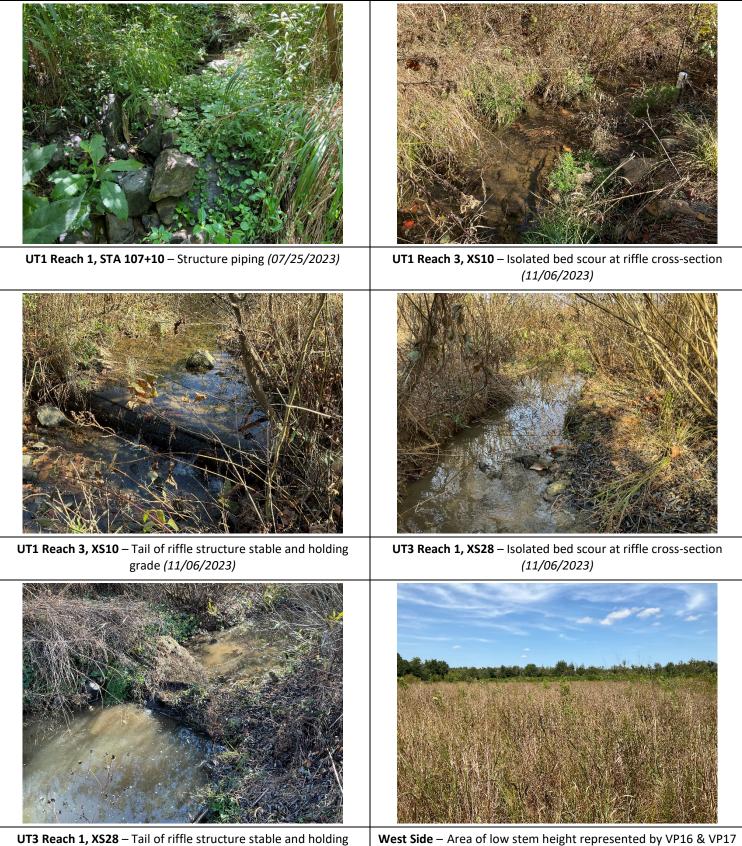
grade (11/06/2023)

West Side – Area of low stem height represented by VP16 & VP17 (09/14/2023)

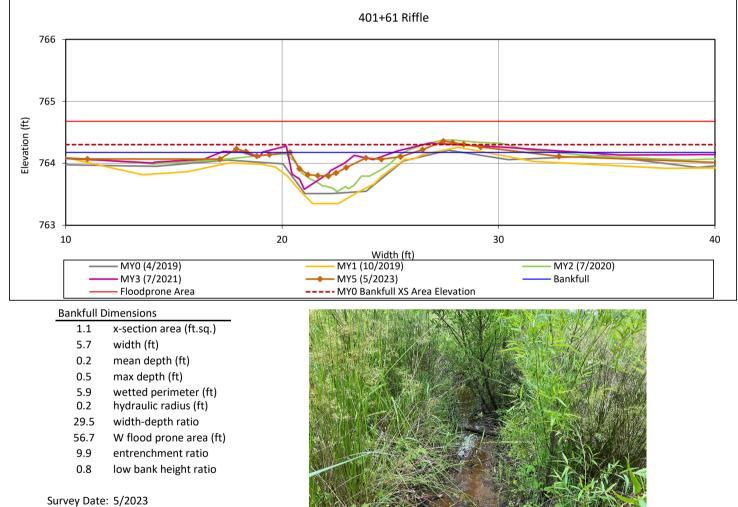
# Cross-Section 19 - UT2A

As woody vegetation has become more established, the minor deposition originally noted in MY2 within cross-sections 19 and 21 along UT2A and cross-sections 29 and 30 along UT3 Reach 2 appears to have reached an equilibrium. These reaches have been shaded out more effectively with in-stream vegetation becoming less of an issue. Both watersheds for UT2A and UT3 are predominantly forested and have not seen a noticeable change in land cover in the past 5 years, according to visual observations and recent aerial imagery. Therefore, there do not appear to be any new sources of sediment.

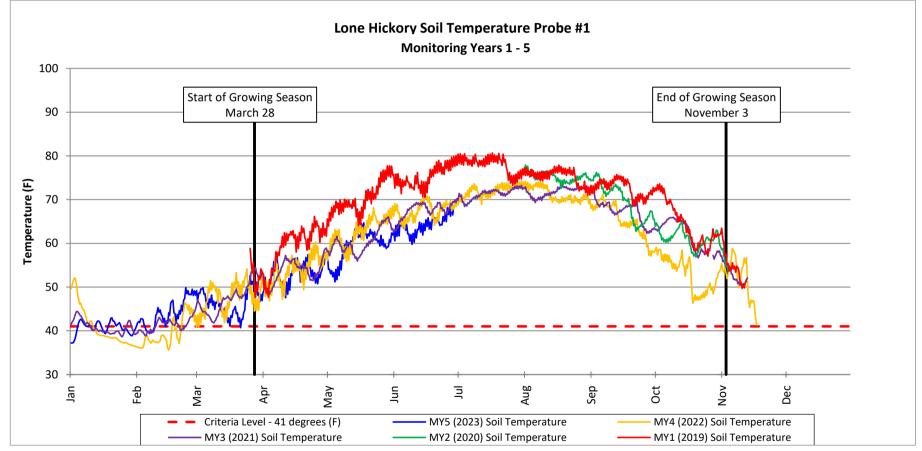
- Probe malfunction in MY2 (2020) which caused a loss of data

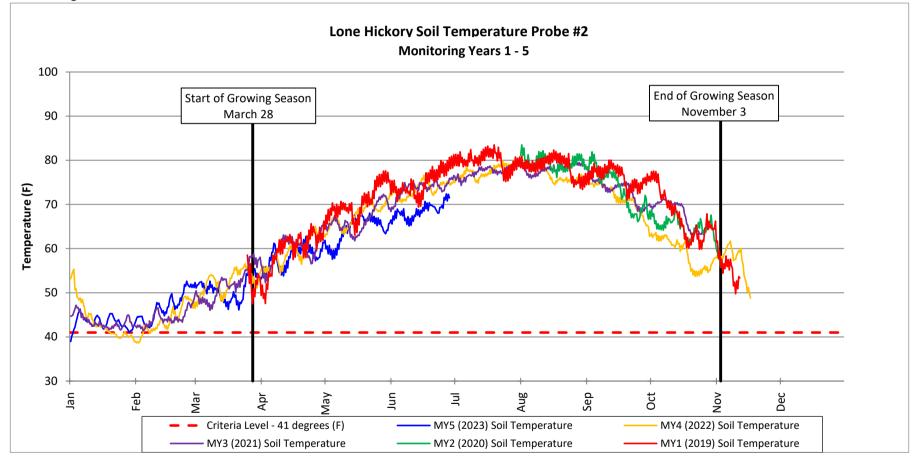
- Probe malfunction in MY2 (2020) which caused a loss of data
