**Unnamed Tributary to Tar River
Stream Restoration
Louisburg, Franklin County, North Carolina
Year 1 Monitoring Report**

Monitoring Year: 2006
Measurement Year 1
As-Built Date 2005
NCEEP Project Number 234

**UNNAMED TRIBUTARY TO TAR RIVER STREAM RESTORATION
YEAR 1 MONITORING REPORT**

CONDUCTED FOR THE NORTH CAROLINA DEPARTMENT
OF
ENVIRONMENT AND NATURAL RESOURCES

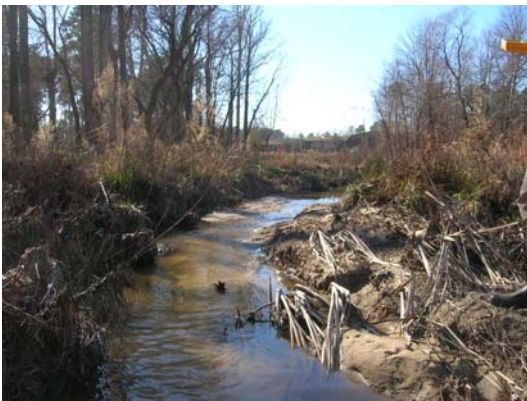
Table VIII. Verification of Bankfull Events UT Tar River Stream Mitigation Site/Project No. 234			
Date of Data Collection	Date of Occurrence	Method	Photo # (if available)
2007	Unknown 2006	Photographic - Near Bankfull	Shown below

Evidence of bankfull event deposition on January 3, 2007.
