McIntyre Creek Stream Restoration Project As-Built Survey and Comparative Analysis

Charlotte (MECKLENBURG COUNTY), North Carolina NCEEP Project # D09024S SCO# 01-0546102

Prepared for
North Carolina Ecosystem Enhancement Program
2728 Capital Blvd, Suite 1H 103
Raleigh, NC 27604

Prepared by
WK Dickson & Company, Inc.
720 Corporate Center Drive
Raleigh, North Carolina 27607
(919) 782-0495

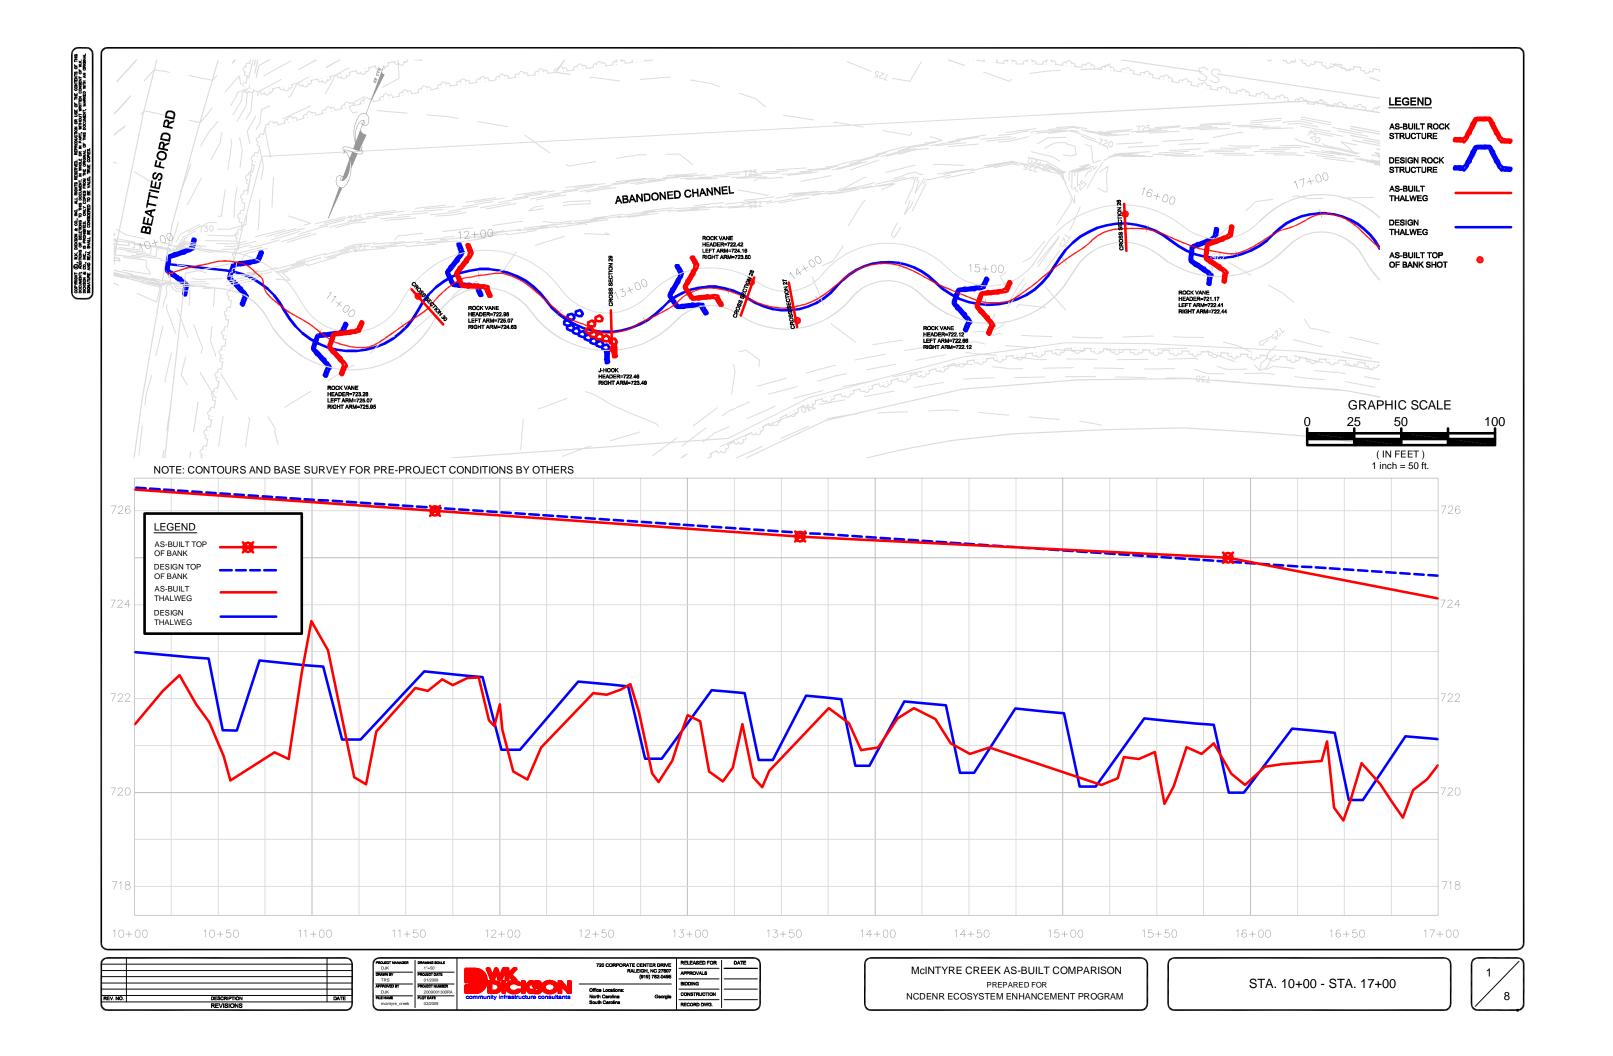
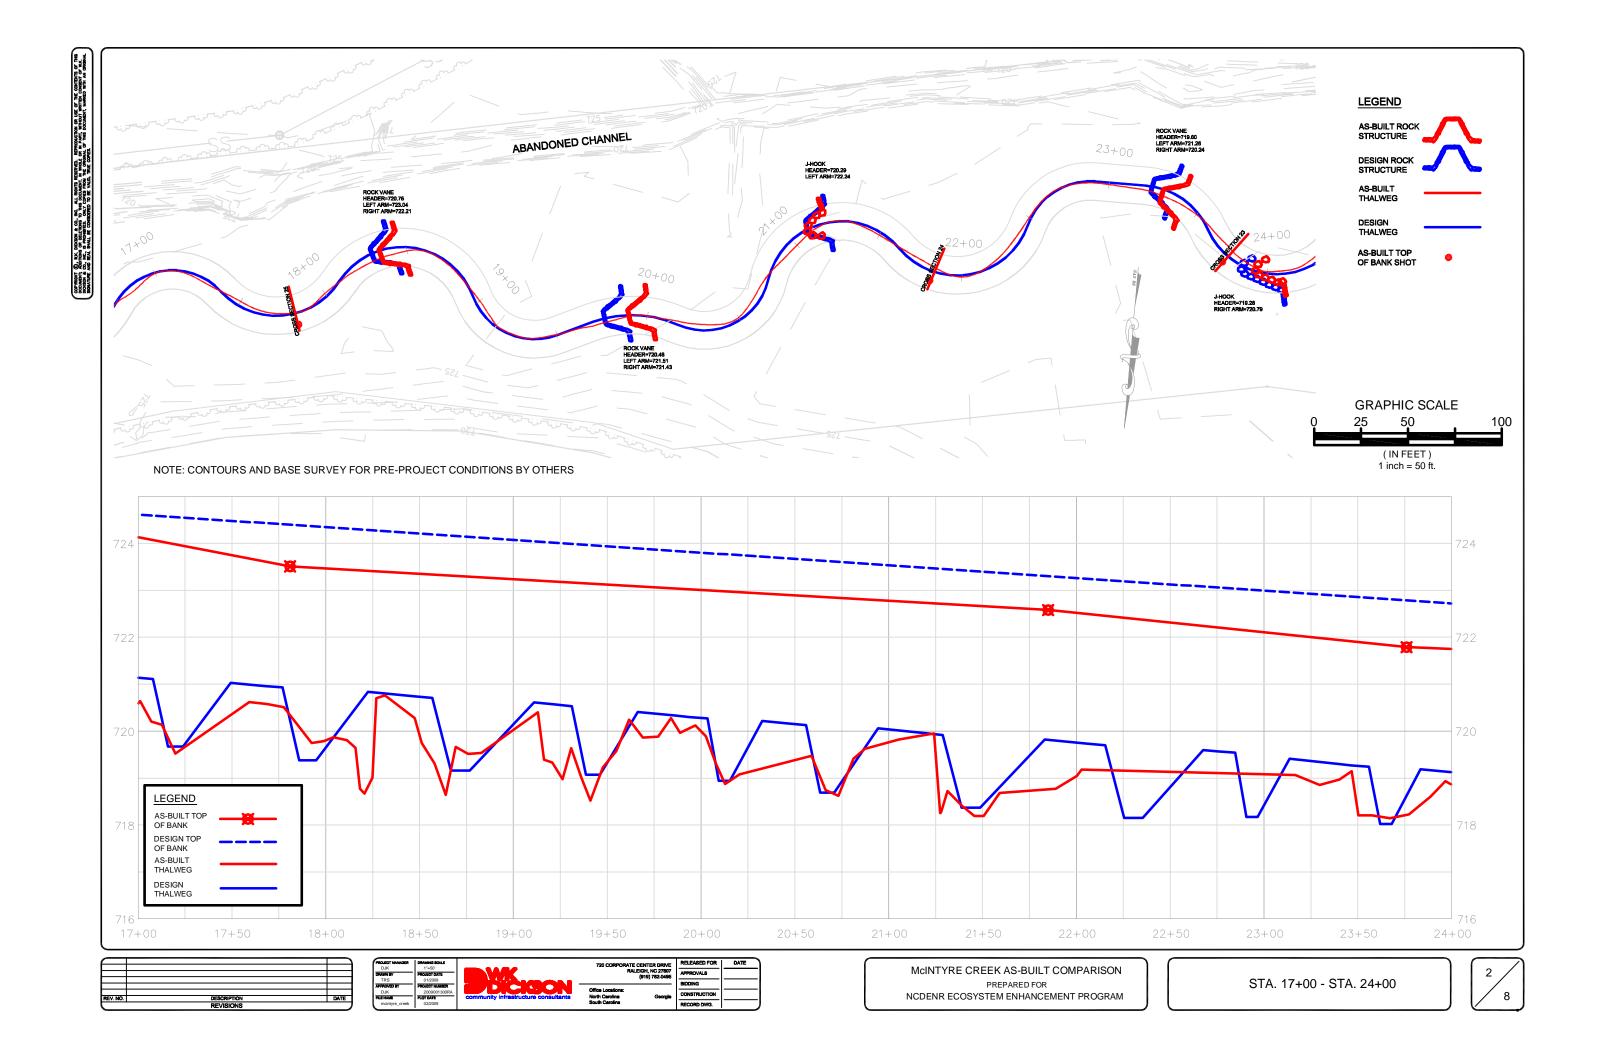
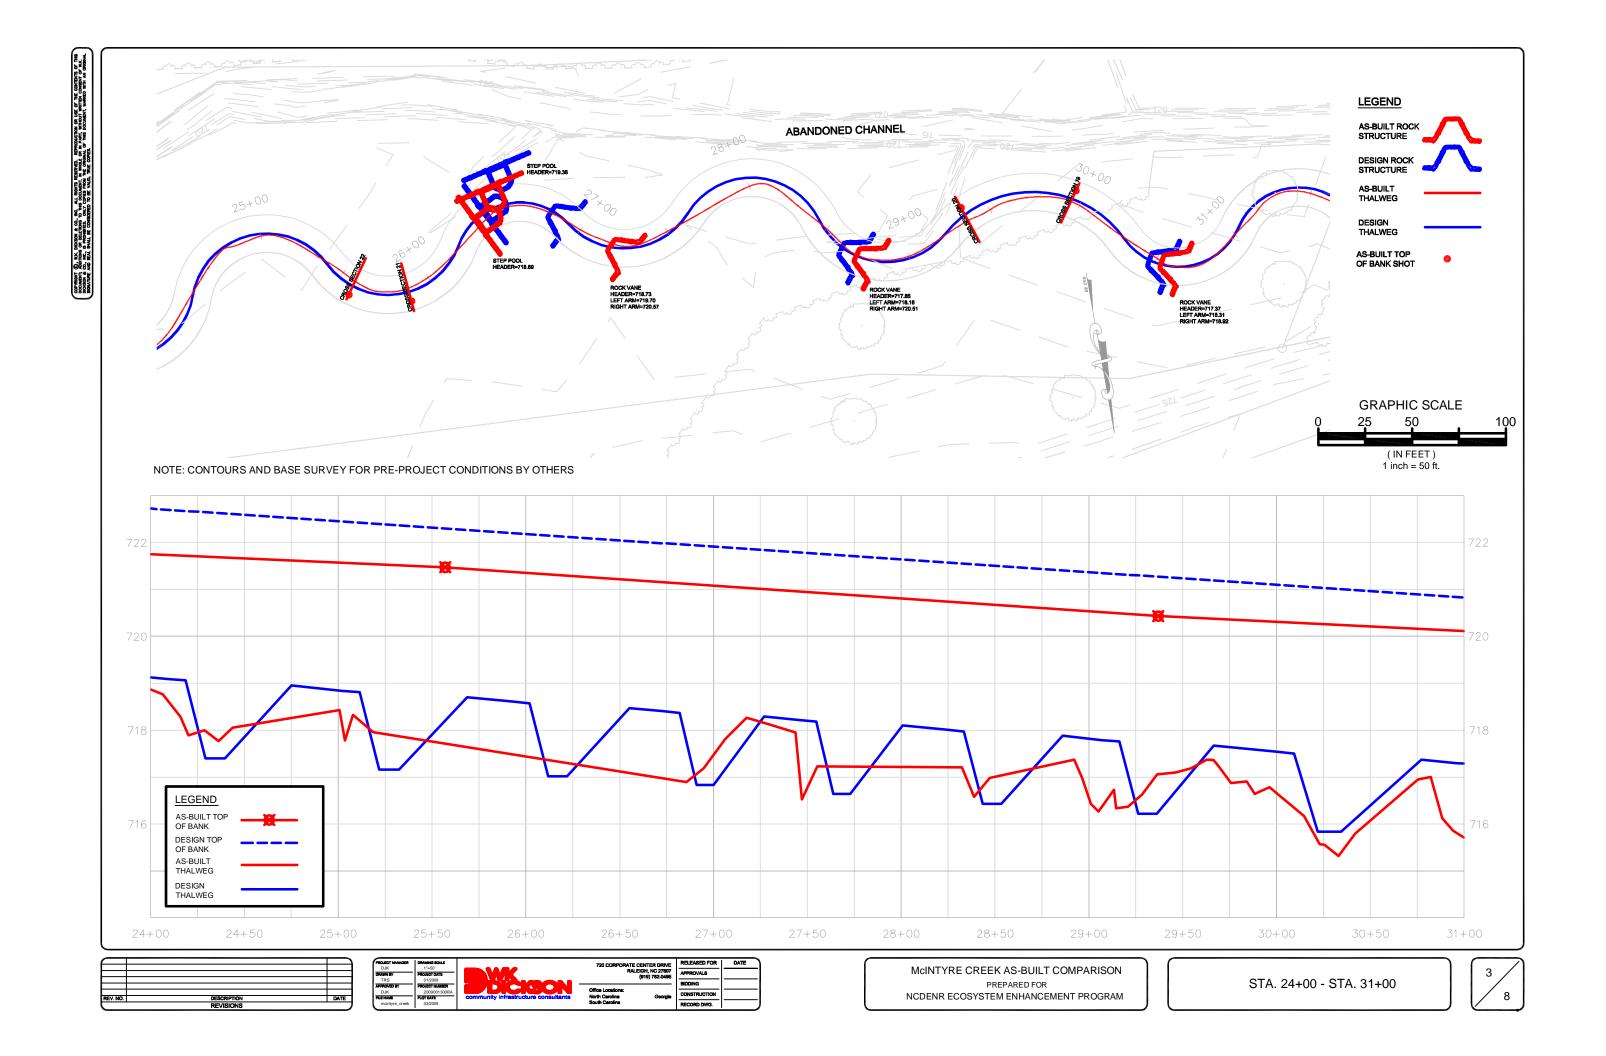
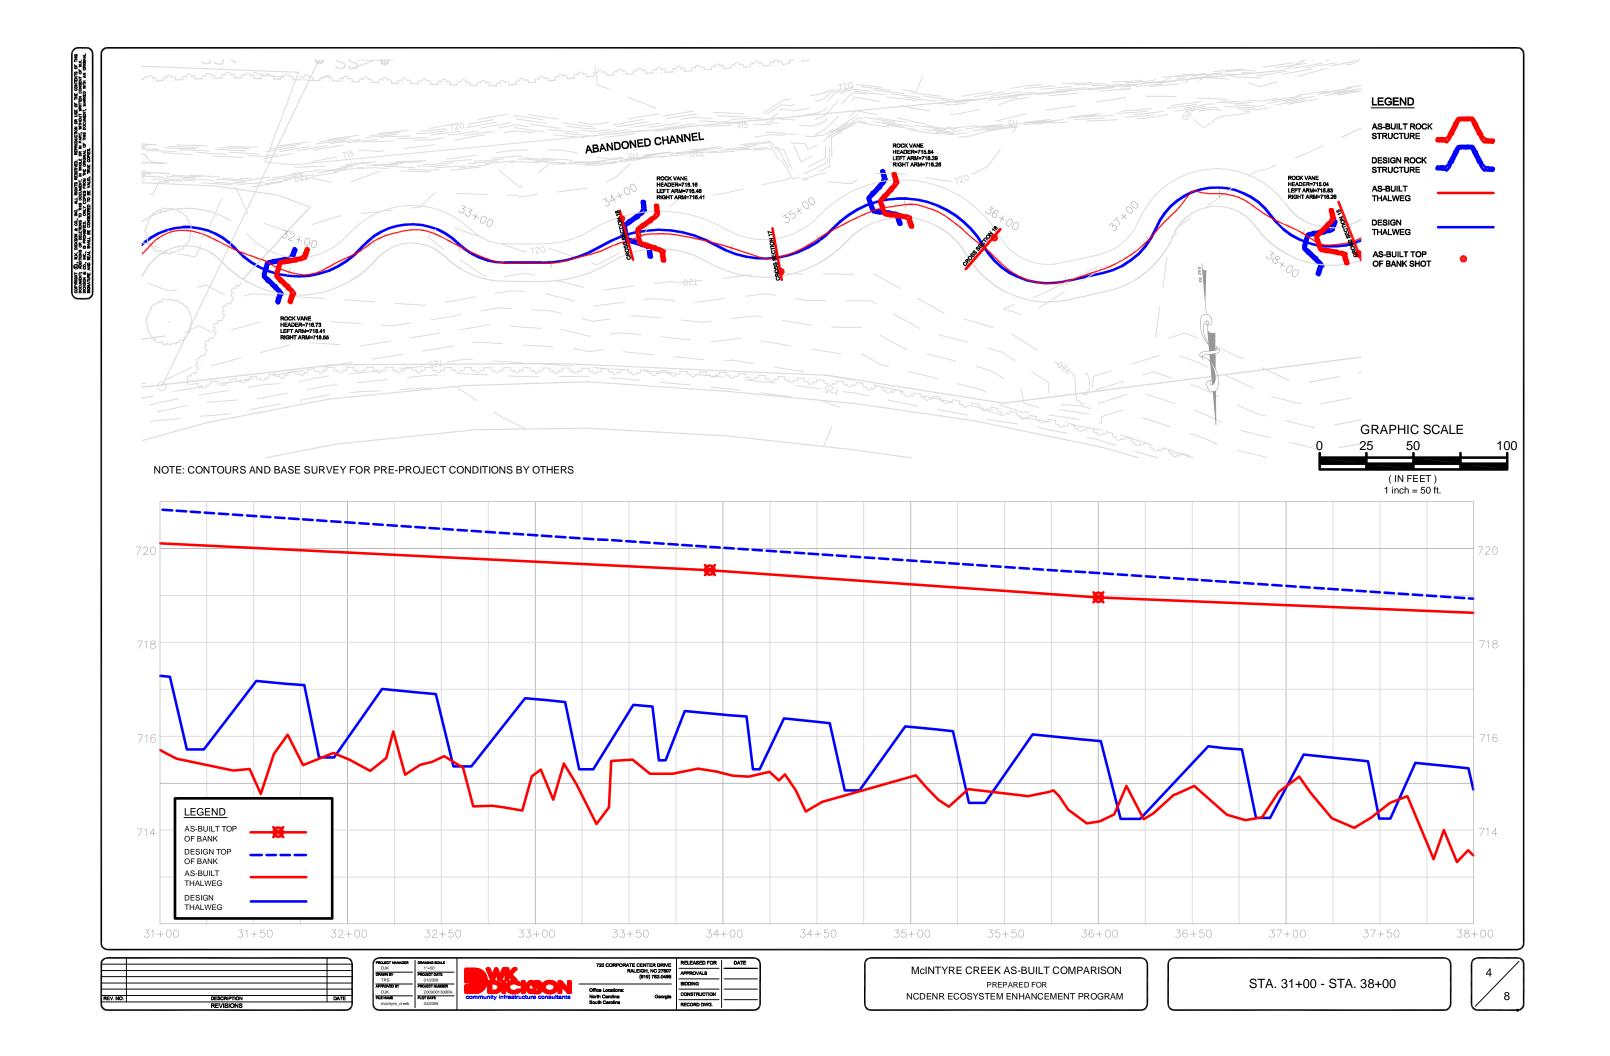
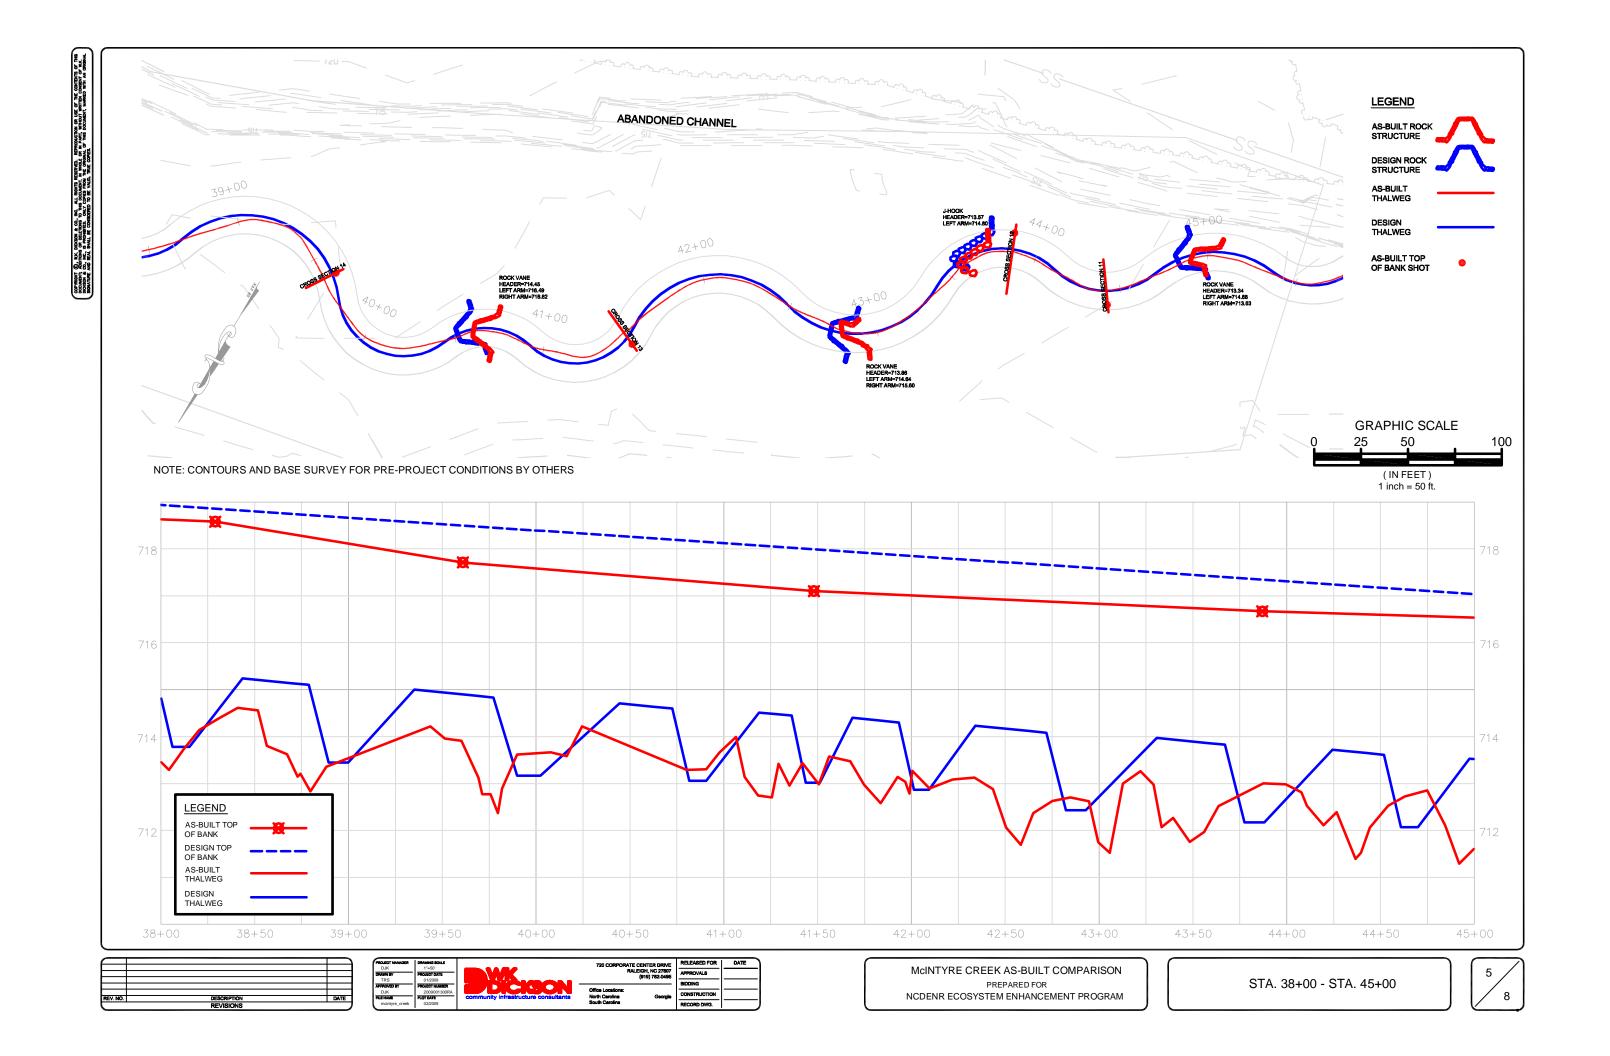
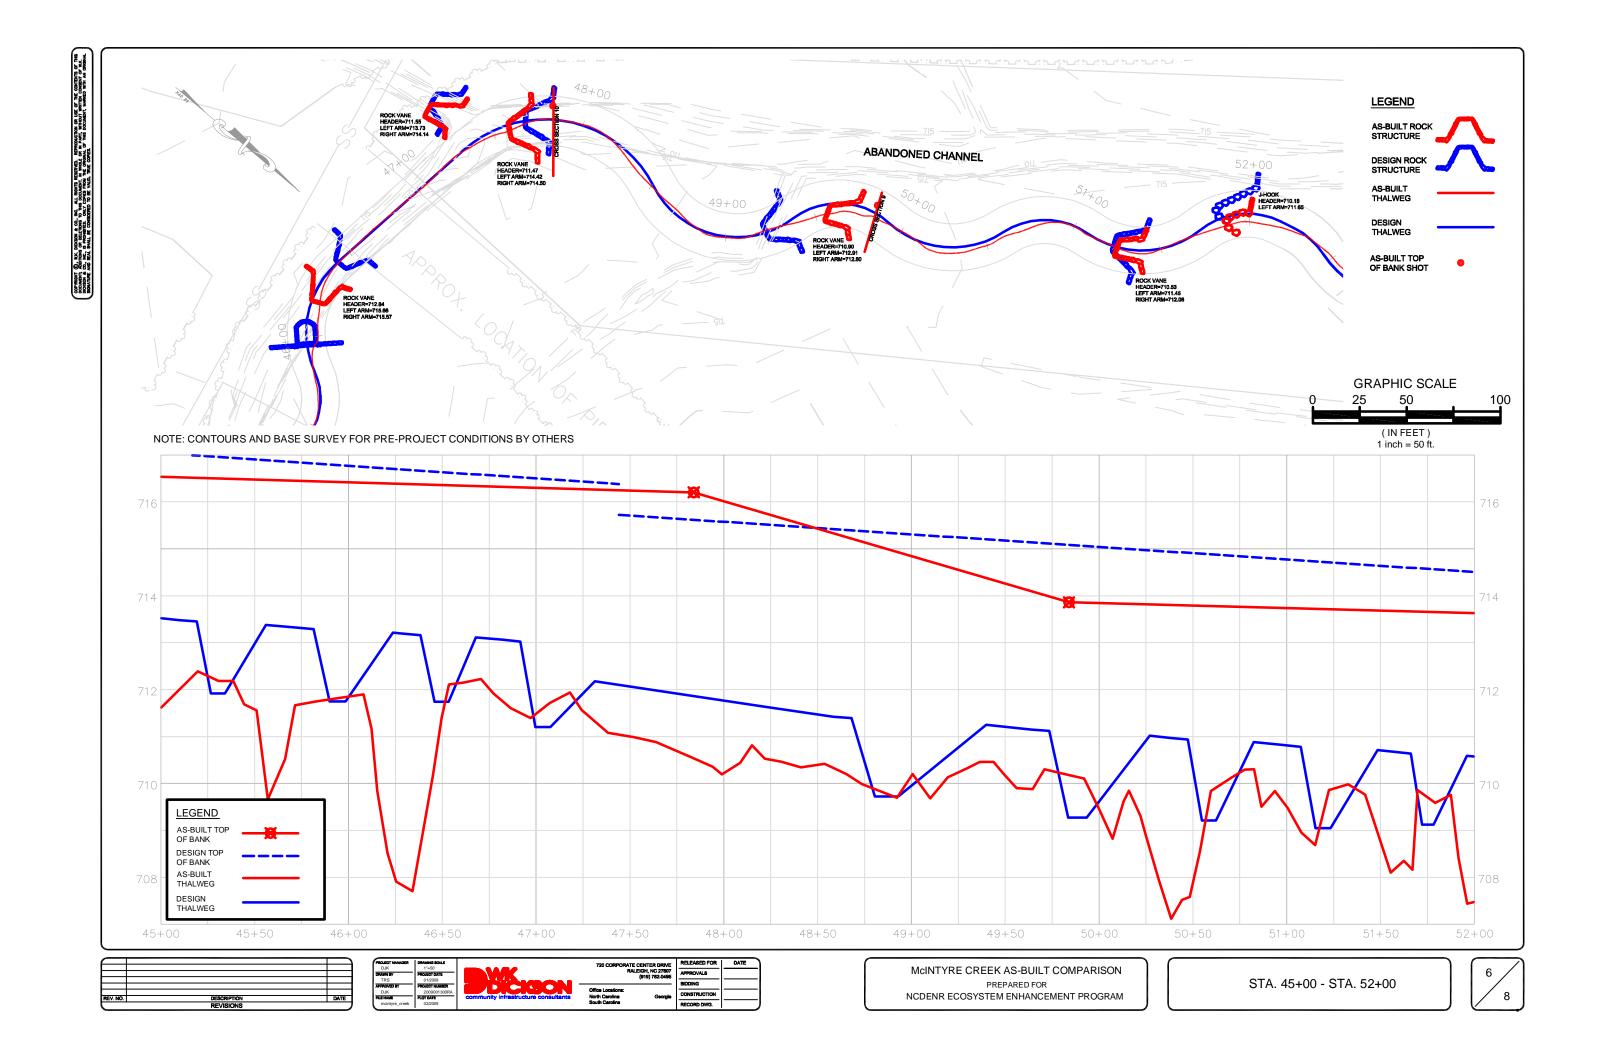
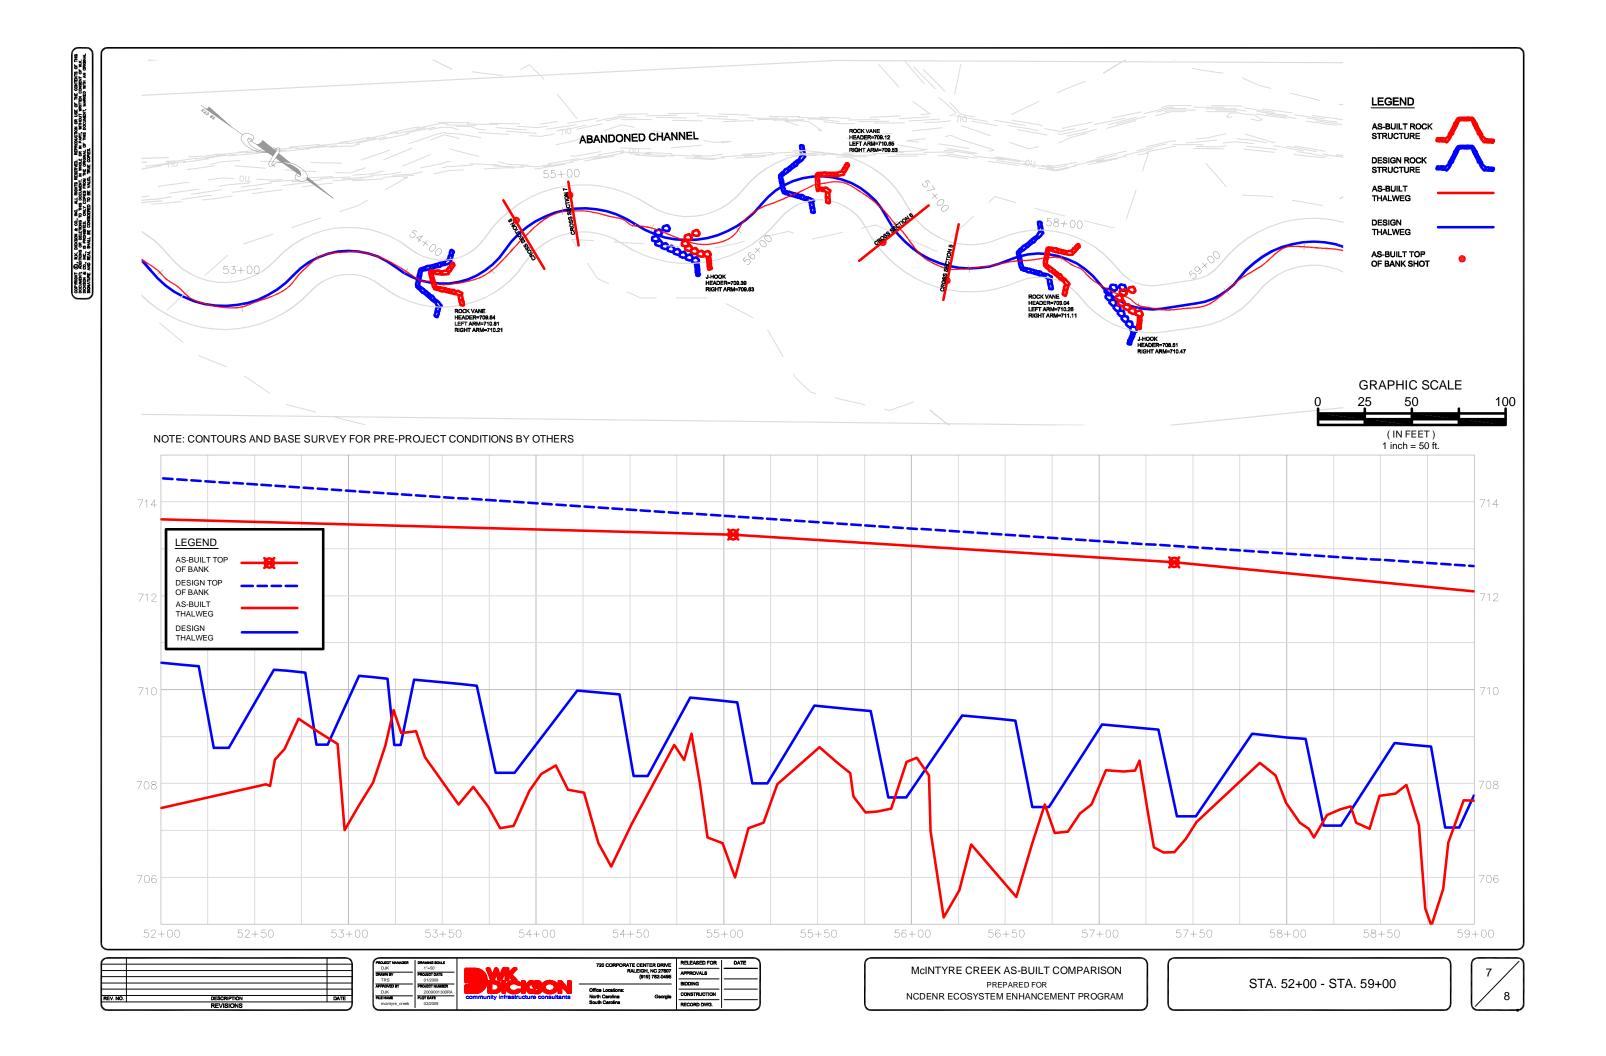
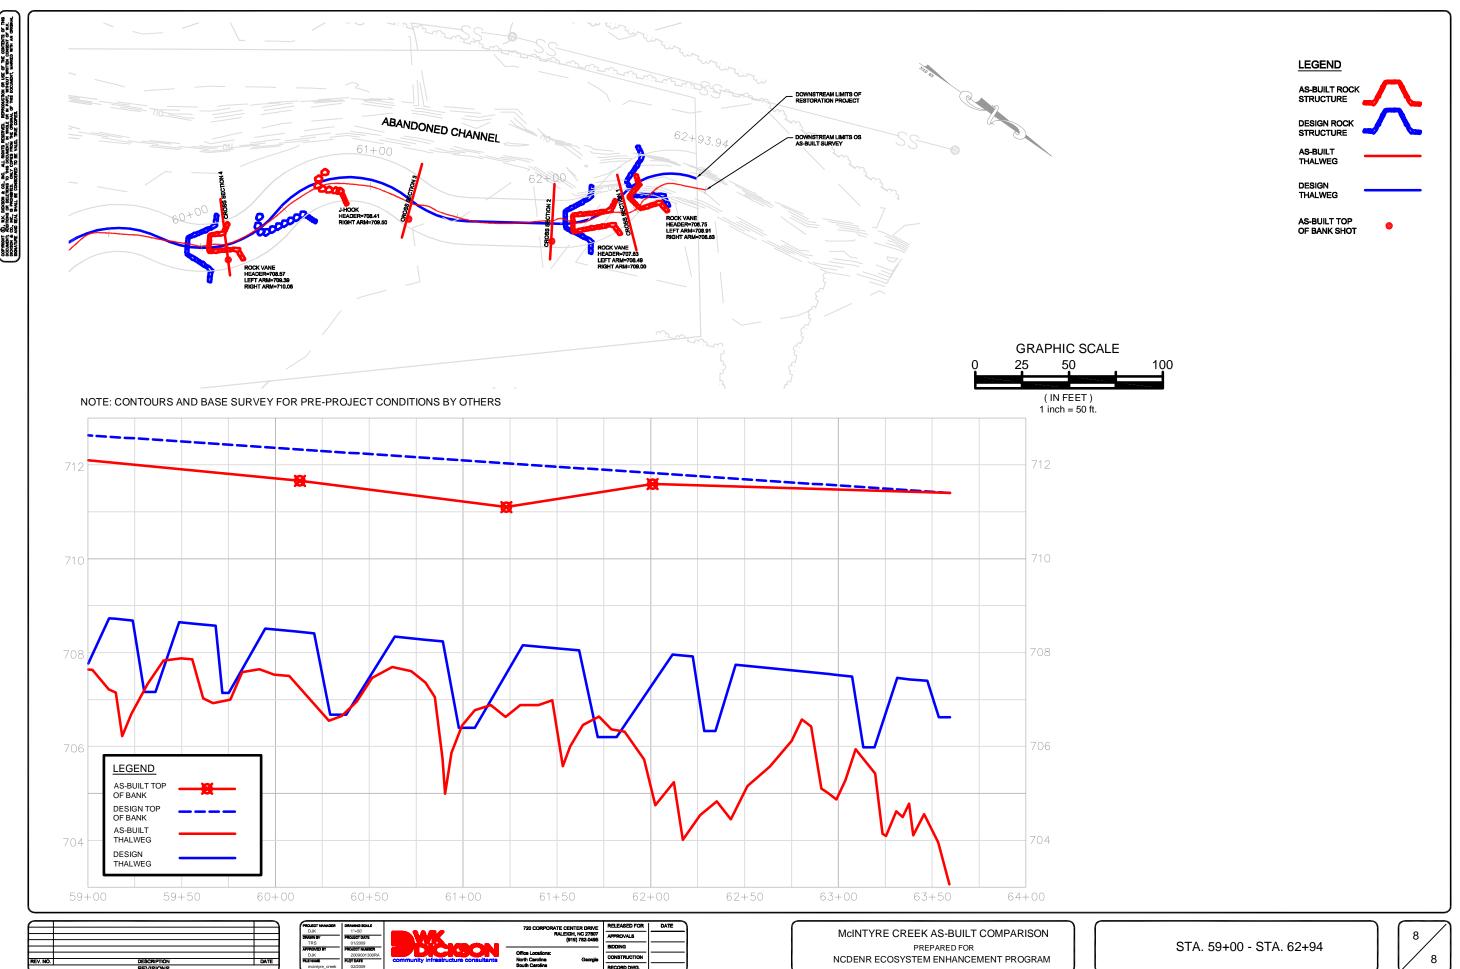
Appendix B

The planform of the stream centerline and horizontal location of rock structures were superimposed on each other for the proposed and as-built conditions (Appendix B). As shown in Appendix B, the as-built thalweg of the channel was built very closely to the proposed centerline location. In general, the as-built channel was built with less sinuosity than the proposed channel. Additionally, the thalweg on the outside of bends in the as-built channel is quite often inside the proposed centerline location.

As shown in Table 2, the as-built channel is less sinuous and had less stream length then the proposed channel. Given a floodplain length of 4659 feet, the sinuosity of the as-built channel is 1.13 which is outside the design range (1.3 to 1.5) provided in the KCl morphological design table found in Appendix D.

- The as-built upstream reach (above Station 48+ 30) more closely matches with the proposed thalweg and top of bank than the downstream reach.
- The channel is beginning to incise in the lower reach downstream of station 48+30.
- The top of bank is typically 0.6 to 1.3 feet lower than the proposed top of bank downstream of station 16+00.
- The as-built thalweg progressively becomes lower than the proposed thalweg the further downstream a comparison is made. Typical differences in riffle thalweg elevations are 1.0 feet.

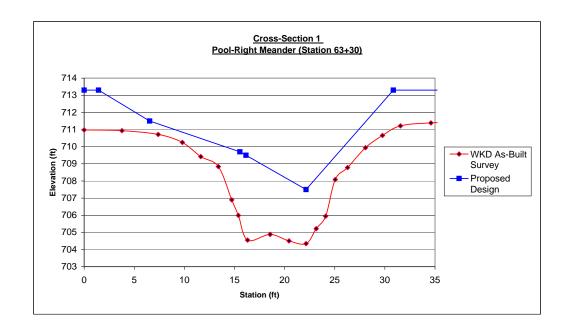
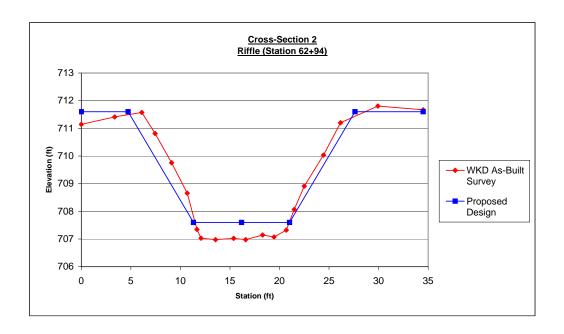
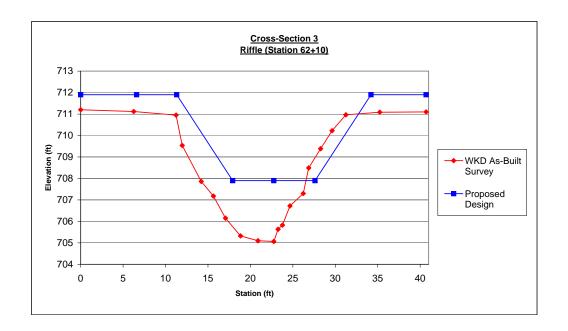
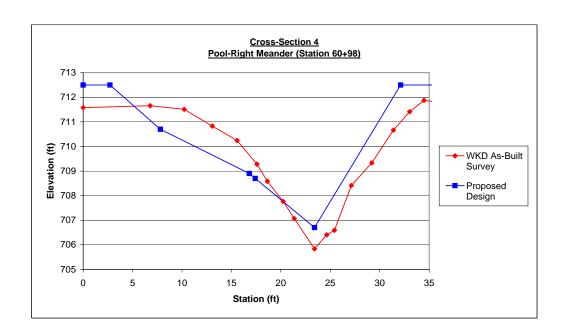
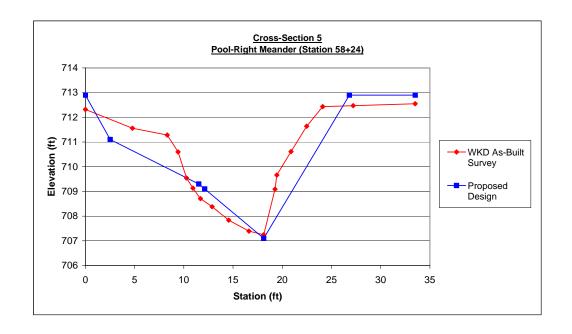
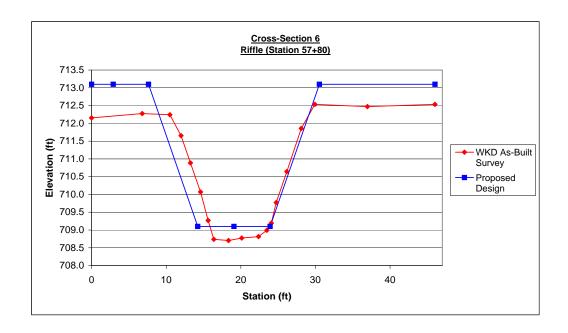
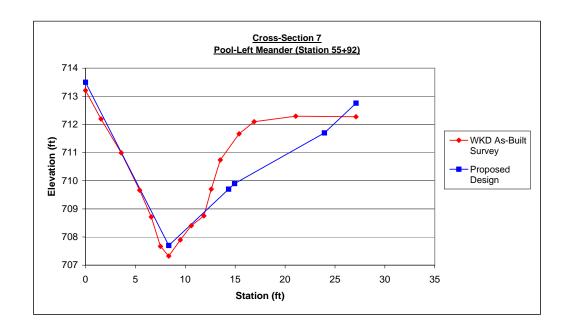
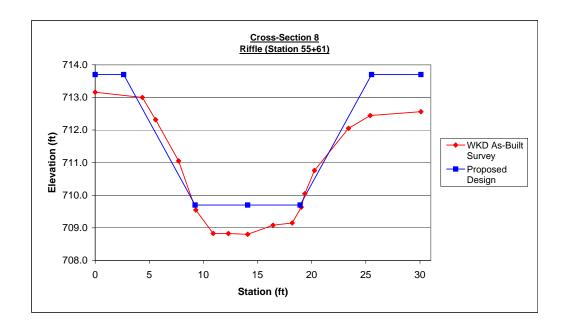
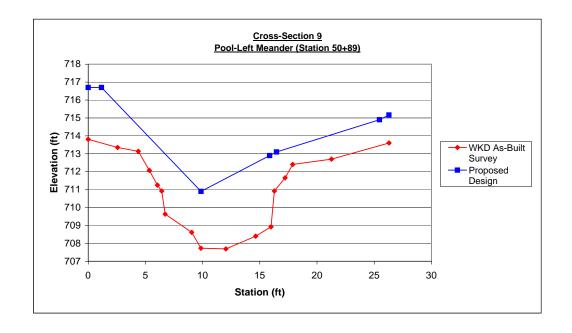
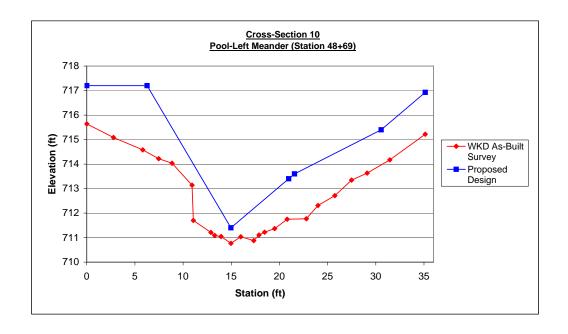
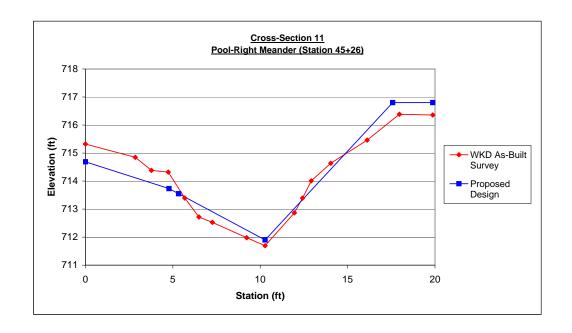
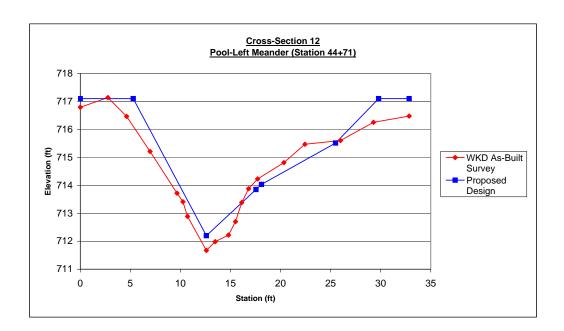
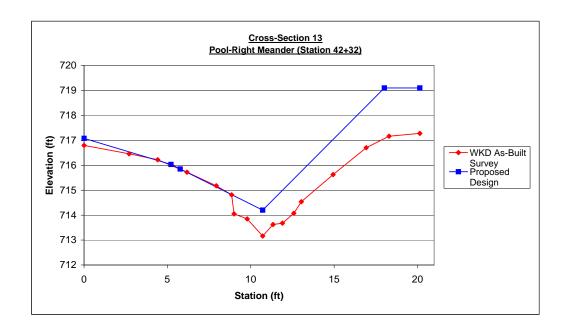
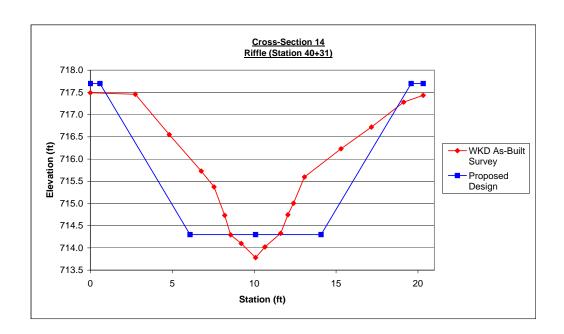
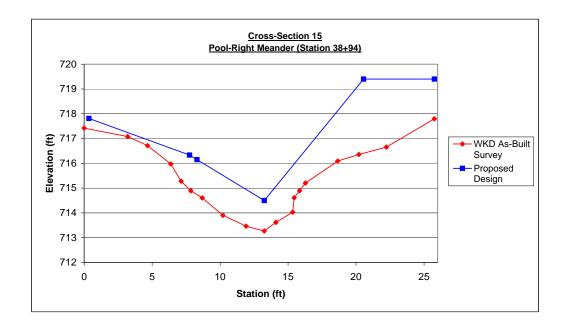
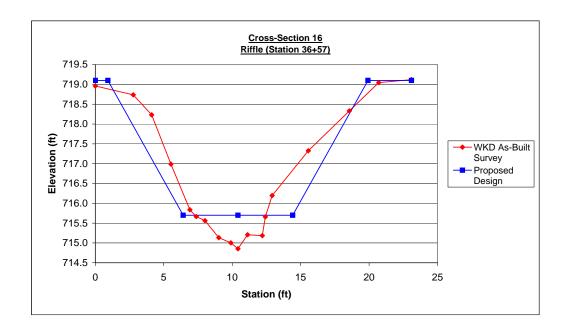
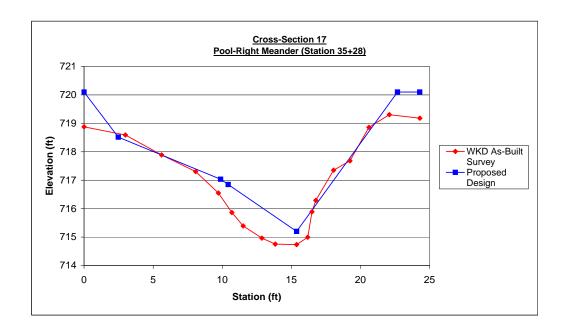
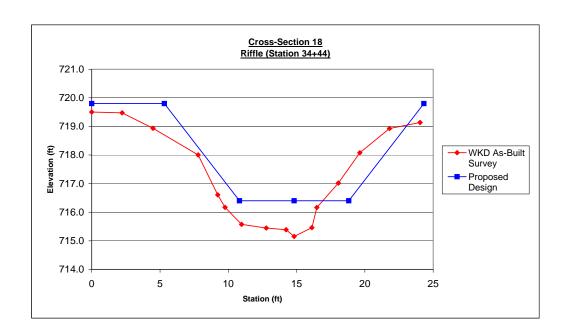
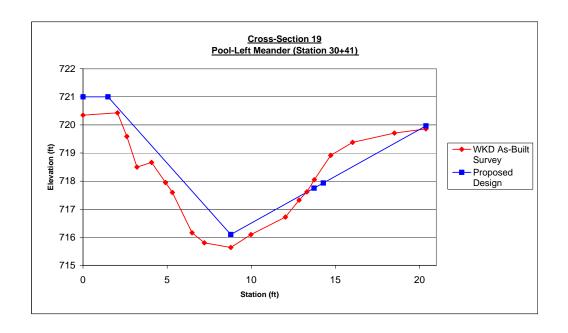
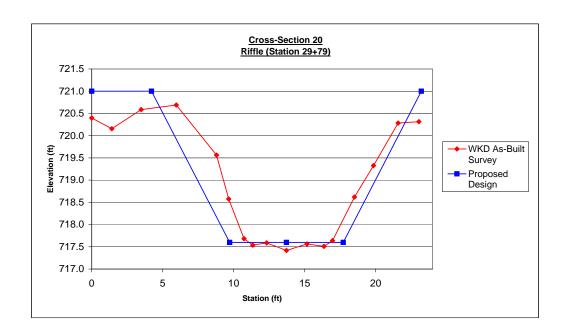
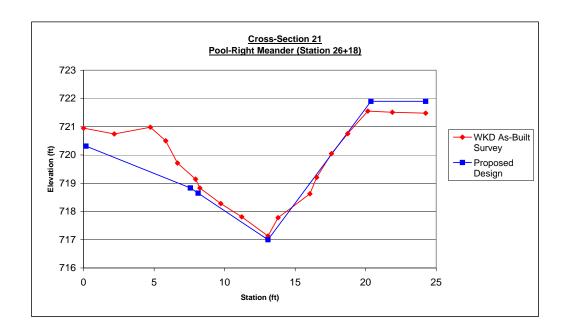
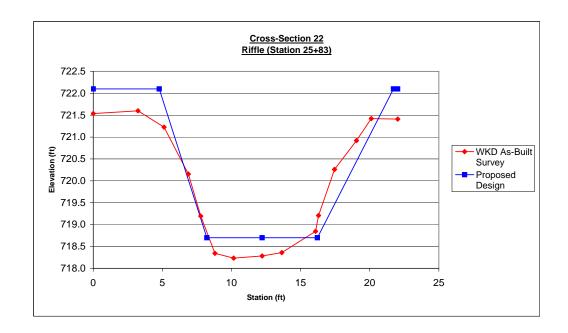
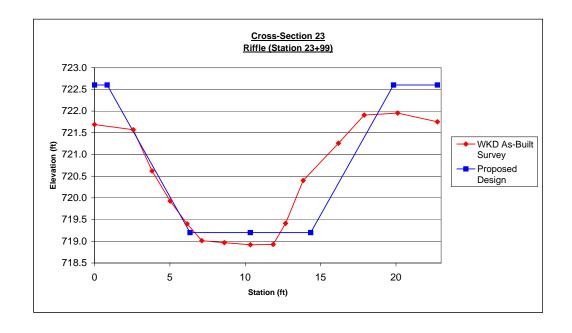
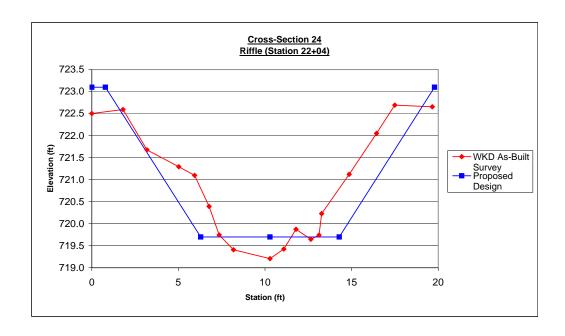
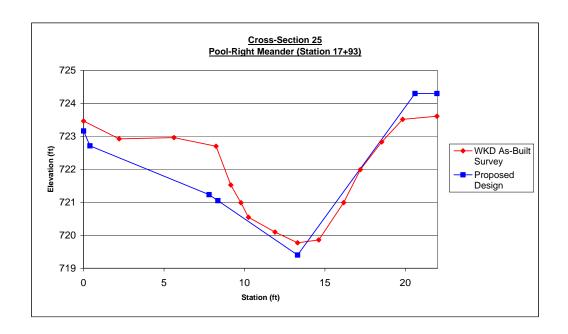
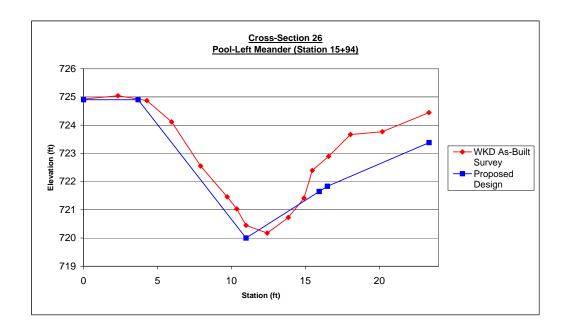
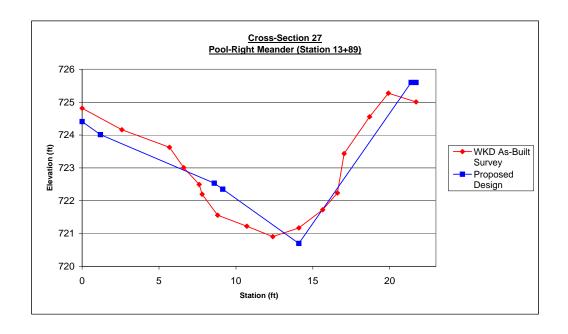
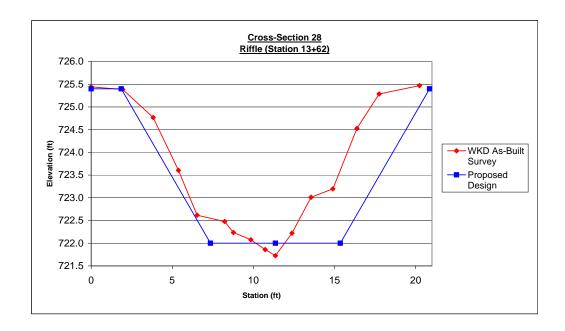
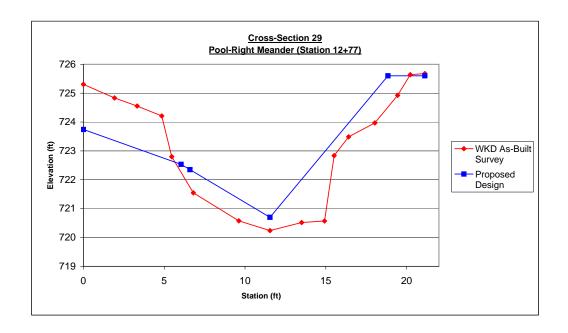
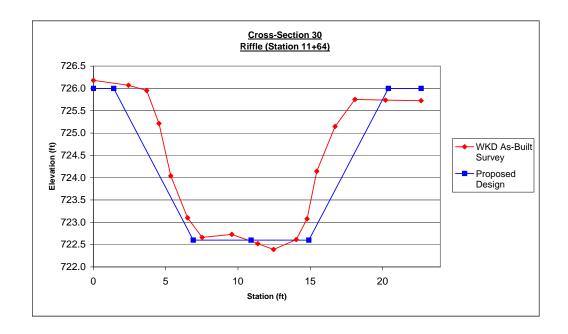
Appendix C

As shown in Table 4, on average the as-built channel topwidths are narrower than the proposed topwidths. The following table summarizes the difference in channel widths based on cross section type and reach:

A comparison of the channel depths shows that the as-built channel is slightly undersized when compared to the proposed design depths. It is difficult to make a direct comparison to the design depths at pools because it is often preferable in a design to have varying pool depths as this is good for habitat and stream stability. For this reason, the following conclusions about design depths are made at riffles only. As-built depths were consistently less than 0.5 feet different when compared to the proposed conditions. The largest difference in design depths occurred at cross section 62+ 10 which is in a section of channel that is undergoing severe erosion.

A review of Table 7 shows that the as-built channel is predominantly 15 percent to 33 percent smaller than the proposed channel. The main reason the channel is smaller is due to the following:

- As-built topwidths are narrower then the proposed topwidths.
- The as-built shape of pools does not match the design cross section. The main difference is that the shape of the as-built cross section is more trapezoidal in shape and does not flatten out where a depositional sand point bar feature would be expected (on the inside of bends). Typically these missing areas on the inside of the bends account for approximately 20 percent to 33 percent of the design cross sectional area.
- 18 of the as-built cross sectional depths were less than the design cross section. Several of these depths were as much as 1.0 foot less. This difference would have

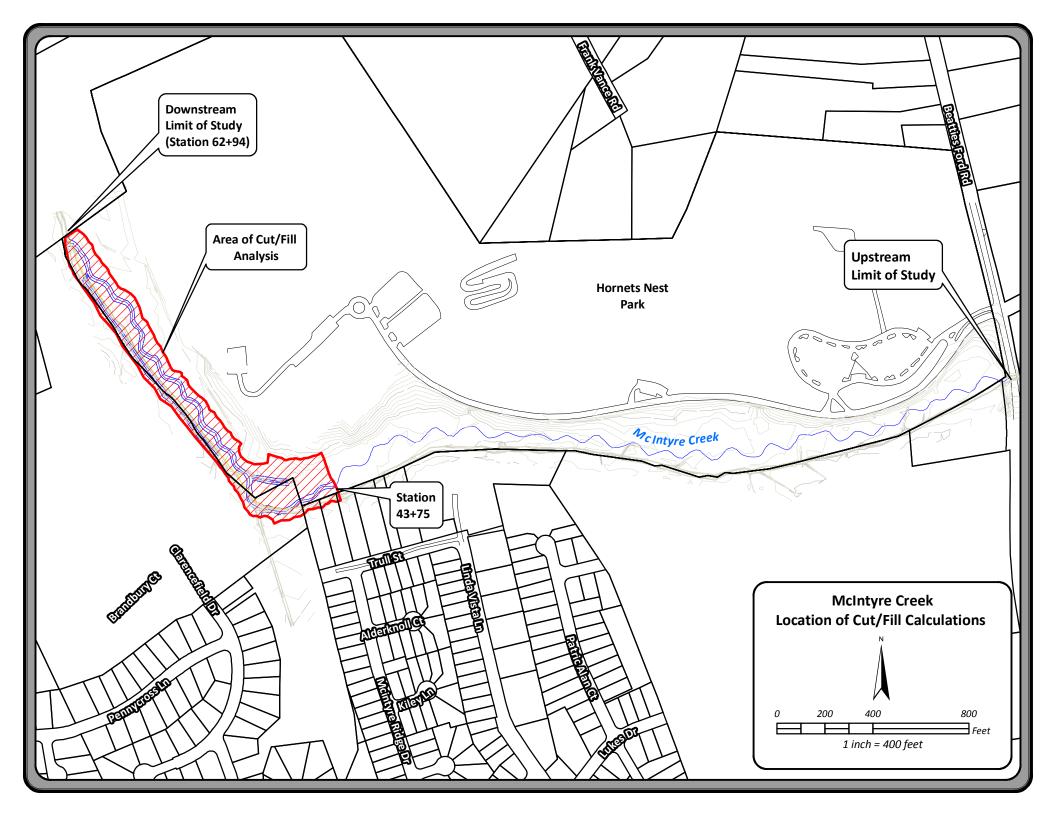
Appendix F

As shown in Table 9 the results generated using Land Desktop match within 10% of the volumes calculated by hand. The Land Desktop automated software is providing accurate results and therefore will be used for the conclusions found in this report. This report ignores the affects of swelling when calculating the volume of material needed to achieve final in place (compacted) quantities.

Per a February 24, 2009 meeting with NCEEP it was determined that the contractor brought in approximately 1370 cubic yards of material. With consideration given to channel erosion since the end of construction, this number of 1370 cubic yards further validates the estimate of 1875 cubic yards calculated by WK Dickson. Based on the hand calculations prepared by WK Dickson and the volume of material brought in by the contractor, the estimate of 1875 cubic yards of fill material is reasonable.
