McKee Creek Stream Restoration Monitoring Report – Year 5 of 5 FINAL

Contract # 004391 DMS Project # 92573

Cabarrus County, North Carolina

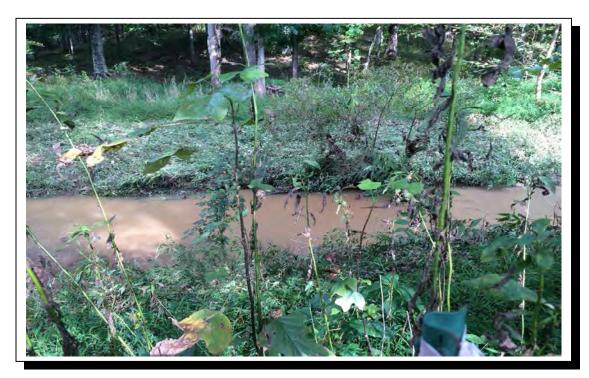
Description: Photo Station #1 - McKee Creek Reach 2

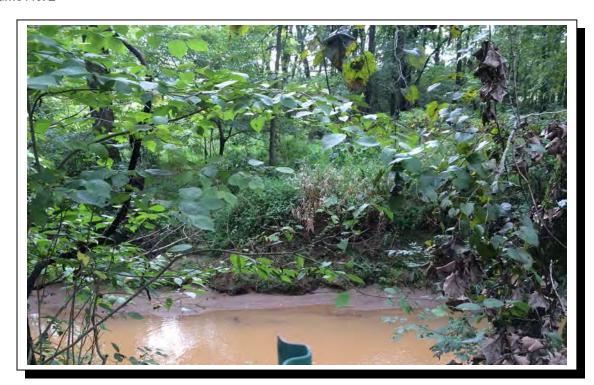
Description: Photo Station #2 – McKee Creek Reach 1

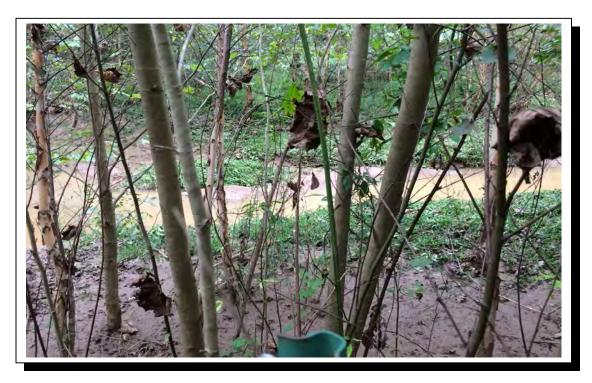
Description: Photo Station #3 - McKee Creek Reach 2

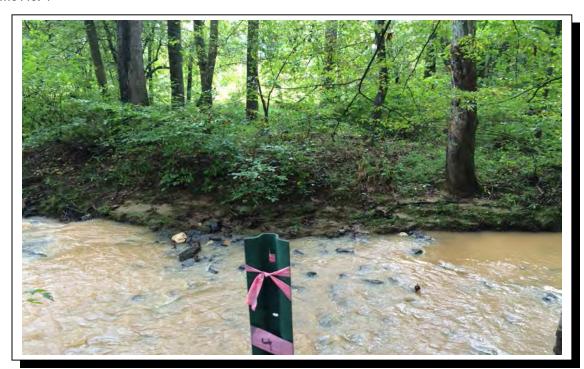
Description: Photo Station #4 - McKee Creek Reach 1

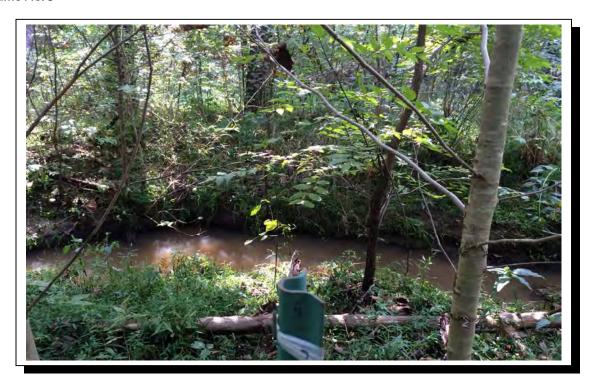
Description: Photo Station #5 - Clear Creek Reach 3

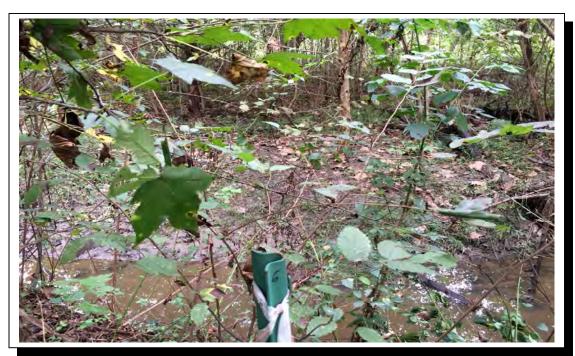
Description: Photo Station #6 - Clear Creek Reach 3

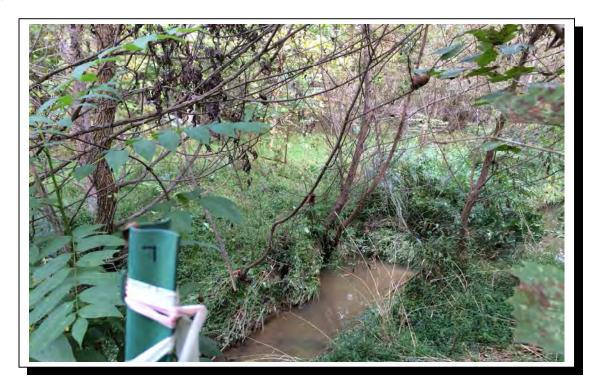
Description: Photo Station #7 - Clear Creek Reach 3

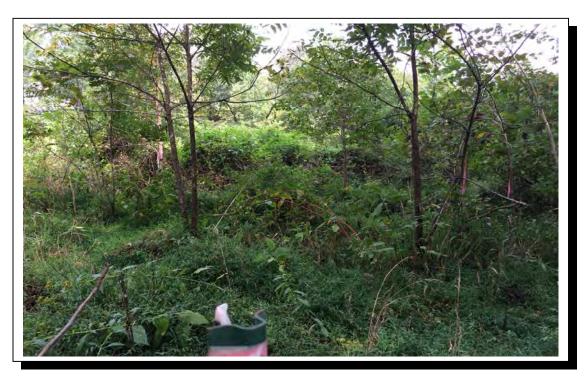
Total stem count was 6 planted live stems (243/acre) and 7 volunteer stems, yielding a total count of 13 stems (526/acre). The planted live stem count is below the success criteria, possibly due to mowing activity in 2012. The 6 live stem count is consistent with the live stem count in Year 3 and Year 4 monitoring (6 live stems each year), and the volunteer stem count of 7 is a decrease from Year 4 monitoring (11 volunteer stems).

Description: Vegetation Plot #1 - McKee Creek Reach 1

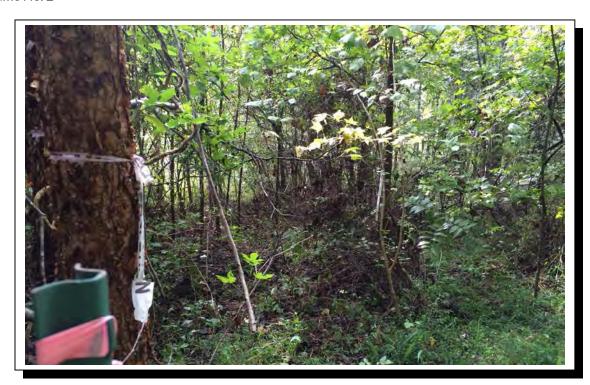
Total stem count was 11 planted live stems (445/acre) and 44 volunteer stems, yielding a total count of 55 stems (2,227/acre). The total planted live stem count is well above the success criteria. The 11 planted live stem count is consistent with the live stem count in Year 4 monitoring (11 live stems), and the volunteer stem count of 44 is an increase from Year 4 monitoring (36 volunteer stems).

Minor non-native invasive vegetation was noted within Vegetation Plots 1, 2 and 3, primarily comprised of Japanese honeysuckle (Lonicera japonica). Vegetation plot 2 continues to have Lonicera intertwined with the hardwood species along the eastern edge of the plot; however, this presence is diminished greatly, and is not considered to be problematic in Year 5.

Description: Vegetation Plot #2 - McKee Creek Reach 1

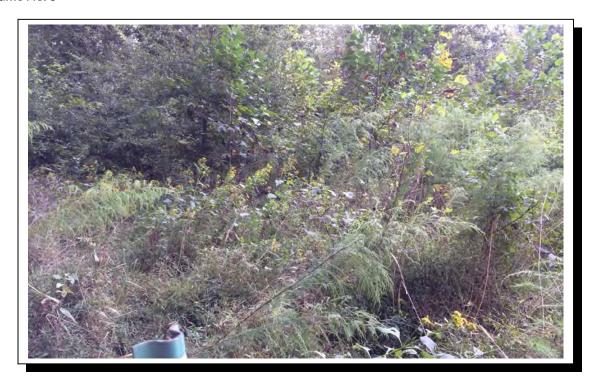
Total stem count was 7 planted live stems (283/acre) and 4 volunteer stems, yielding a total count of 11 stems (445/acre). The total planted live stem count exceeds the success criteria of 260 stems/acre at Year 5. The 7 planted live stem count is consistent with the live stem count in Year 4 monitoring (7 live stems), and the volunteer stem count of 4 is an increase from Year 4 monitoring (3 volunteer stems).

Description: Vegetation Plot #3 – McKee Creek Reach 2

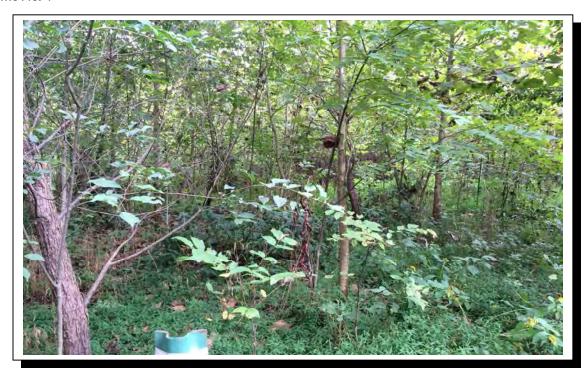
Total stem count was 17 planted live stems (688/acre) and 47 volunteer stems, yielding a total count of 64 stems (2,591/acre). The total planted live stem count is well above the success criteria. The 17 live stem count is reduced from the live stem count in Year 4 monitoring (18 live stems), and the volunteer stem count of 47 is increased from Year 4 monitoring (44 volunteer stems).

Description: Vegetation Plot #4 - Clear Creek Reach 3
