Annual Monitoring Report

Monitoring Year 3 of 5

Middle South Muddy Stream Restoration Site

NCDMS Project No.: 93875

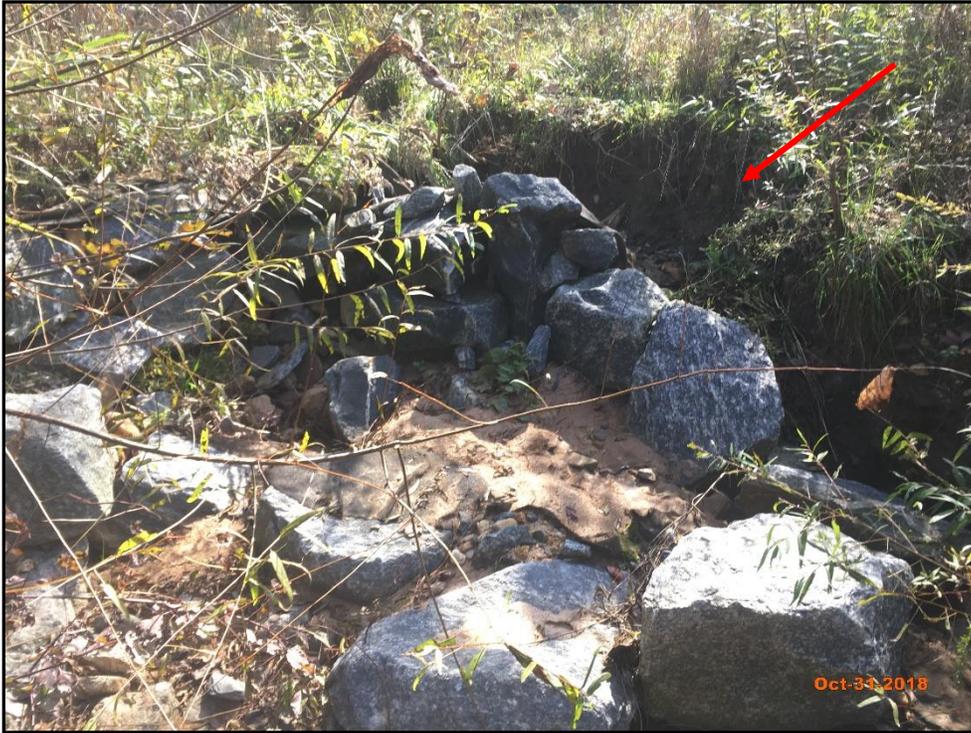
have been removed creating one large pool rather than a step pool sequence. Bed material from this area has been deposited downstream causing aggradation in the subsequent riffle. This change increased the total percent of the reach characterized by as a pool by 4% and decreased the percentage of steps by 4%. For the first time since baseline conditions, Iva Branch had water present upstream of the culvert. Water surface slopes were generated for both Upper and Lower Iva Branch.

Failed Structure – Iva Branch STA 303+67 (looking upstream)

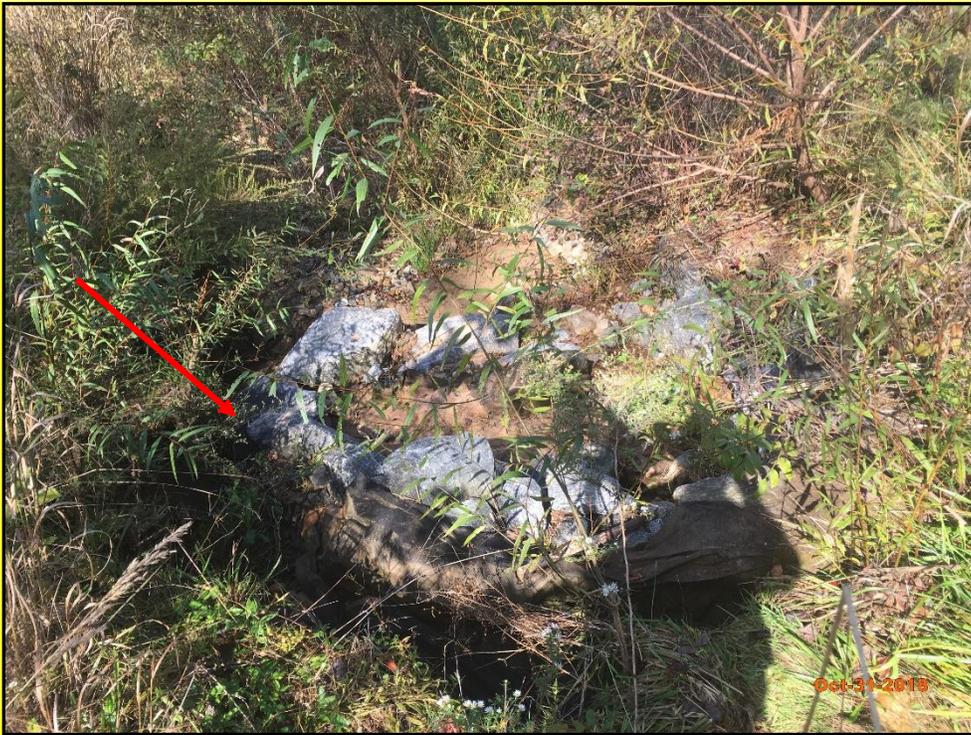
Failed Structure – Iva Branch STA 303+67 (looking upstream)

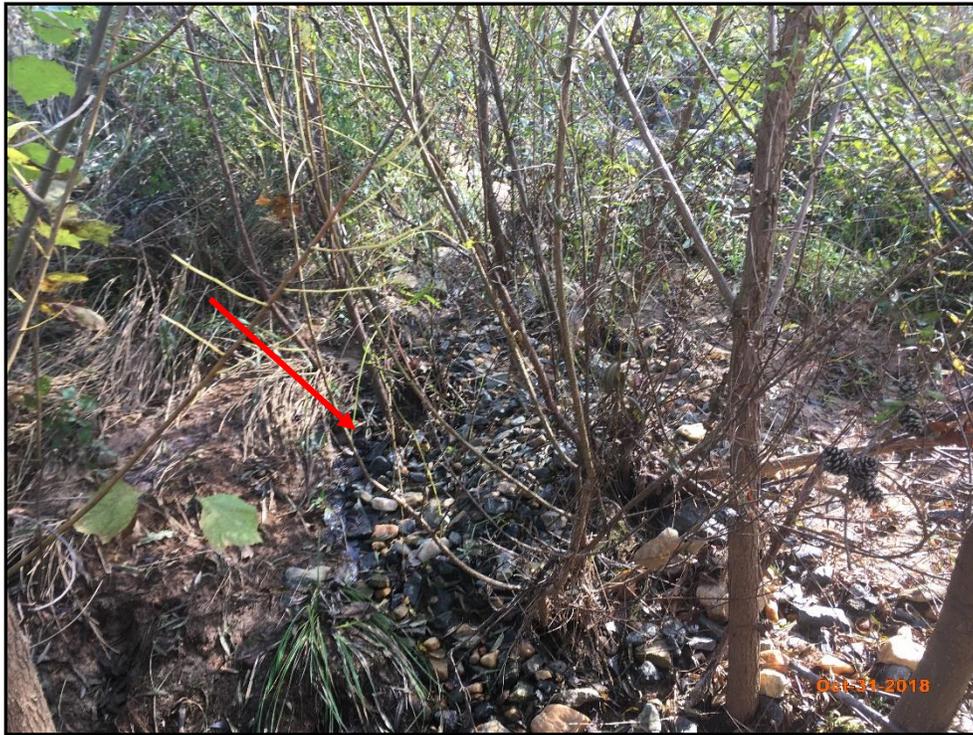
Aggradation– Iva Branch STA 303+75 (looking downstream)

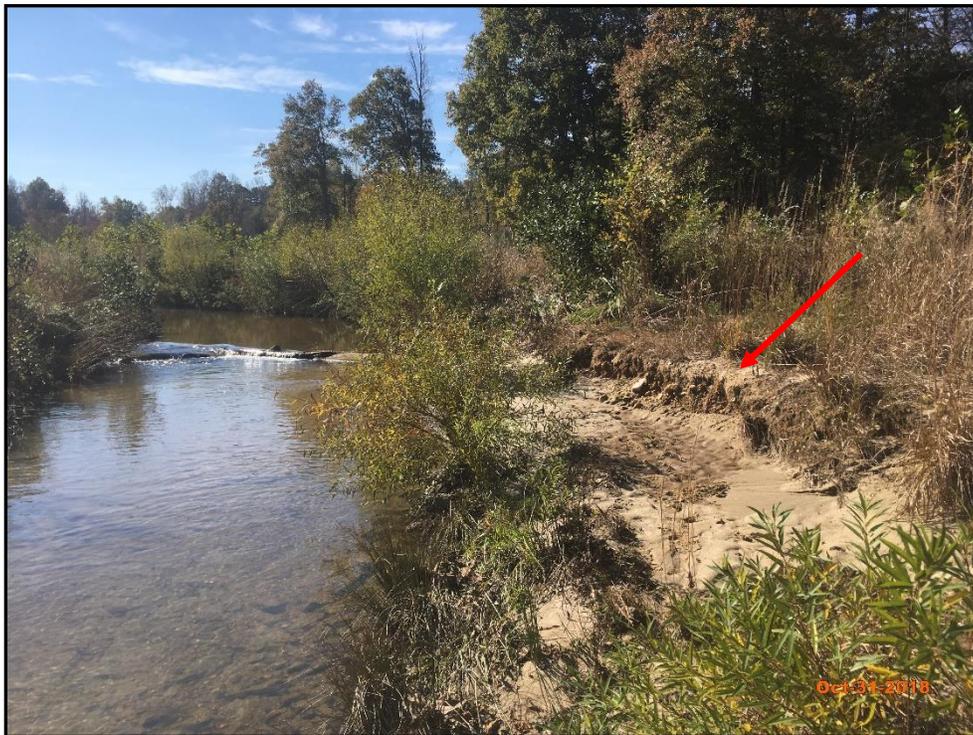
Bank Scour LDB– South Muddy Creek 109+00 (looking upstream)

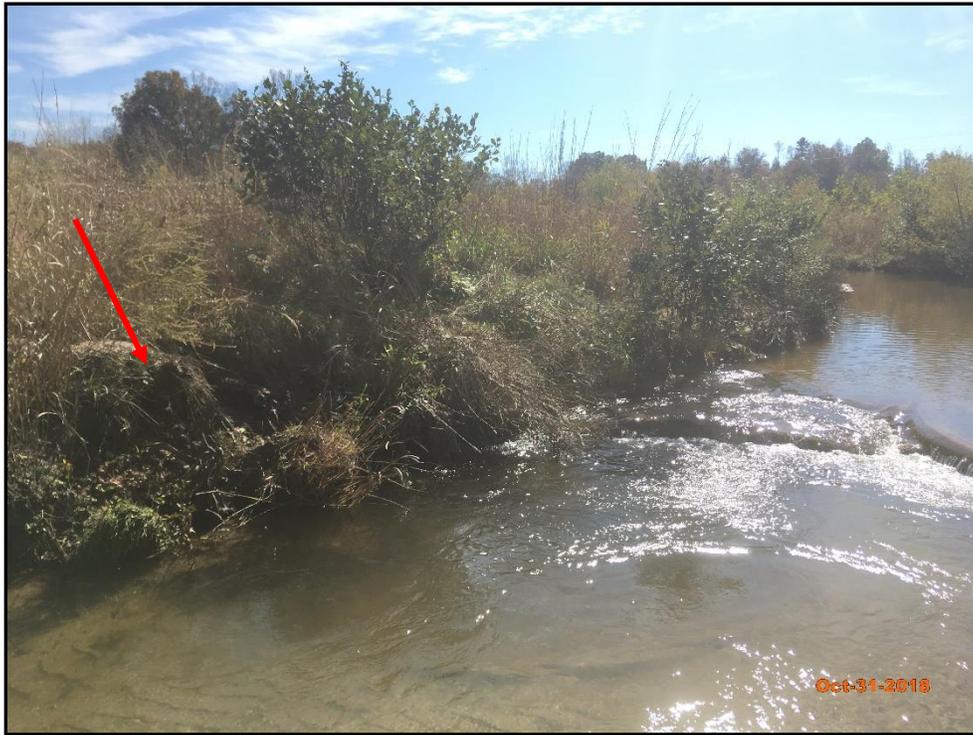
Bank Scour RDB– South Muddy Creek 109+00 (looking upstream)

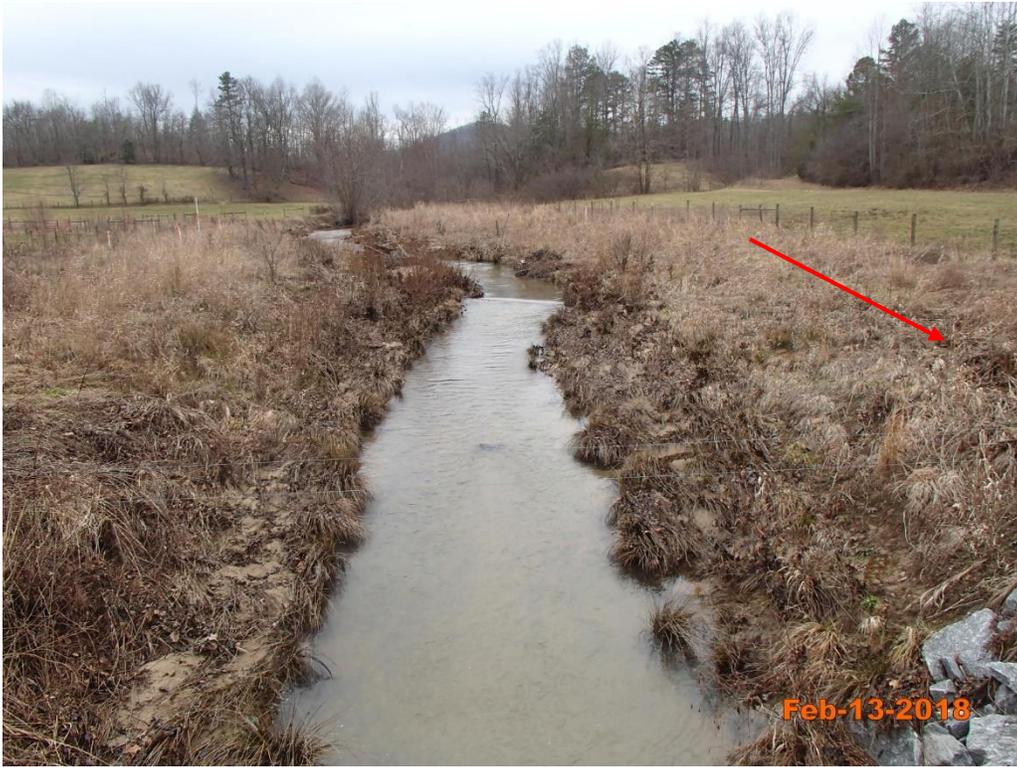
Photo #1 - South Muddy Creek Wrack Lines from bridge looking upstream

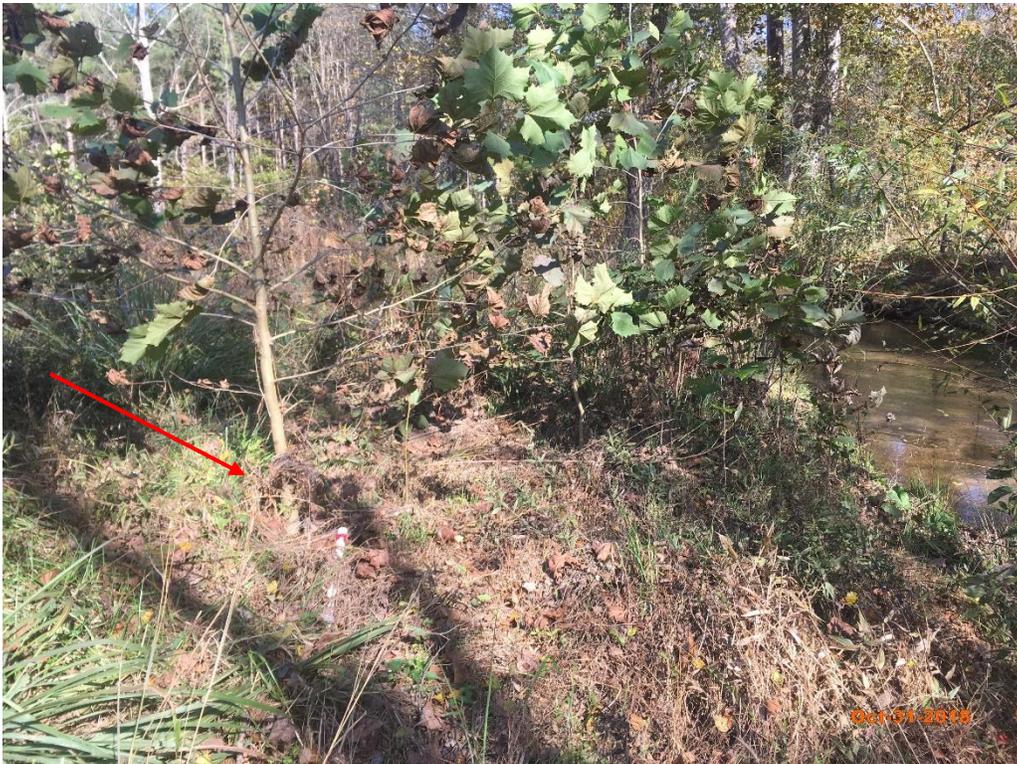
Photo #2 - South Muddy Creek Wrack Lines STA 111+25

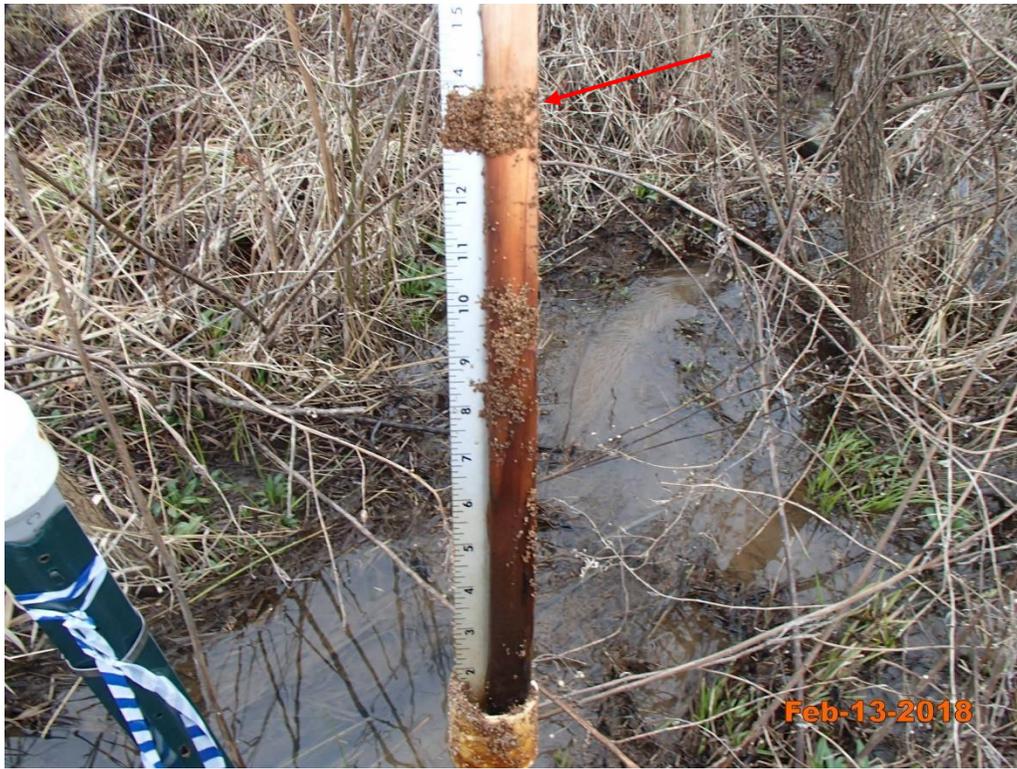
Photo #3 – Sprouse Branch Crest Gauge at 14 inches (recorded bankfull is 9”)

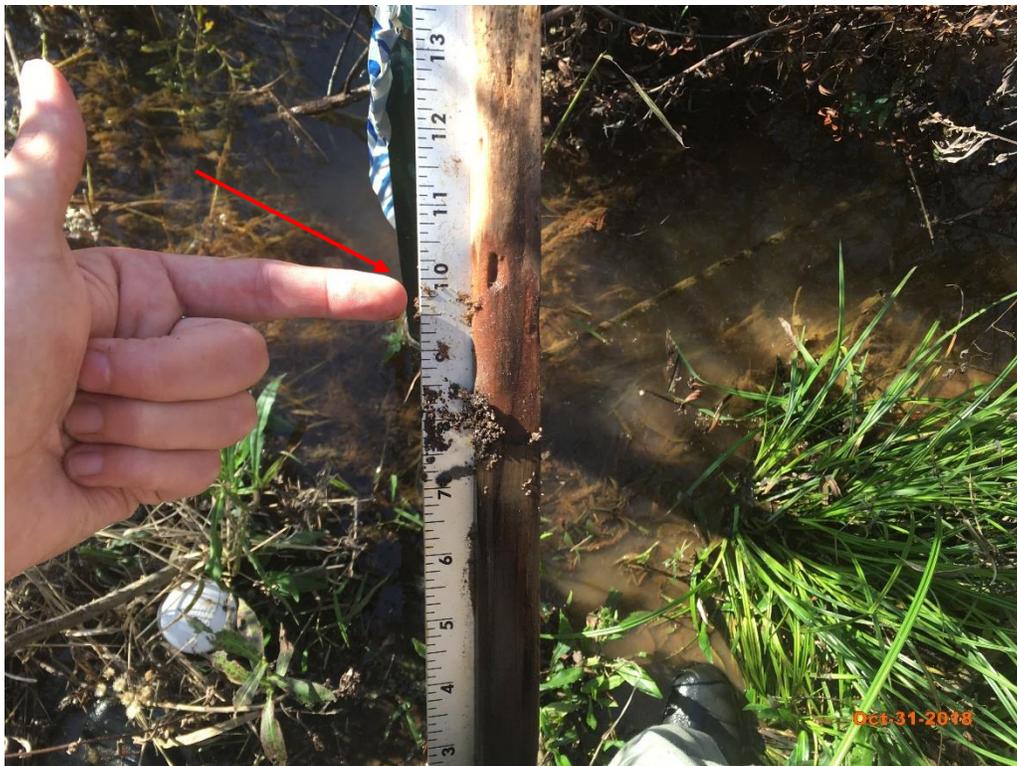
Photo #4 – Sprouse Branch Crest Gauge at 10 inches (recorded bankfull is at 9”)

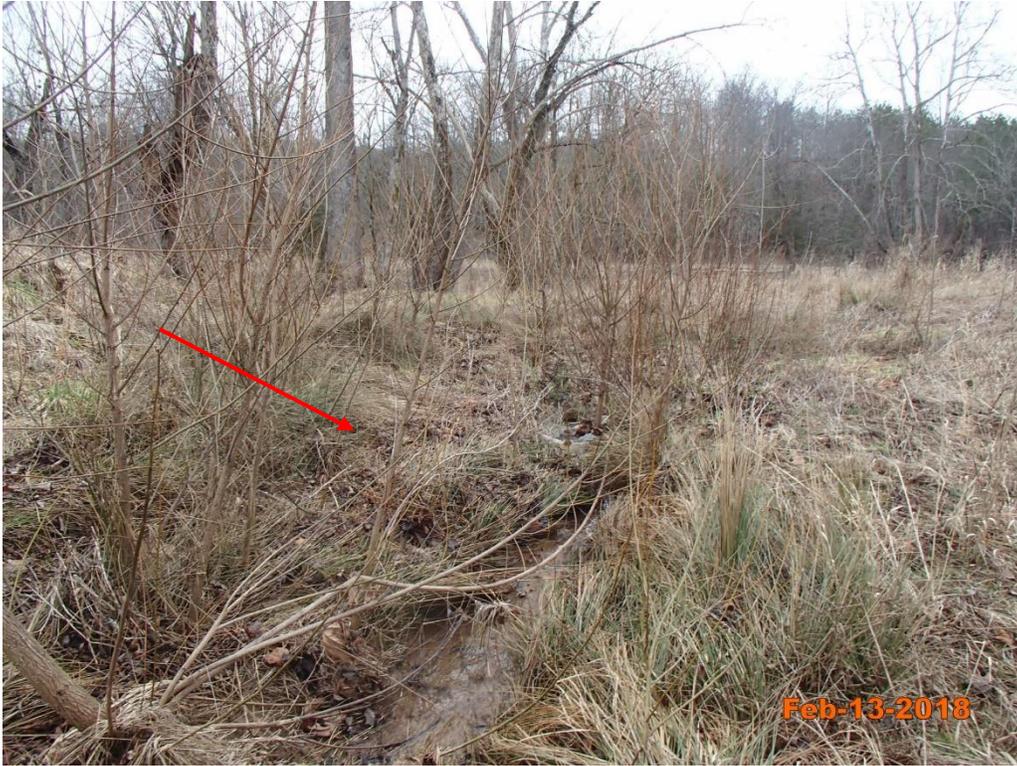
Photo #5 – Iva Branch Wrack Lines at STA 305+00

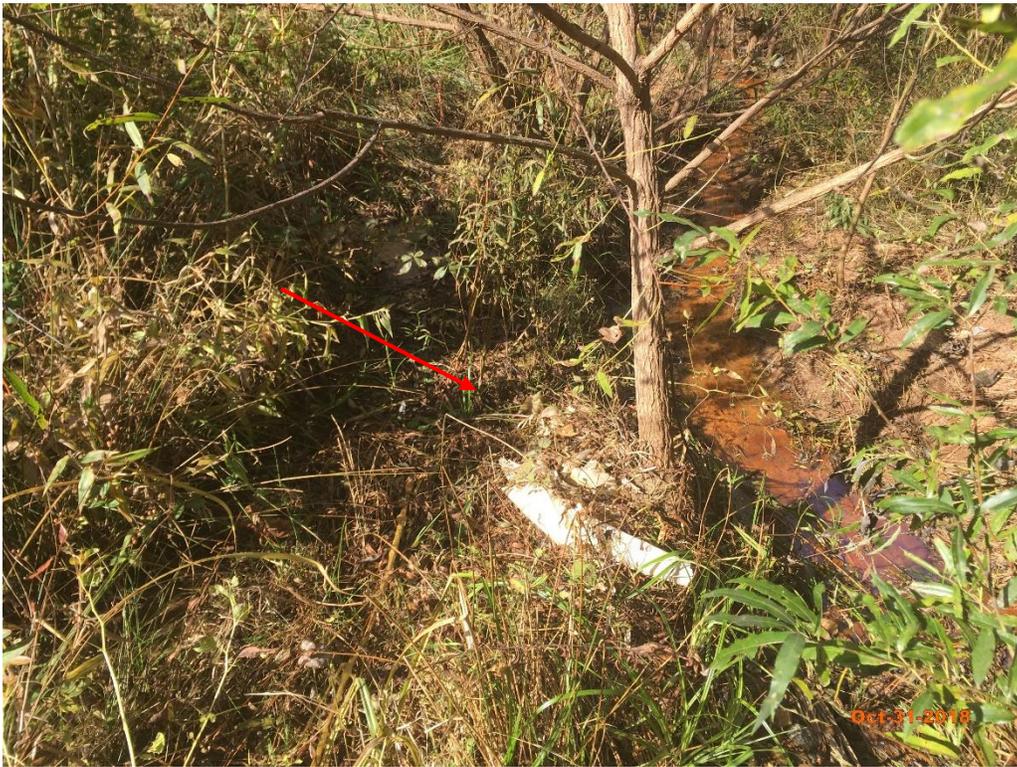
Photo #4 – Iva Branch Wrack Lines at STA 304+25
