**Modlin Property Wetland Mitigation Project
Martin County, NC**

**2008 Annual Monitoring Report
Year 2**

**NCEEP Project Number D050241
Roanoke River Basin**

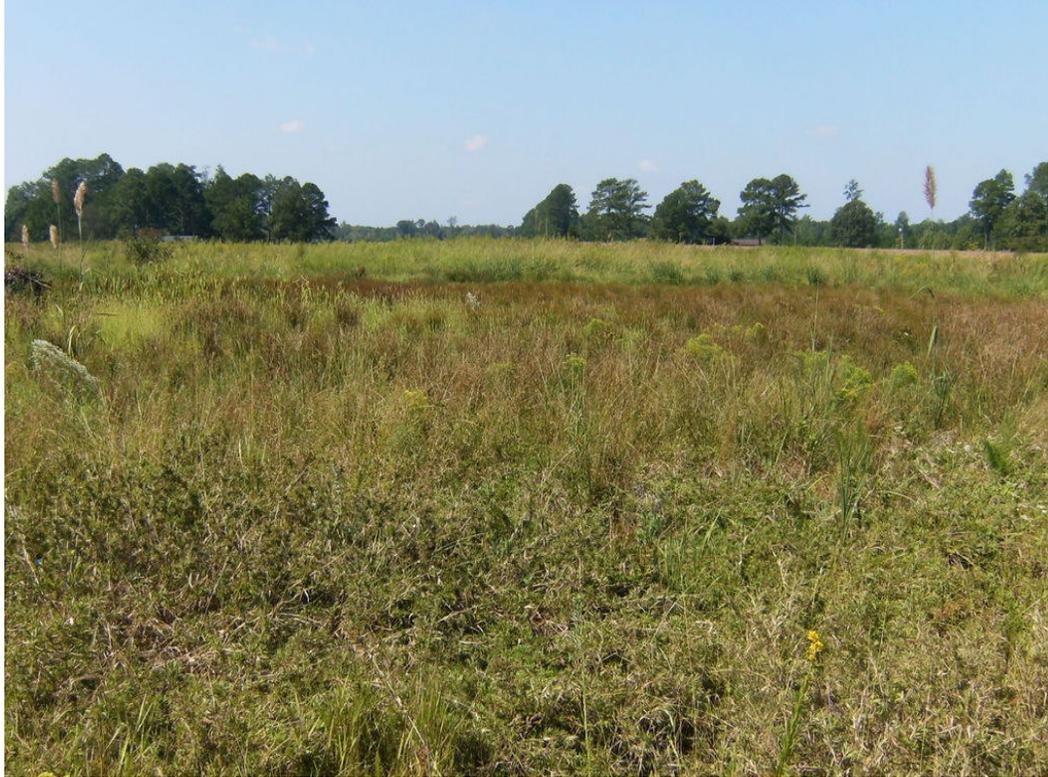
VPA 1

Table 6. Vegetation Problem Areas			
Feature/Issue	Plot	Probable Cause	Photo #
Herbaceous competition/Poor to moderate growth	All	Dense herbaceous cover, insufficient rainfall	VPA 1, 2 and 3

Indicative of lower elevations on site (Sept. 08)

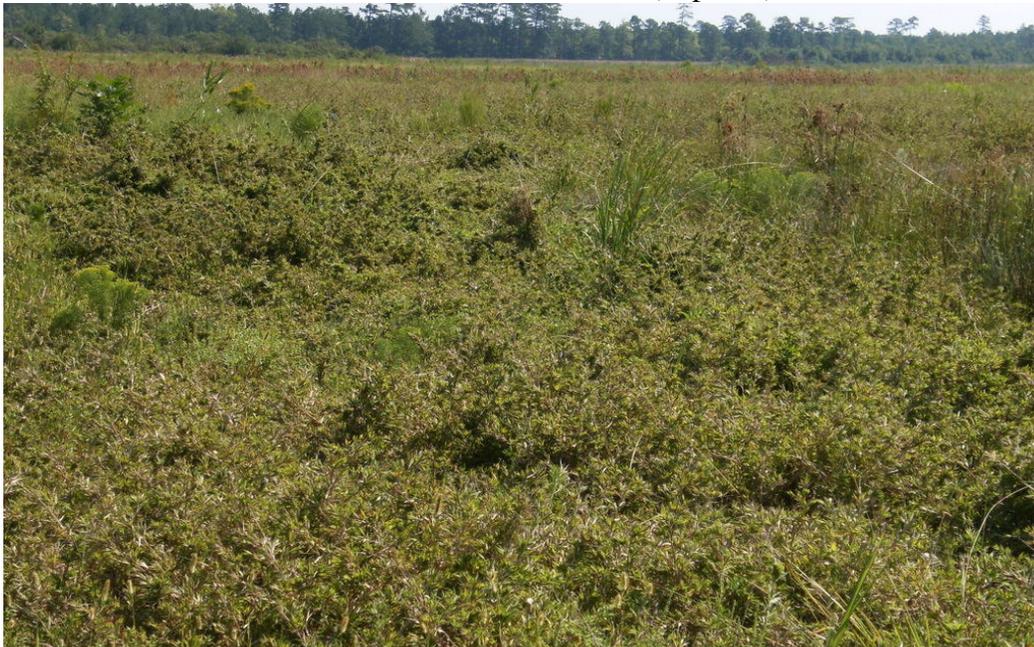
VPA 2

Indicative of lower elevations on site (Sept. 08)

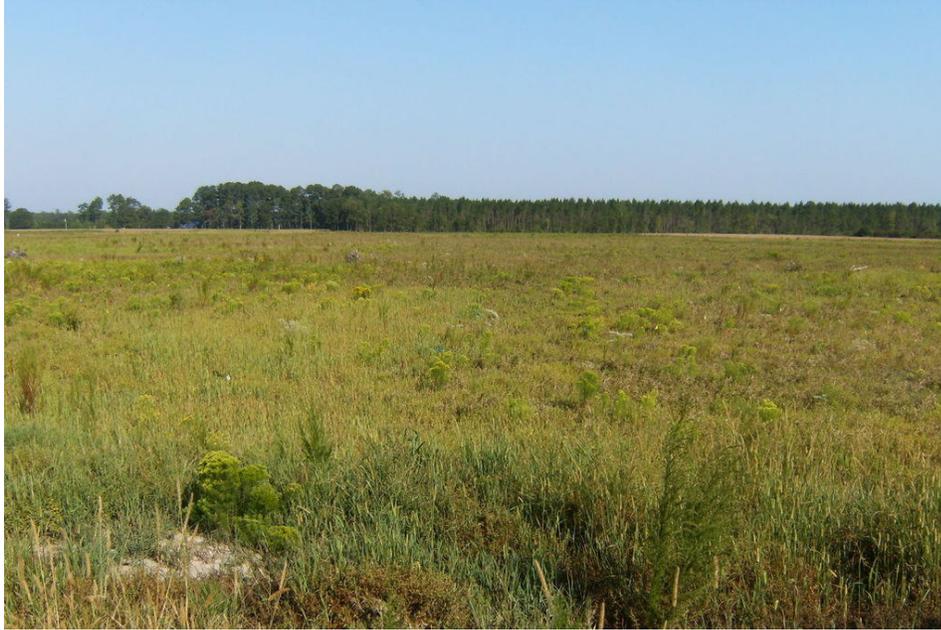
VPA 3
Indicative of upper, dryer elevations on site (Sept. 08)

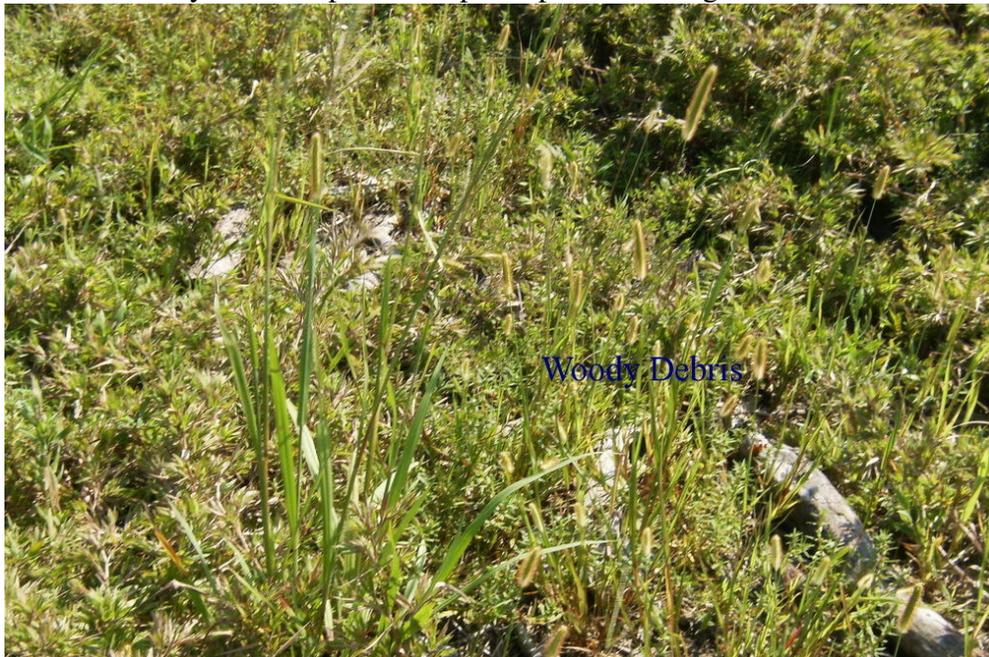
Woody debris deposited at pinch point after high water event

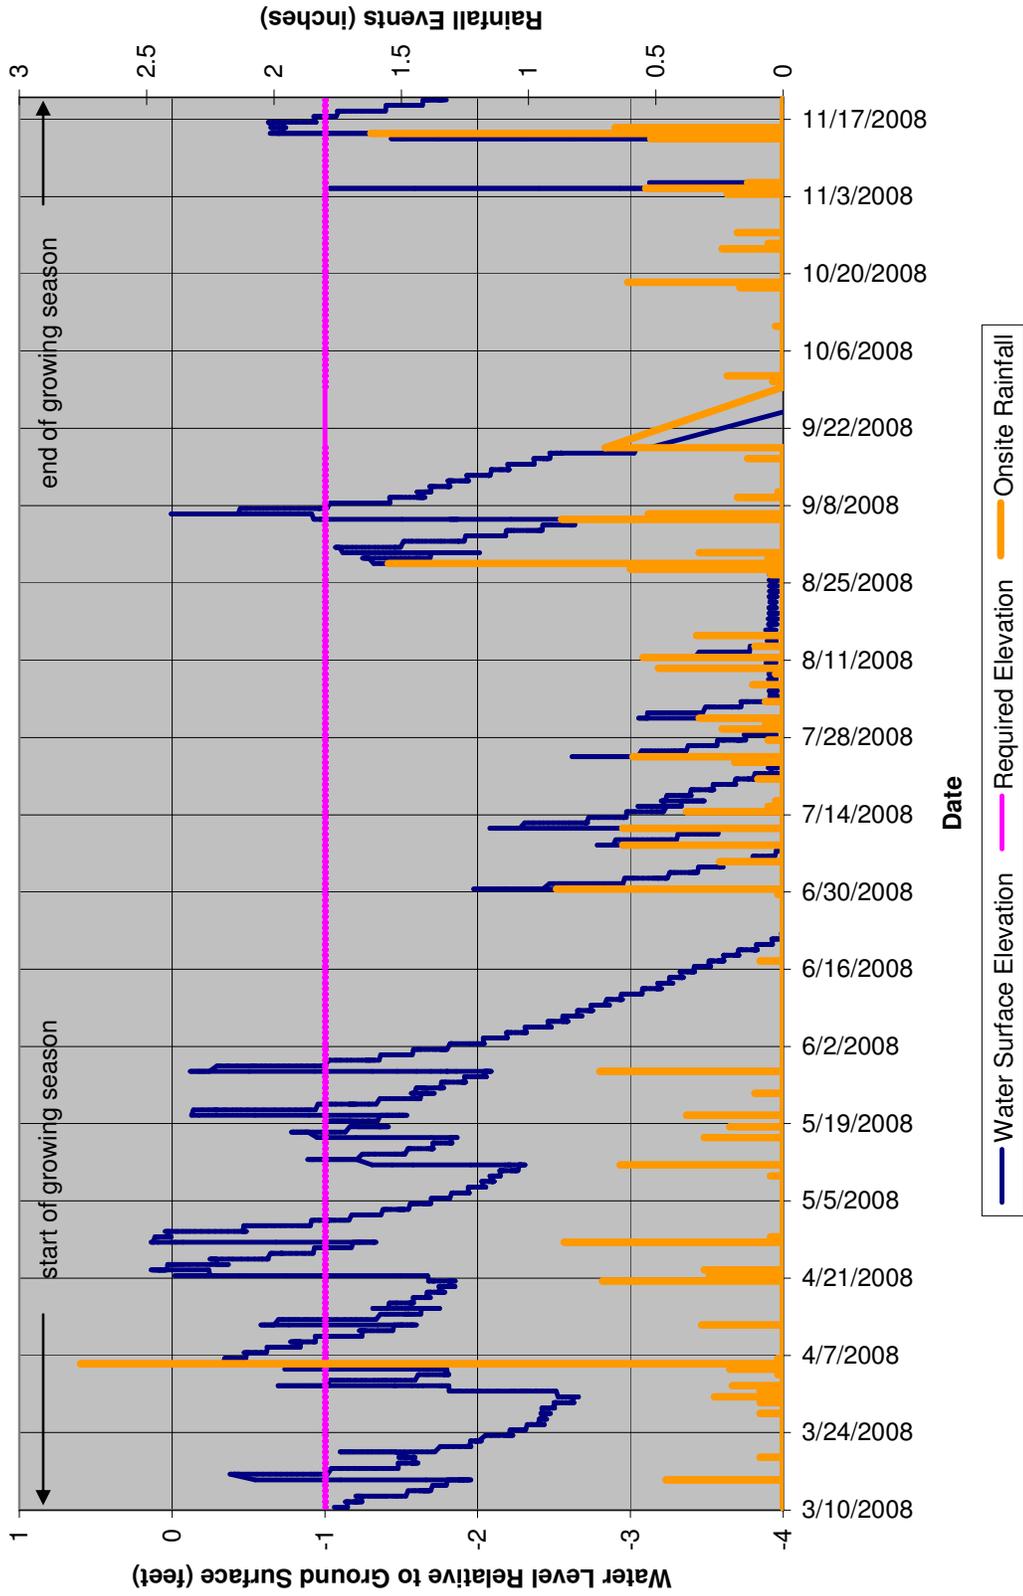
Modlin Monitoring Gauge #1 (1126654)

The wetland problem areas are generally the floodplains out beyond the drainage course. The lower areas of the emergent zone were able to retain water for longer periods, but the upper reaches of the floodplain were not due to lack of rainfall. The hydrographs in Appendix C show the how the soil moisture levels recharged quickly after rainfall but a high water table was not maintained due to insufficient frequency and duration of rainfall. Gauges 2 and 5, both of which are within the boundaries of the drainage course, achieved hydrologic success with a hydroperiod in excess of the minimum 21 consecutive days. Gauge 6 measured a hydroperiod of 18 consecutive days. The longest hydroperiods measured by gauges 3 and 4 were 15 and 16 days respectively. These hydroperiods all occurred from March to May before rainfall events became sporadic and light.

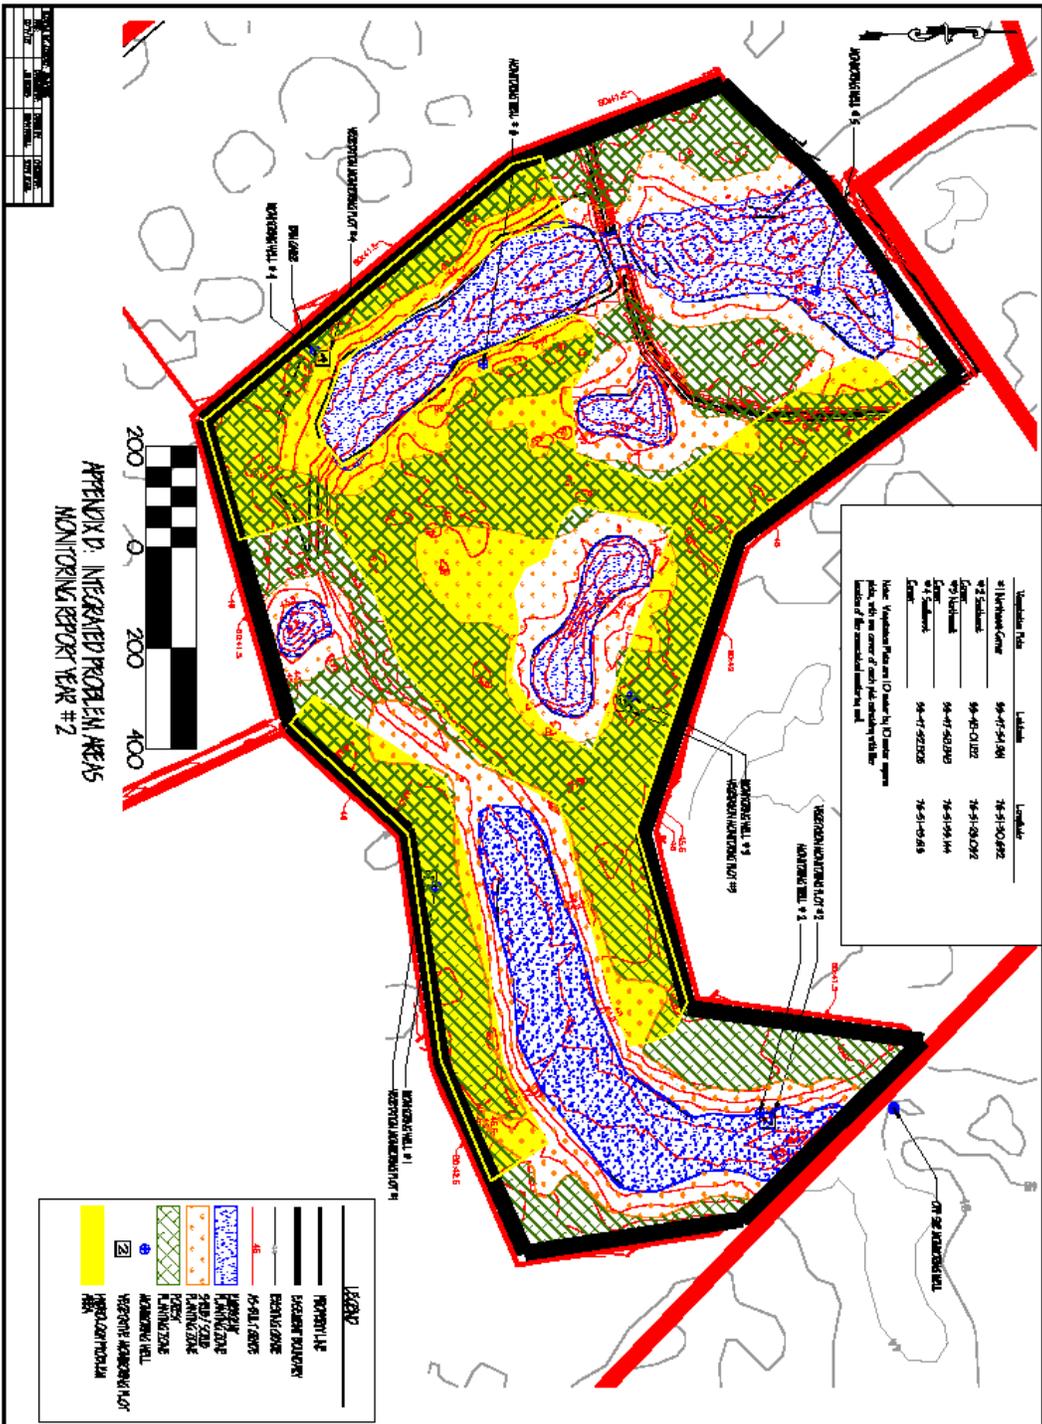
Figure 4 in Appendix D illustrates the dryer areas of the site where the observed herbaceous cover was much lighter. Seedling survival in these areas was good, though growth was minimal even on two-year-old stock. There was better growth on two-year-old stock, in the lower wetter areas even where the herbaceous cover is extremely dense and tall.

Figure 4 in Appendix D provides an overview of the site. The area shaded in yellow on the plan view indicates the driest areas during the growing season which was mostly the forest plant community. Much of the emergent zone was inundated for some time during the growing season as evidenced by the site photos in Appendix A. There was evidence of debris movement at the internal berm toward the outfall end of the project. This berm slows the movement of water offsite and appears to be functioning properly as evidenced by the deposition of woody debris at its lowest spot in the berm. In contrast, those areas higher in the flood plain remained somewhat droughty for most of the summer and fall.
