FINAL
YEAR 6 (2021) ANNUAL
MONITORING REPORT

**NEIGHBORS BRANCH/WALTON CRAWLEY BRANCH
STREAM & WETLAND RESTORATION SITE**

NCDMS Project No. 92872
Contract No. D09023S
USACE Action ID No. SAW-2009-917 & NCDWR Project No. 10-0123v2
SCO No. 08-07308-01
McDowell County, North Carolina

Data Collection: April-November 2021
Submission: December 2021

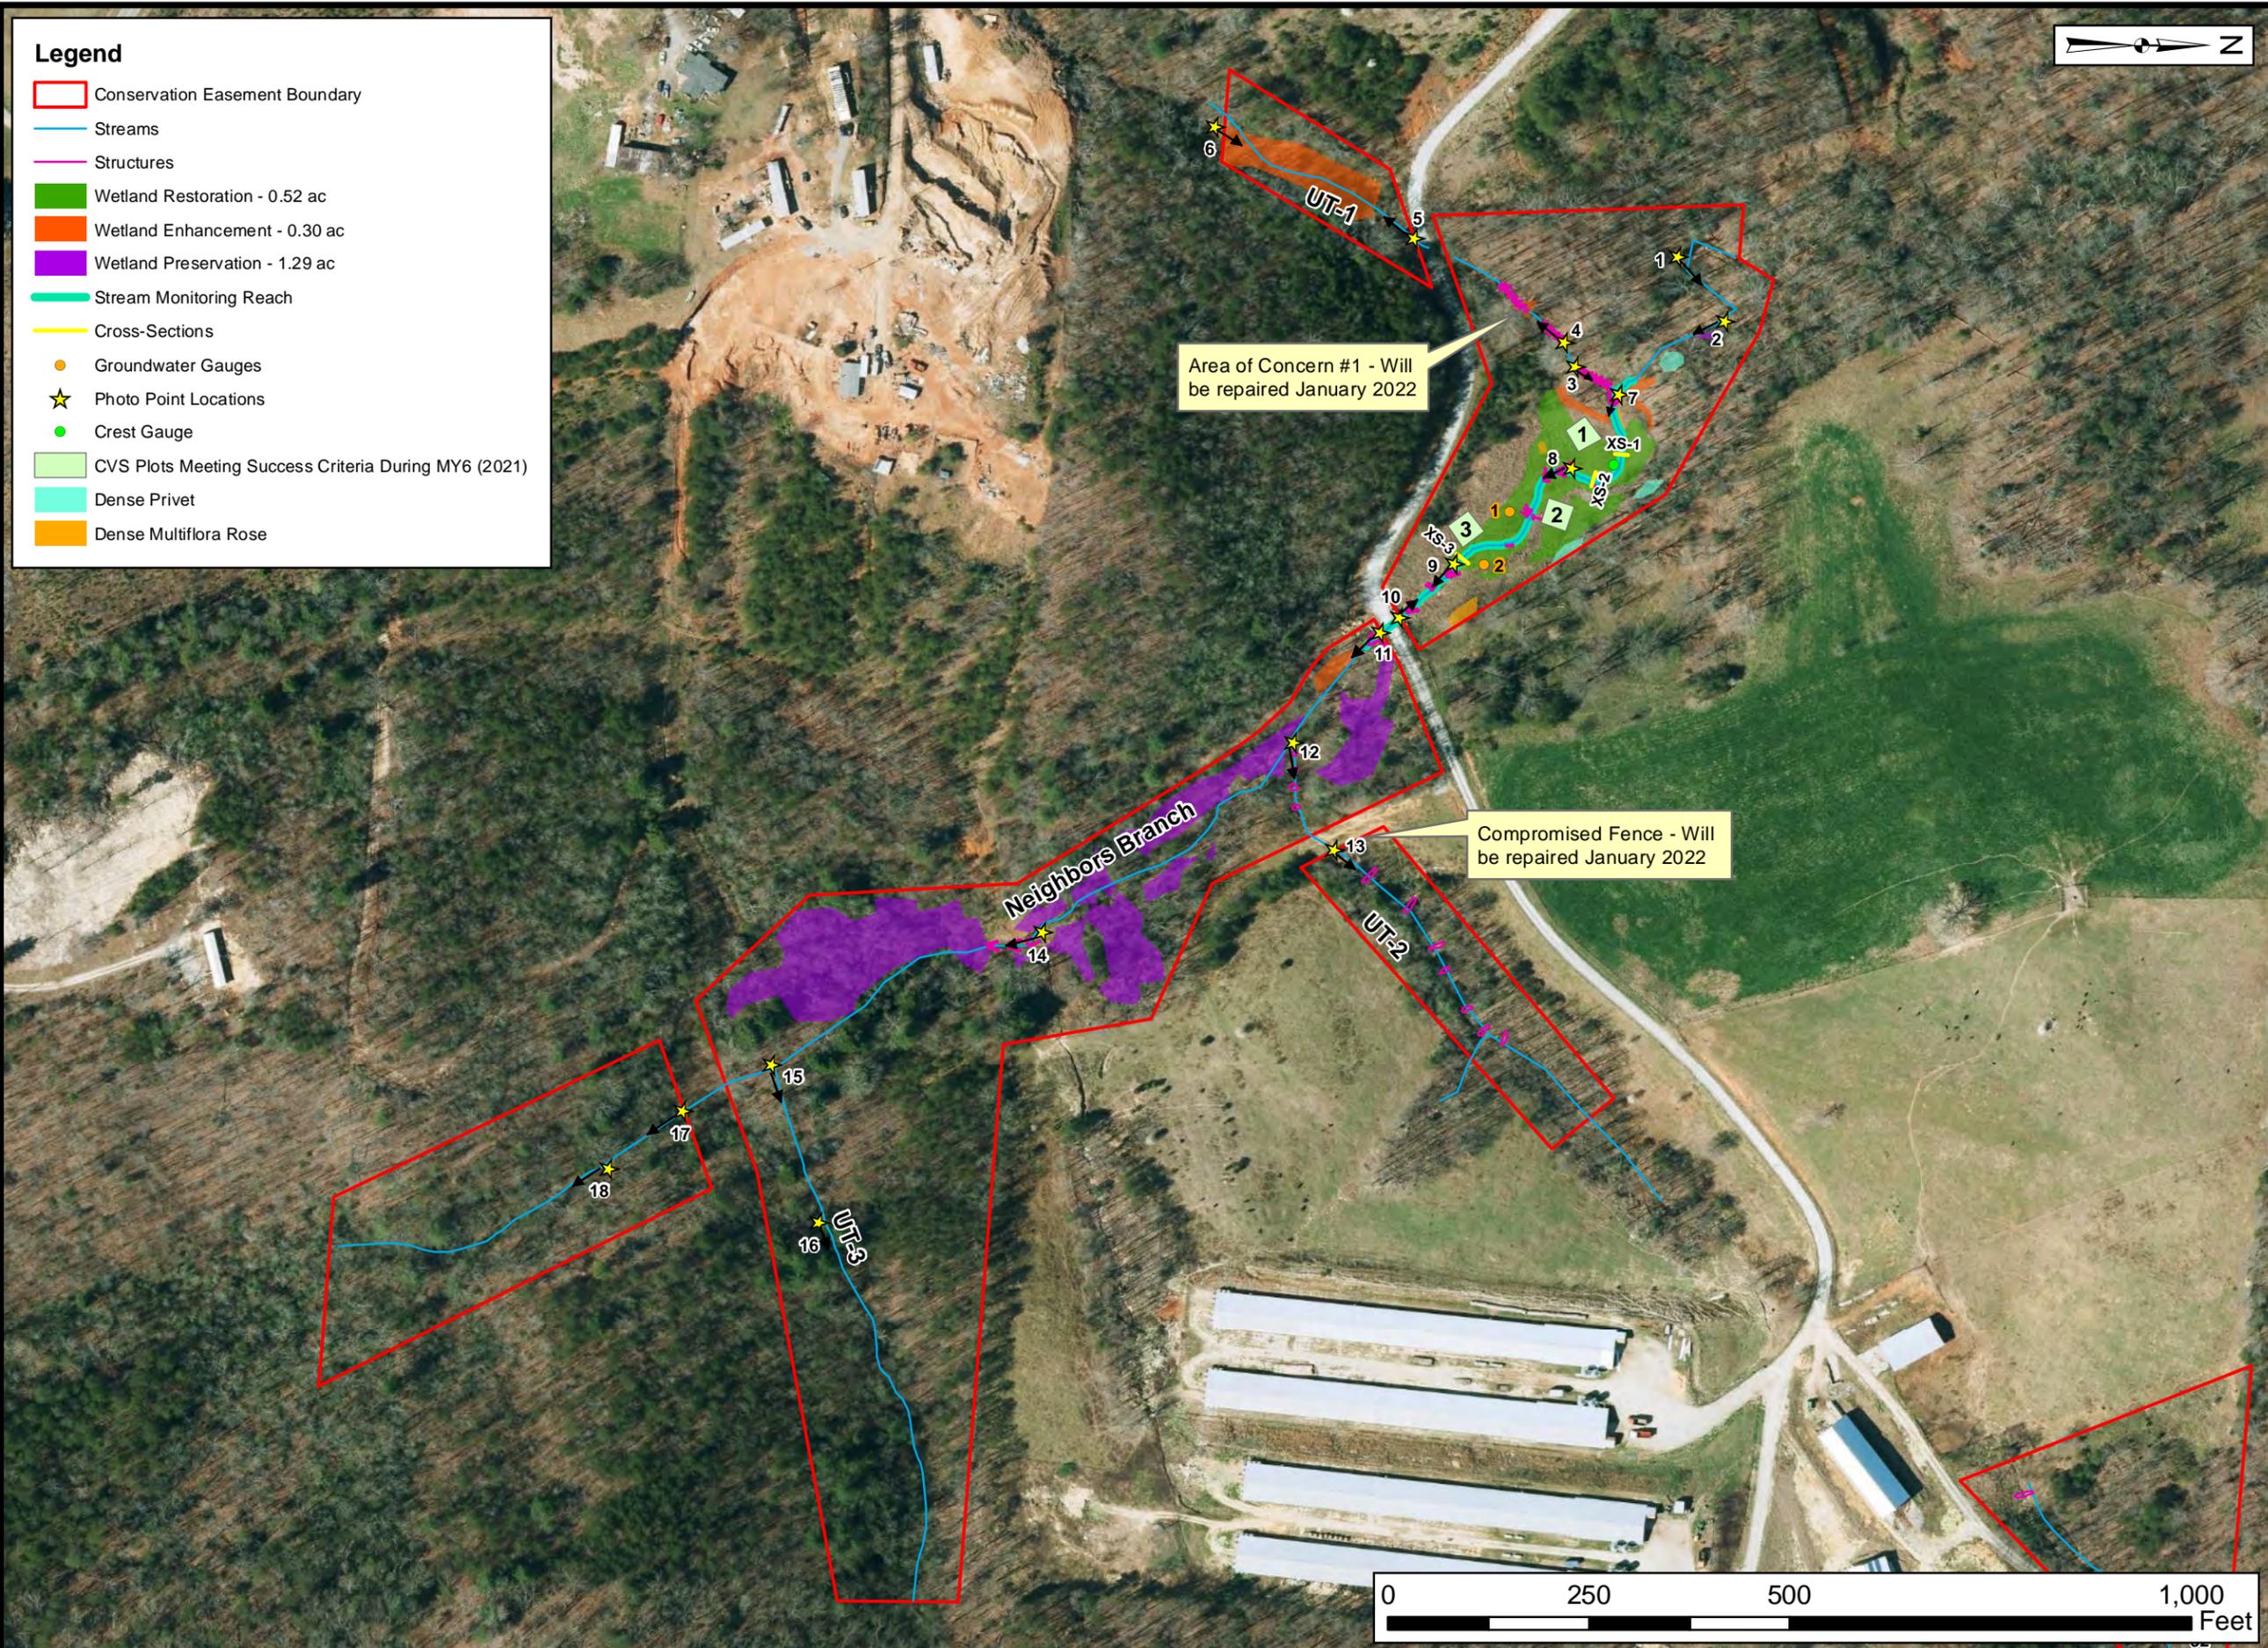
FIGURE
2A

Several dense populations of Chinese privet (*Ligustrum sinense*) and multiflora rose (*Rosa multiflora*) were observed along Neighbors Branch, Walton Crawley Branch, and UT-2 to Walton-Crawley Branch (Figures 2A-B, Appendix B). NCDMS currently has implemented an invasive management plan and is under contract through closeout. Invasive treatments occurred in February, April, and June 2021 during year 6 (2021). During the last site visit invasive treatment areas were closely inspected. Treatments throughout the site have been extremely successful, and populations of invasive species have been reduced significantly.

Several areas of compromised easement integrity were observed during year 6 (2021). The fence on the northeast side of the crossing over UT-2 to Neighbors Branch has been compromised by large amounts of sediment during several high flow events. DMS has been working with the landowner to repair the downed fence, and some repairs have been made; however, the overall integrity of the fence remains questionable. A permanent repair to this fence is included in the January 2022 repair plan (Appendix F). Additionally, a footpath and bridge identified in MY3 that extends through the conservation easement just north of UT-1 remains. DMS and DEQ Stewardship worked with the landowner to limit the width of the path to a minimum cutting for foot traffic only. Based on visual observations and photo-documentation, the foot path has remained the same width with no additional vegetation disturbed. These areas are depicted on Figures 2A-B (Appendix B).

Two groundwater monitoring gauges were installed to take measurements after hydrological modifications were performed at the Site. Hydrological sampling will occur during the growing season (March 26 to November 5). Approximate locations of gauges are depicted on Figure 2A (Appendix B), and hydrology data can be found in Appendix E.

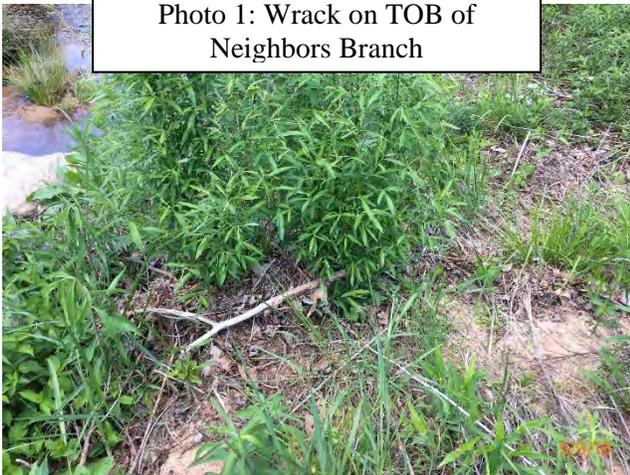
Photo 1: Wrack on TOB of Neighbors Branch

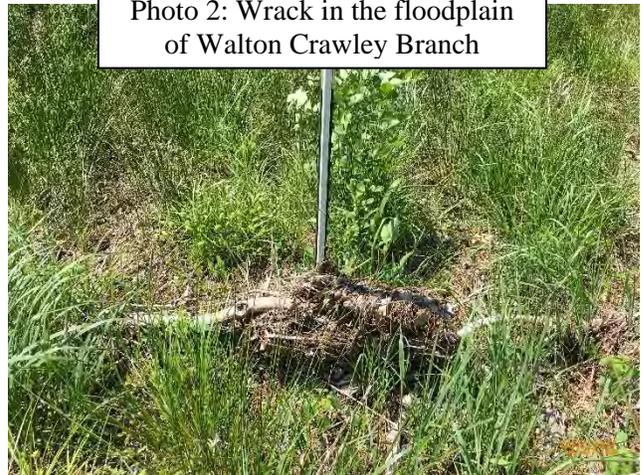
Photo 2: Wrack in the floodplain of Walton Crawley Branch

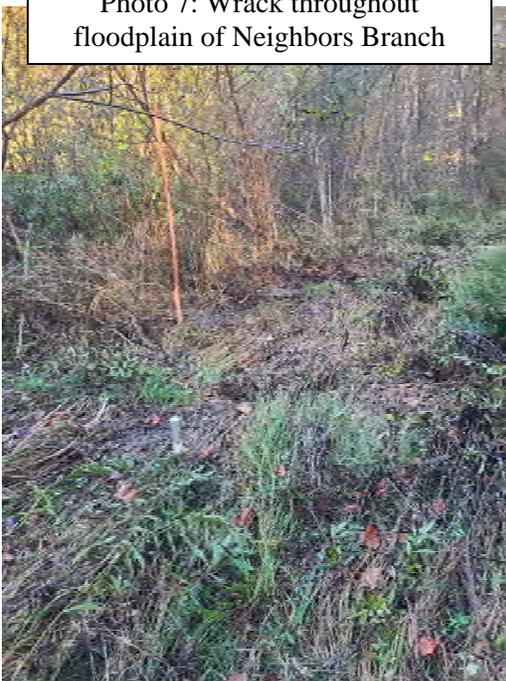
Photo 7: Wrack throughout floodplain of Neighbors Branch

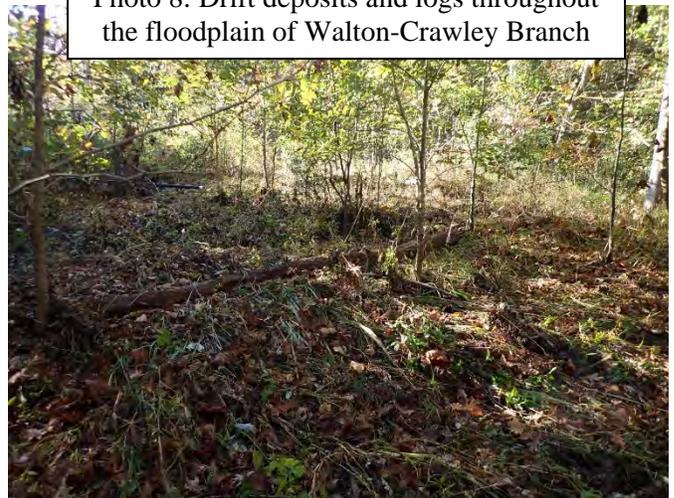
Photo 8: Drift deposits and logs throughout the floodplain of Walton-Crawley Branch
