Neu-Con Umbrella Wetland and Stream Mitigation Bank
Westbrook Lowgrounds Wetland and Stream Mitigation Site
As-Built Report

EXECUTIVE SUMMARY

**STREAM AND WETLAND RESTORATION PROJECT
ENVIRONMENTAL BANC AND EXCHANGE, LLC
WESTBROOK LOWGROUNDS SITE**

**TYPE OF WORK: AS-BUILT DRAWING FOR WETLAND
AND STREAM MITIGATION**

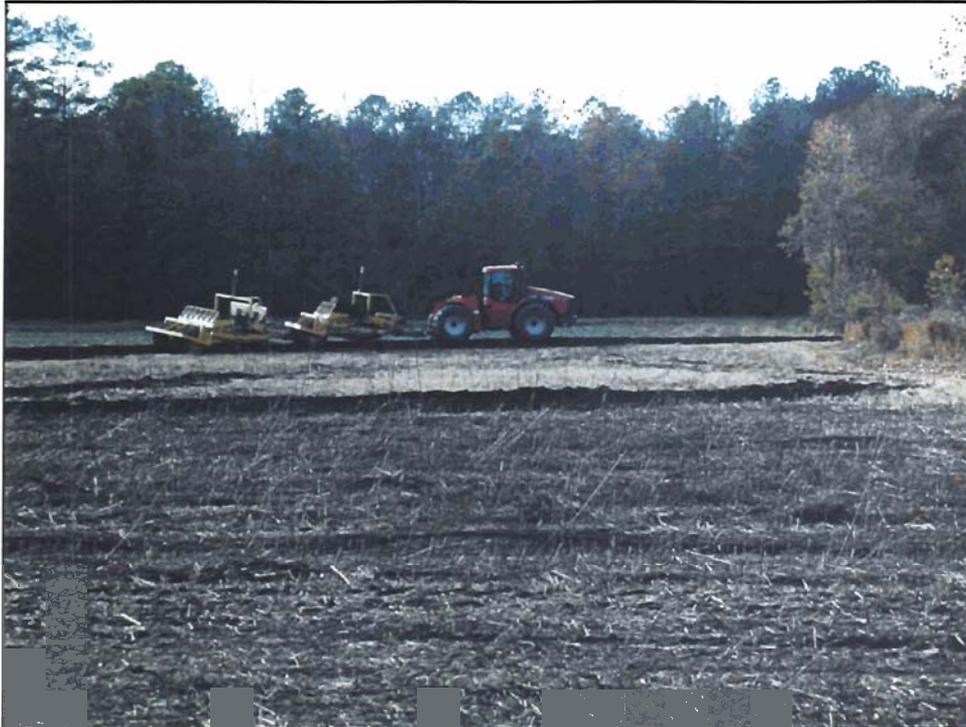
Photo C1. Minor grading of the site was performed to remove field crowns and provide fill material for ditches on the site (Nov. 22,2002).

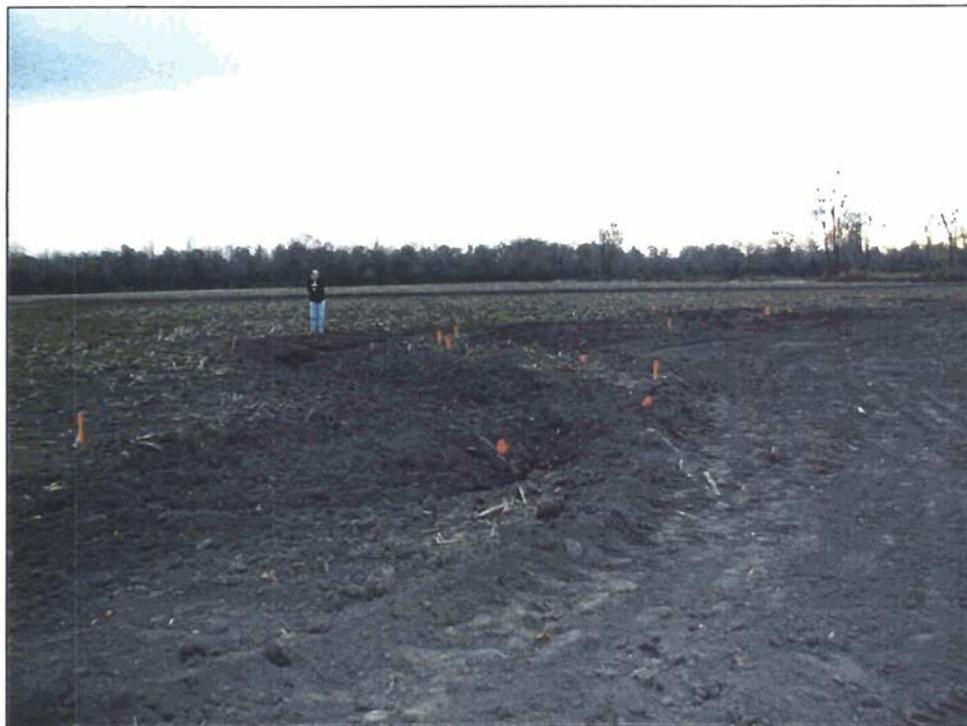
Photo C2. A section of channel excavated and ready for the installation of structures, transplants, and matting. The orange stakes mark the design top of banks (Dec. 2,2002).

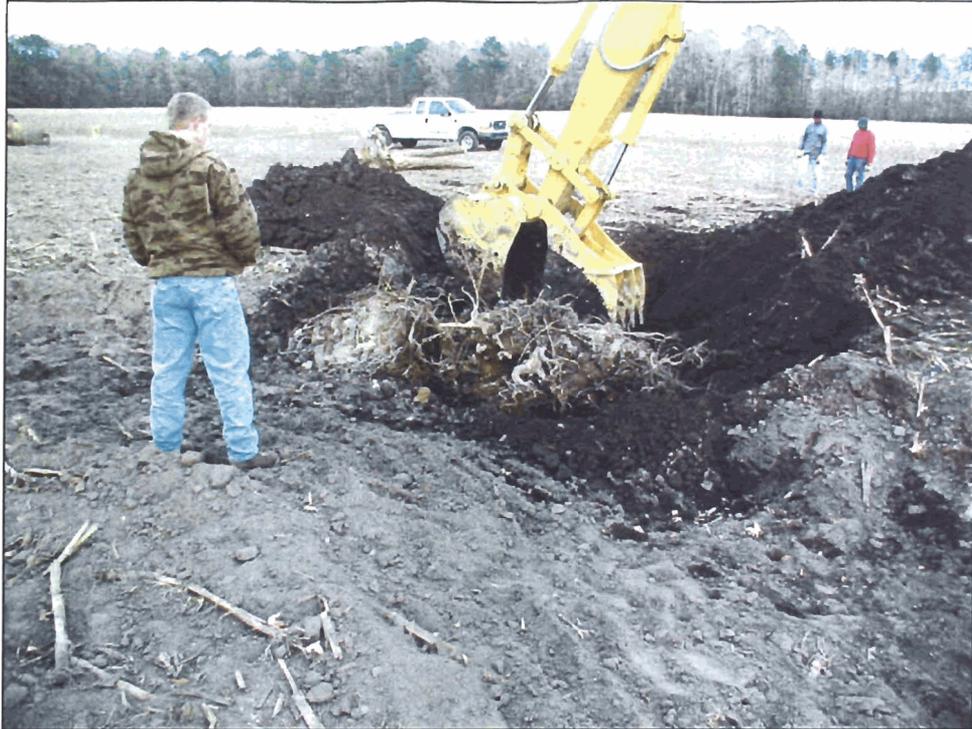
Photo C3. Installation of rootwads on the outside of a meander bend. The rootwads provide stability and habitat features (Dec. 2, 2002).

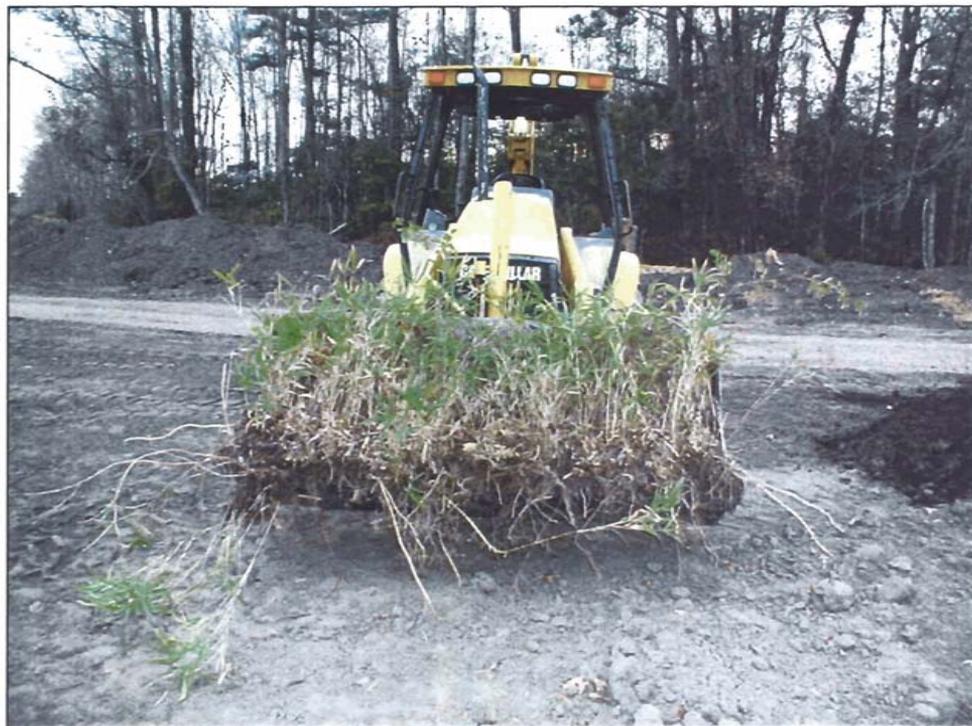
Photo C4. Native cane transplants ready to be installed along the new streambanks (Dec. 2, 2002).

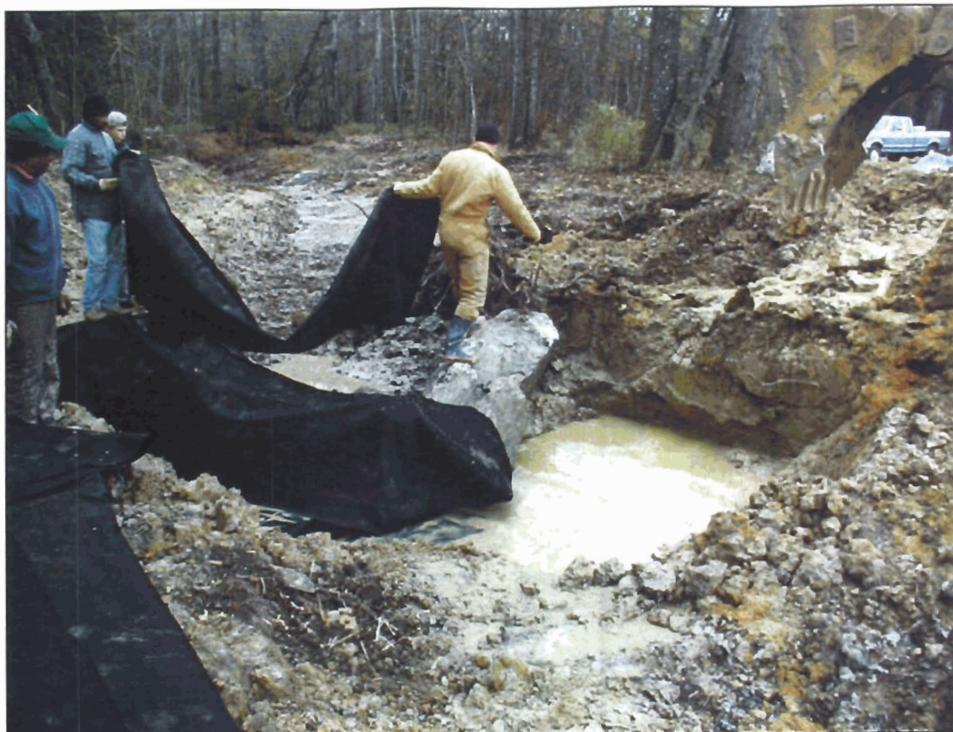
Construction of the stream channel proceeded as planned throughout the project. The rock-cross vane structures at the downstream end of the project were constructed first and proved to be the most time consuming structures constructed during the project. However, the structures proved to be absolutely essential in stabilizing the streambed and allowing for a steeper gradient at the downstream end to connect the channel back to the elevation of Mill Creek. During a large flow event approximately one month after construction, water flowed around cross-vane #3 and caused a gully to form behind the left arm of the structure where overbank flows re-entered the channel. The structure has shifted slightly but is still holding the bed of the stream as designed. Repair of the structure is scheduled for mid-April 2003 and will involve the re-alignment of boulder rocks, filling a low area in the floodplain so that future out-of-bank flows will flow back into the channel at a more stable location, and more transplants and matting along the streambank downstream of the structure.

Photo C5. Construction of one of the cross-vane structures installed at the outlet end of the project. Cross-vanes control the bed elevation of the new stream and protect the stream from downcutting (Dec. 4, 2002).

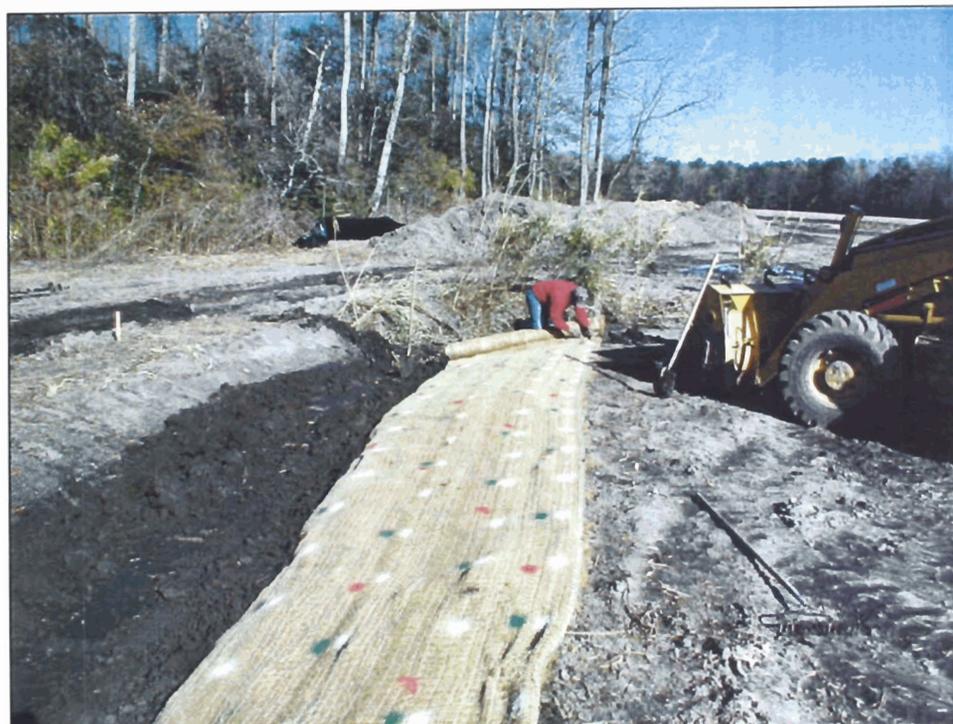
Photo C6. Installation of coir fiber matting along completed sections of new streambank (Dec.16, 2002).

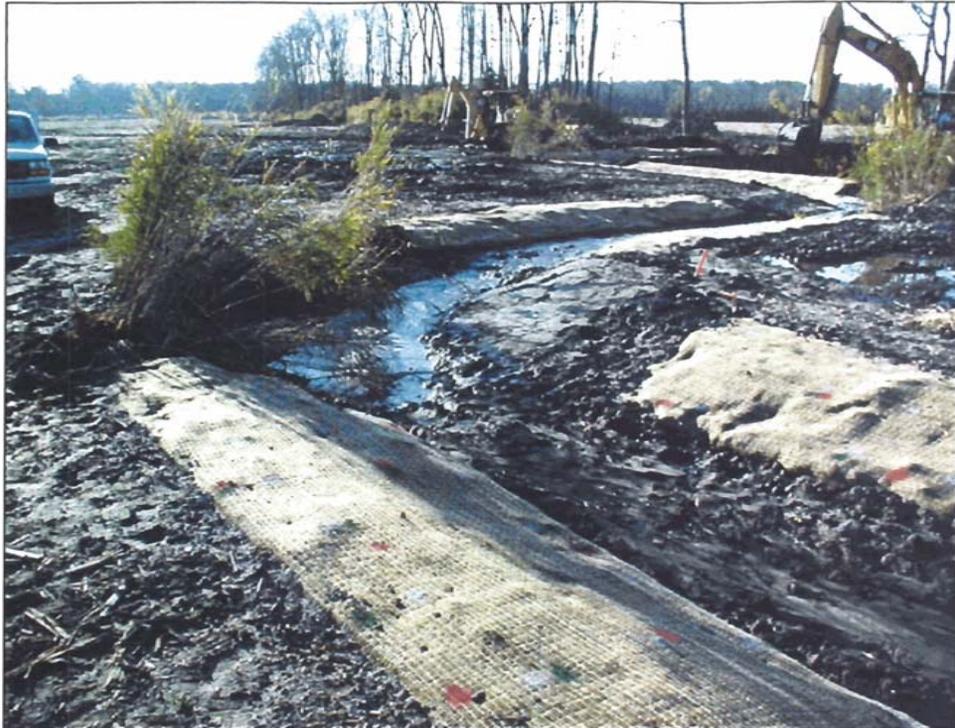
Photo C7. Water begins to flow in the first new segment of restored stream channel. The trackhoe in the background has just installed a plug in the old channel, diverting the water into the new channel (Dec. 16, 2002).

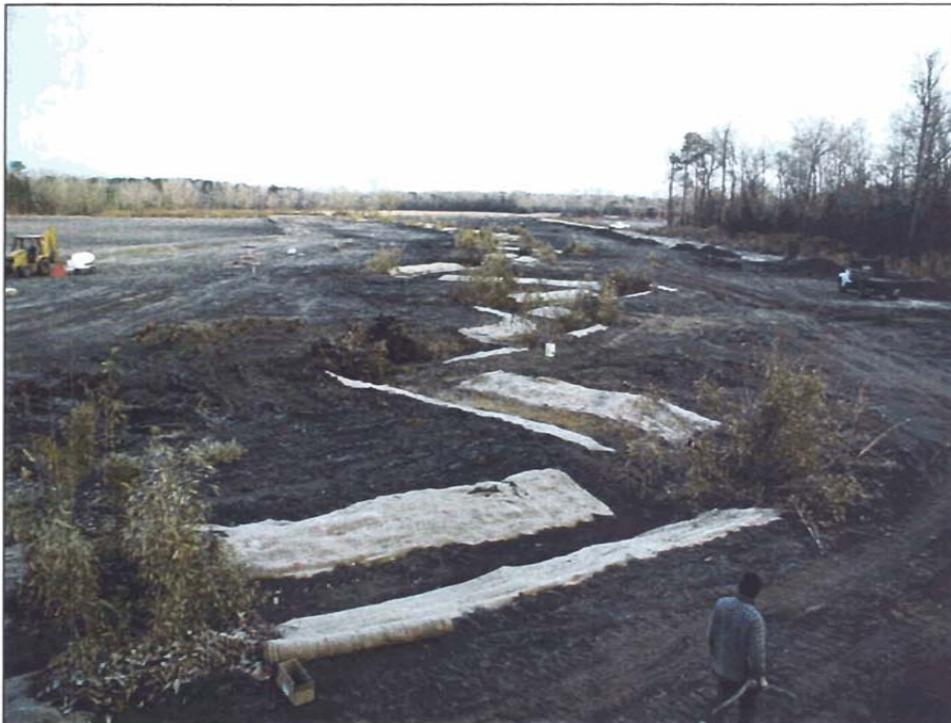
Photo C8. The last segment of new channel is completed at the upstream end of the project and ready to receive water (Jan. 16, 2003).

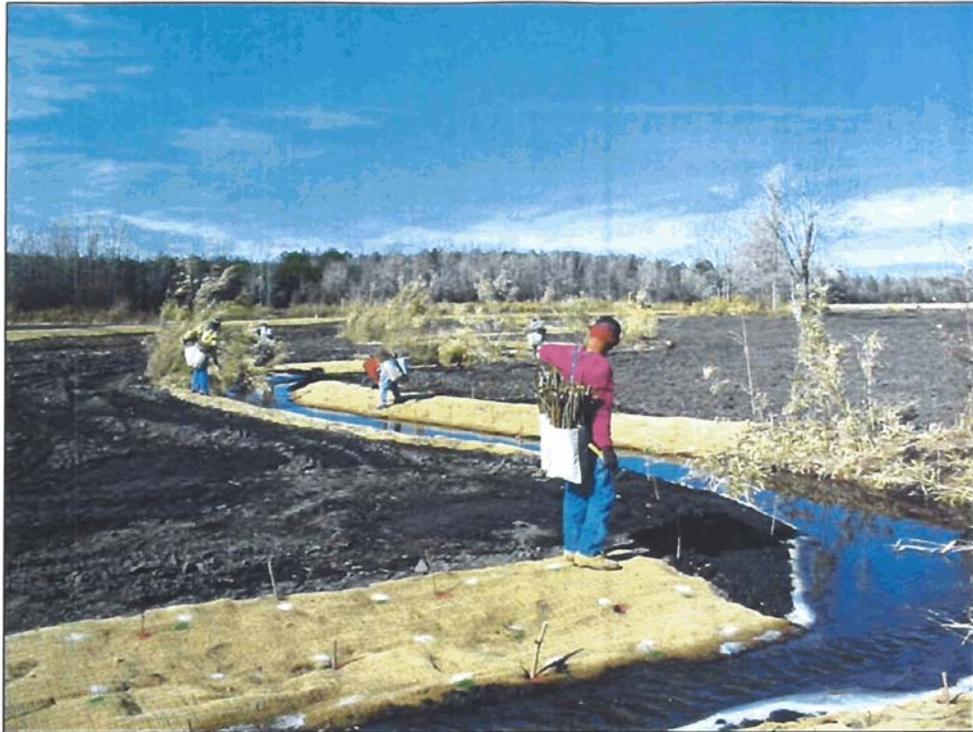
Photo C9. Live stakes being installed on the newly constructed streambanks (Jan. 28,2003).

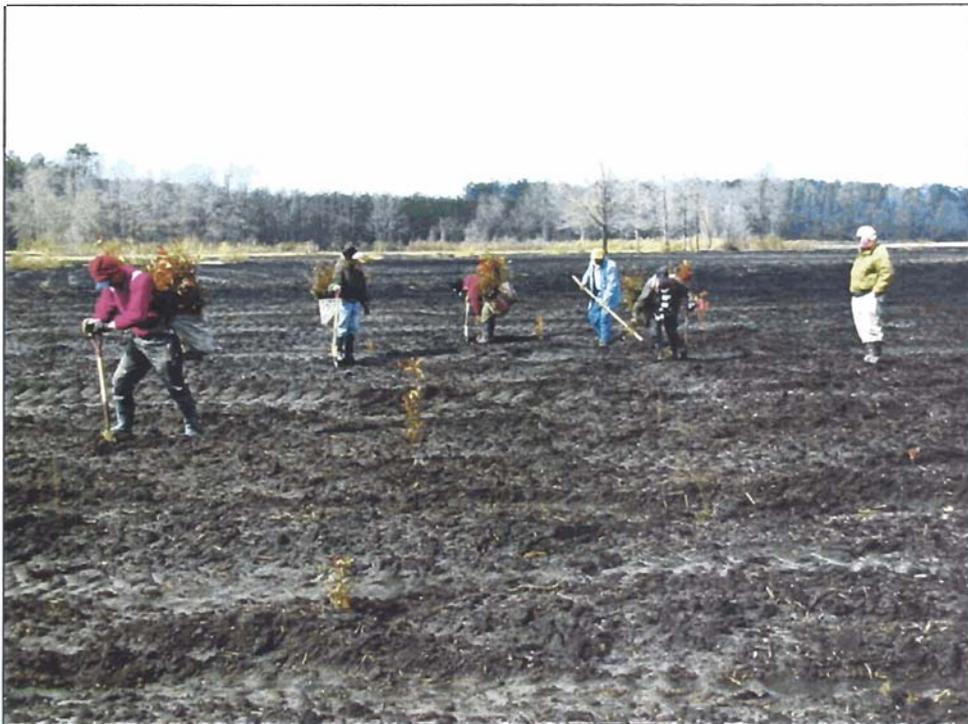
Photo C10. Bare-root trees being planted on the restored wetland areas of the site (Feb. 28,2003).

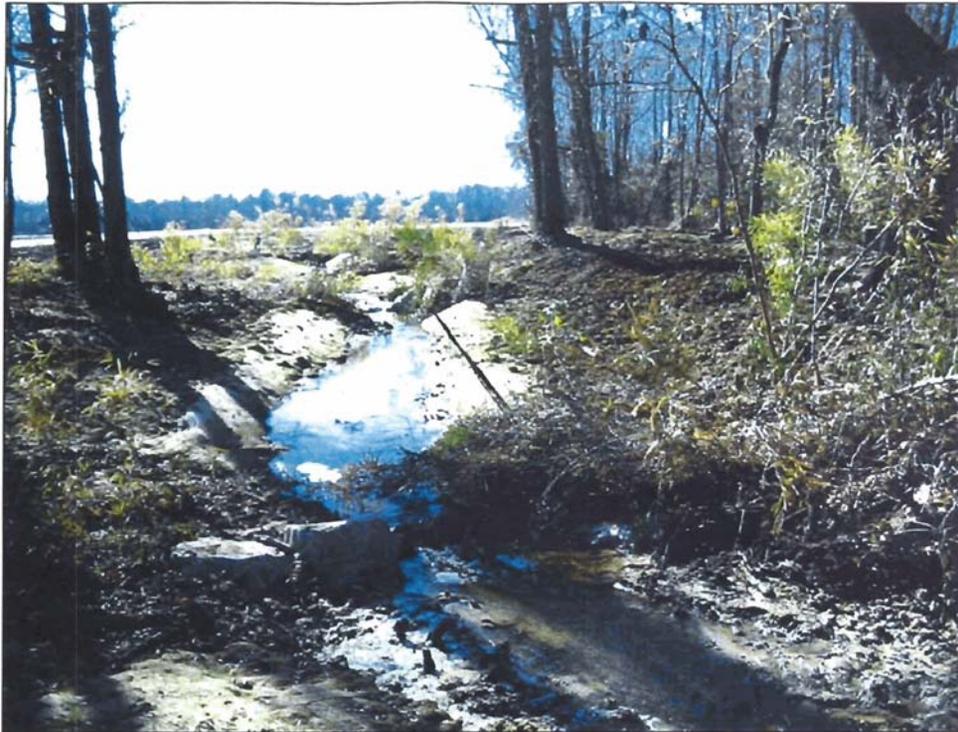
Photo P1. The downstream end of the project where the new channel connects with the existing channel and Mill Creek. Two cross-vane structures are visible in this picture (Jan. 28, 2003).

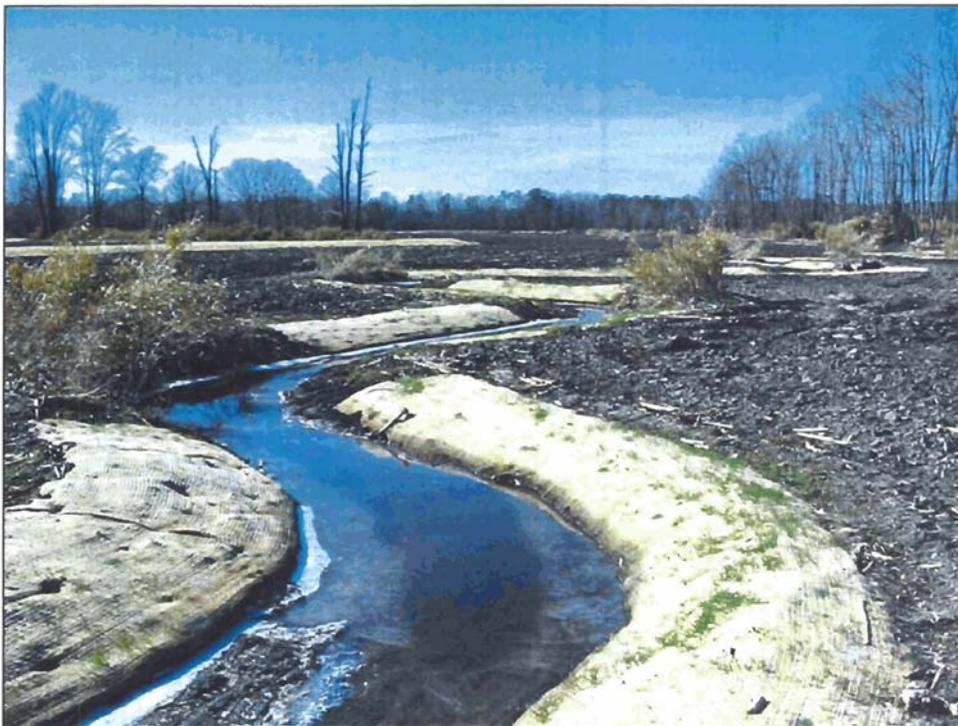
Photo P2. A restored section of channel near station 46+00 looking upstream (Jan. 28, 2003).

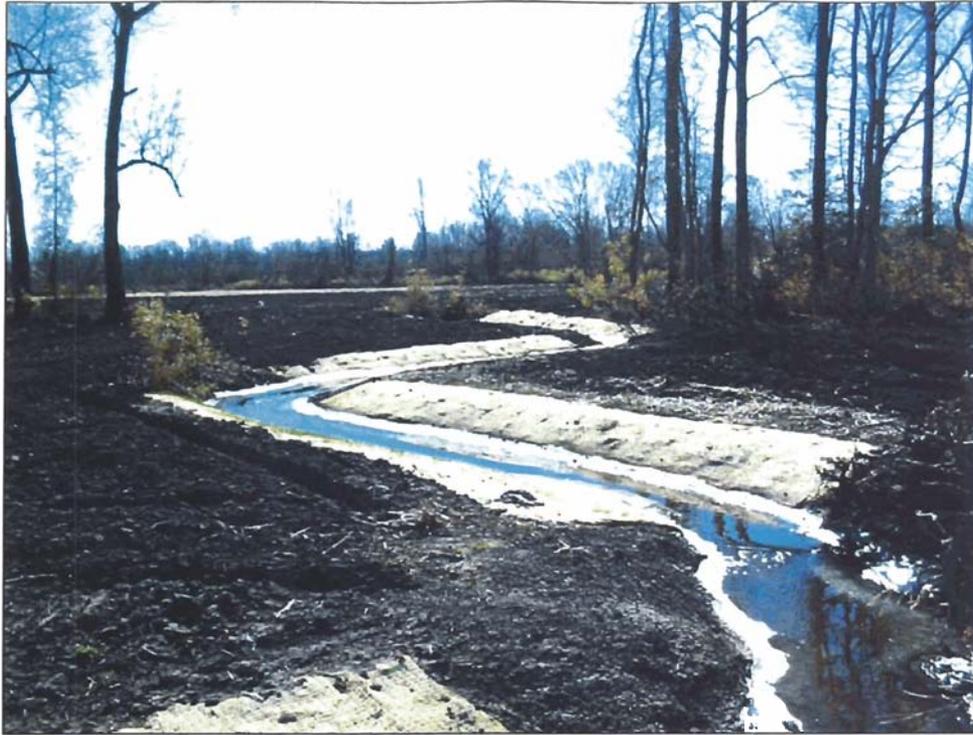
Photo P3. Completed stream channel near station 41+00 looking downstream. Existing trees along the old stream channel were left standing to the extent possible to allow for shading, habitat, and seed source (Jan. 28,2003).

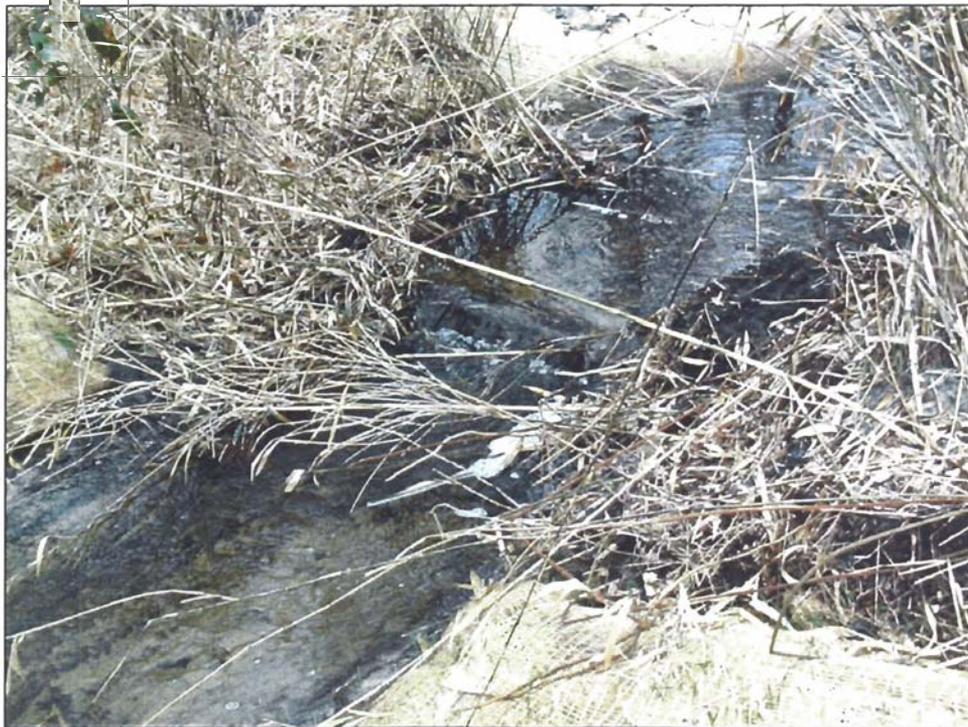
Photo P4. A completed log weir structure. The log weir is used to set the grade of the **streambed upstream** of the structure **and** keep the channel **from** downcutting. Log weirs also provide habitat features (Feb. 28,2003).

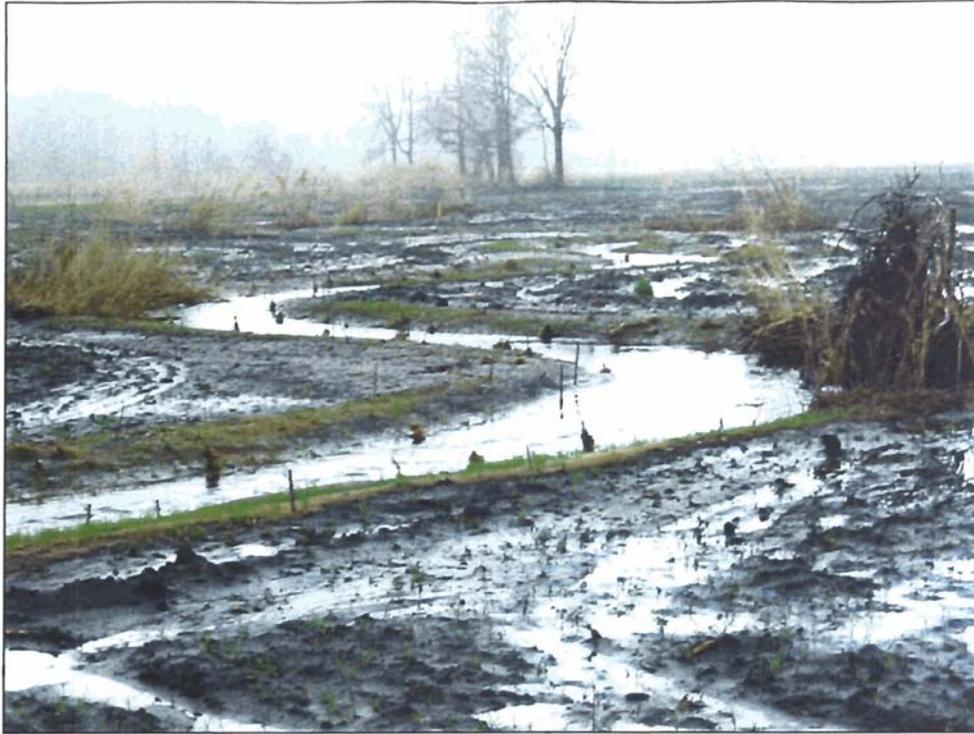
Photo P5. A completed segment of stream channel near station 6+00 looking downstream (March 11,2003).

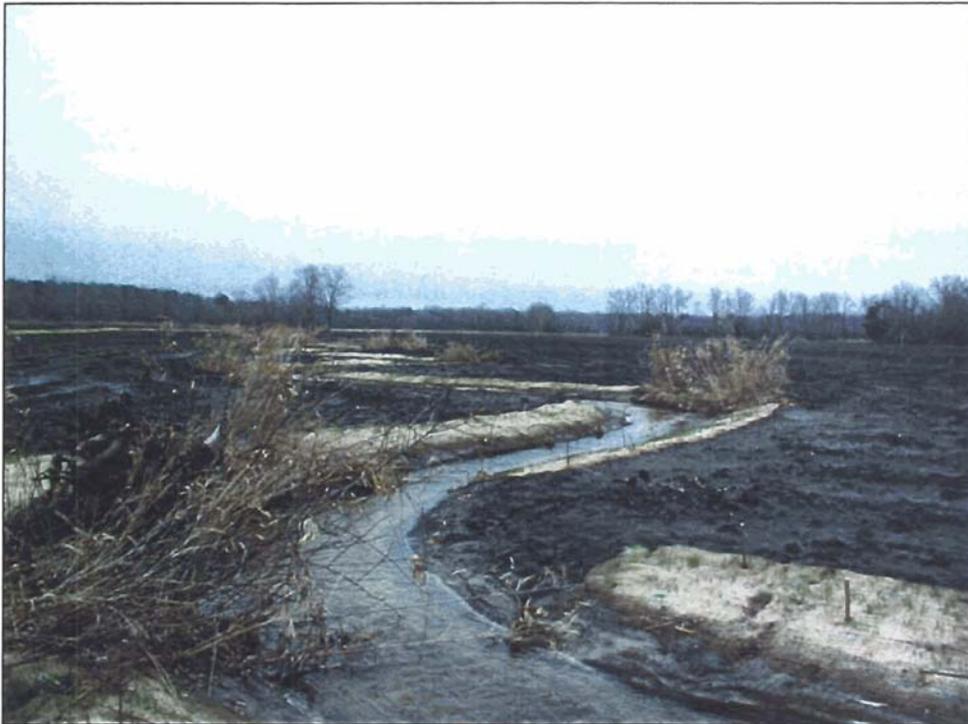
Photo P6. Stream channel at approximate station 17+00 looking downstream after bankfull event the night before (March 21,2003).

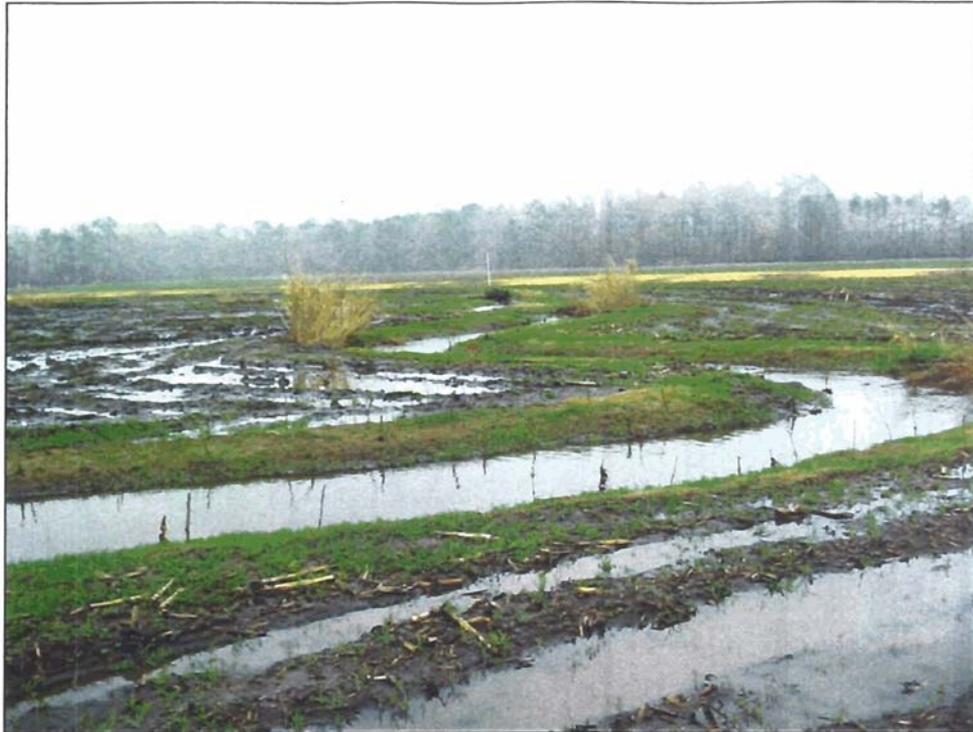
Photo P7. Stream channel at approximate station 46+00 looking downstream **after bankfull** event the night before (March 21, 2003).

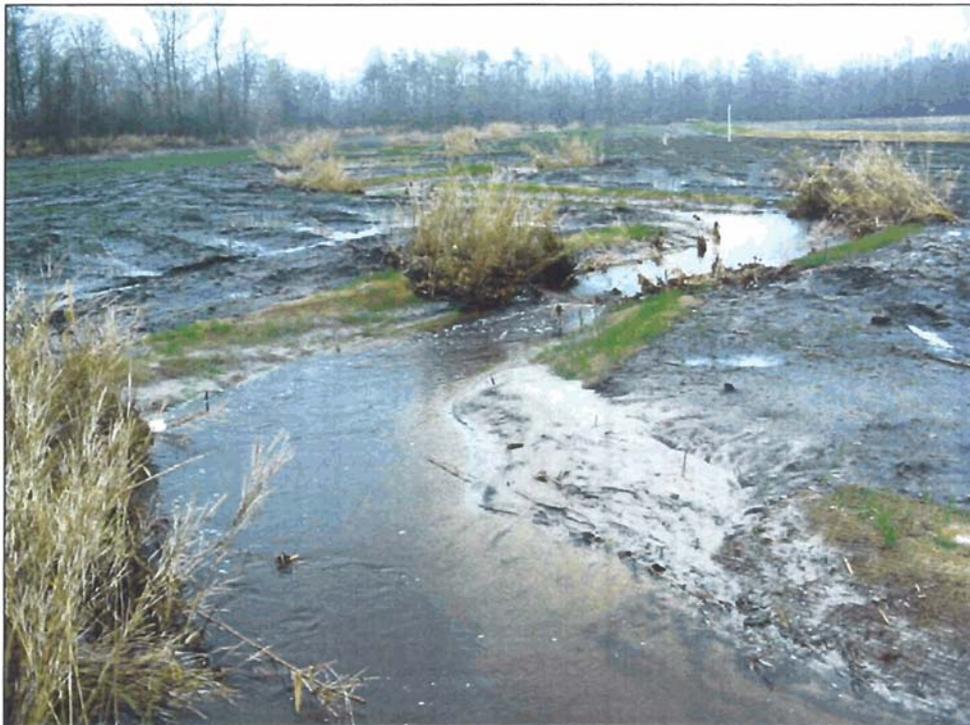
Photo P8. Stream channel at approximate station 14+00 looking upstream **after bankfull** event the night before. Note the development of the point bar depositional feature on the inside of the meander bend (March 21, 2003).

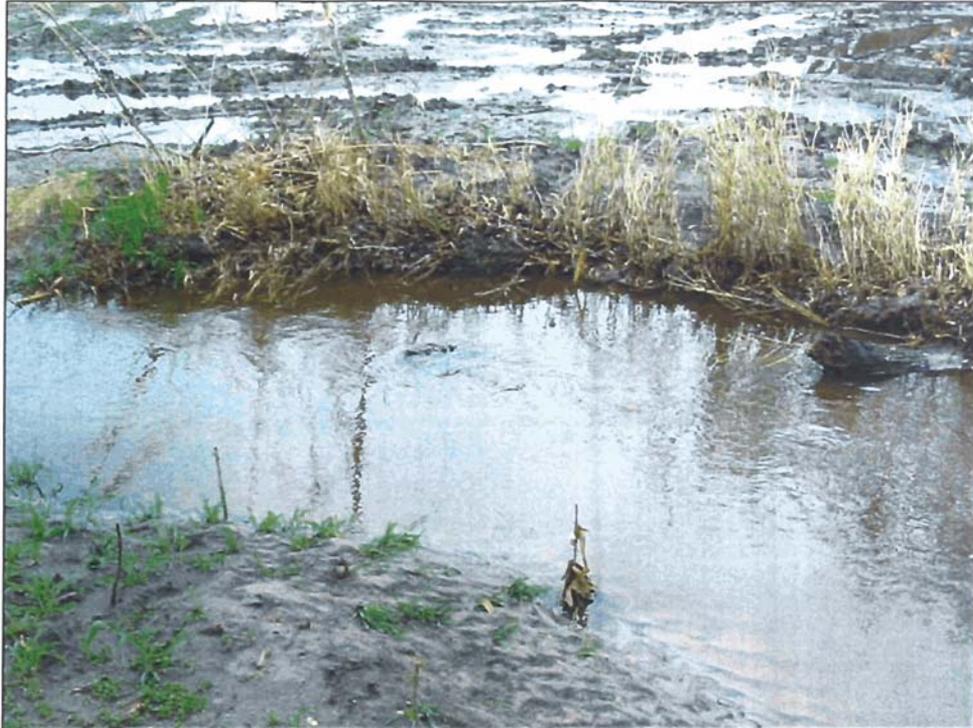
Photo 99. A meander bend of the restored channel after a **bankfull** event the night before. The outside of the meander bend shows no erosion due to the transplants that were placed there. The log vane structure is keeping the strongest velocities and energy near the center of the channel and away from the banks. Note the debris on the live stake in the foreground, indicating stream stage, and the deposition of sediment on the point bar (March 21, 2003).

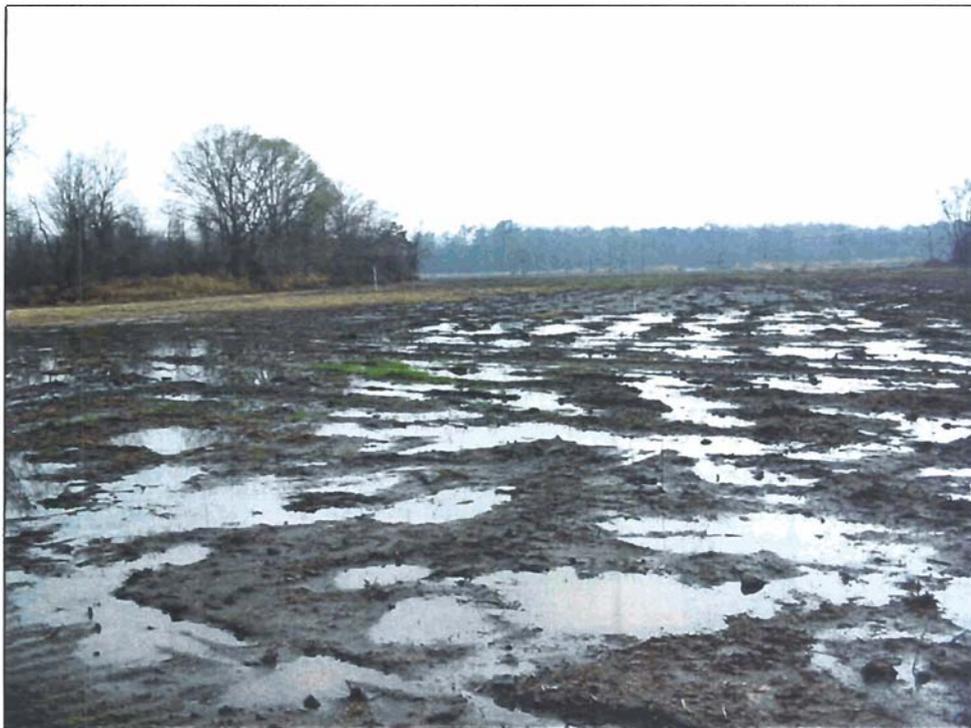
Based on early observations, the hydrology of the site has been altered to a much wetter regime than present prior to construction. Ponding on the site in isolated pockets has been observed for extended periods after rainfall events. At least one overbank flooding event has also occurred since construction was completed. The wetland pockets restored on the northern end of the tract also appear to be performing well.

Photo P10. Surface ponding across the site after a bankfull event the night before (March 21, 2003).
