**Newtown Stream and Wetland  
Restoration Project  
Union County, North Carolina  
EEP Project #94150  
Contract No. 002025**

**MY-04 Monitoring Report**

Data Collected: May & September 2014

Submitted: October 2014

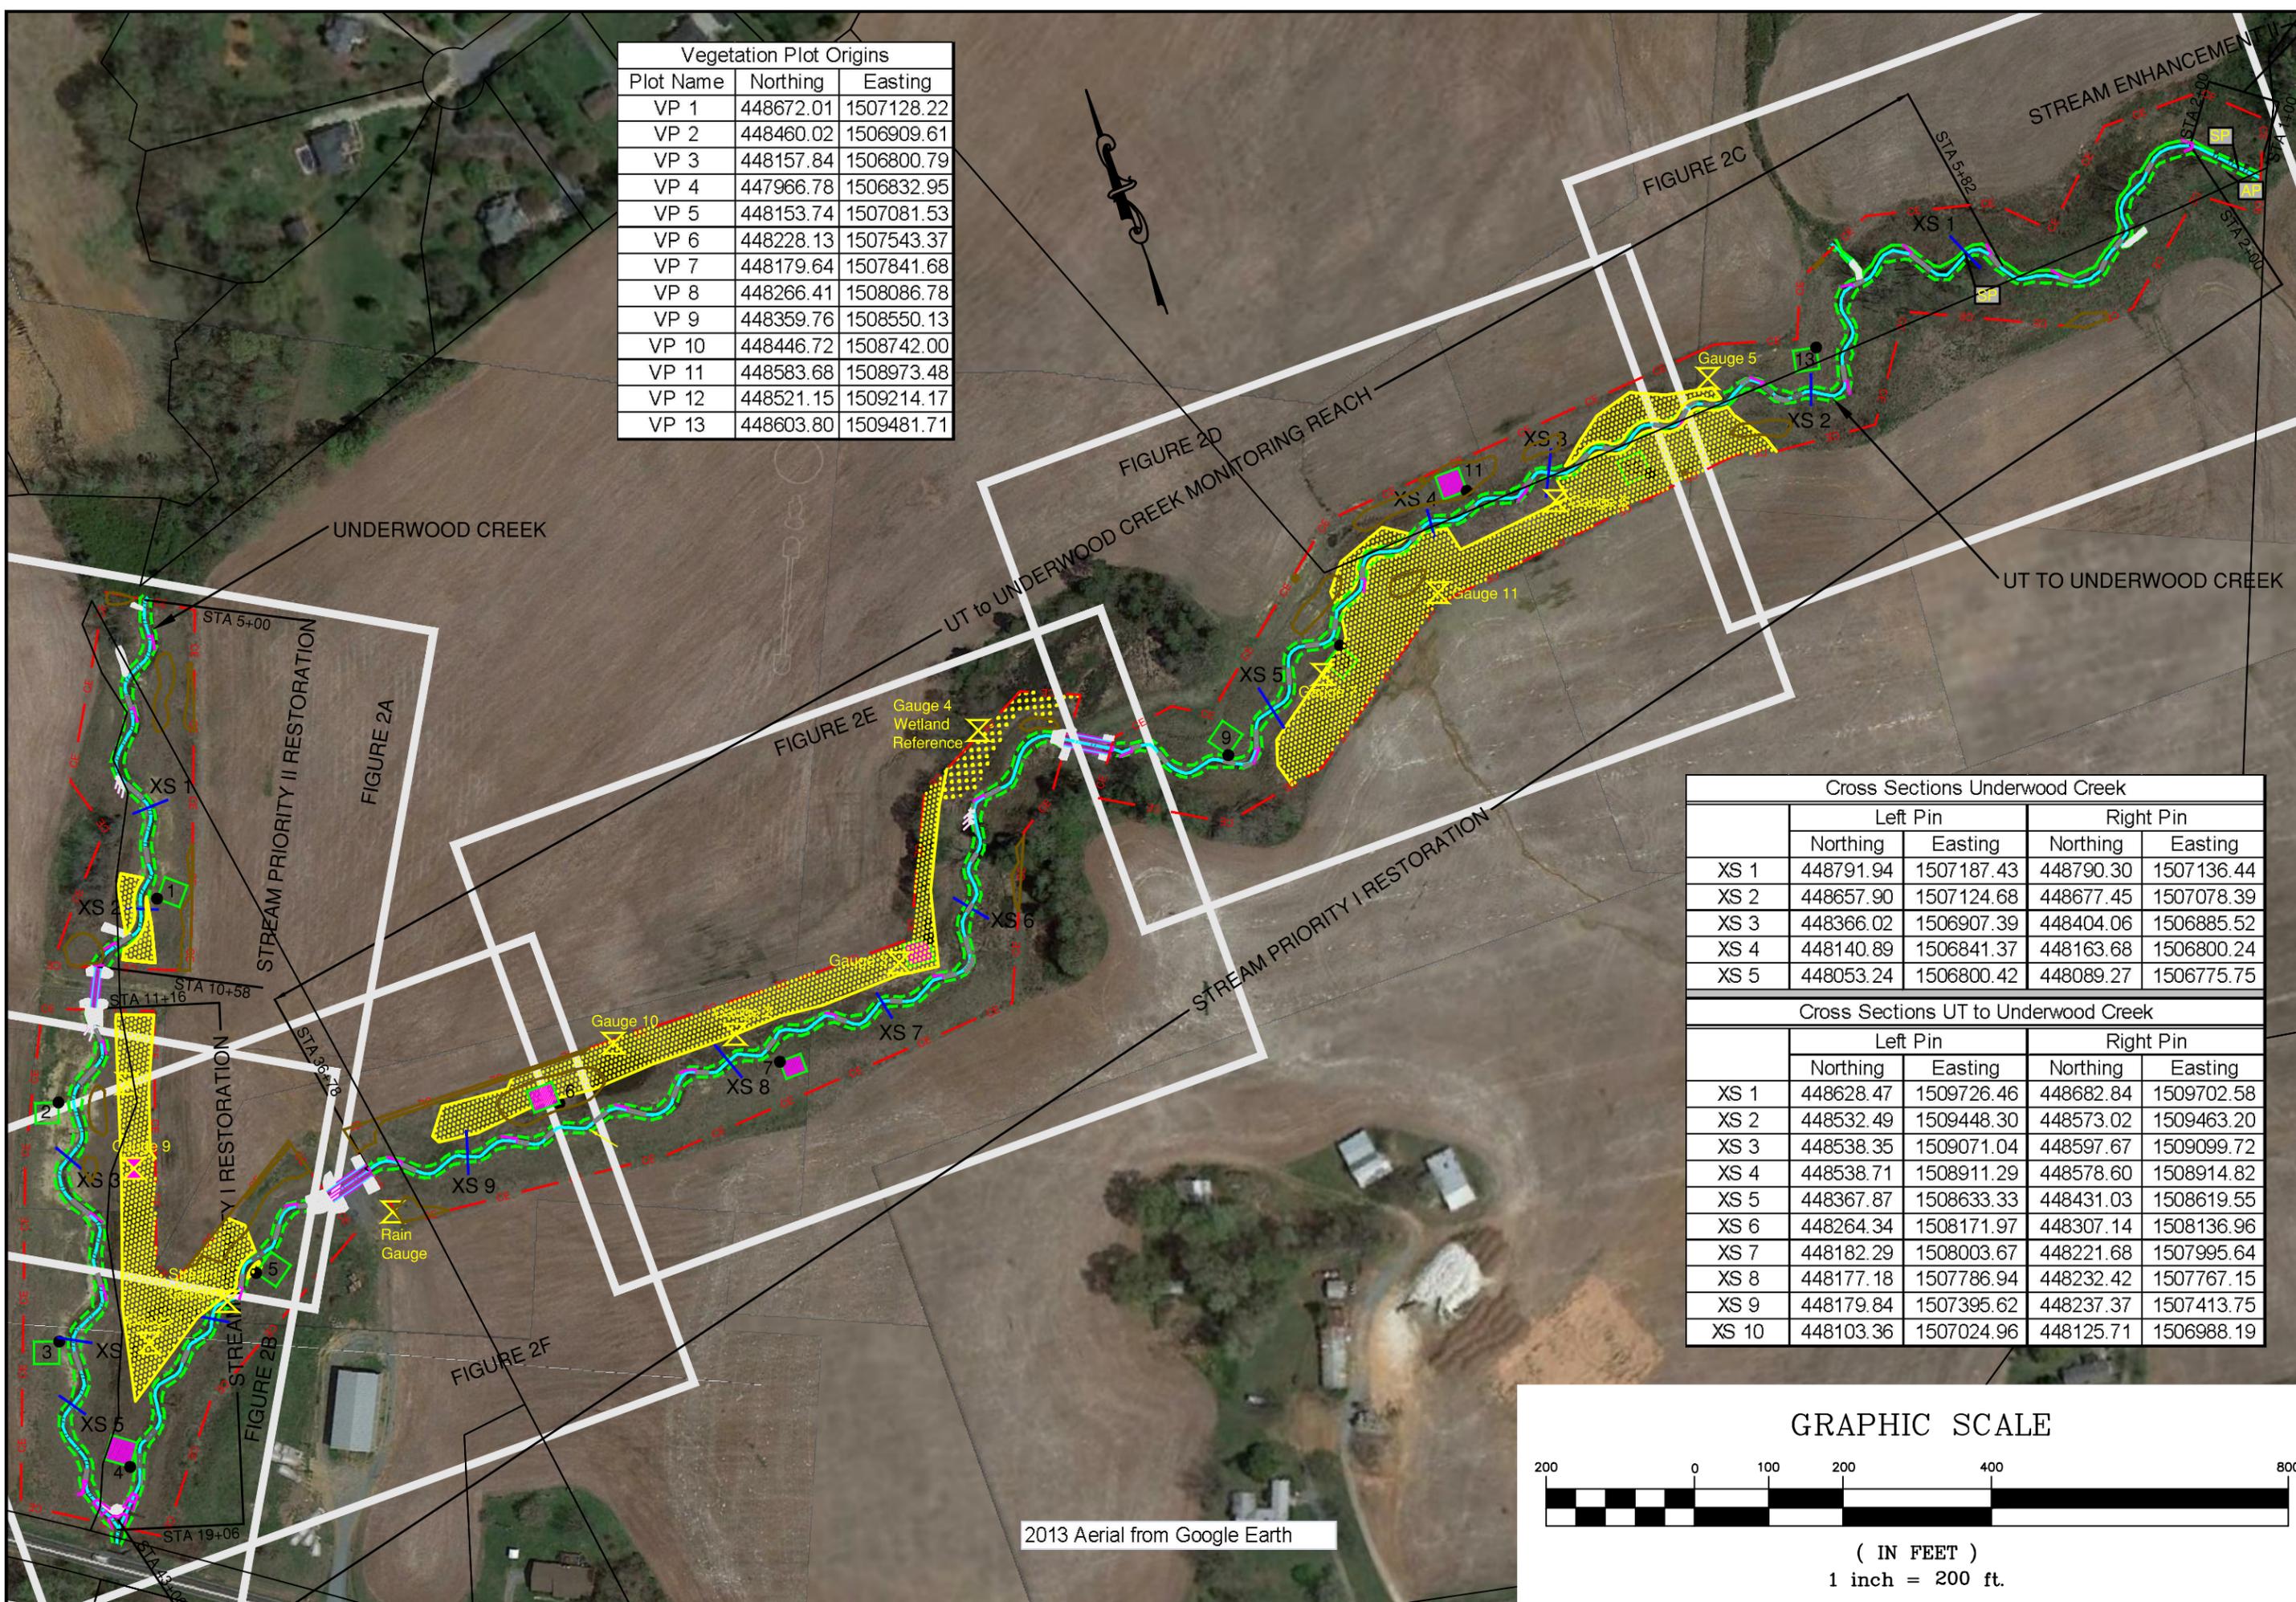
**FIGURE 2**

<b>MY-04 Vegetation Problem Areas</b>			
<b>VPA #</b>	<b>Station Number</b>	<b>Suspected Cause</b>	<b>Proposed Remedial Action</b>
1	See CCPV	Chinese Privet is scattered in forested areas that were present during pre-construction.	Chinese privet has been treated throughout the CE. Persistence will be monitored and treated again if deemed necessary.
2	See CCPV	Johnson grass is scattered in small patches and along the conservation easement boundary. The CCPV depicts areas where it is concentrated.	Johnson grass has been treated throughout the CE. Persistence will be monitored and treated again if deemed necessary.
3	See CCPV	Japanese stiltgrass is concentrated in an area adjacent to woodlands where it escaped.	Japanese stiltgrass persistence will be monitored and treated if deemed necessary.
5	See CCPV	Low stem densities were observed in patches throughout the conservation easement in areas where planted and natural stem densities were low.	Areas of low stem densities will be replanted in 2015.

<b>MY-04 Stream Problem Areas</b>			
<b>PA</b>	<b>Station</b>	<b>Suspected Cause</b>	<b>Proposed Remedial Action</b>
1	See CCPV	Tree growing in Stream	Recommend Removal

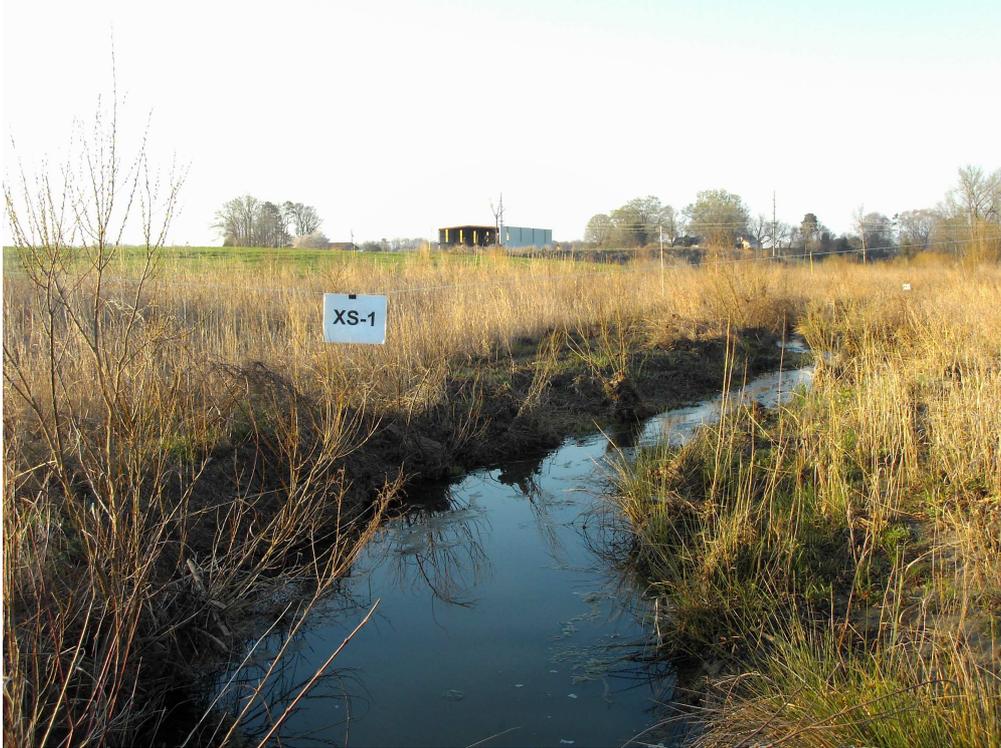
Photo 1. Looking downstream at Underwood Creek XS-1

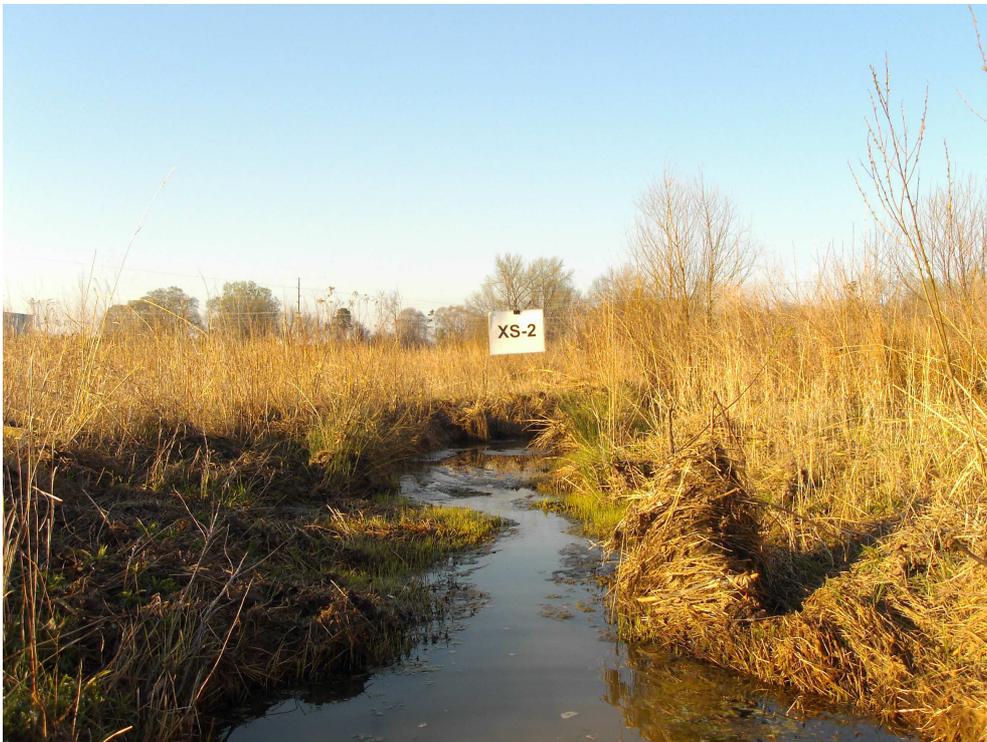
Photo 2. Looking downstream at Underwood Creek XS-2

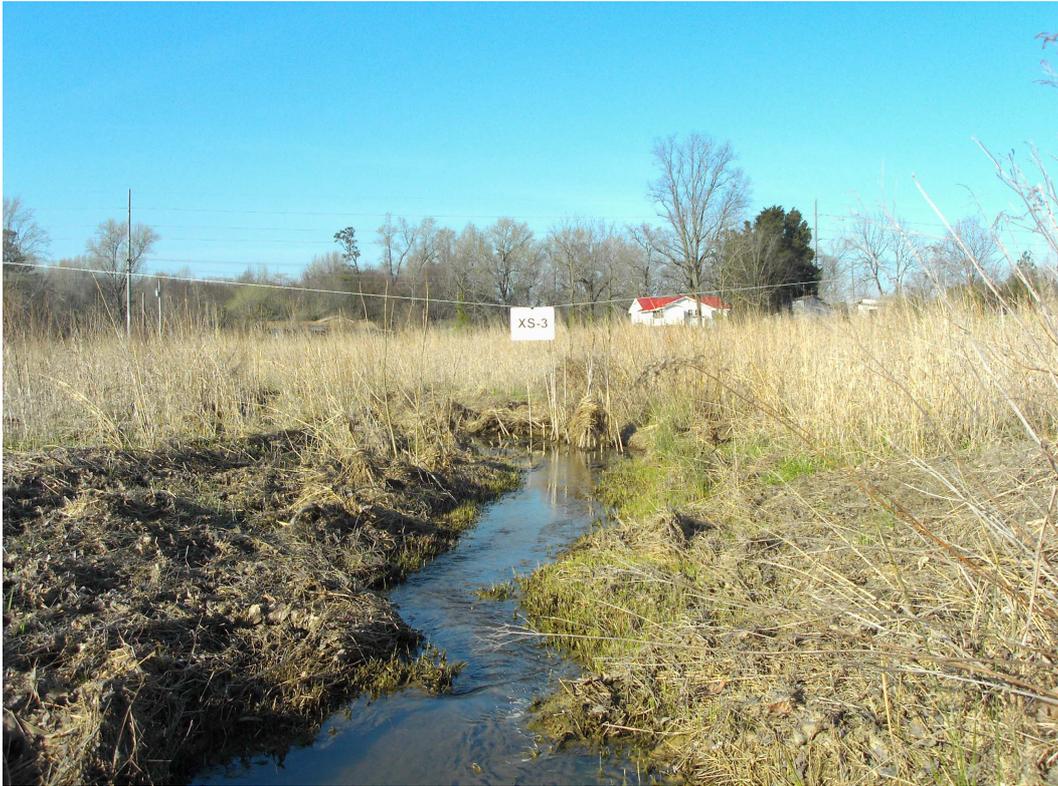
Photo 3. Looking downstream at Underwood Creek XS-3

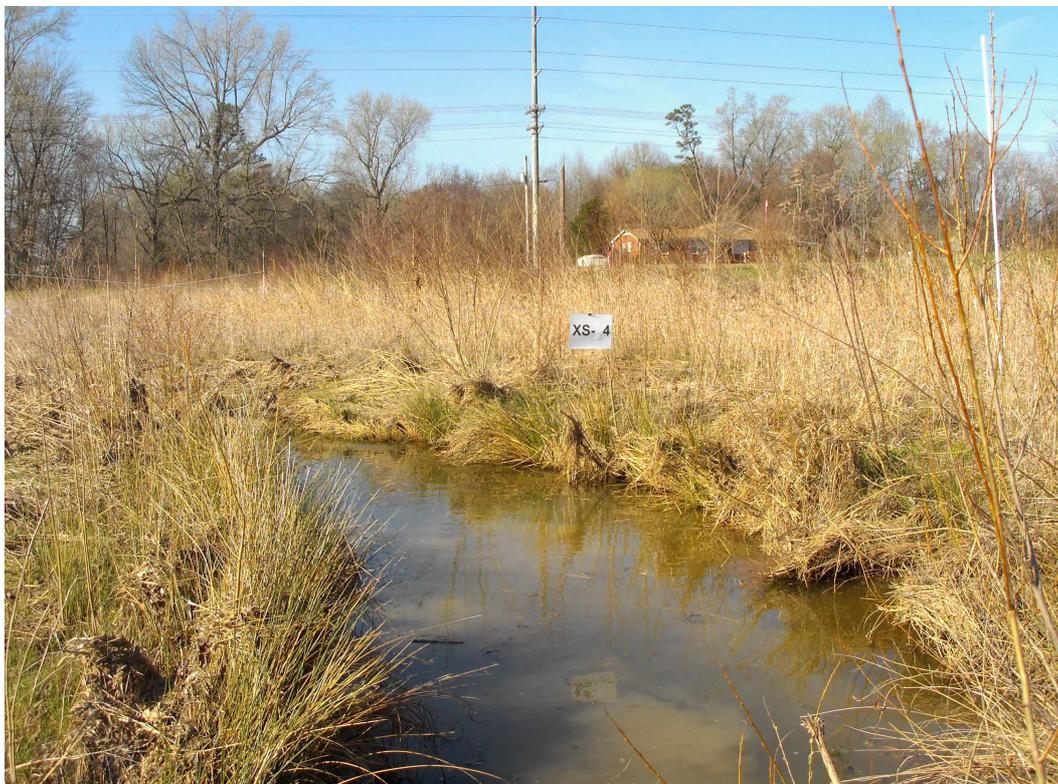
Photo 4. Looking downstream at Underwood Creek XS-4

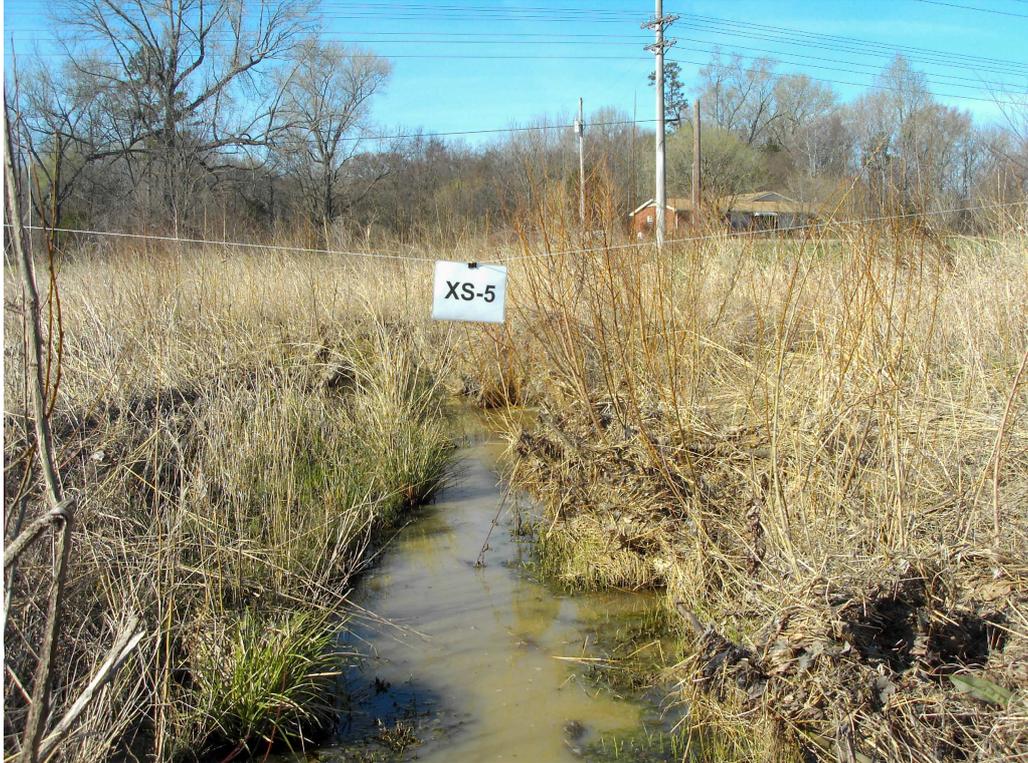
Photo 5. Looking downstream at Underwood Creek XS-5

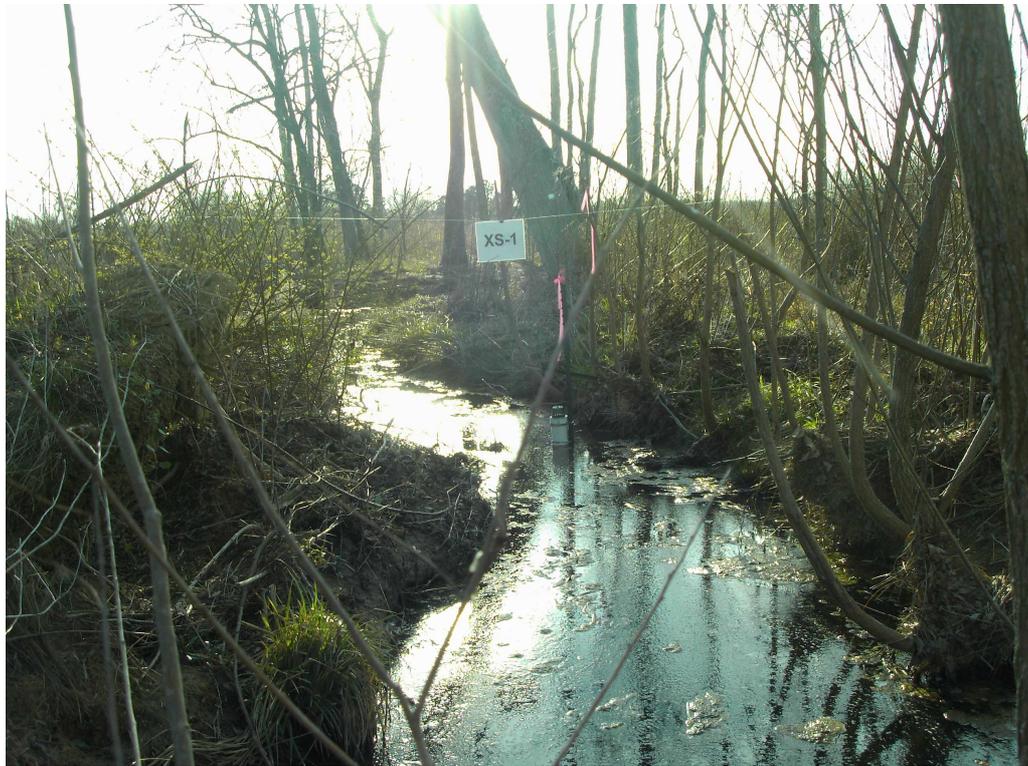
Photo 6. Looking downstream at UT to Underwood Creek XS-1

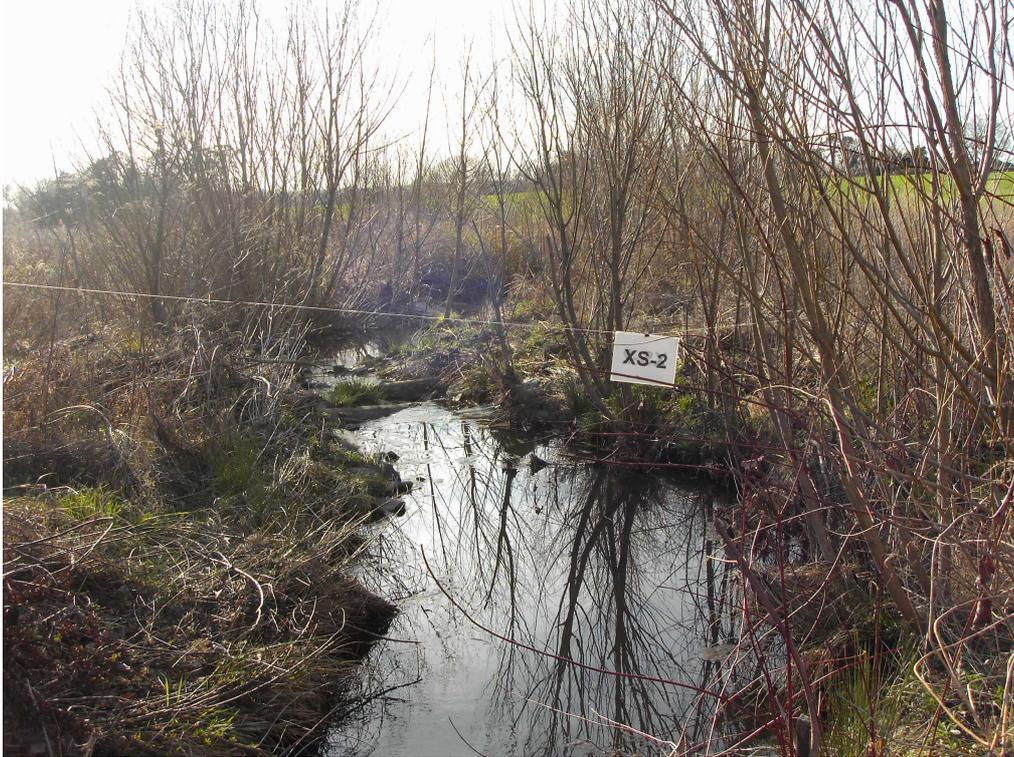
Photo 7. Looking downstream at UT to Underwood Creek XS-2

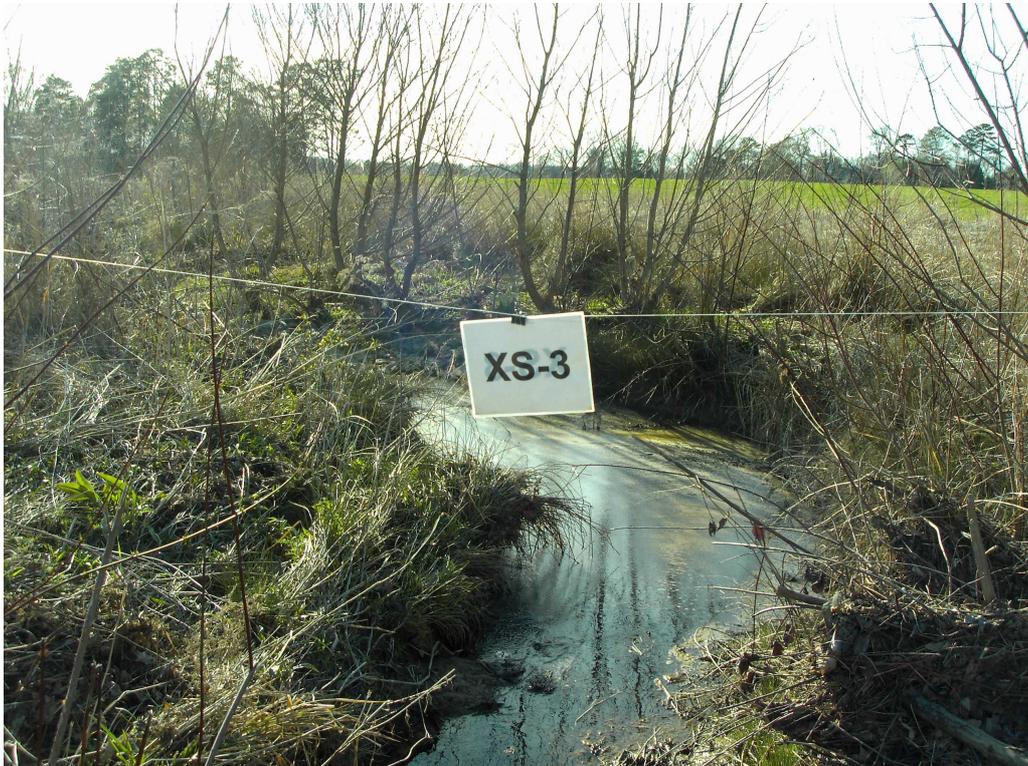
Photo 8. Looking downstream at UT to Underwood Creek XS-3

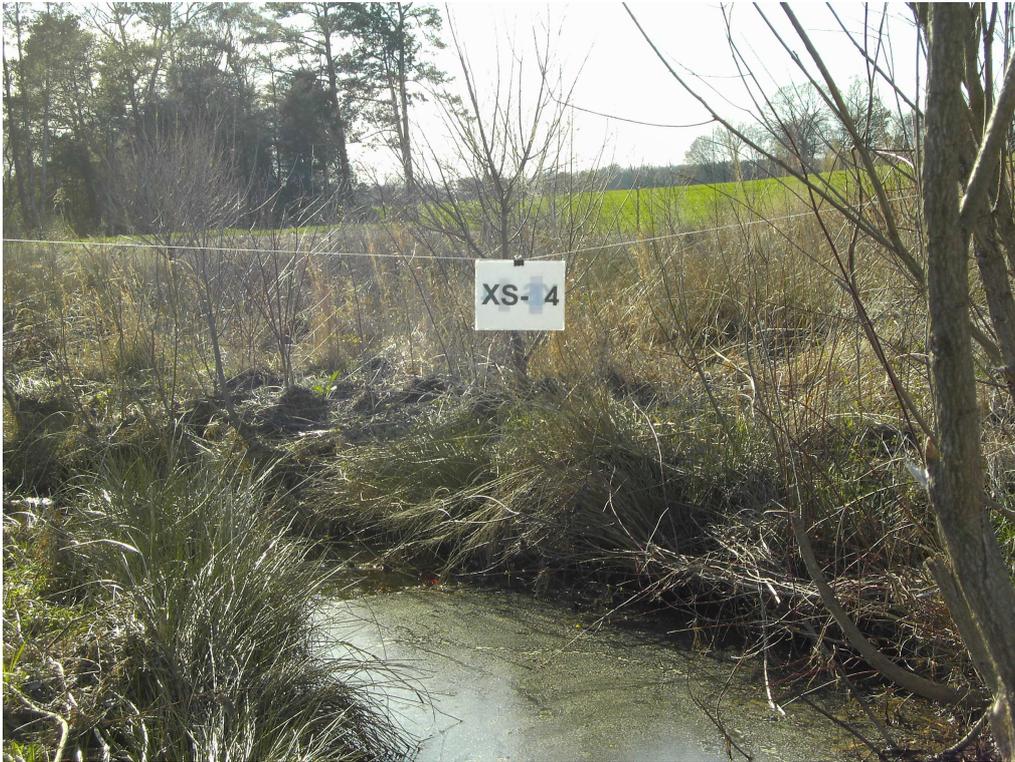
Photo 9. Looking downstream at UT to Underwood Creek XS-4

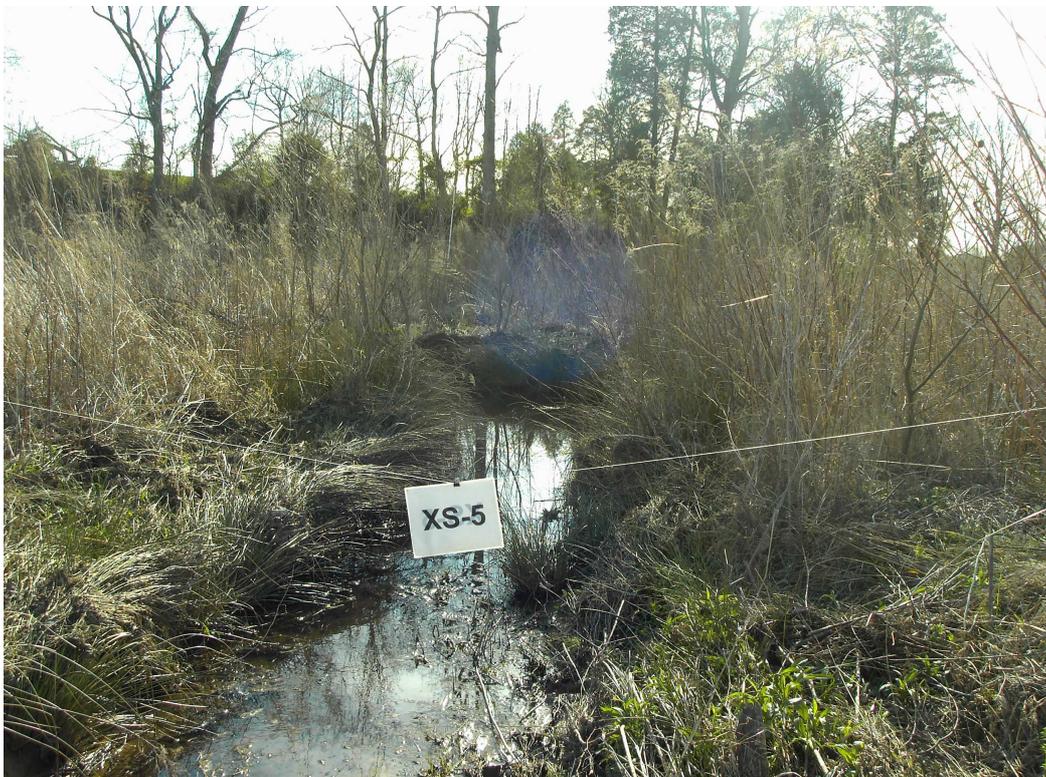
Photo 10. Looking downstream at UT to Underwood Creek XS-5

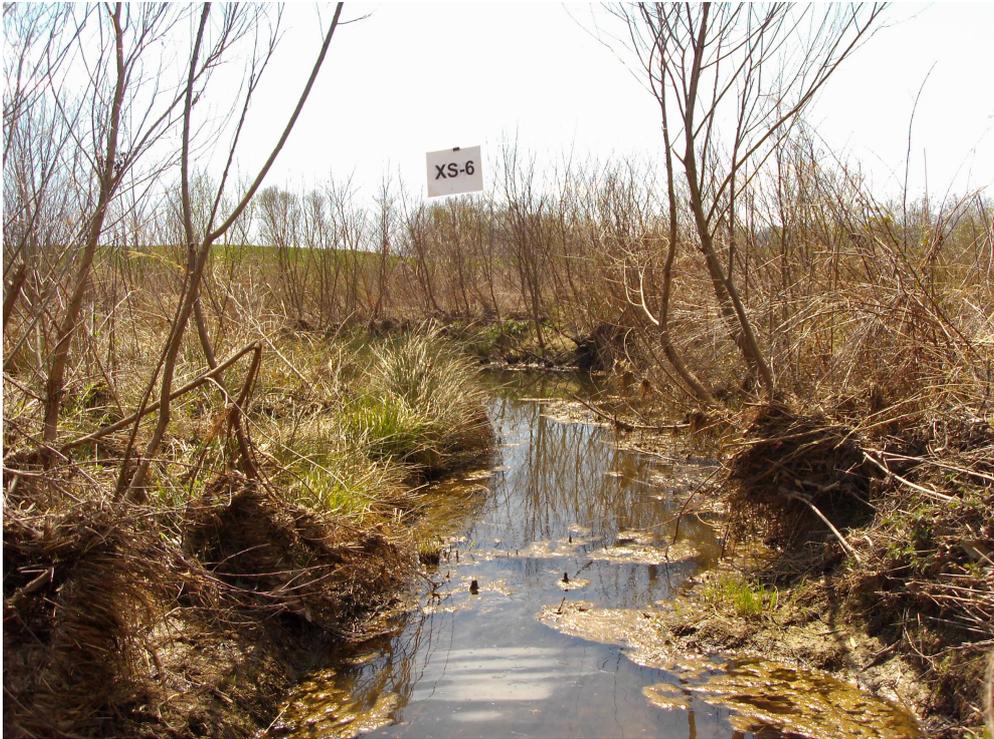
Photo 11. Looking downstream at UT to Underwood Creek XS-6

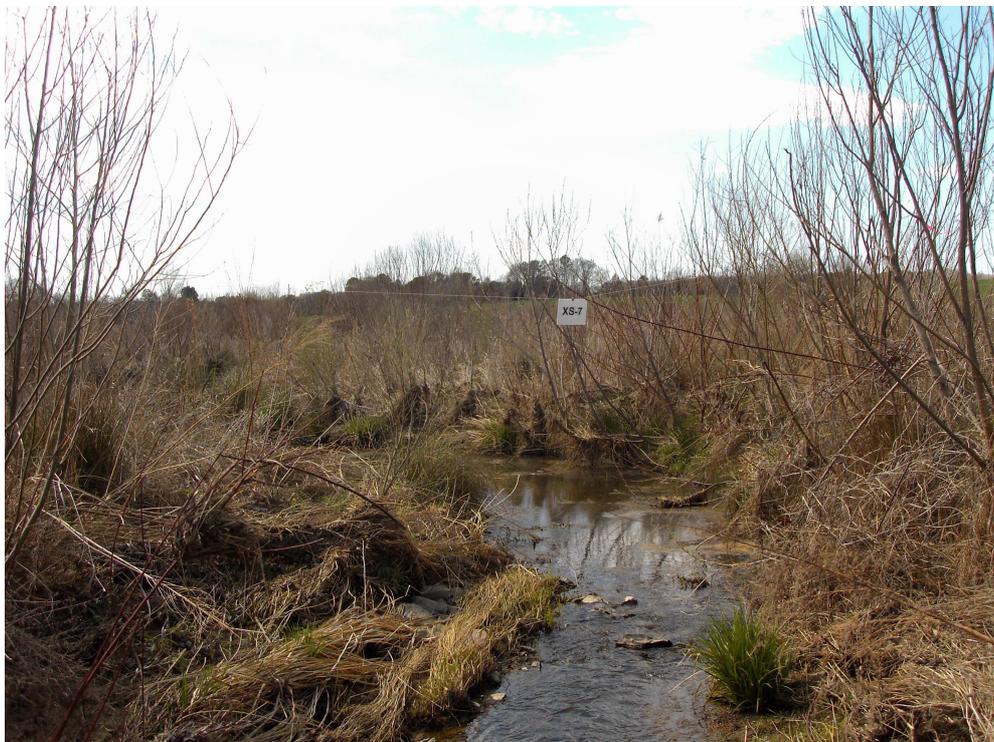
Photo 12. Looking downstream at UT to Underwood Creek XS-7

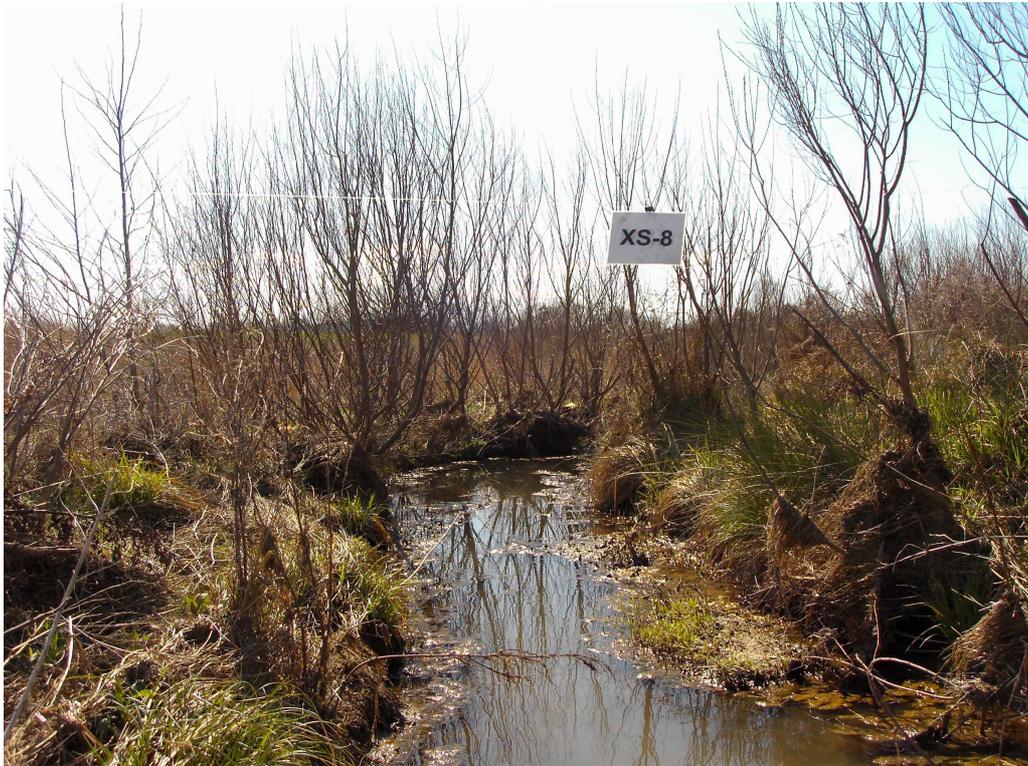
Photo 13. Looking downstream at UT to Underwood Creek XS-8

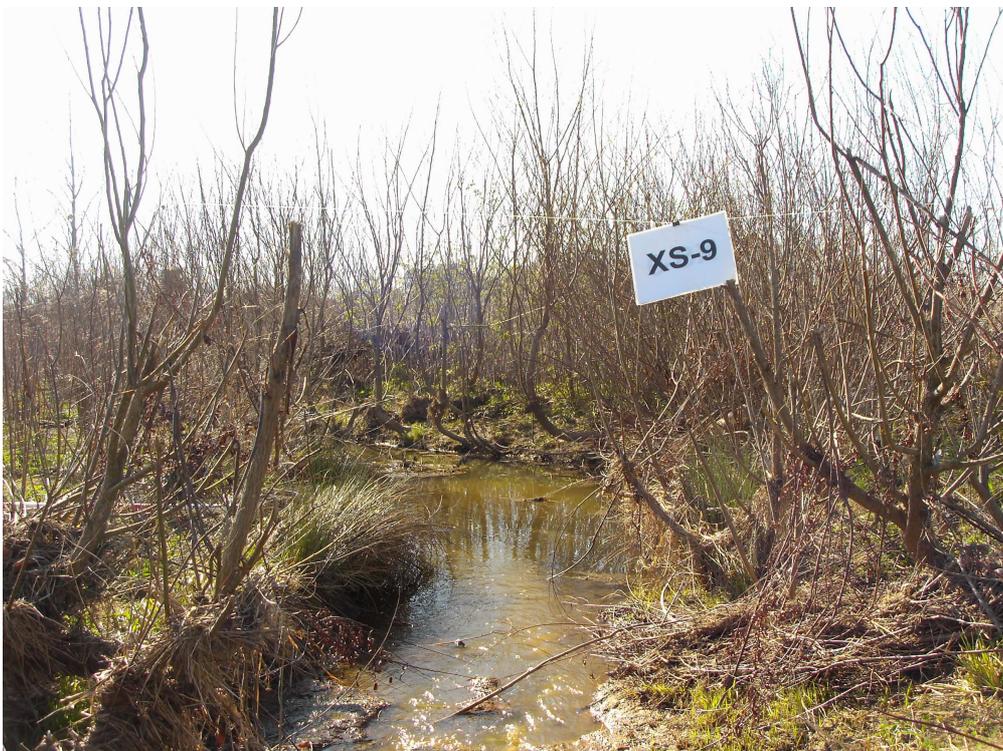
Photo 14. Looking downstream at UT to Underwood Creek XS-9

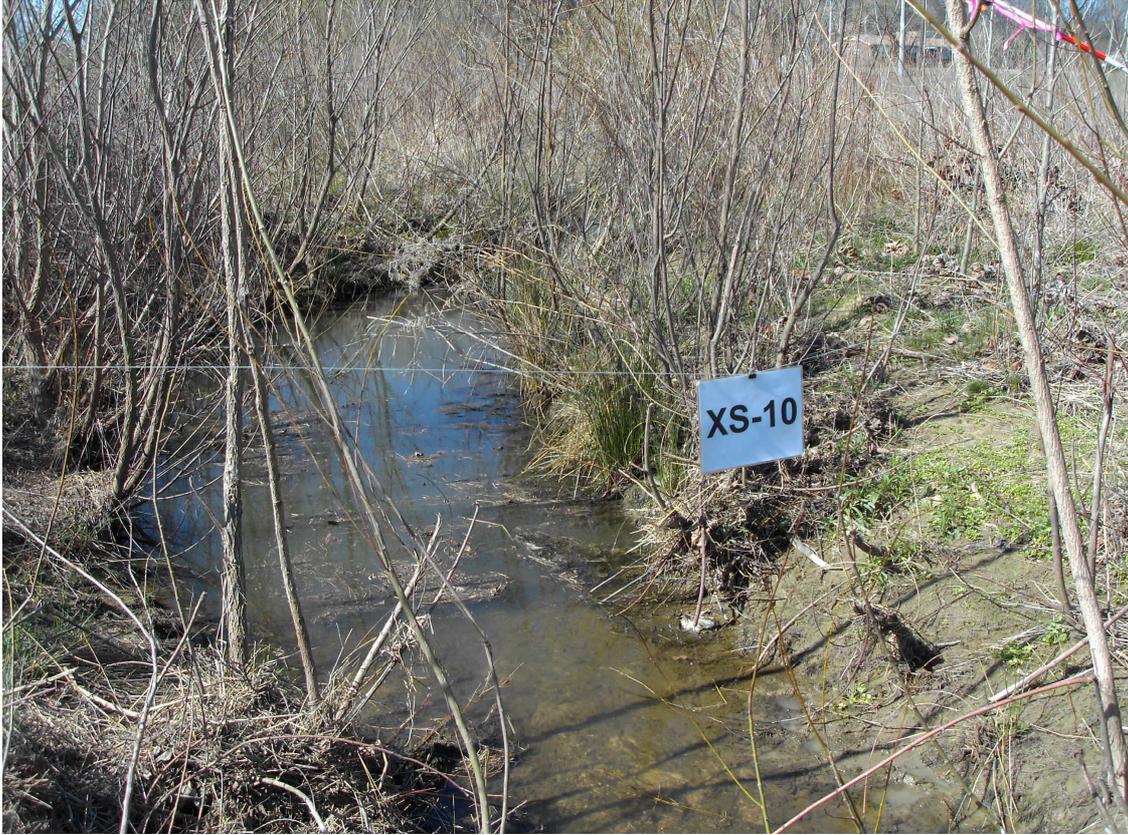
Photo 15. Looking downstream at UT to Underwood Creek XS-10
