Monitoring Report FINAL VERSION Pen Dell Mitigation Project Monitoring Year 1 Calendar Year of Data Collection: 2018

NCDEQ DMS Project Identification # 97079 NCDEQ DMS Contract # 6824 Neuse River Basin (Cataloging Unit 03020201) USACE Action ID Number: SAW-2016-00885 NCDEQ DWR Project # 2016-0403 Johnston County, NC Contracted Under RFP # 16-006477 Data Collection Period: March-May 2018, Submission Date: March 2019

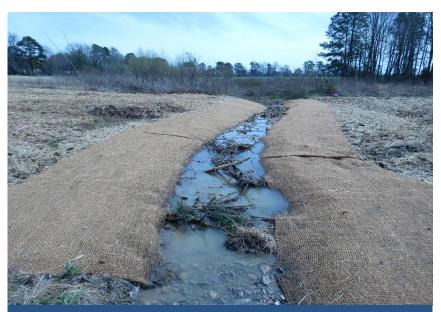
R1, facing upstream, Sta 20+00, March 29, 2018 (MY-00)

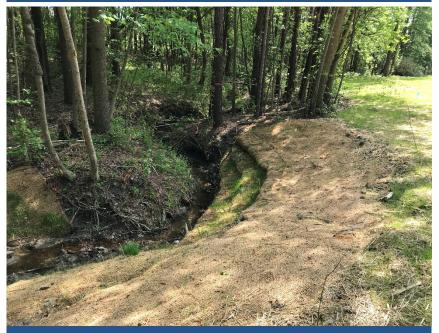
R2, facing downstream, Sta 21+50, April 27, 2018 (MY-00)

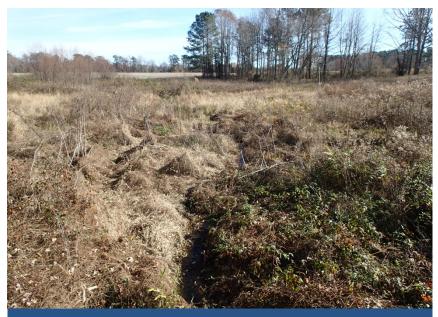
R1, facing upstream, Sta 20+00, Dec 6, 2018 (MY-01)

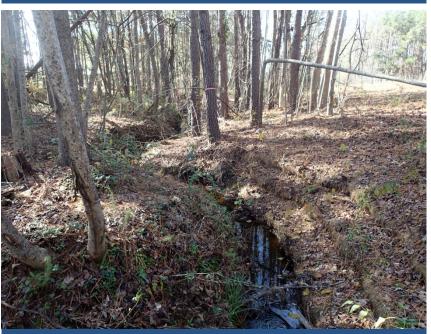
R2, facing downstream, Sta 21+50, Dec 6, 2018 (MY-01)

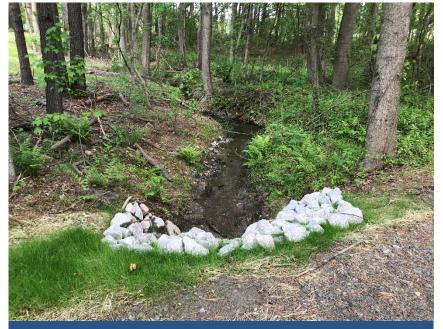
R2, facing upstream at crossing, Sta 23+00, April 27, 2018 (MY-00)

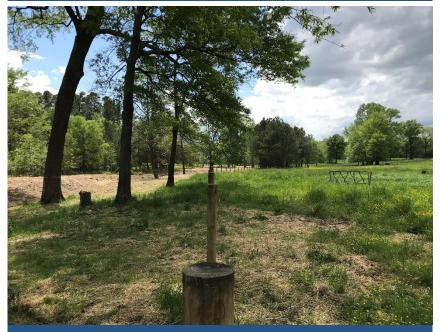
R3, facing downstream, Sta 31+00, April 27, 2018 (MY-00)

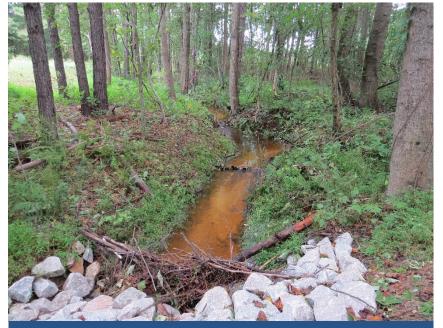
R2, facing upstream at crossing, Sta 23+00, Sept 17, 2018 (MY-01)

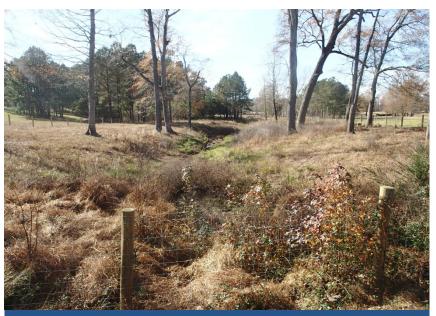
R3, facing downstream, Sta 31+00, Dec 6, 2018 (MY-01)

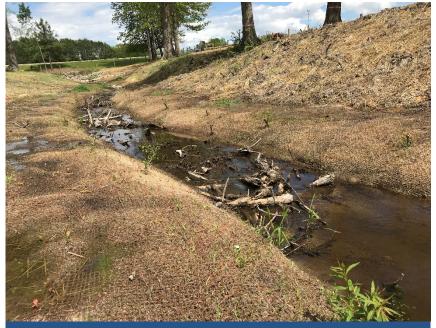
R3, facing upstream, Sta 33+00, April 27, 2018 (MY-00)

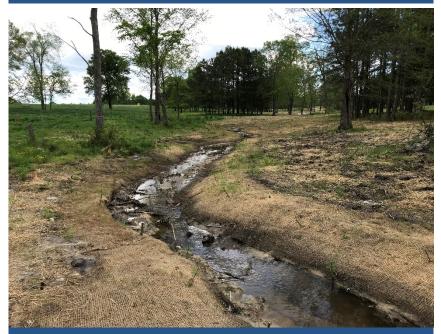
R4, facing upstream, Sta 43+50, April 27, 2018 (MY-00)

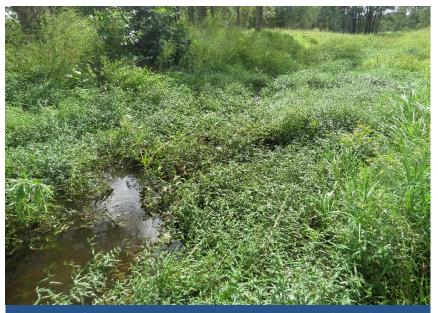
R3, facing downstream, Sta 33+00, Sept 17, 2018 (MY-01)

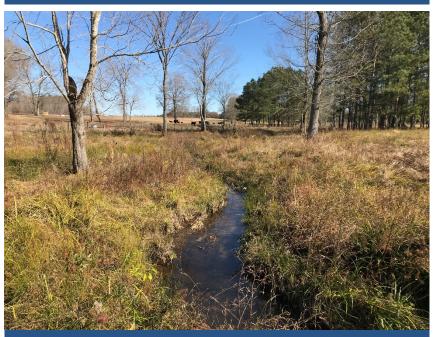
R4, facing upstream, Sta 43+50, Dec 18, 2018 (MY-01)

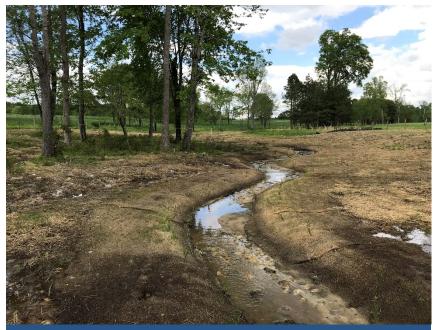
R4, facing upstream, Sta 44+50, April 27, 2018 (MY-00)

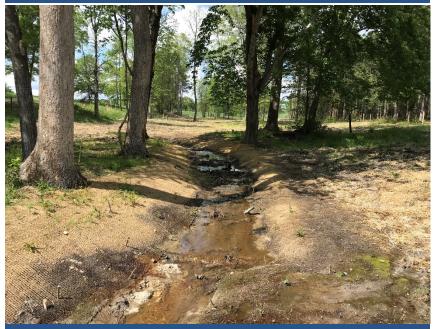
R4, facing upstream, Sta 52+00, April 27, 2018 (MY-00)

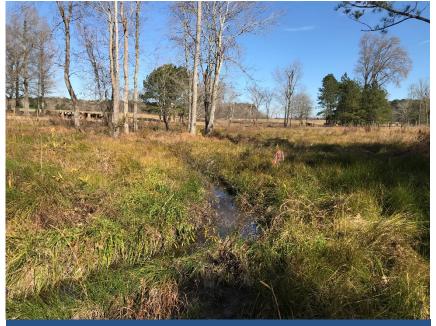
R4, facing upstream, Sta 44+50, Dec 18, 2018 (MY-01)

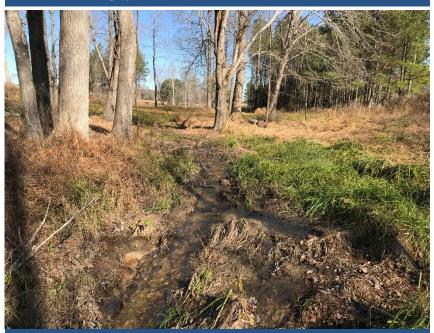
R4, facing upstream, Sta 52+00, Dec 18, 2018 (MY-01)

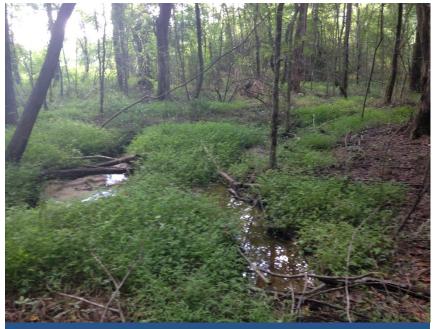
R5, facing upstream, near Sta 62+00, Sept 1, 2015, 2018 (MY-00)

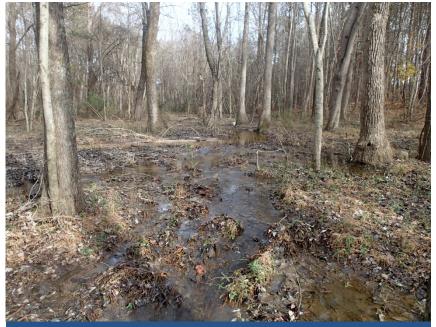
R5, facing upstream, Sta 62+00, Dec 12, 2018 (MY-01)
