**MONITORING YEAR 3
ANNUAL BUFFER REPORT
FINAL**

PERRY HILL MITIGATION SITE

Orange County, NC
Neuse River Basin
HUC 03020201

NCDEQ Contract No. 7744
DMS Project No. 100093
NCDWR Project No. 2019-0157v2
RFP No. 16-007576

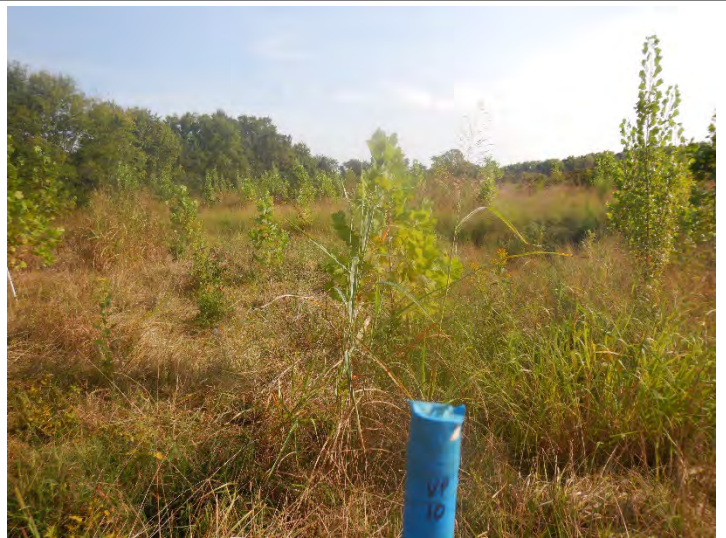
VEG PLOT 10 (09/07/2023)

Wildlands does not believe the area around vegetation plot 10 has low stem density or needs replanting at this point. As mentioned above, there are healthy planted stems with density and growth that resemble the rest of the site outside the vegetation plot boundary. However, Wildlands will continue to observe the area to confirm that tree health and density stays at an appropriate level.

Plot	Success Criteria Met*	Tract Mean
1	Yes	93%
2	Yes	
3	Yes	
4	Yes	
5	Yes	
6	Yes	
7	Yes	
8	Yes	
9	Yes	
10	No	
11	Yes	
12	Yes	
13	Yes	
14	Yes
