MONITORING YEAR 1 AND 2 REPORT

PHILLIPS–WILLIS SITE MIDDLE FORK CREEK

FINAL

EEP Project Number: 92703
Contract Number: D06082; Task Order: 07MON1-11

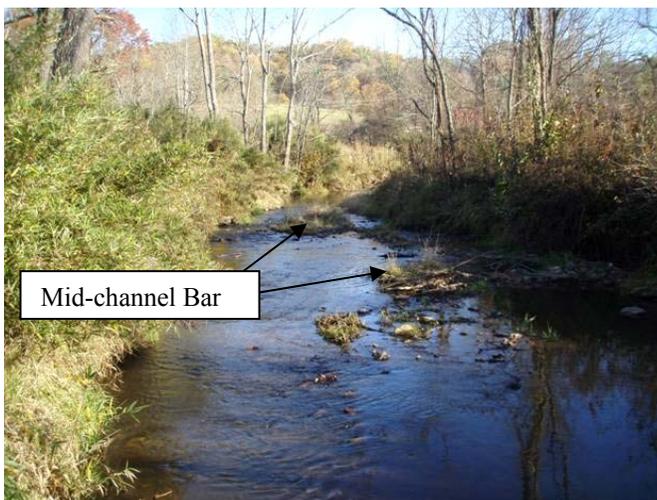
The few problem areas that were observed and photo documented were confined to the MFC channel (Appendix Table B.2.1). Problem areas such as bank sloughing or scour were typically <25 ft in length. Three mid-channel bars were noted along the MFC reach. Bank sloughing likely caused by a field drain appears to have resulted in the formation of one mid-channel bar. The others appear to be the result of a combination of beaver dam construction and the heavy bed load being transported from upstream areas. Beaver dam removal and animal eradication have occurred at the project site on two separate occasions; once the beaver dams were removed, the channel cut through the sediments deposited when the dams were ponding stream flows. Beaver dams also created two observed over-wide areas in the channel. These over-wide points along the channel have resulted in bank scour and bar formation problem areas.

Stream problem area 1, mid-channel bars, 4 Dec 2007.

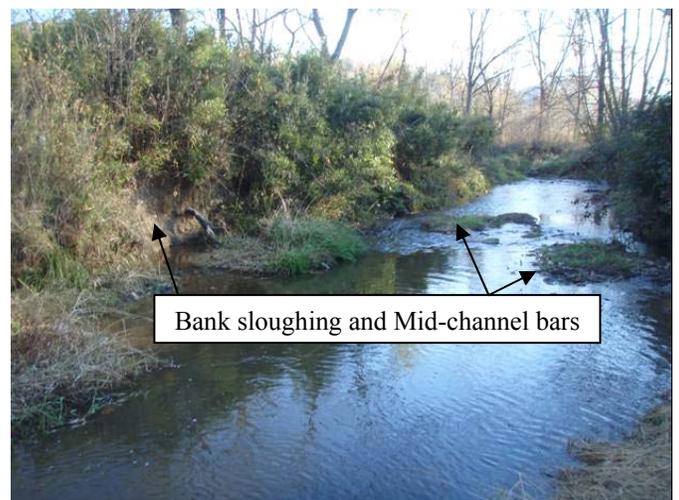
Stream problem area 2, bank scour, 4 Dec 2007.

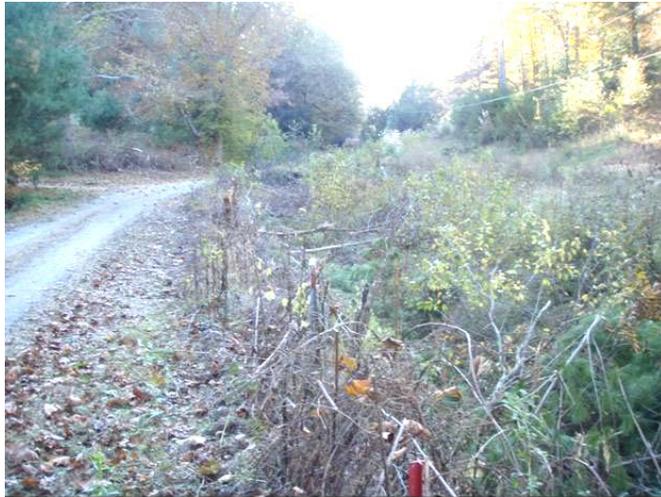
MY1 Vegetation Problem Areas Phillips-Willis Site (EEP project number 92703)			
Feature/Issue	Station Number/Range	Probable Cause	Photo Number
Conservation easement encroachment	MB 0+00, left bank	Long arm mower	1

Vegetation problem area 1 MB, facing downstream, 15 Oct 2007.
