MONITORING YEAR 1 AND YEAR 2 REPORT
PLEMMONS/KIRKPATRICK MITIGATION SITE
SPRING CREEK

Madison County, North Carolina

EEP Project Number: 92607
Contract Number: D06082; Task Order: 06FB05-1

Period Covered: December 2007 – February 2009

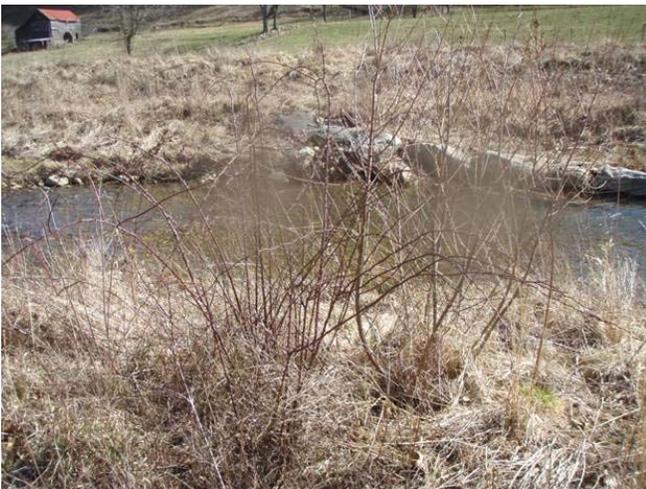
Sparse sprigs of multiflora rose *Rosa multiflora* and Chinese privet *Ligustrum sinense* were observed during the MY1 and MY2 site assessments (Appendix Table A.3.1.). The observed non-native vegetation most likely regenerated from root stock remaining in the soil following ground clearing and has been confined to isolated locations. The lower most portion of the right bank (Sta. 5+75) has the highest density of Chinese privet and multiflora rose of which some mature stems were not removed during construction.

MY2 Vegetation Problem Areas Spring Creek (EEP project number 92607)			
Feature/Issue	Station Number/Range	Probable Cause	Photo Number
Chinese privet - sparse	3+00, left bank	Root stock	
Multi-flora rose - clump	4+75, left bank	Root stock	1
Multi-flora rose, Chinese privet, honeysuckle - clumps	5+75, right bank	Parent Stock	2

Vegetation problem area photo 1, 13 Feb 2009.

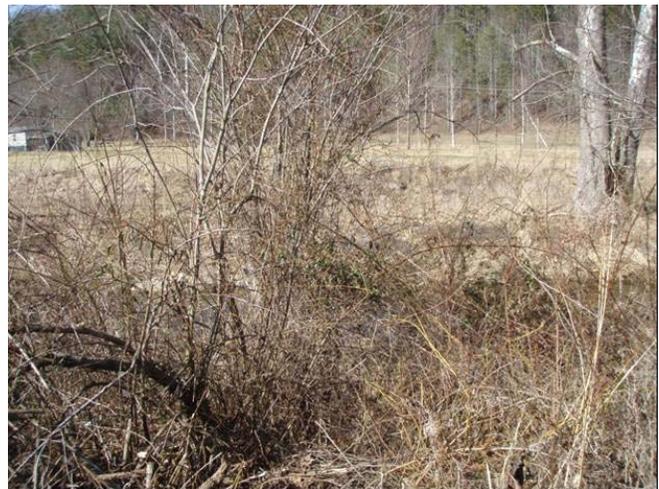
Vegetation problem area photo 2, 13 Feb 2009.

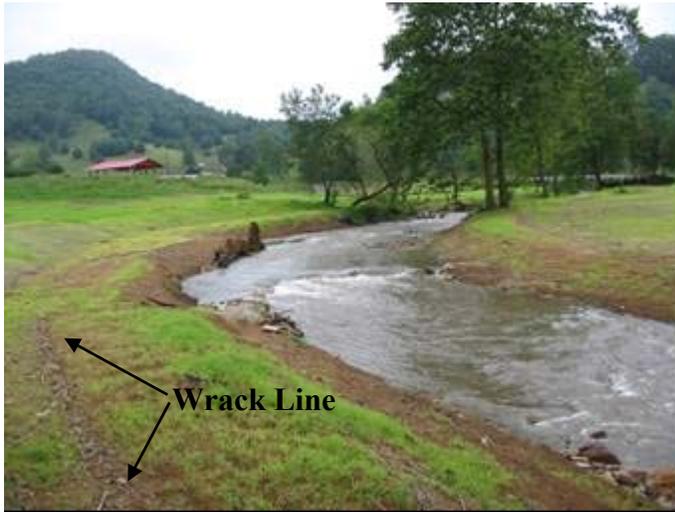
One bankfull event was documented between the end of construction and completion of the as-built survey (Table 5). A wrack line above the bankfull elevation was observed and photographed for verification on 5 Sep 2006 (Appendix B.9). To monitor additional bankfull events, a simple crest gauge was installed on the left bank (sta. 2+30) downstream of cross-section 2 and adjacent to a large sycamore tree. The crest gage was dislodged in July 2008 during a flow event that approached three-quarters of the bankfull elevation. The crest gage was relocated adjacent to the root wad structures in the large meander bend (Sta. 4+00). With the widespread drought conditions experienced during the 2007 and 2008 monitoring years, no additional bankfull events have been documented.

Wrack line following bankfull event on 1 Sep 2006.
