# **Year 1 Monitoring Report**

## **Hatchet's Grove Stream Restoration**

**April 2006**

**EEP Project No. 289**

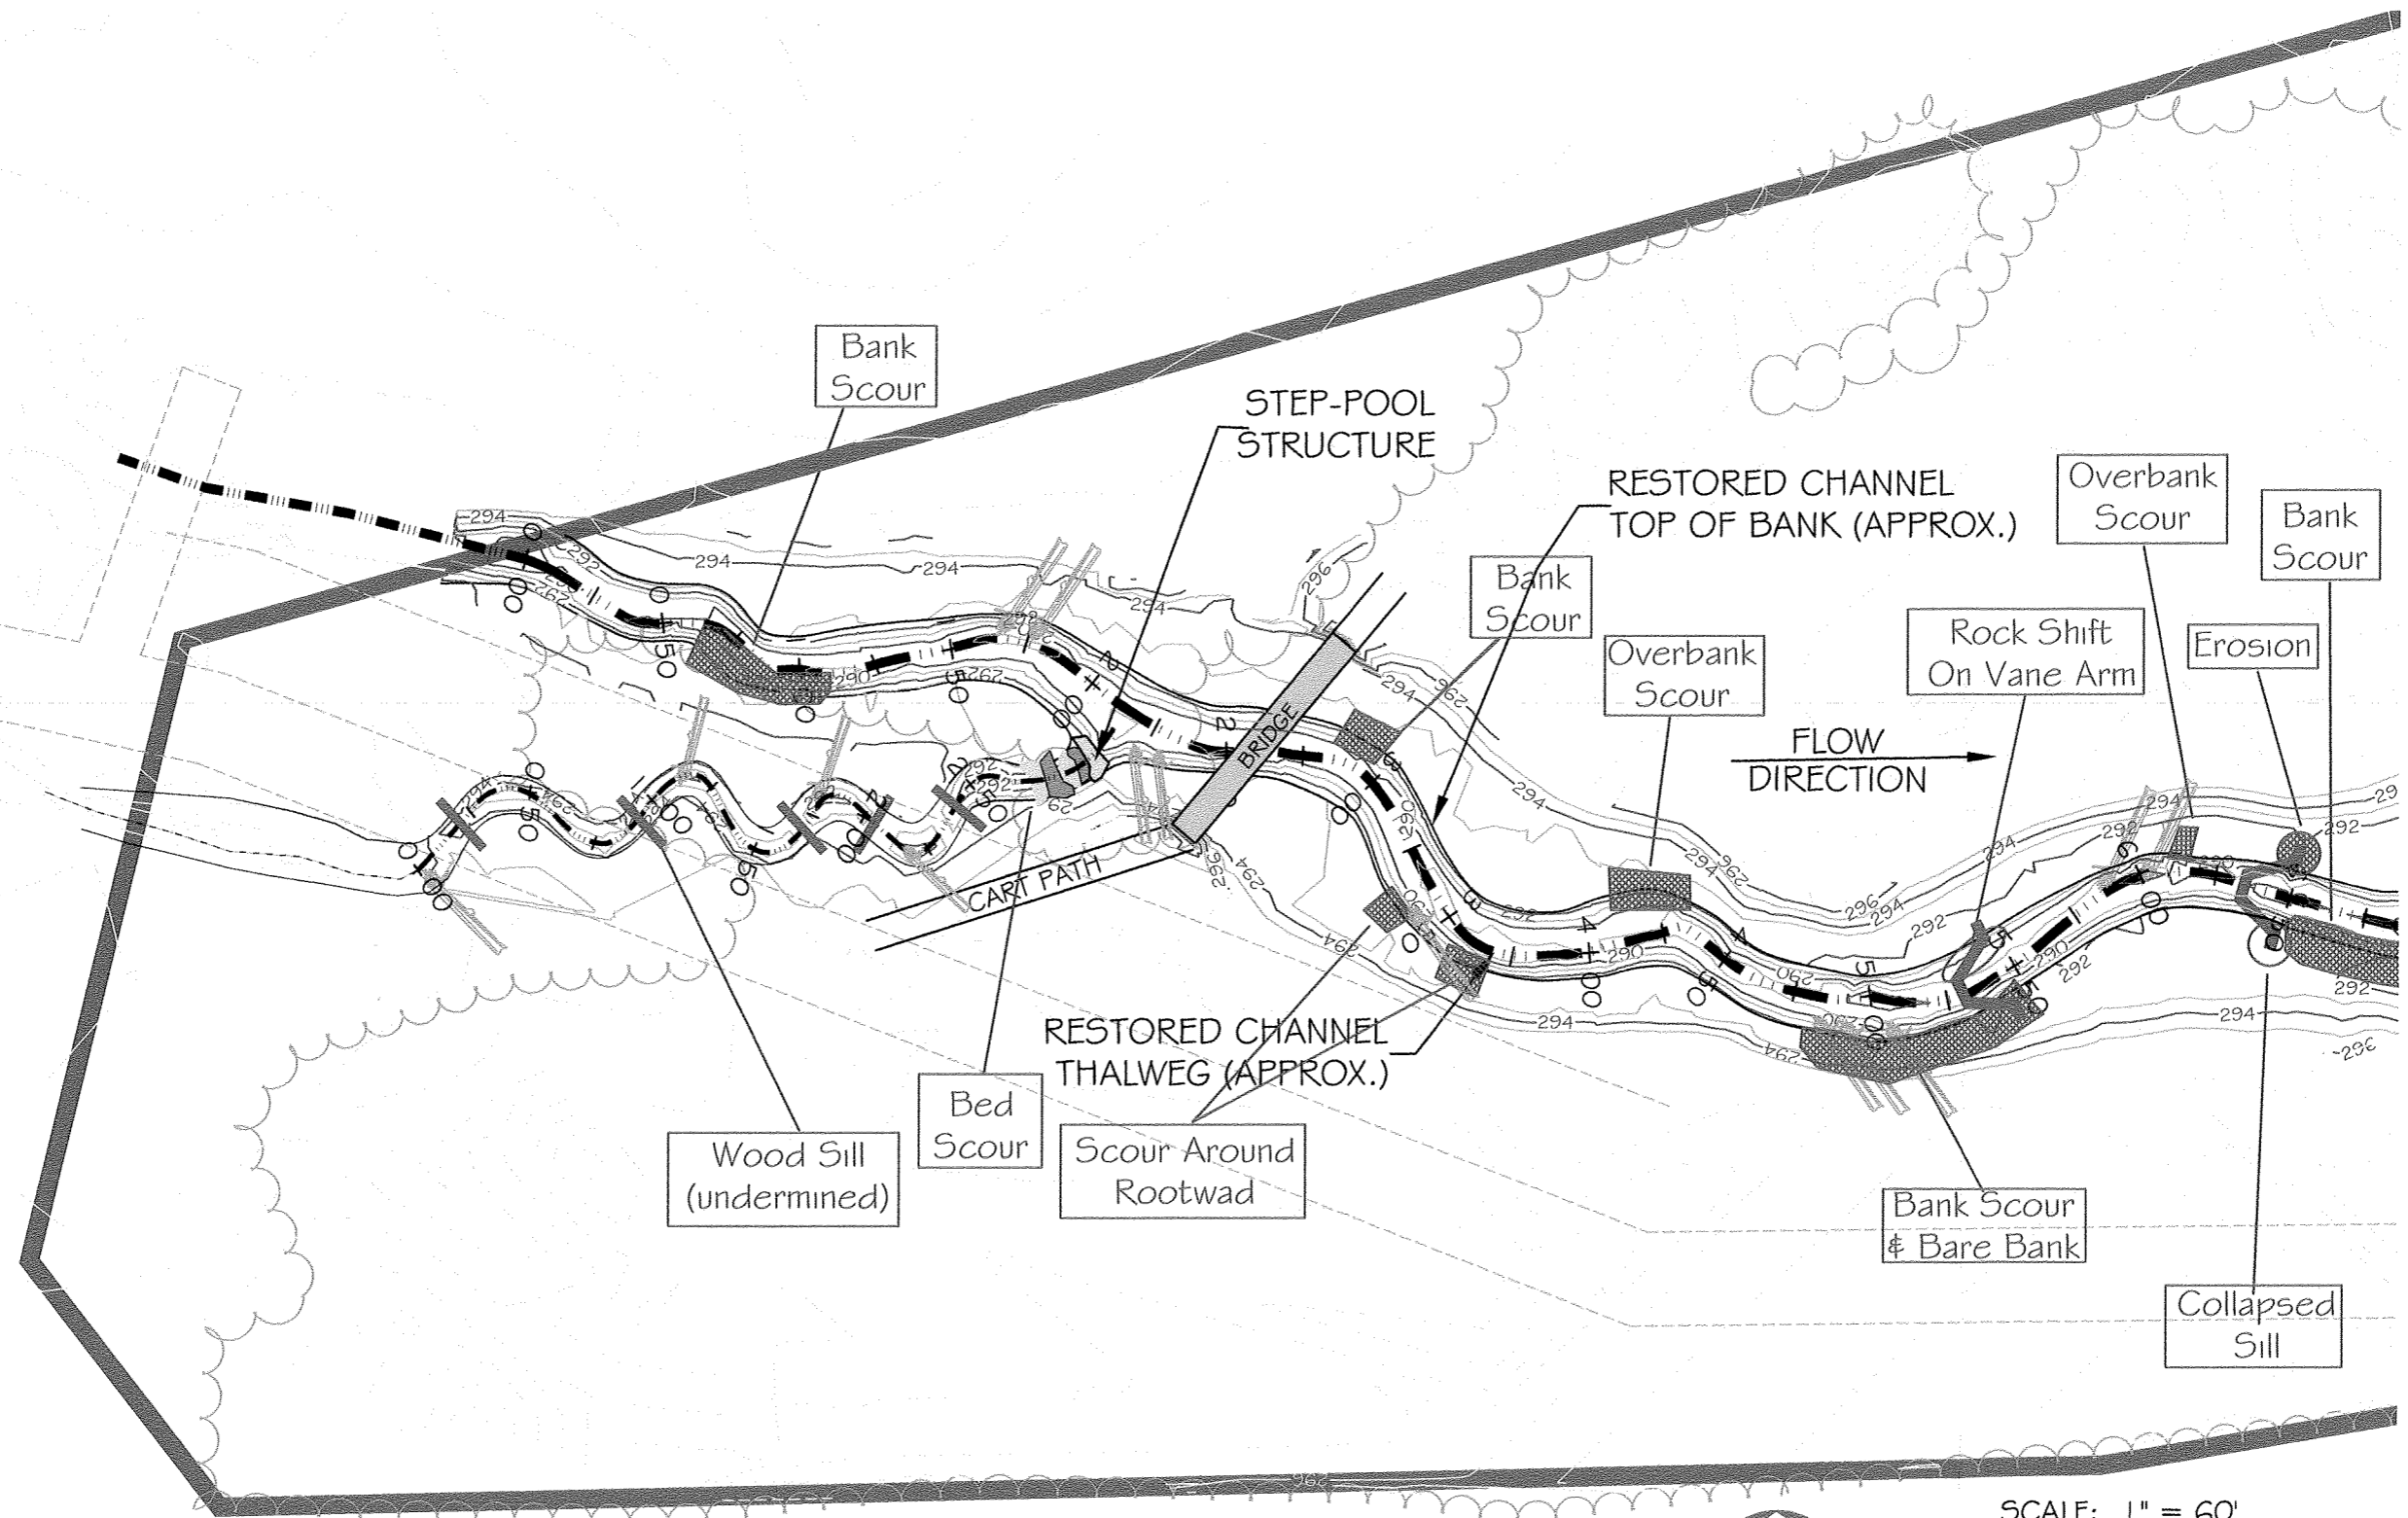
# PROBLEM AREA PLAN VIEW - E

An assessment of the stability of the channel was performed on September 17, 2005, by S&EC. Several areas of concern were observed and documented including localized bank scour, overbank scour, and several failing structures. These problem areas are shown on Sheets 7 through 10 – Problem Area Plan Views E through H.

And while the channel is generally stable these areas of concern should be considered for repair or stabilization to ensure the future success of the project.

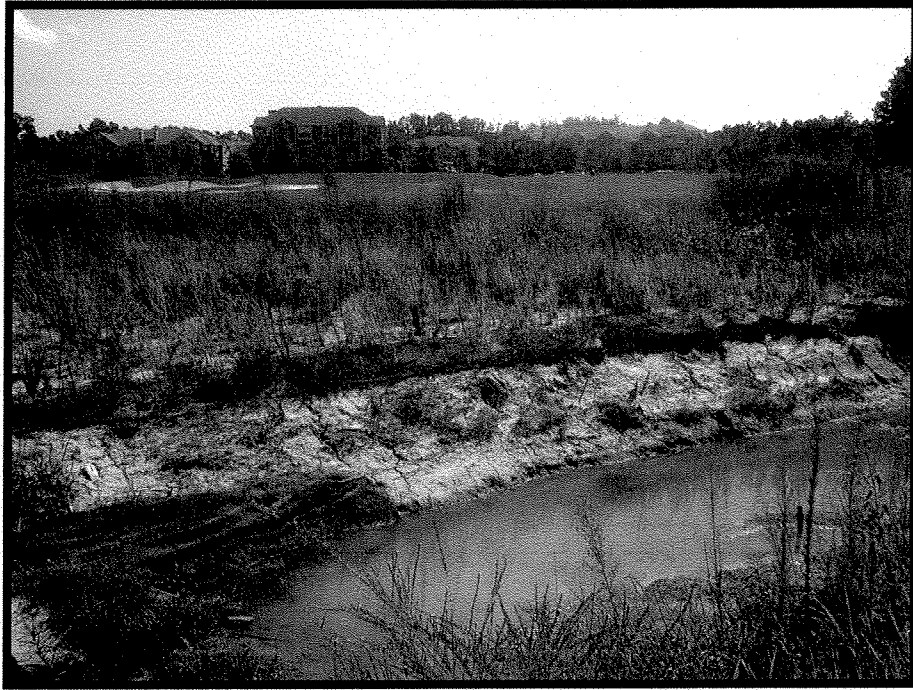
Upon inspection on September 17, 2005, it was noted that several areas along the banks of Hatchet's Grove and its floodplain have suffered localized loss of vegetation. It is suspected that large overbank flows which occurred before the newly planted vegetation had sufficient time to establish roots strong enough to withstand flow. There are several areas with exposed soil as indicated on the problem area plan view as "Bare Bank."

<b>Feature Issues</b>	<b>Station numbers</b>	<b>Suspected Cause</b>	<b>Photo number</b>
Bare Bank	6+50 to 7+25	overbank flow	N/A
	23+50 to 24+00	overbank flow

Vegetative Problem Area—Bare Bank

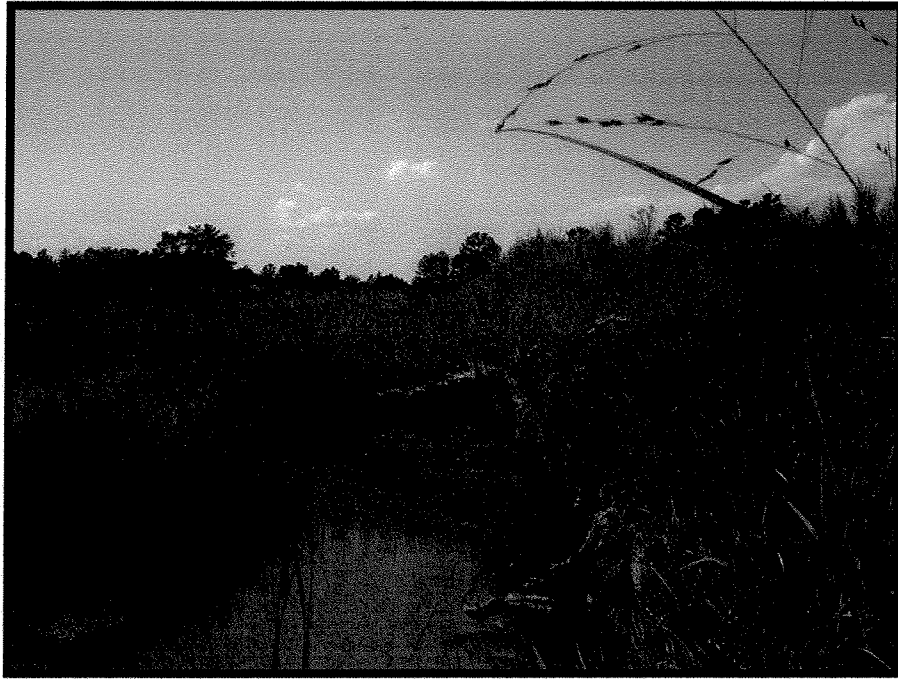
<b>Feature Issues</b>	<b>Station numbers</b>	<b>Suspected Cause</b>	<b>Photo number</b>
Bank Scour	0+50 to 1+00	high velocity/excess shear	Stream Problem Areas 1-2
	2+75	high velocity/excess shear	
	4+80 to 5+60	high velocity/excess shear	
	6+50 to 7+25	high velocity/excess shear	
	7+50	high velocity/excess shear	
	8+00 to 8+50	high velocity/excess shear	
	10+25 to 11+00	high velocity /excess shear	
	11+50 to 12+00	high velocity/excess shear	
	18+50 to 19+00	high velocity/excess shear	
	23+50 to 24+00	high velocity /excess shear	
	31+00 to 31+75	high velocity/excess shear	
Overbank Scour	3+25	floodplain drainage/stormwater outfall	N/A
	6+00	floodplain drainage/stormwater outfall	
	10+50	downstream of sewer pipe	
	25+00	floodplain drainage/stormwater outfall

Stream Problem Area 1—Bank Erosion

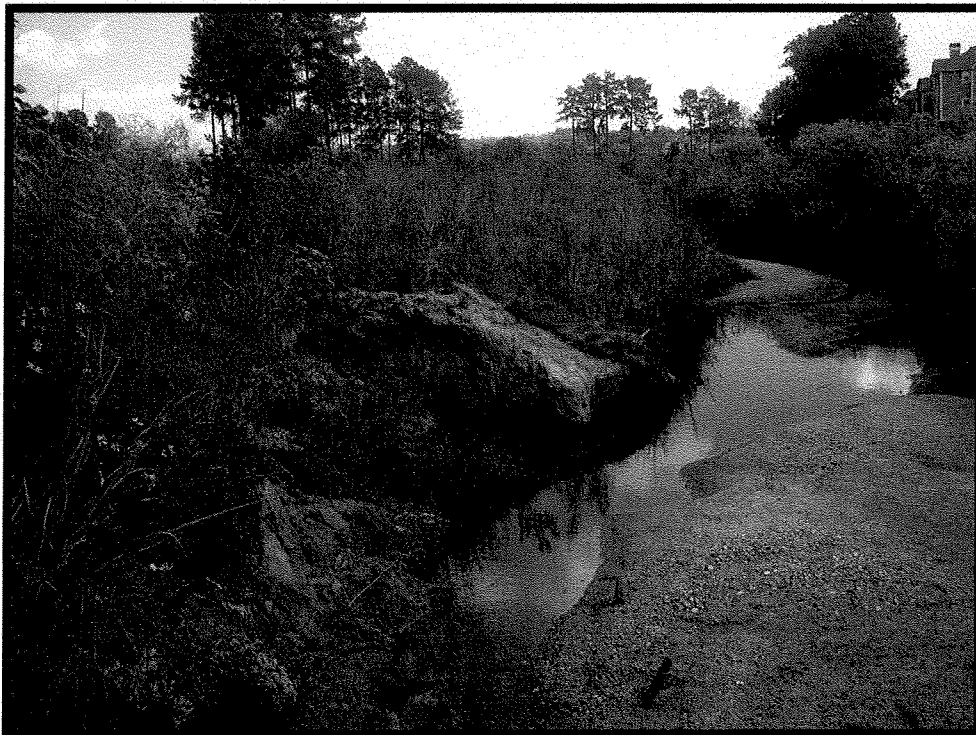
Stream Problem Area 2—Bank Erosion

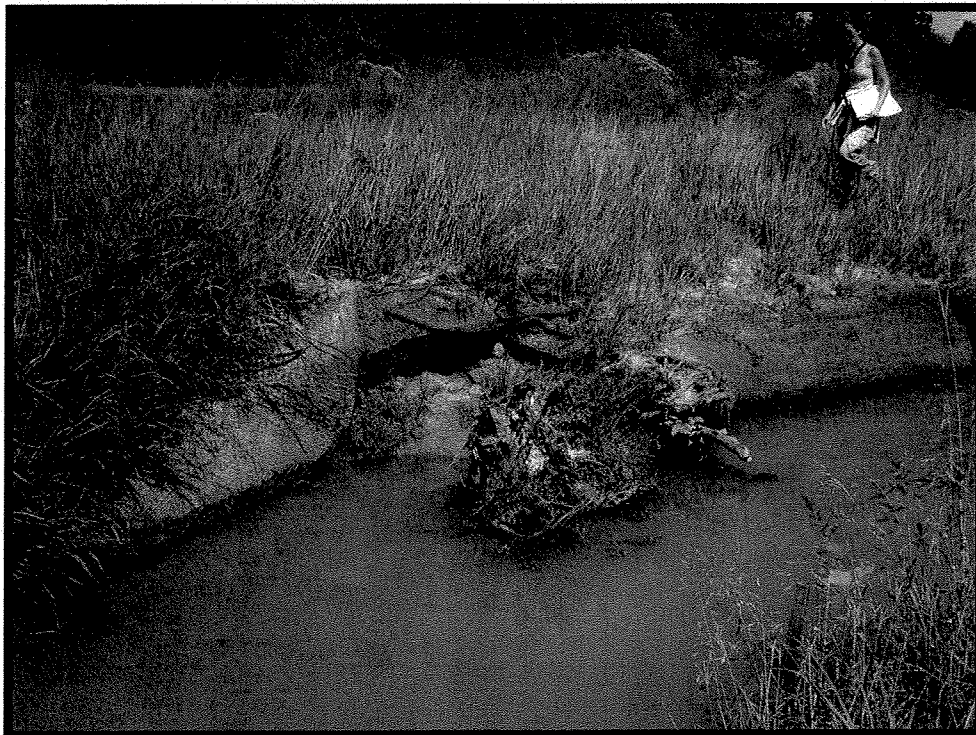
28+50	floodplain drainage/stormwater outfall	
Failing Structures	3+25 to 3+50	rootwad scour	Stream Problem Areas 3-4
	5+25	rock shift on arm	
	6+50	collapsed sill	
	14+50	rootwad scour	
	18+50	scour at arm	
	22+75	arms of crossvane failed	
	25+25	rootwad scour	
	26+25	rootwad scour	
	31+25	rootwad scour	
	31+75	rock shift at apex of vane	
	32+50	footer rock shift (left arm)	
	14+50	rootwad scour	
	18+50	scour at arm	
	22+75	arms of crossvane failed	
	25+25	rootwad scour	
	26+25	rootwad scour	
	31+25	rootwad scour	
	31+75	rock shift at apex of vane	
	32+50	footer rock shift (left arm)

Stream Problem Area 4—Failing Structure
