**Prestonwood Golf Course  
(Hatchet's Grove)  
Stream Restoration Monitoring Report  
EEP Project # 289  
Monitoring Year – 05  
2009**

**December 2009**

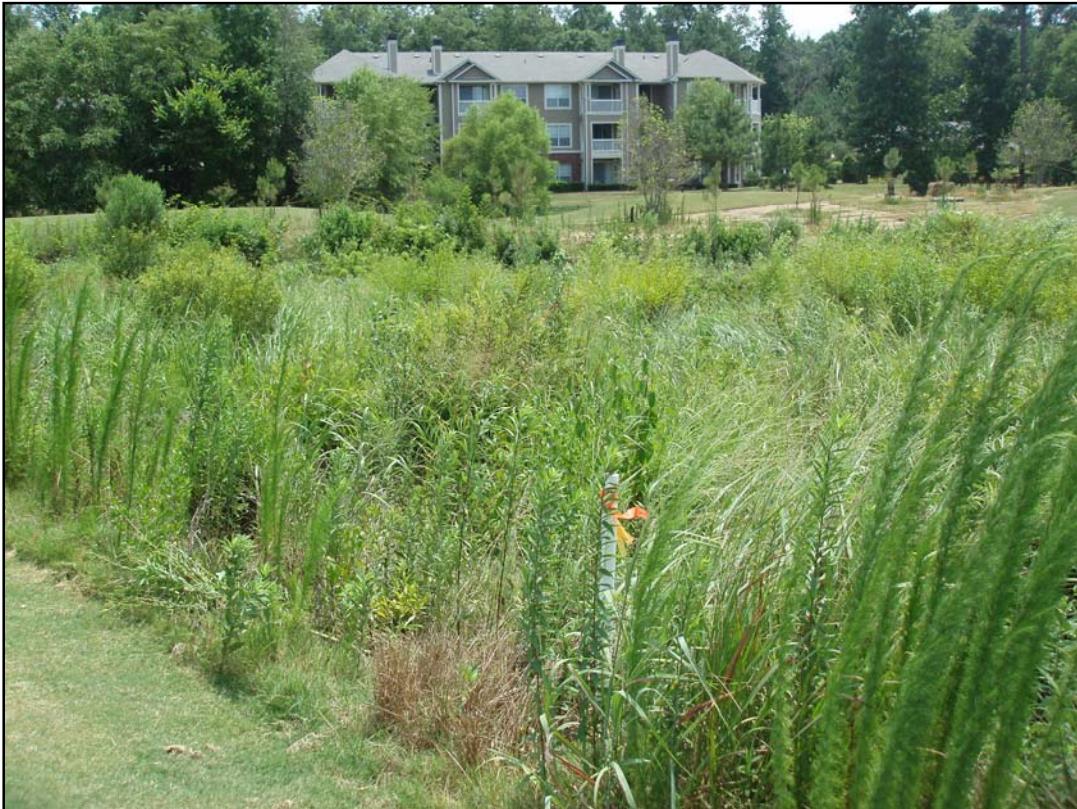
Vegetation Plot 1 – 7/9/09 - MY 05

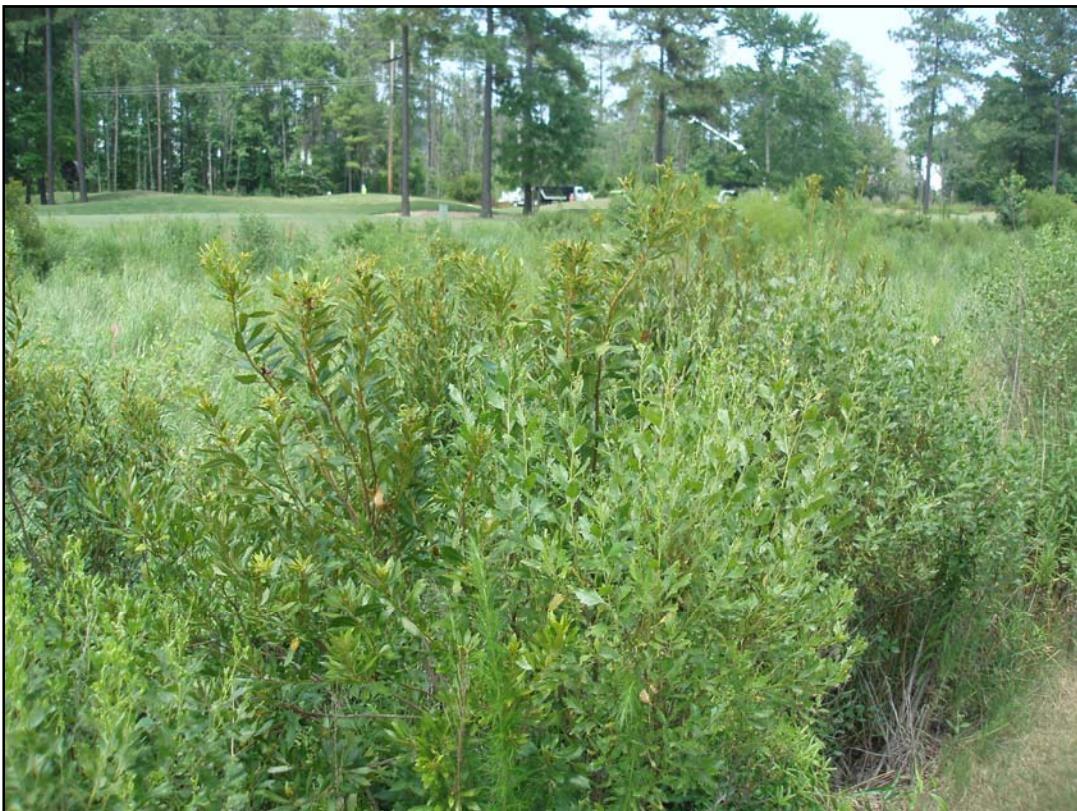
Vegetation Plot 2 – 7/9/09 - MY 05

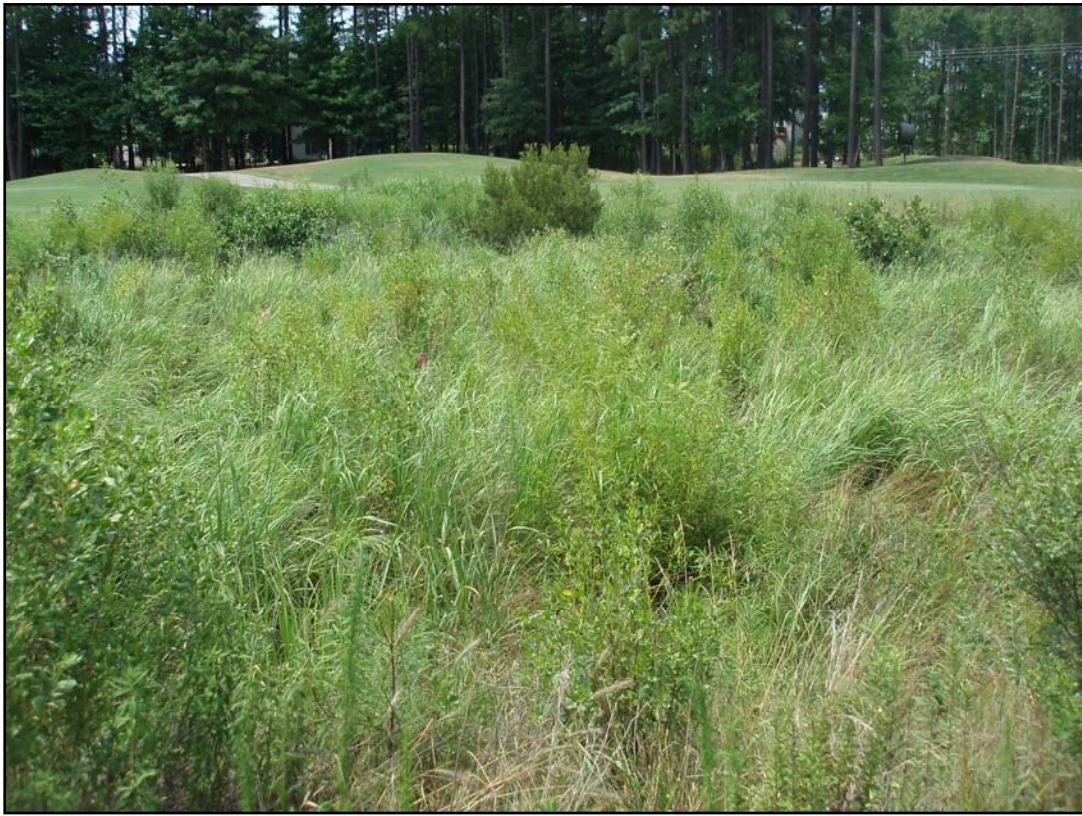
Vegetation Plot 2 – Supplemental photo from opposite corner. 7/9/09 - MY 05

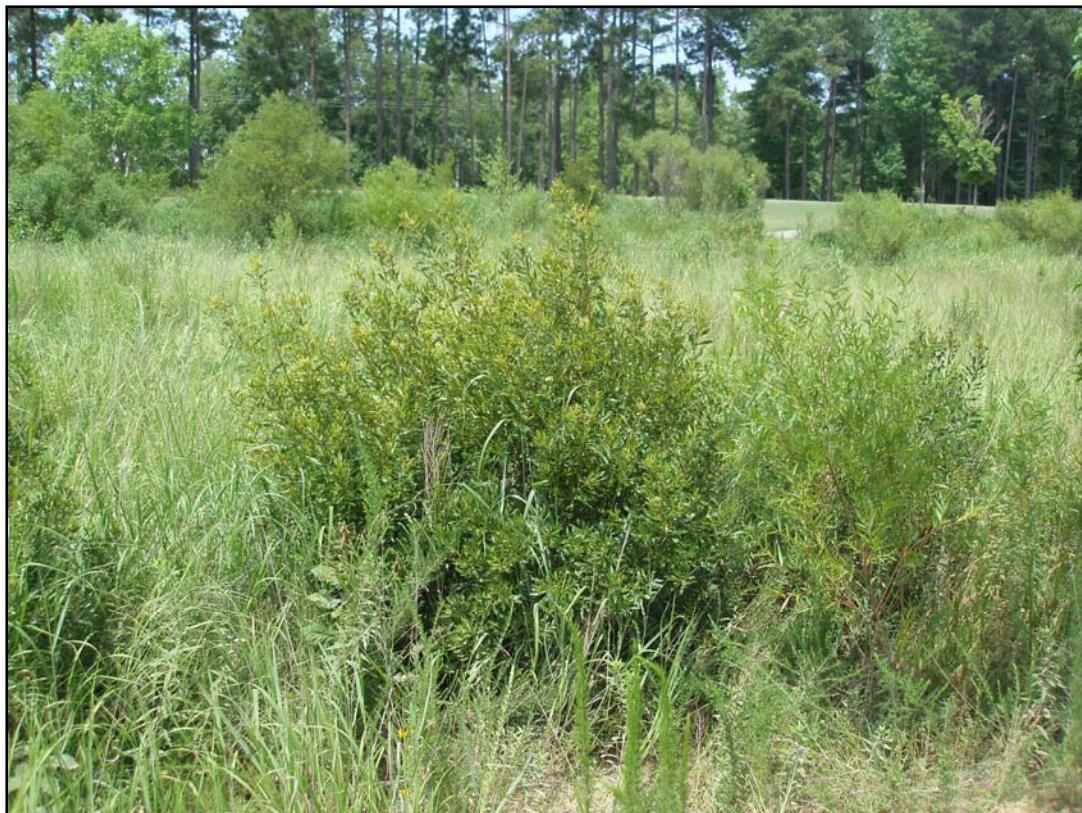
Vegetation Plot 3 – 7/9/09 - MY 05

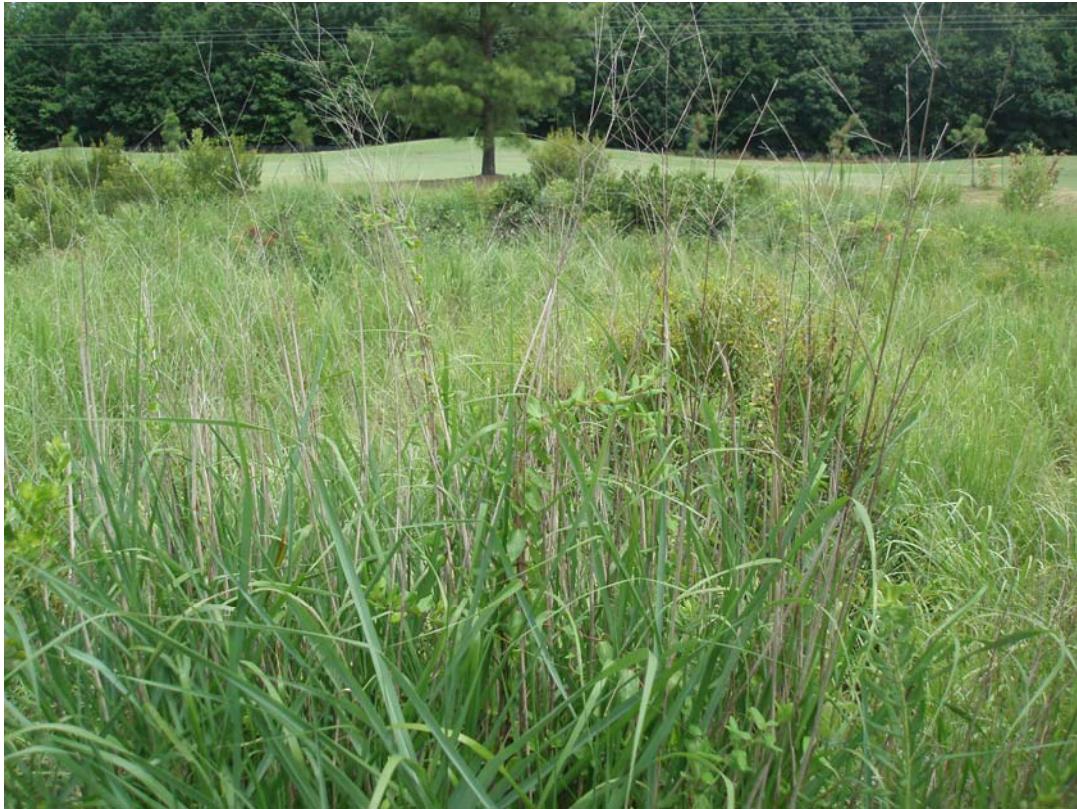
Vegetation Plot 4 – 7/9/09 - MY 05

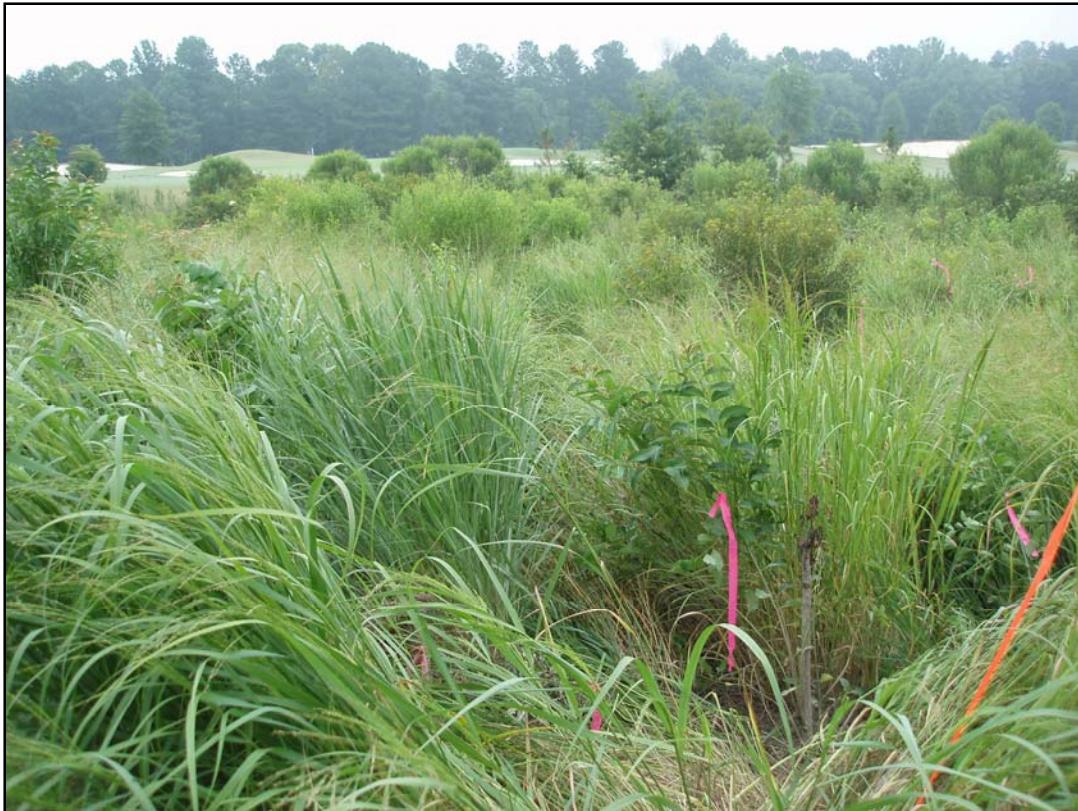
Vegetation Plot 5 – 7/15/09 - MY 05

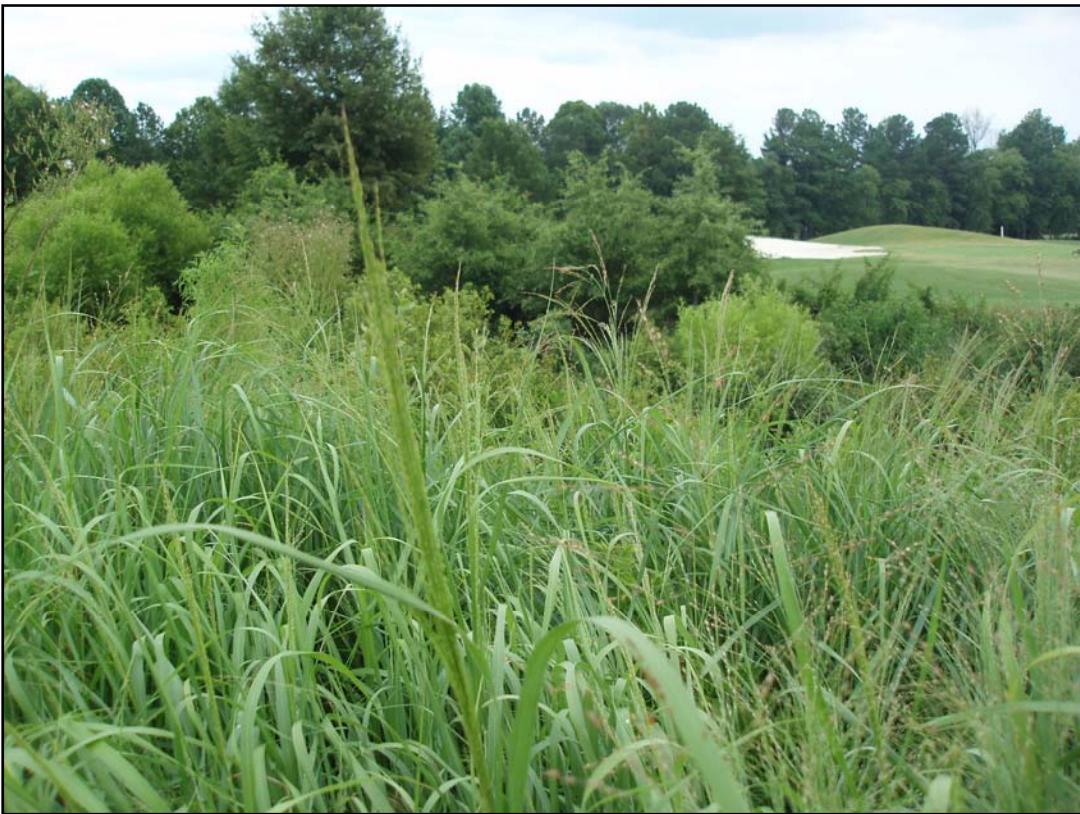
Vegetation Plot 6 – 7/9/09 - MY 05

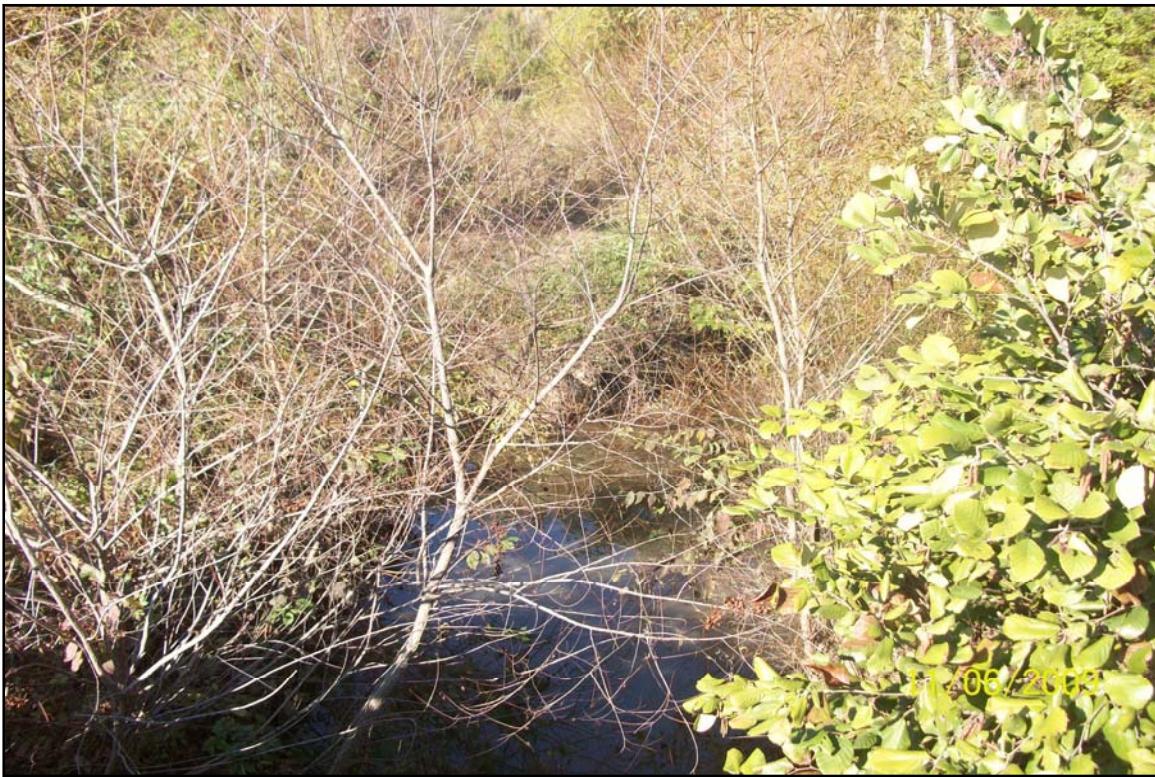
Photo Point 1 – Taken looking upstream from golf cart bridge at the upper 300 feet of the Hatchet's Grove. 11/6/09 - MY 05

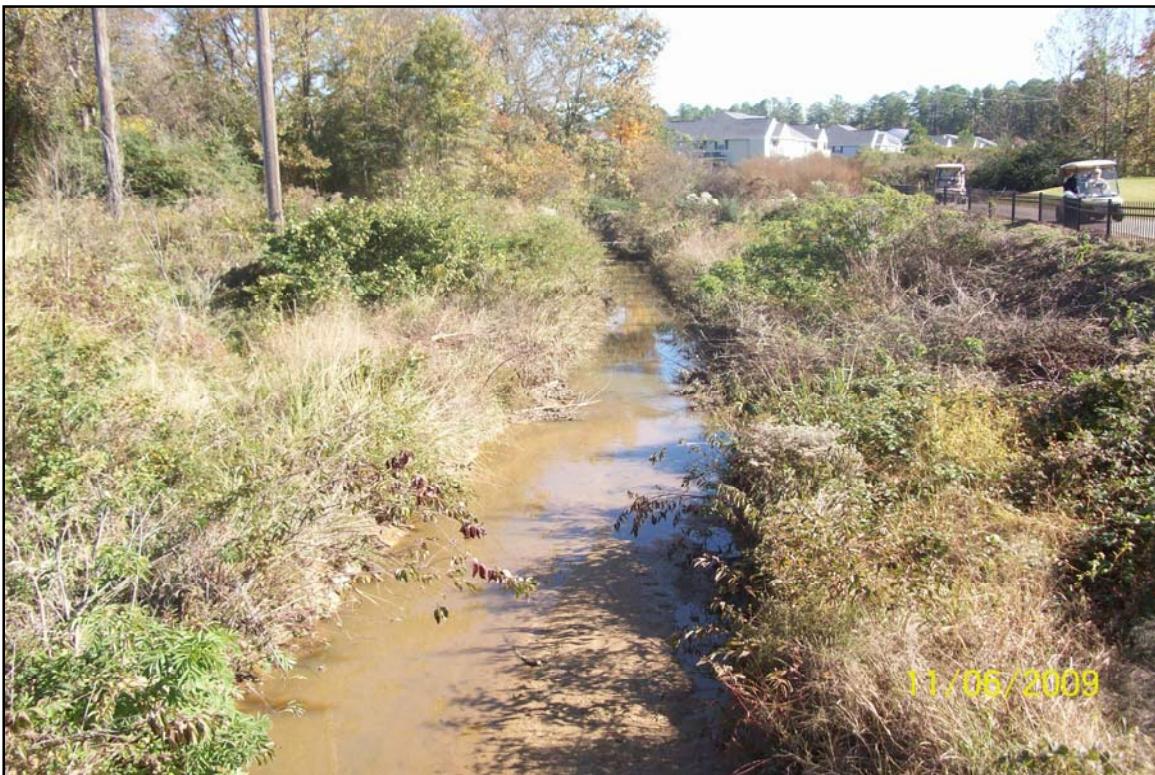
Photo Point 2 – Taken looking downstream from golf cart bridge at the lower 300 feet of the Hatchet's Grove. 11/6/09 - MY 05
