Purlear Creek Phase II Monitoring Report

Year 0 of 5 (2006)

Wilkes County, North Carolina

Project ID No. 010559701

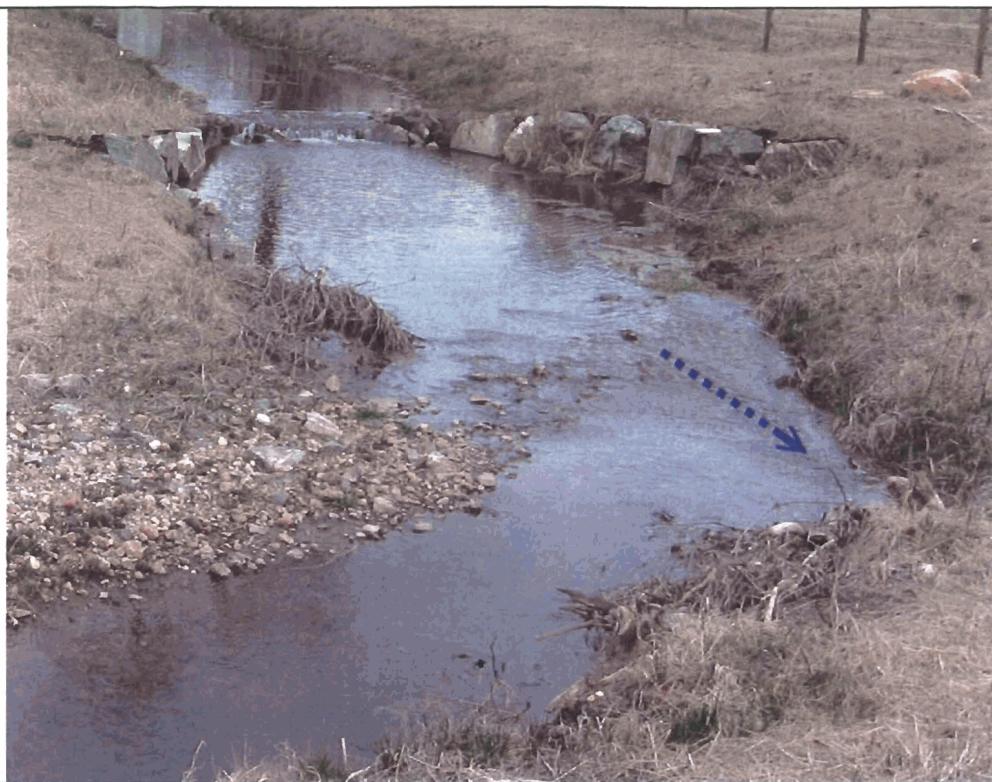
Feature Issue	Reach	Station numbers	Description	Suspected Cause	Photo number
Aggradation/Bar Formation	--	--	--	--	--
	--	--	--	--	--
Bank scour	1	305+91	Potential for scour from transverse bar	--	SP01
	1	312+32	Potential for scour from transverse bar	--	--
Engineered structures – back or arm scour Etc.	4	67+66	Minor piping in lower cross of A-Vane	Various Possibilities: Temporary loss of backing fabric or fill materials	--
	4	68+41	Minor piping in lower cross of A-Vane		--
	--	--	--	--	--

Photograph SP1 – Transverse bar directing flow into outside pool bank downstream..
