**RACEY MITIGATION SITE ON LAXON CREEK,
WATAUGA COUNTY**

Year 5 Monitoring Report

Period Covered: July 31, 2005 - June 27, 2006

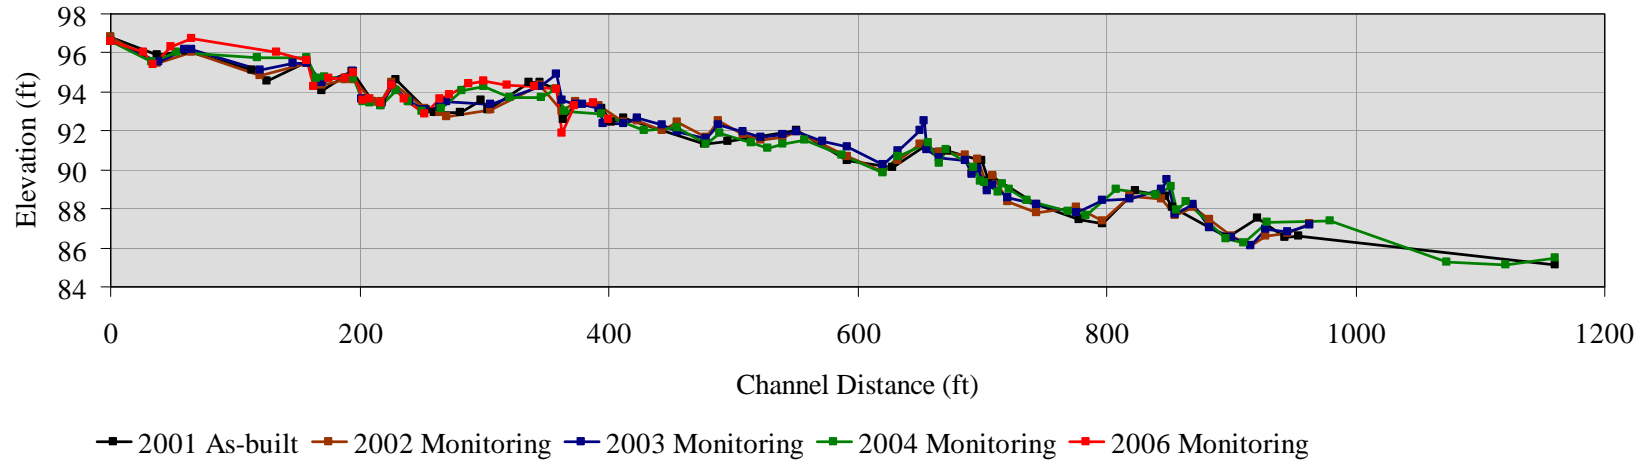
Prior longitudinal profile survey data indicated little change in the channel thalweg (Figure 2). Visual observations prior to the 2006 longitudinal profile survey revealed the channel had changed little from previous surveys; therefore a decision was made to collect longitudinal

profile data only from station 0+0 to 4+00; approximately one-third the project length (Figure 2). The remaining portion of the channel was to be surveyed if the data showed a significant change in the channel thalweg. There was no appreciable change in the profile of this section between 2001 (as-built) and 2002; however, in 2003 beavers constructed dams at stations 1+58, 3+58, 6+53, and 8+58. These dams were subsequently washed out during the flood events associated with a series of hurricanes in 2004. The 2006 data reveals minor changes in stream bed elevation at stations 0+48 to 1+58 and 2+64 to 3+40 that can be attributed to sediment being deposited behind the beaver dams. It should be noted that the 2001 and 2002 longitudinal profile surveys ended at station 9+23 because little construction activity occurred between this point and the confluence of the South Fork New River. Comparison of the 2006 data with previous years indicates that the minor changes in the longitudinal profile are the result of normal storm events and not the result of stream enhancement activities.

FIGURE 2.—Longitudinal profile comparisons for 2001-2004 and 2006, Racey mitigation site, Laxon Creek, Watauga County. It should be noted that the 2001 and 2002 longitudinal profile surveys ended at station 9+23 because little construction activity occurred between that point and the confluence with the South Fork New River.

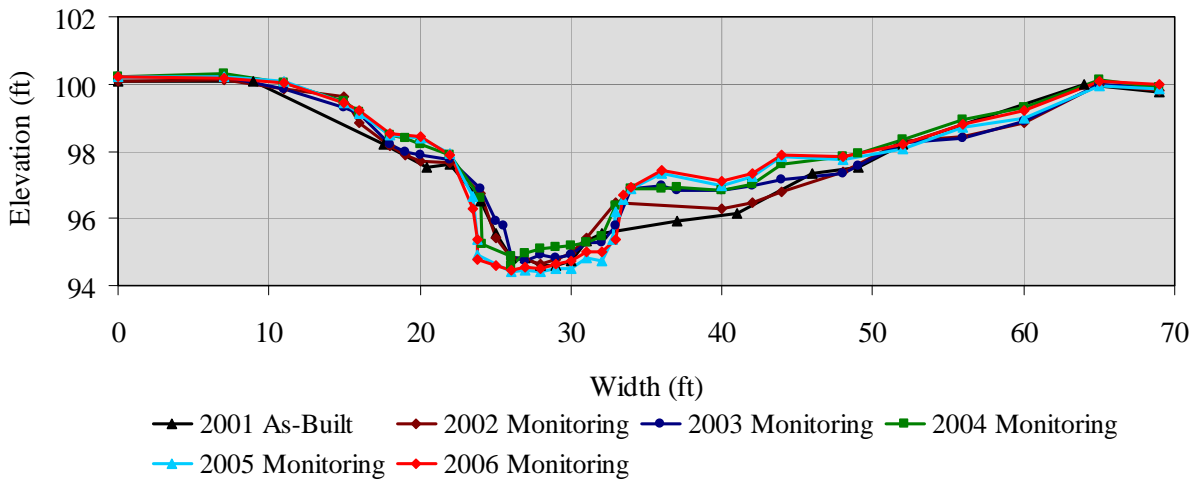
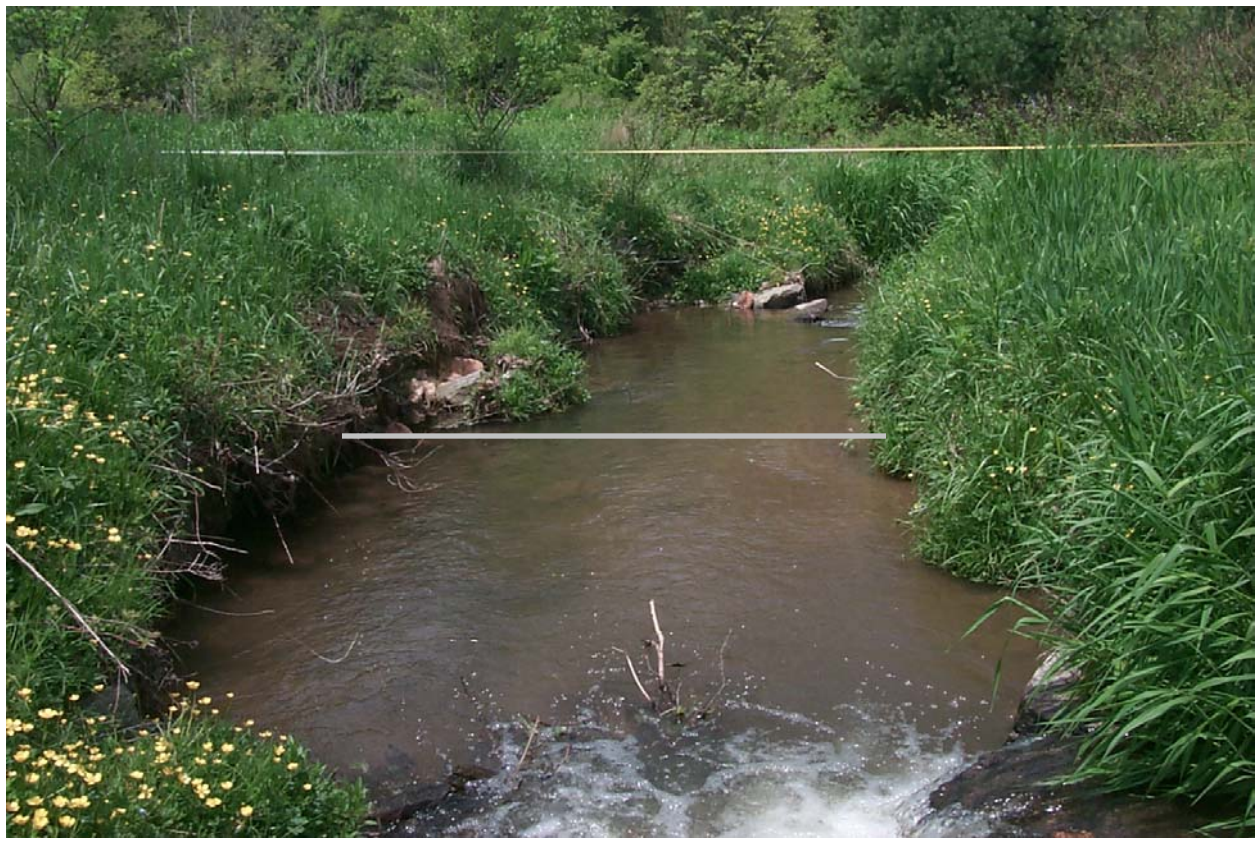
FIGURE 3.1.—Cross-section 1+88, run.

CROSS-SECTION 1+88 – run (Figure 3.1): This cross-section is located just above a root wad. There has been little change in the cross-section from 2001 through 2006. The thalweg deepened and the channel widened slightly following the three September 2004 hurricanes; in spite of this the banks are stable and well vegetated.

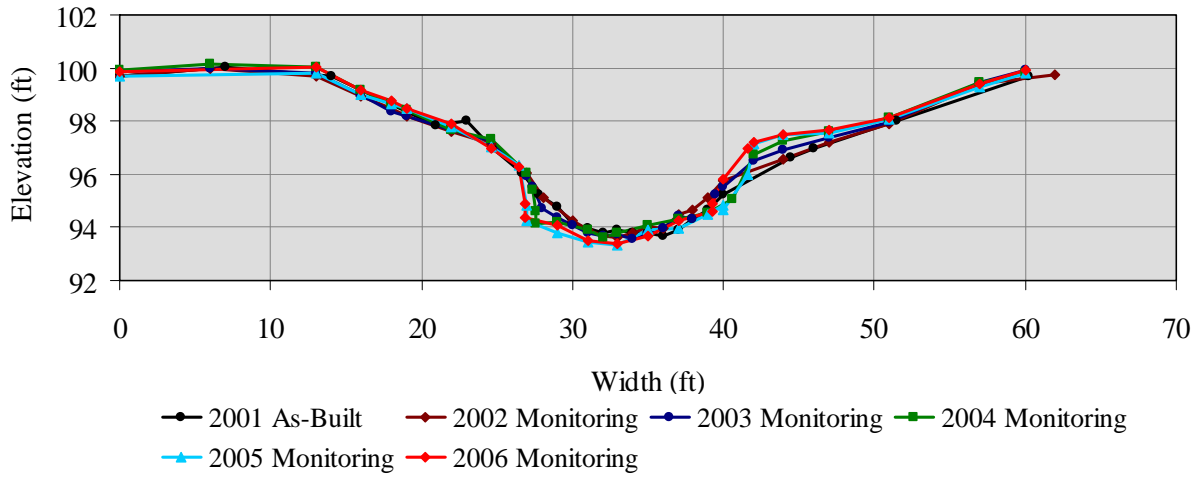
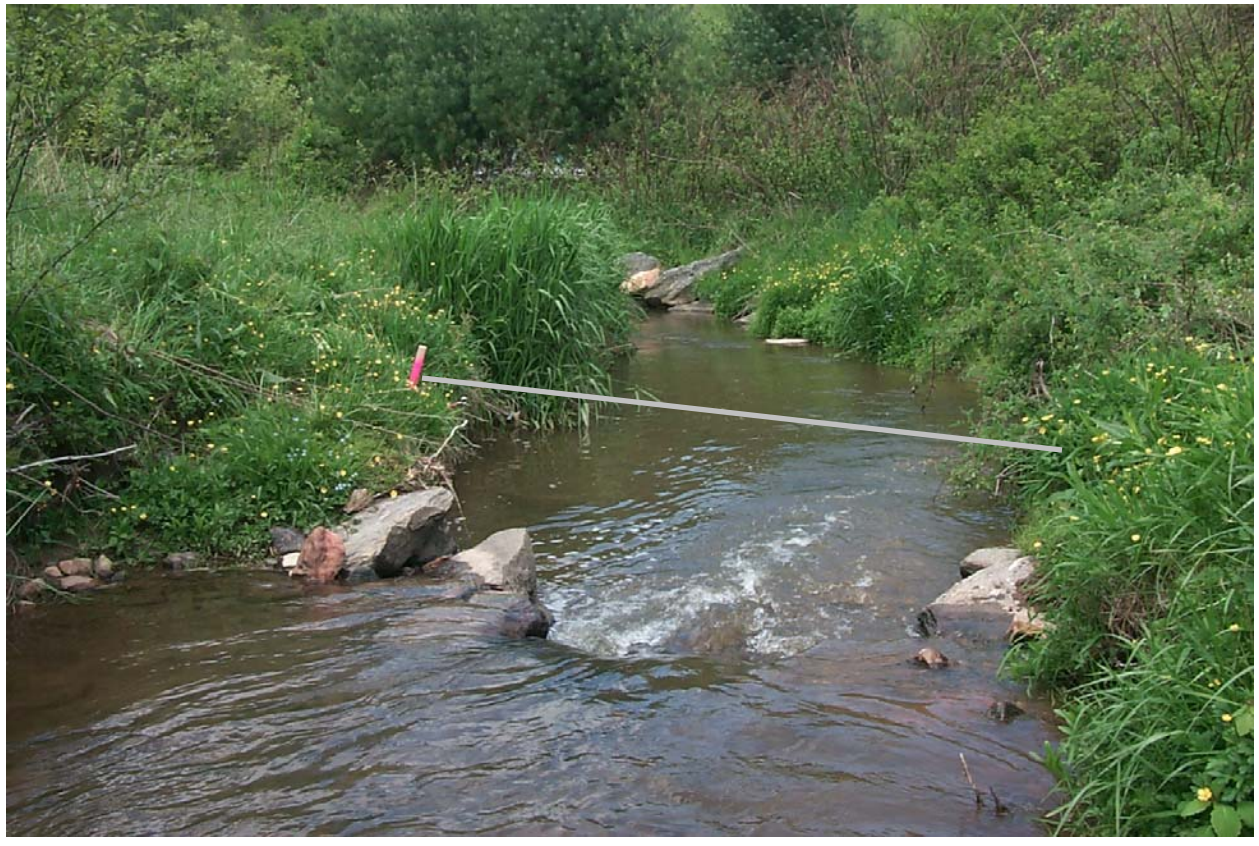
FIGURE 3.2.—Cross-section 2+08, pool.

CROSS-SECTION 2+08 – pool (Figure 3.2): This cross-section is located over the middle of a pool just below a rock weir and has changed little over time. The thalweg has remained stable compared with the 2005 data, but has deepened when compared to the as-built through 2004 measurements. Although the channel widened slightly following the three September 2004 hurricanes, the banks are stable and well vegetated.

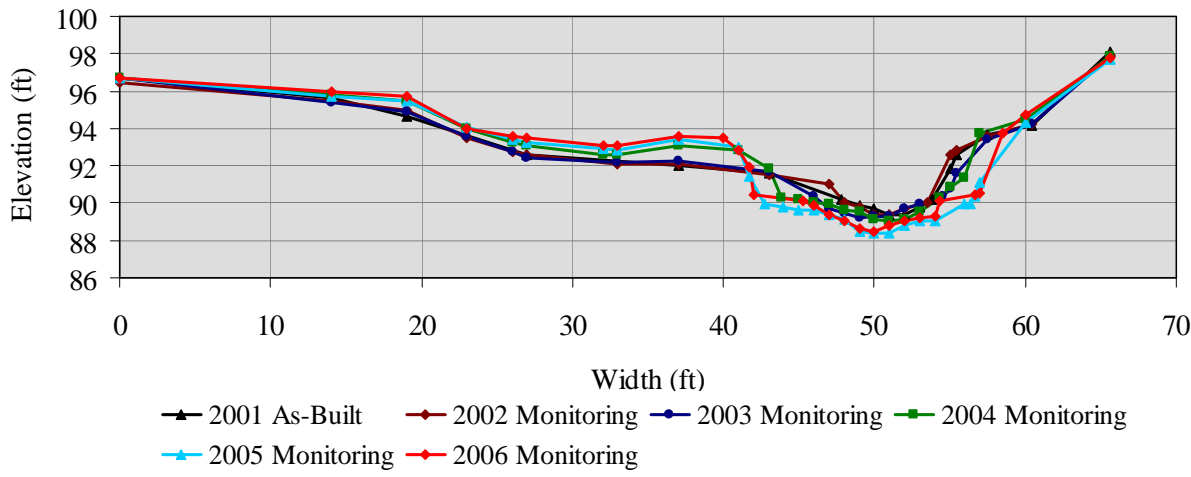
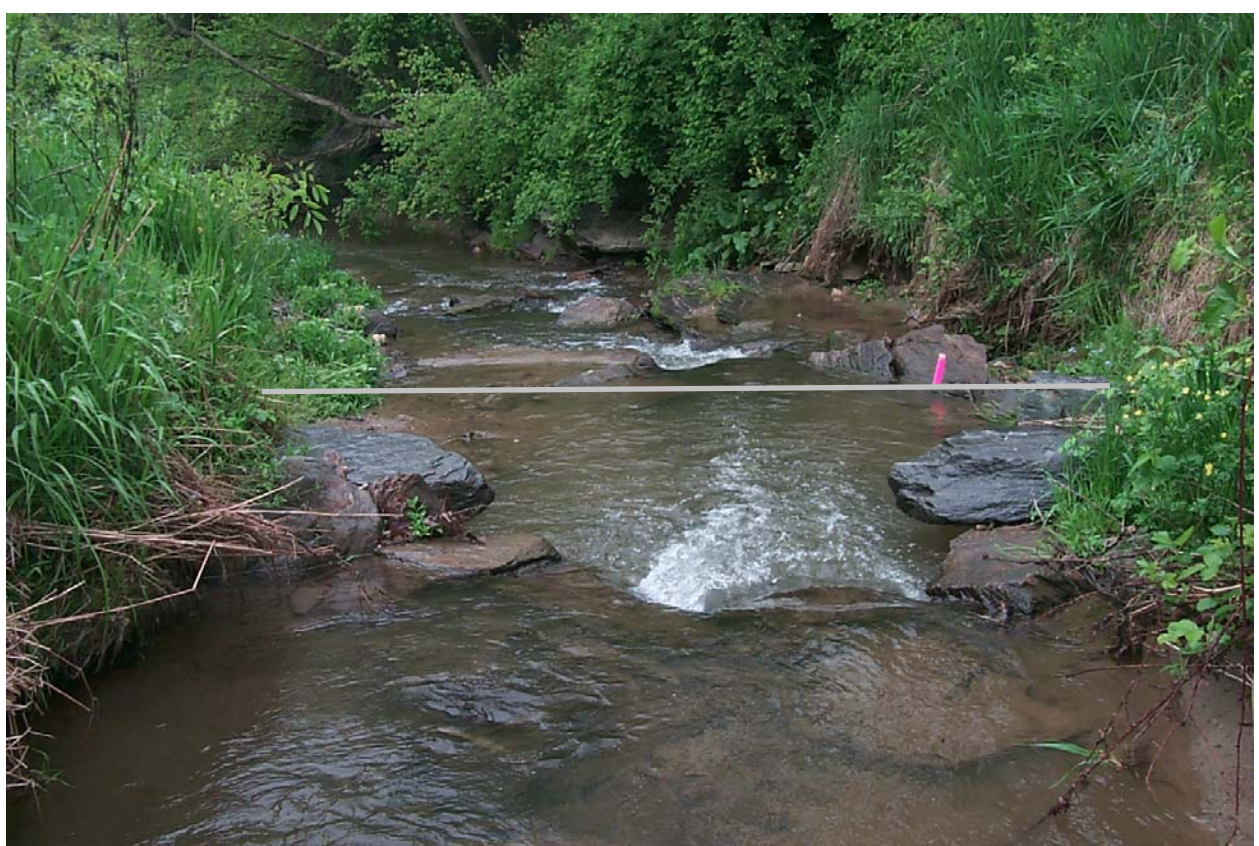
FIGURE 3.3.—Cross-section 7+13, step pool.

CROSS-SECTION 7+13 – step pool (Figure 3.3): This cross-section is located between two rock weirs. The thalweg has deepened since the 2001 as-built survey was completed. The streambanks are stable and well vegetated. While the banks are stable, the steep right bank should be monitored for potential bank erosion problems. Overall this cross-section is stable.

The steep right bank at cross-section 7+13 and the central bar below cross-section 8+40 should be monitored annually for bank erosion problems. The interpretation of the five years of monitoring data, the fact that there have been no major failures to the structures or streambanks, and the continuing growth of the dense riparian vegetation suggests that the stream reach at the Racey site is stable, and needs no further detailed monitoring. It is our recommendation that this site be considered stabilized and released from further monitoring. Furthermore, we recommend NCDOT be awarded 1,160 mitigation credits (1:1 ratio) for this site as approved by NCDWQ (NCDWQ letter to the NCWRC dated November 6, 2000).

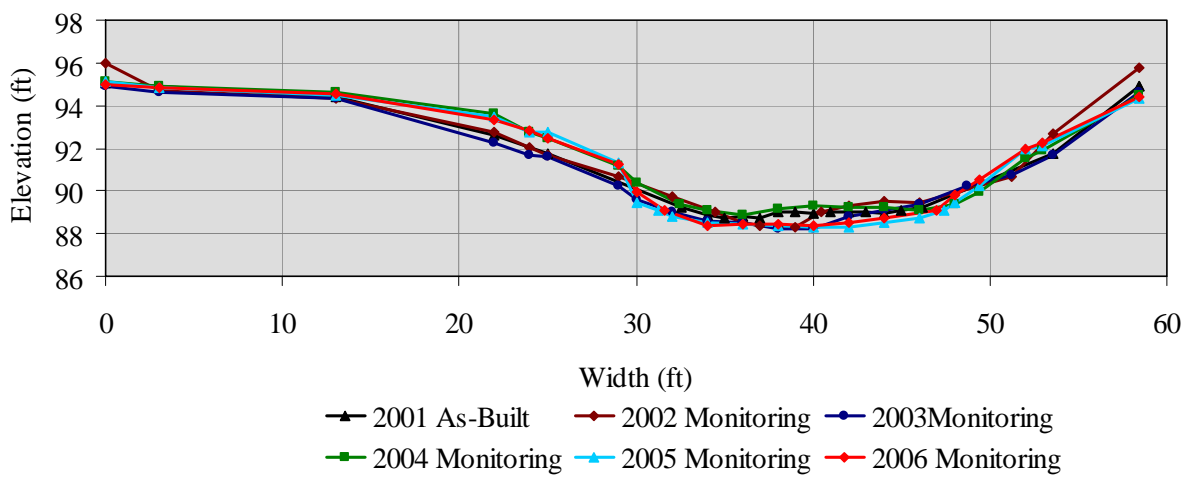
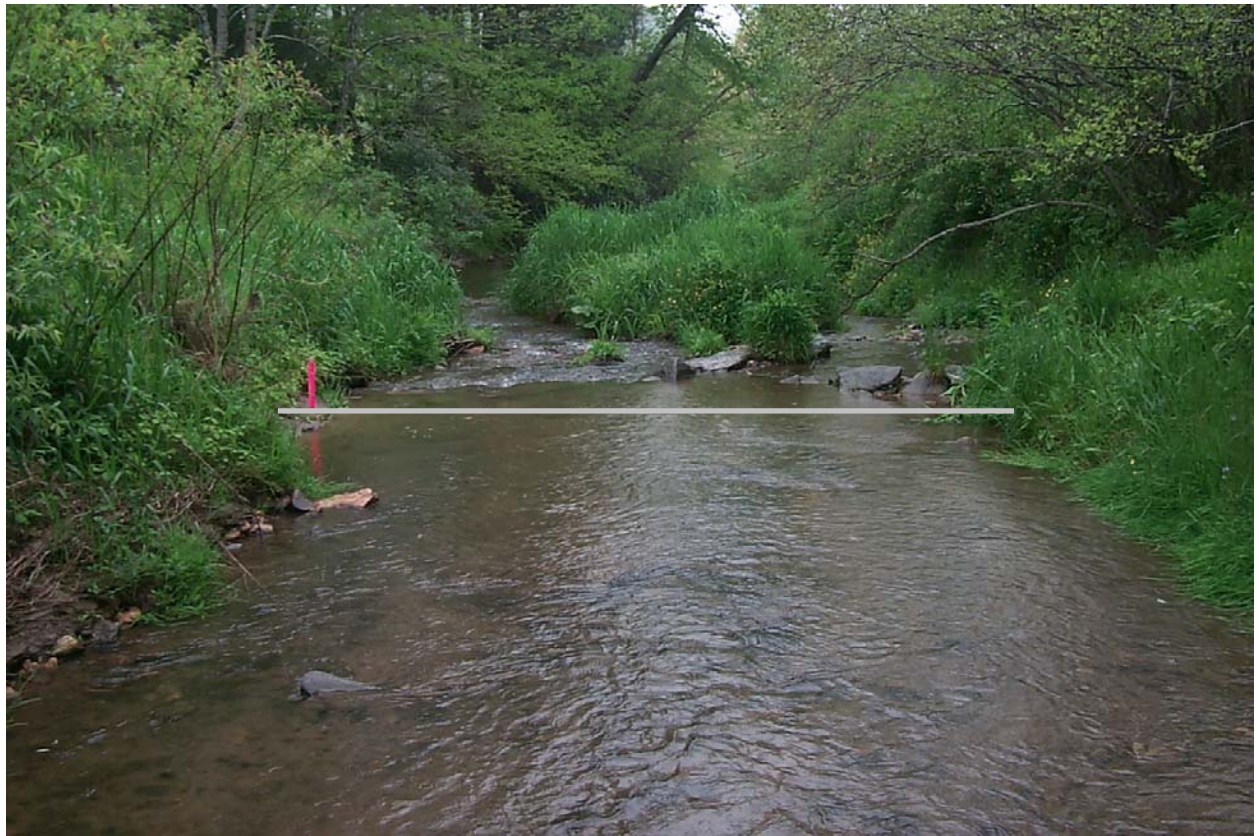
FIGURE 3.4.—Cross-section 8+40, run.

CROSS-SECTION 8+40 – run (Figure 3.4): The thalweg has deepened since the as-built survey was completed. Both streambanks are aggrading as the vegetation continues to grow and trap sediment (silt, sand, and small gravel). The stream channel at this cross-section has remained stable throughout the five years of monitoring.

Immediately below cross-section 8+40 the left bank has migrated slightly and a central bar has developed creating a separate channel along the right bank. These channel adjustments are

the direct result of beaver activity during 2003-2004. While both banks are well vegetated and stable, there is the potential risk of bank erosion developing along the right bank should the central bar continue to grow. This location should be monitored for bank erosion problems.

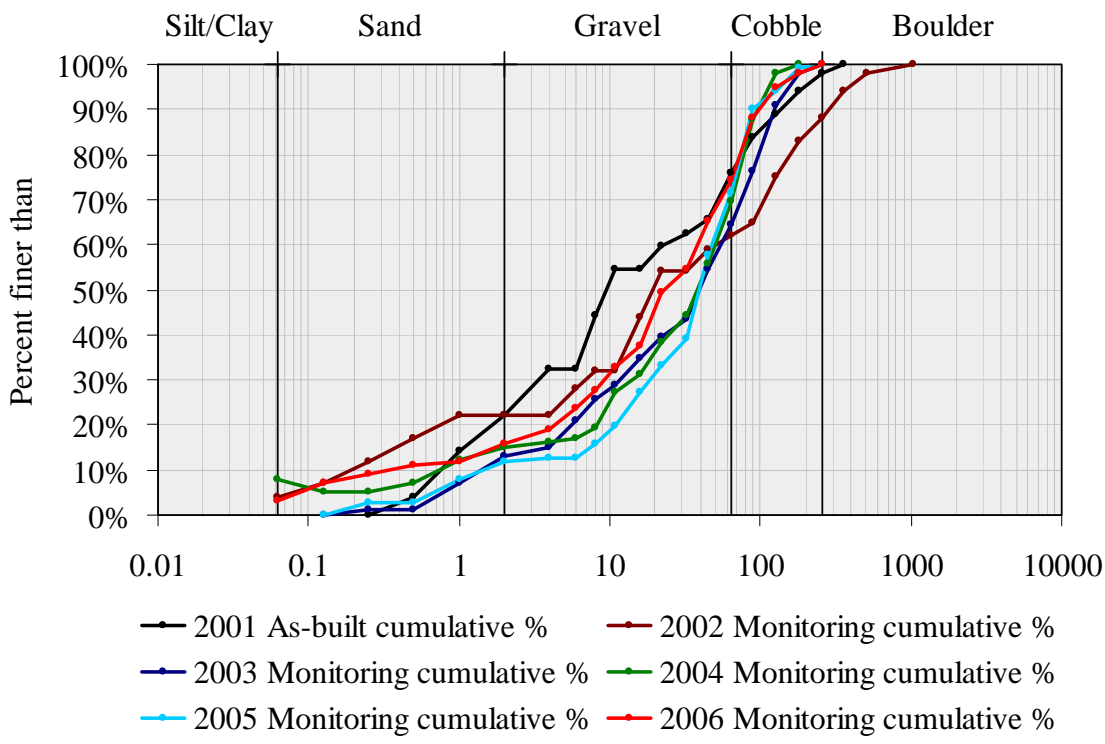
FIGURE 4.—Pebble count data comparisons, Racey mitigation site, Laxon Creek, Watauga County, 2001-2006.

Pebble count data were collected from a riffle at cross-section 1+88 (Figure 4). Pavement analysis trends remained consistent from 2003 to 2005. In 2006 there was a slight downward trend for all particle sizes except for the D_{84} . Since 2001 the D_{50} cumulative distribution has ranged in size from medium gravel (9.5 mm) to very coarse gravel (39.0 mm) to course gravel (23.0 mm) (Figure 4). Fluctuations in particle size are normal and can be attributed to sampling bias, flood events, and sediment being transported from disturbed land higher in the watershed. These changes are not significant enough to show any trends or negative impacts.

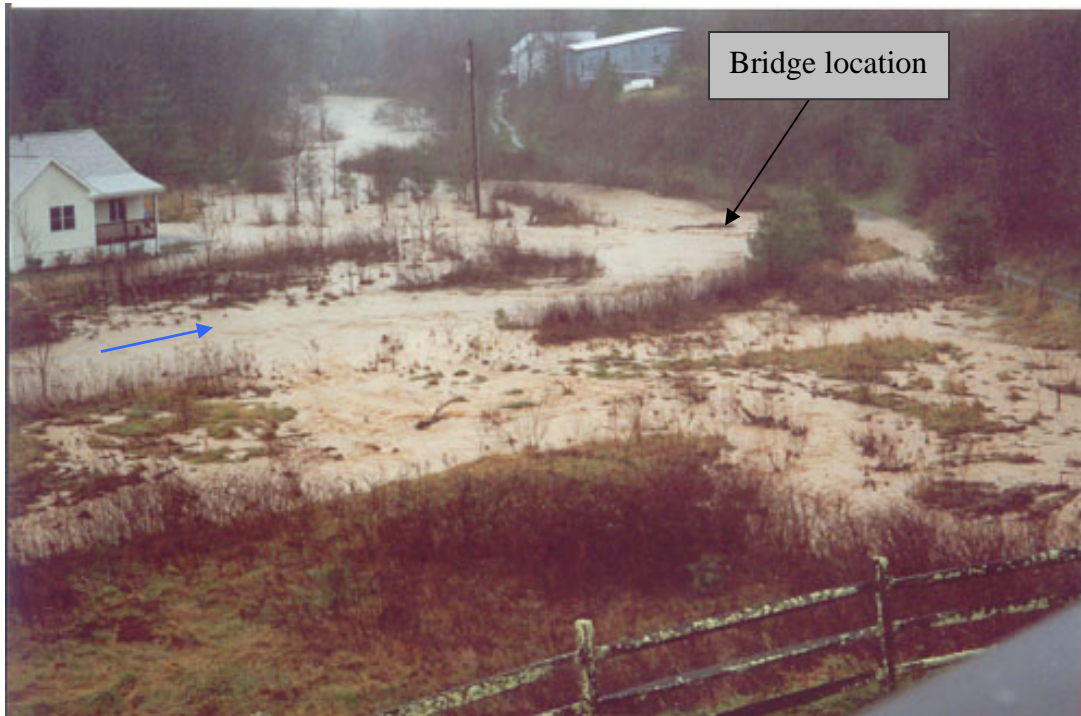
A major flood event occurring on November 19, 2003 resulted in some minor damage to the rock crossvane at station 3+57 (Appendix 4). Damage to the structure occurred after a ford crossing was replaced with a bridge by the landowner in 2002 (construction of a bridge at this location was permitted in the conservation easement). Flood waters crested the bridge and lateral movement of flood waters was constricted by the bridge abutments. This constriction resulted in the flood waters creating an upward current under the crossvane boulders, causing the structure to fail. Under normal flood conditions water would have flowed over the structure, holding it in place. This structure, along with some minor bank damage immediately downstream from the site, was repaired on February 25, 2004. These repairs have been the only ones required at this site since construction was completed on November 3, 2000 (Mickey and Scott 2001).

APPENDIX 4. Overview photograph showing the location of the bridge at longitudinal profile station 3+57 during the November 19, 2003 flood event on Laxon Creek, Watauga County. The rock crossvane at this location was damaged during the flood and had to be repaired. Photograph courtesy of Dr. Jana Carp.
