**Paschal Golf Course (Richland Creek)
Stream Restoration Monitoring Report
DMS Project # 276
DMS Contract # 004927
Monitoring Year 05**

Construction Completed: May 2010

Data Collection: August 2016

Submitted: November 2016

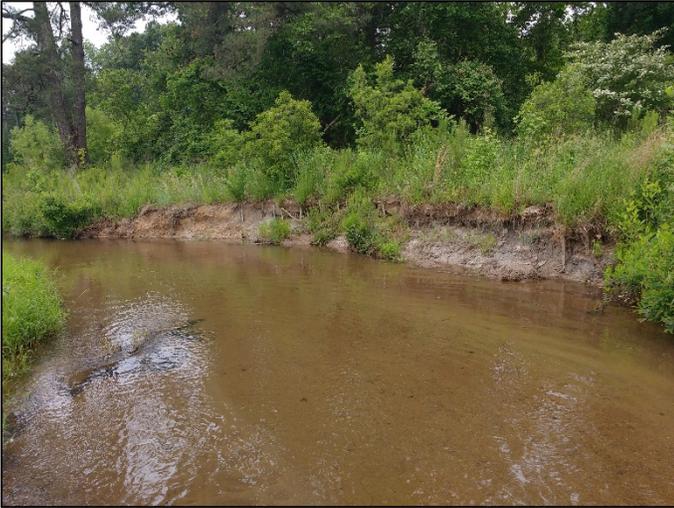
Fifth-year monitoring found Richland Creek to be mostly stable, with only minor changes from the baseline conditions. The stream has two areas of localized bank erosion near stationing 14+50 and 26+15. All other areas of erosion or mass wasting reported in previous years' reports were repaired in March 2016. Several beaver dams were noted during the 2016 monitoring. As of the end of year site visit on 11/28/16, two beaver dams are present at stationing 13+40 and 16+90. The longitudinal and cross-sectional data also reflect the overall stability in the project streams. As a part of the stream success criterion, the stream must experience at least two bankfull events, each in separate monitoring years. The site has experienced multiple bankfull events since construction.

Bank Erosion Station 14+50– 5/17/16

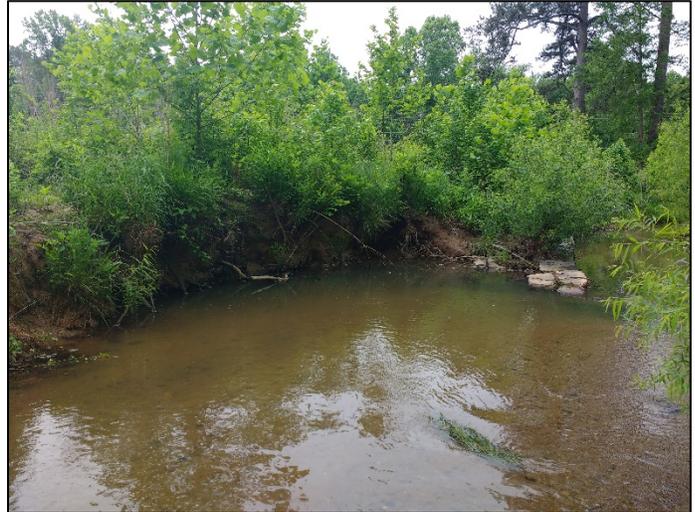
Bank Erosion Station 26+15 – 5/17/16

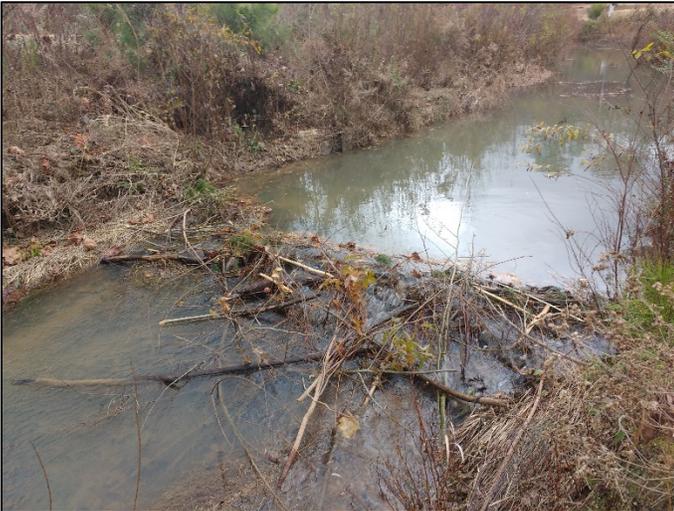
Beaver Dam Station 13+40 – 11/29/16

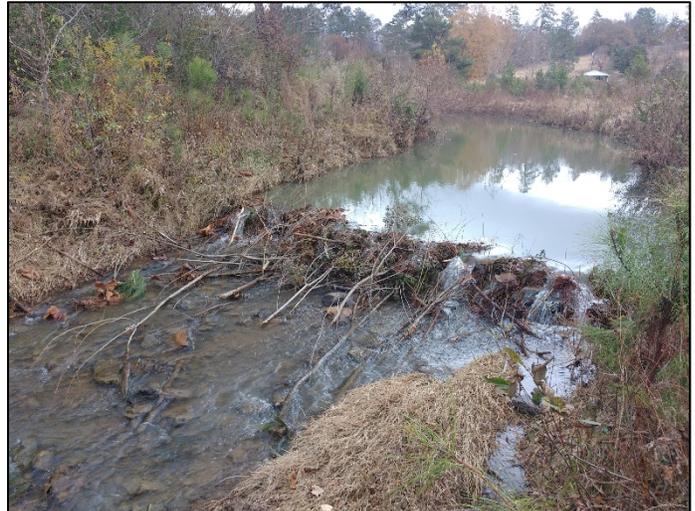
Beaver Dam Station 16+90 – 11/29/16

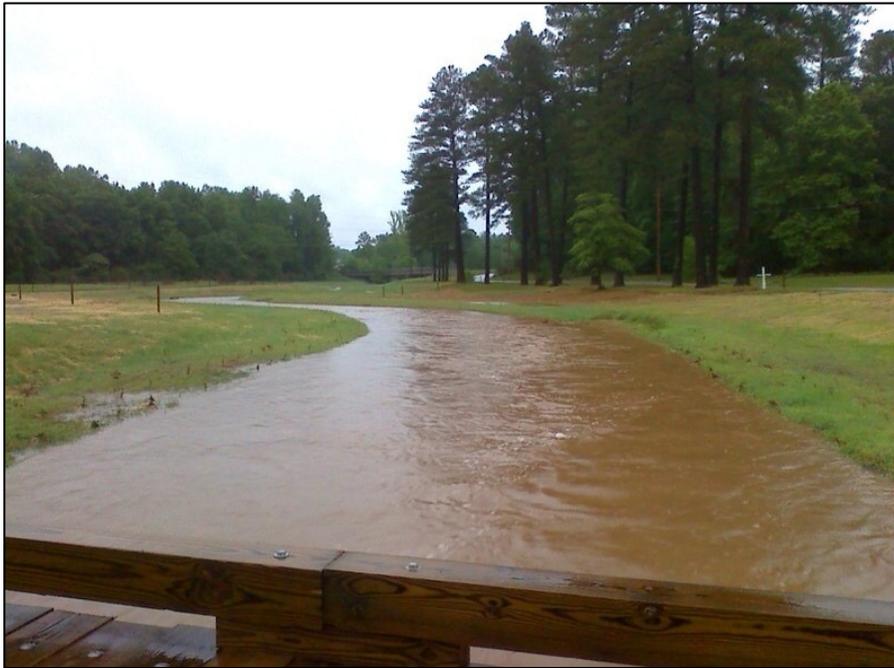
Photo #1 - Bankfull Event, 5/17/2010

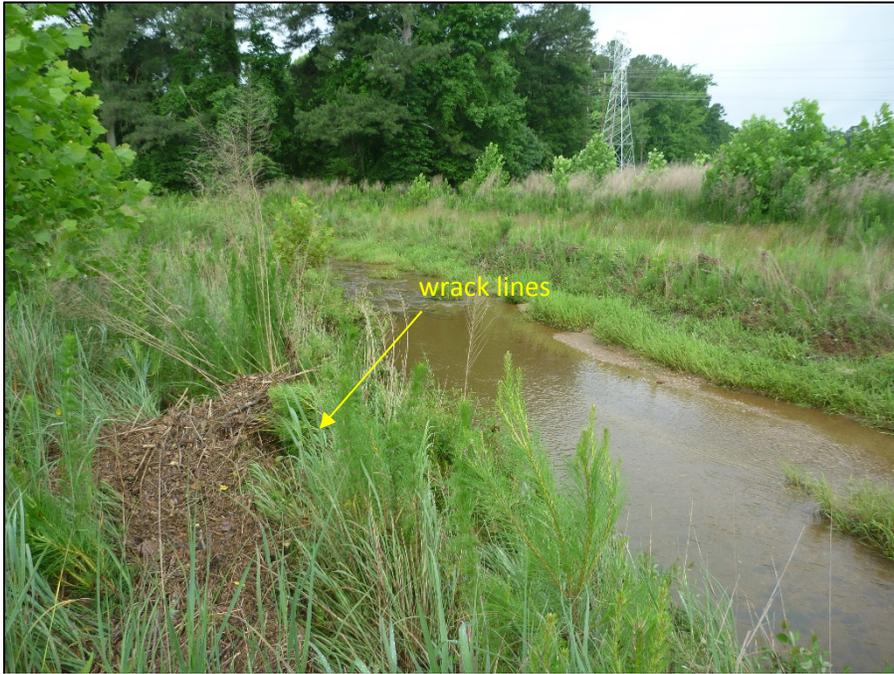
Photo #2 – Bankfull Evidence (wrack lines), 6/10/2013

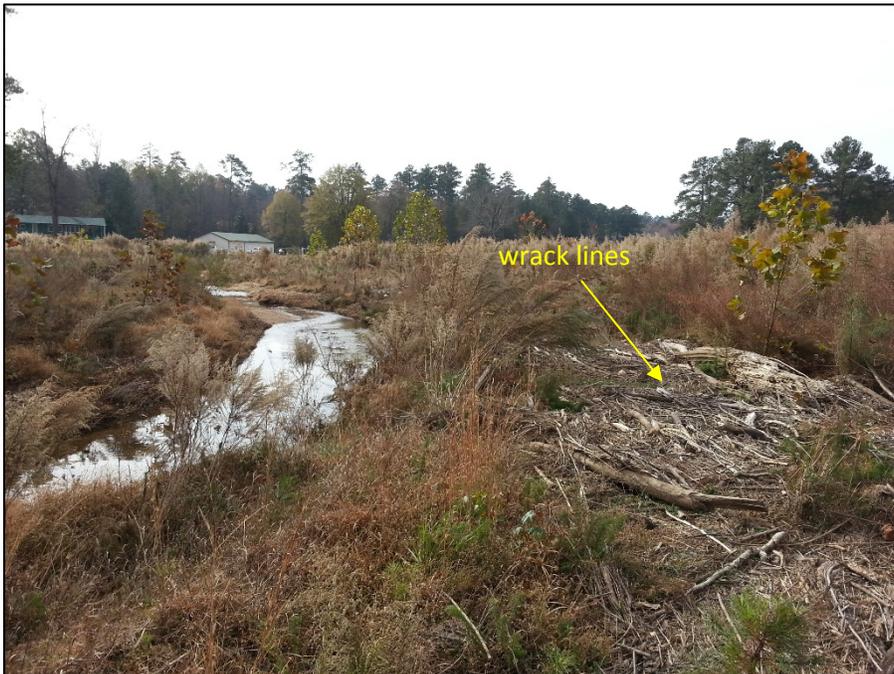
Photo #3 – Bankfull Evidence (wrack lines), 11/15/2013

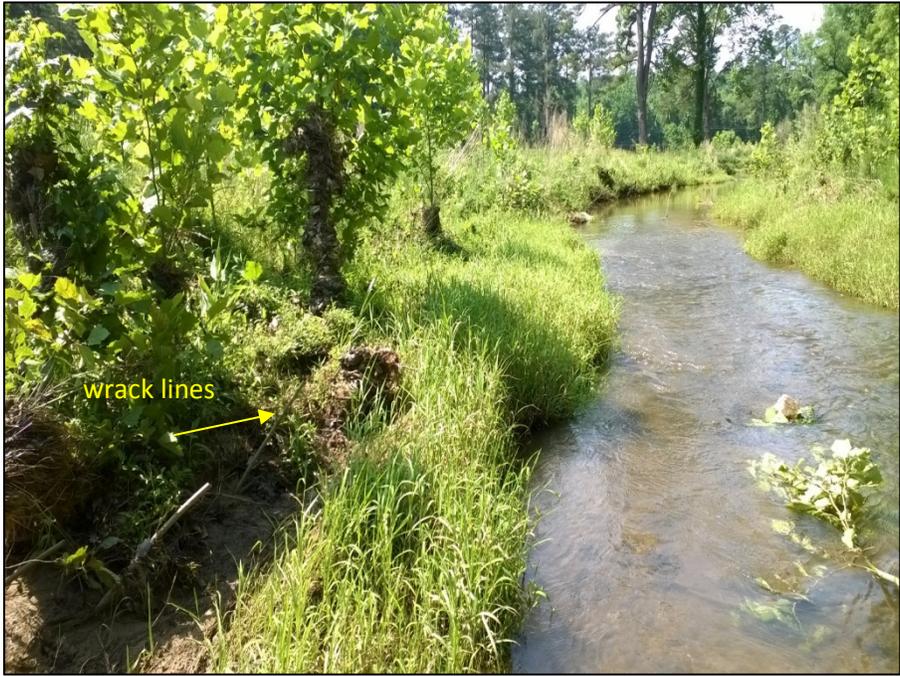
Photo #4 – Bankfull Evidence (wrack lines), 5/28/2014

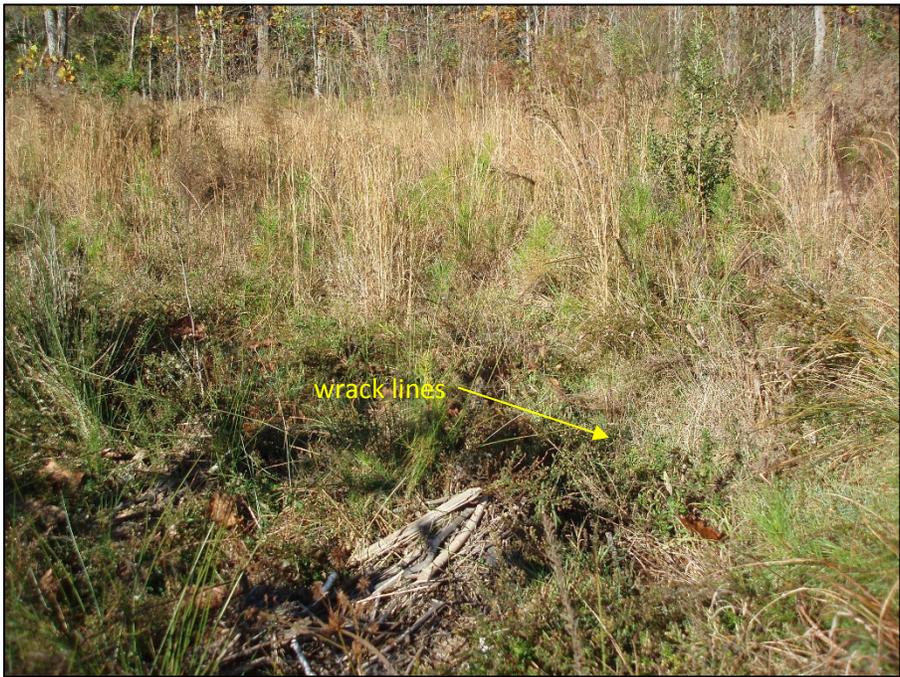
Photo #5 – Bankfull Evidence (wrack lines), 11/10/2014

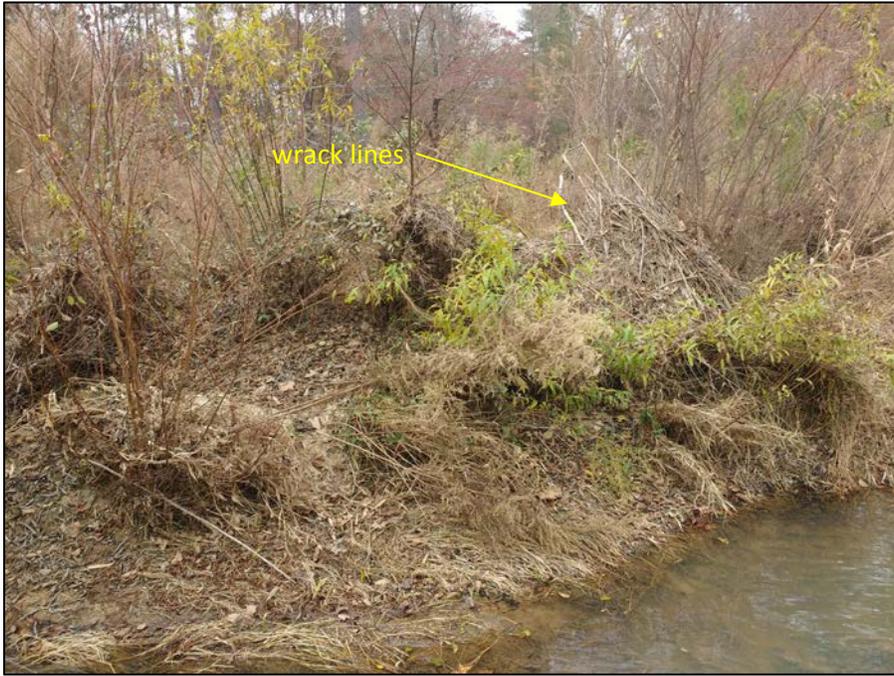
Photo #6 – Bankfull Evidence (wrack lines), 11/29/2016
