**Monitoring Year 4 Report**  
**Final**  
**2023**

**Rough Horn Swamp Restoration Site**  
**Monitoring Year – MY04**

**Rough Horn Swamp II Restoration Site**

**Columbus County, North Carolina**

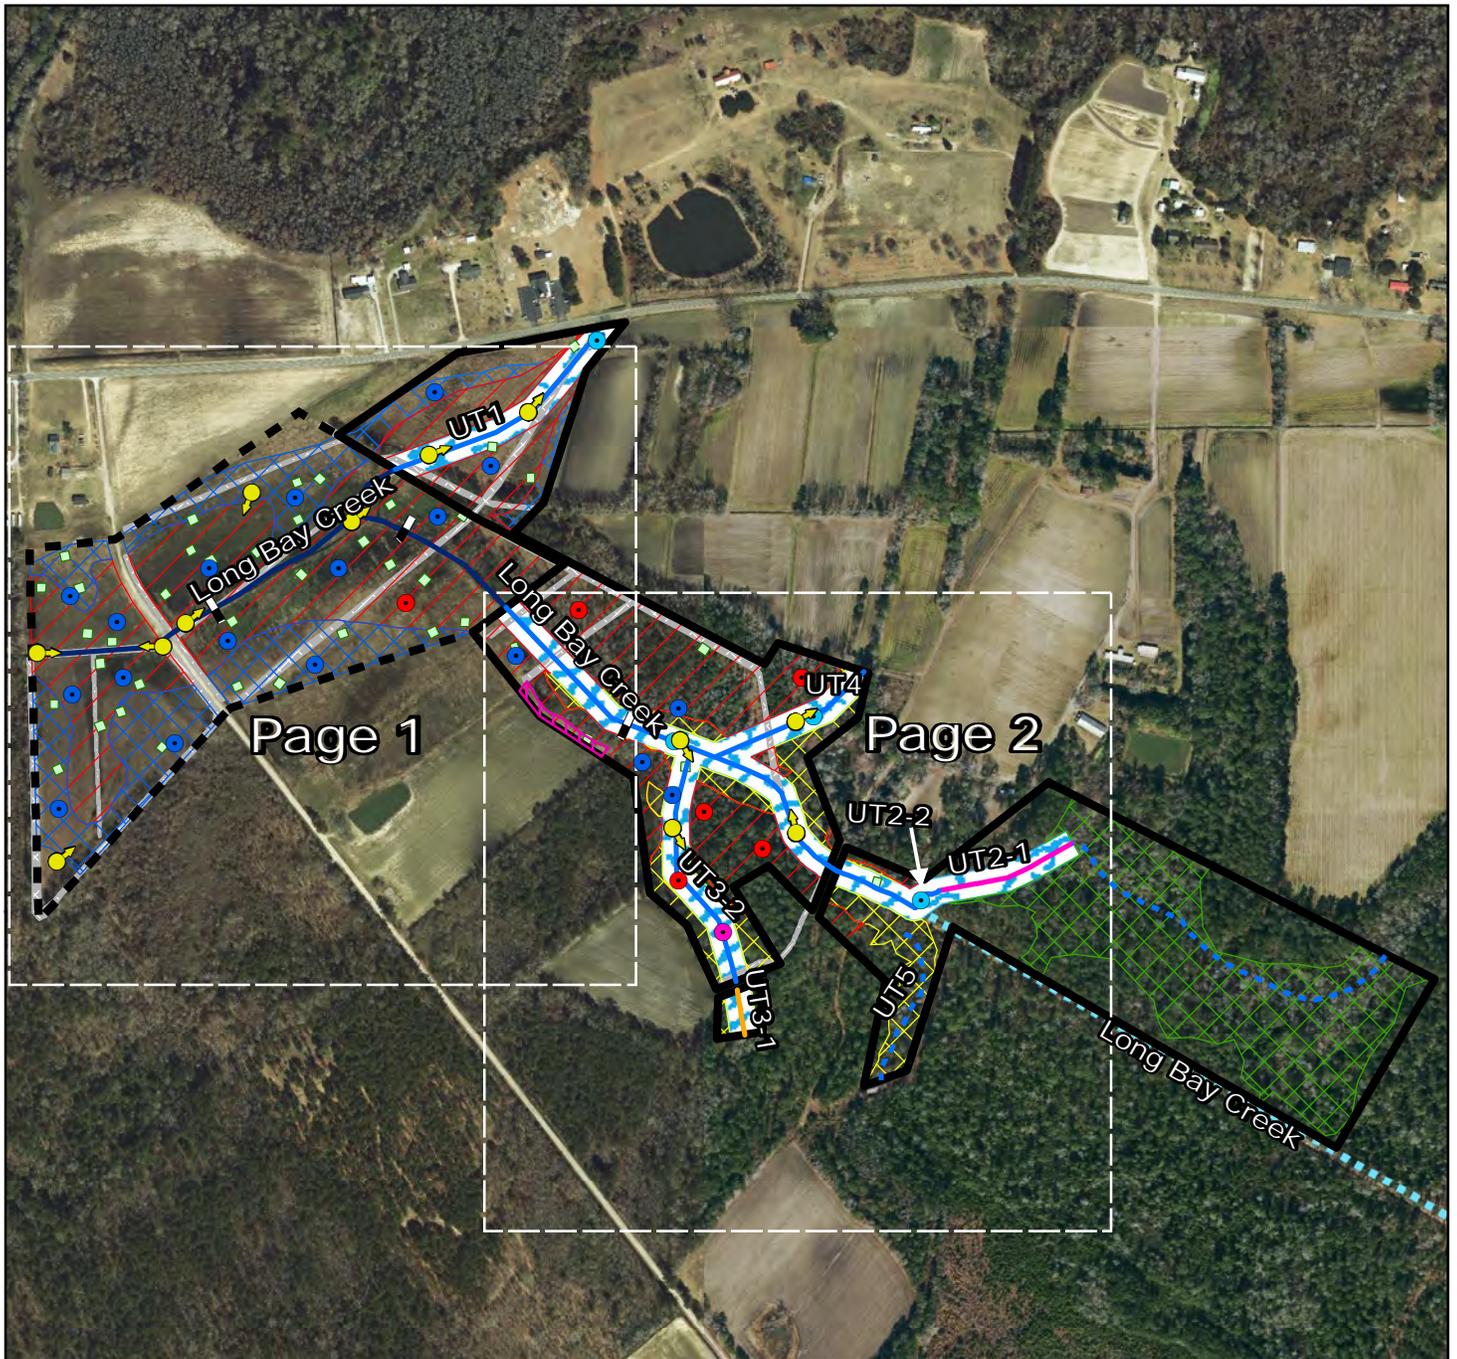
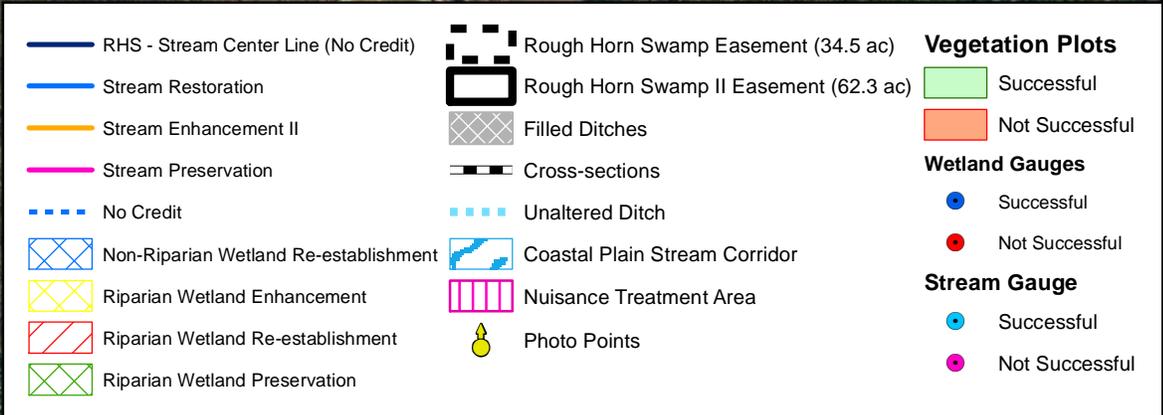
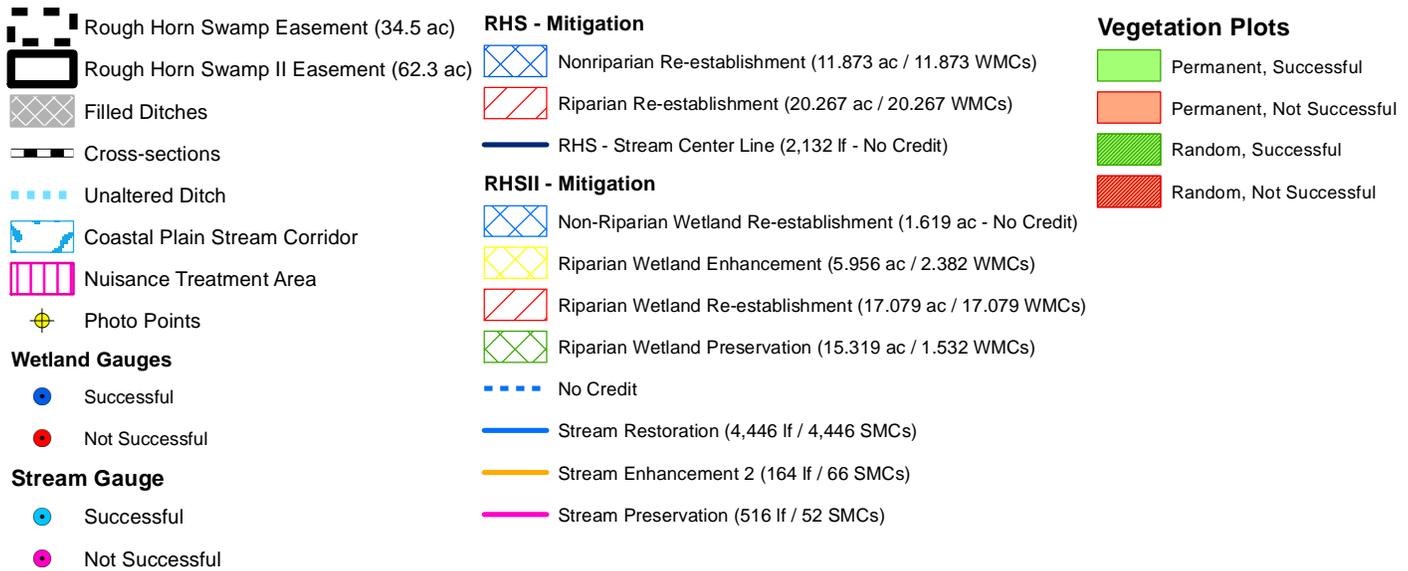
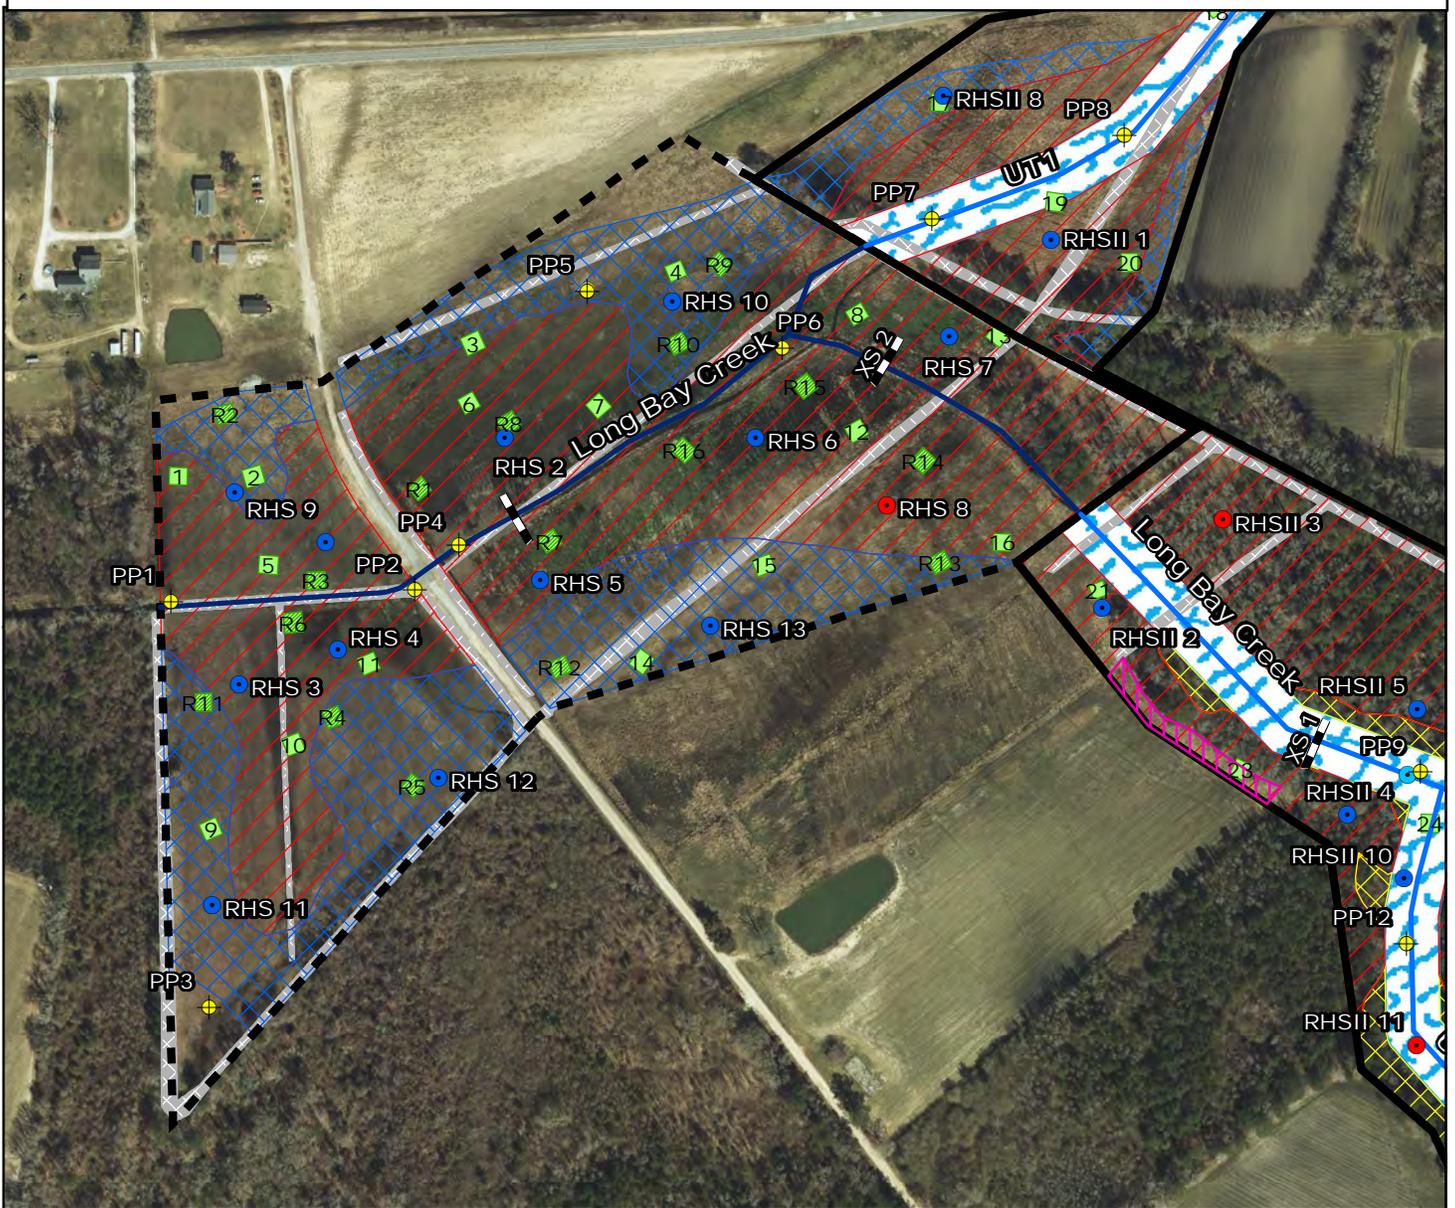
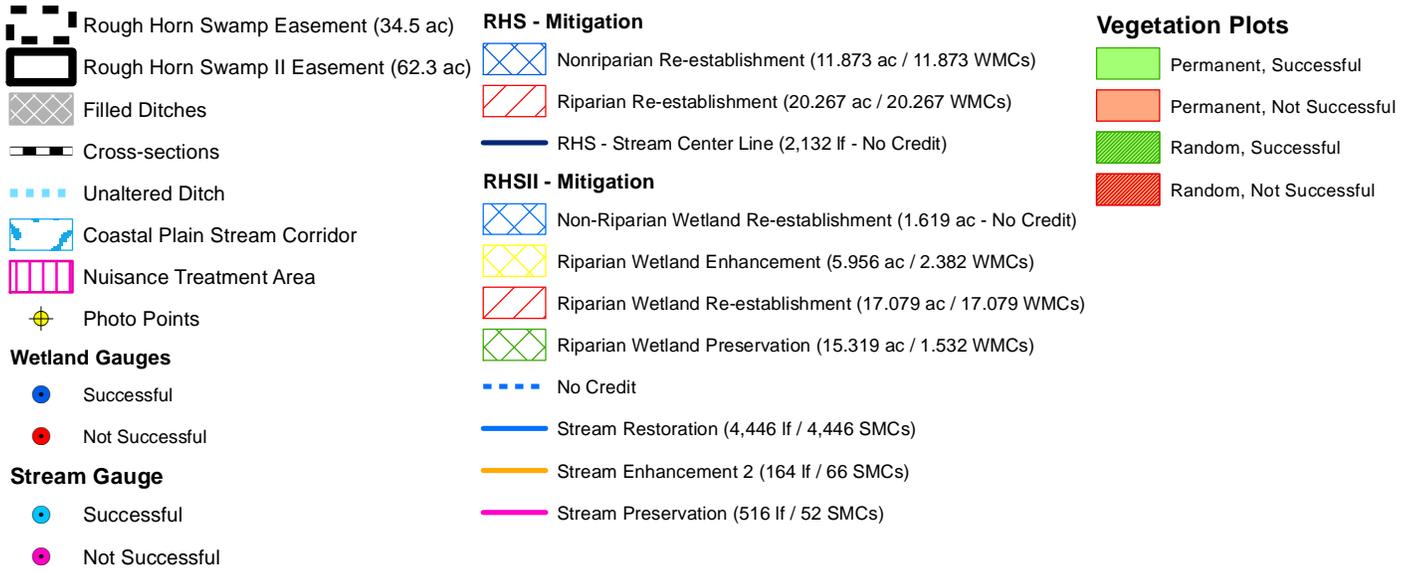
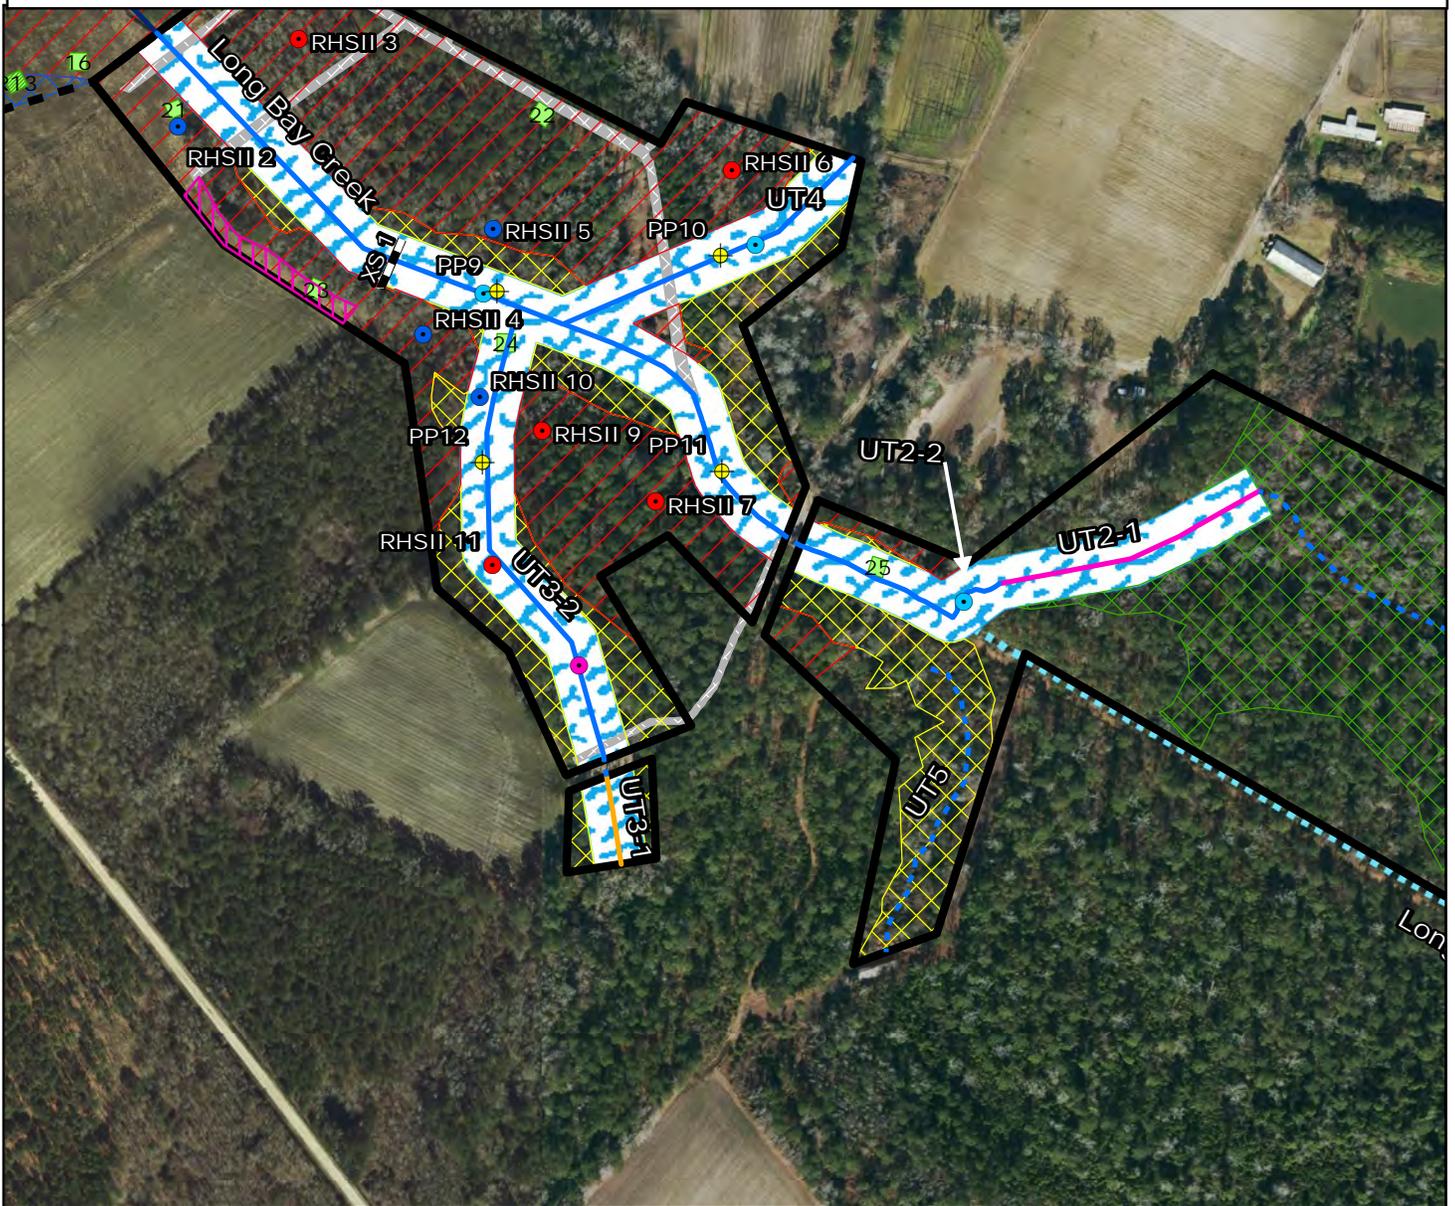
**CURRENT CONDITIONS PLANVIEW  
ROUGH HORN SWAMP RESTORATION SITE &  
ROUGH HORN SWAMP II RESTORATION SITE  
COLUMBUS COUNTY, NC**

3. CCPV: Please update groundwater gauge color coding to match MY4 data. Ex: RHSI 11 met criteria, but it's shown as not meeting.  
*KCI Response: This error has been corrected.*

4. CCPV: Please label RHSII 9.

*KCI Response: This has been corrected.*

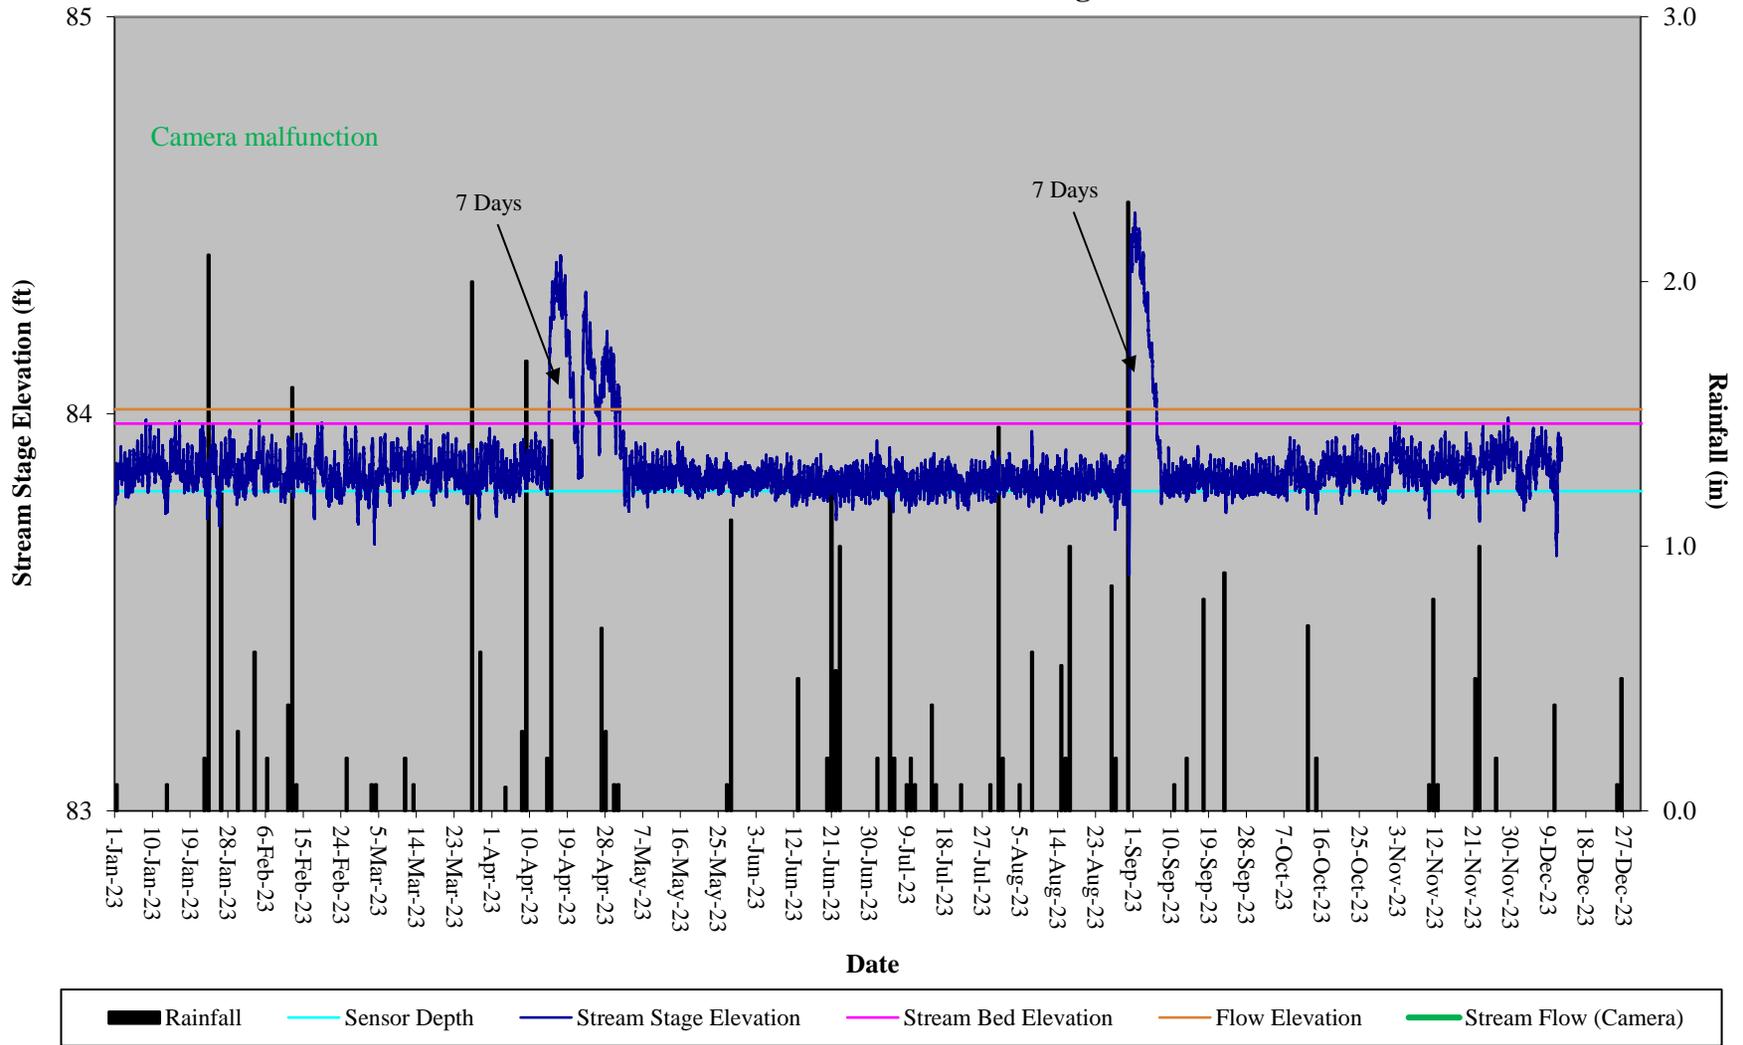
# Rough Horn Swamp Restoration Site Hydrograph UT3 Stream Flow Gauge

After recording 71 and 98 days of flow during MY01 and 02, the gauge on T3 has failed to meet the success criteria in the past two years (recording 0 days in 2022 and 7 days in 2023). KCI believes that the lack of flow that this reach has experienced is a result of the very low amount of rainfall that the site received in 2022 and the inconsistent rainfall received in 2023. According to the Army Corps of Engineers' Antecedent Precipitation Tool, the site experienced "drier than normal" conditions from August 2021 until January 2023, with one brief period of "normal conditions" from mid-December 2021 until mid February 2022. This extended period of drier than normal conditions led to the water table being depleted and the stream drying up. This trend was reflected in the wetland gauges, which experienced much lower rates of success than in the first two years. After a brief period of "wetter than normal" conditions in February 2023, the site returned to "drier than normal" conditions for the month of March. It then remained under normal conditions for most of the rest of the year, with a period of "drier than normal conditions" in late May/early June, and a longer period of "drier than normal conditions" for all of October and most of November. While the extended periods of normal conditions that the site saw in 2023 allowed the water table to begin recharging, as reflected by the sporadic periods of flow that T3 saw, the intervening periods of "drier than normal" conditions prevented it from fully recharging from the extremely dry conditions it experienced last year. KCI is hopeful that with continued and sustained periods of normal conditions, the stream will return to the levels of flow seen during the first two monitoring years. At a meeting with the IRT to evaluate this reach on July 14, 2023, the IRT acknowledged that the T3 stream corridor showed evidence of previous flow events and appeared to have the appropriate geomorphology for the designed system, while also

expressing concern at the lack of flow. KCI will continue to monitor this area closely heading into the fifth growing season.

UT3	MY01 (2020)	MY02 (2021)	MY03 (2022)	MY04 (2023)	MY05 (2024)	MY06 (2025)	MY07 (2026)
Max consecutive days channel flow	71	98	0	7			
Presence of litter and debris (wracking)	Yes	Yes	No	No			
Leaf litter disturbed or washed away	No	No	No	No			
Matted, bent, or absence of vegetation (herbaceous or otherwise)	Yes	Yes	No	No			
Sediment deposition and/or scour indicating sediment transport	No	No	No	No			
Water staining due to continual presence of water	Yes	Yes	No	No			
Formation of channel bed and banks	No	No	No	No			
Sediment sorting within the primary path of flow	No	No	No	No			
Sediment shelving or a natural line impressed on the banks	No	No	No	No			
Change in plant community (absence or destruction of terrestrial vegetation and/or transition to species adapted for flow or inundation for a long duration, including hydrophytes)	No	No	No	No			
Development of channel pattern (meander bends and/or channel braiding) at natural topographic breaks, woody debris piles, or plant root systems	Yes	Yes	No	No

At the July 14, 2023 meeting with the IRT, it was recommended that additional groundwater gauges should be installed within the 100 foot wide T3 stream corridor to monitor the water table as it recharges and to provide additional data if flow does not return and it is necessary to convert this portion of the site to wetland credits. It was also recommended that an additional gauge be installed in the vicinity of Gauge RHII-7, which has only achieved the success criteria in one out of the four monitoring years. These gauges were installed on August 1, 2023, with two (RHII-10 and RHII-11) within the T3 stream corridor and one (RHII-9) approximately 250 feet northwest of RHII-7. Because they were installed so late in the growing season, they did not capture what is typically the wettest part of the year, and so only RHII-10 (on the lower portion of the T3 stream corridor) achieved the success criteria in 2023.
