Russell Gap Stream Mitigation Project Year 4 (2023) Monitoring Report FINAL

DMS Project ID No. 100003, DEQ Contract No. 6980

Alexander County, North Carolina, Catawba River Basin: 03050101-120010

MY4 Data Collection Period: January – October 2023

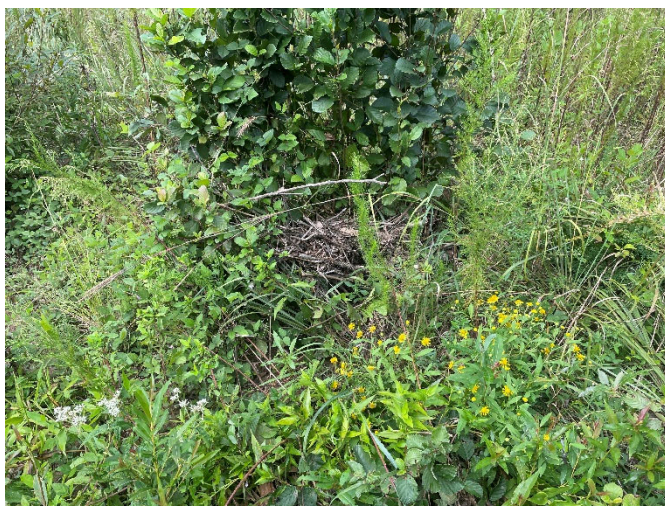
Overbank Wrack Lines (June 14, 2023)

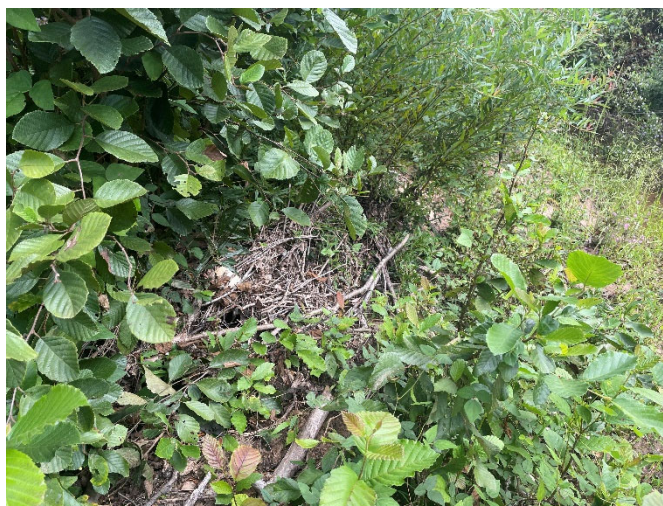
Overbank Wrack Lines (June 14, 2023)

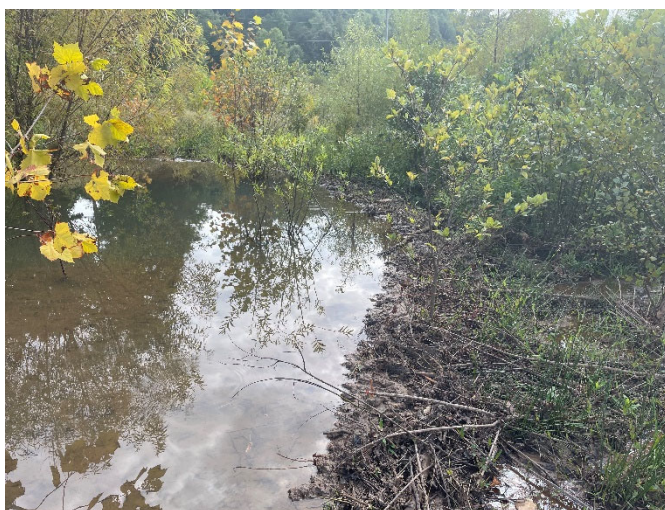
Beaver Dam located on R1 (September 20, 2023)

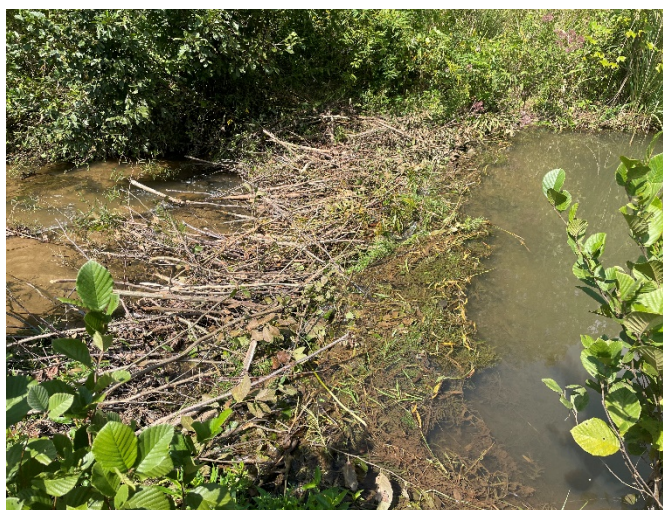
Beaver Dam located on R3 (September 20, 2023)

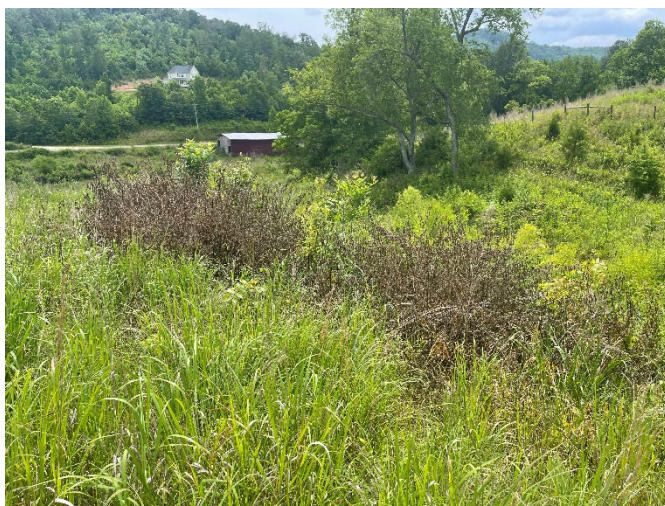
Invasive Treatment on R14 (June 14, 2023)

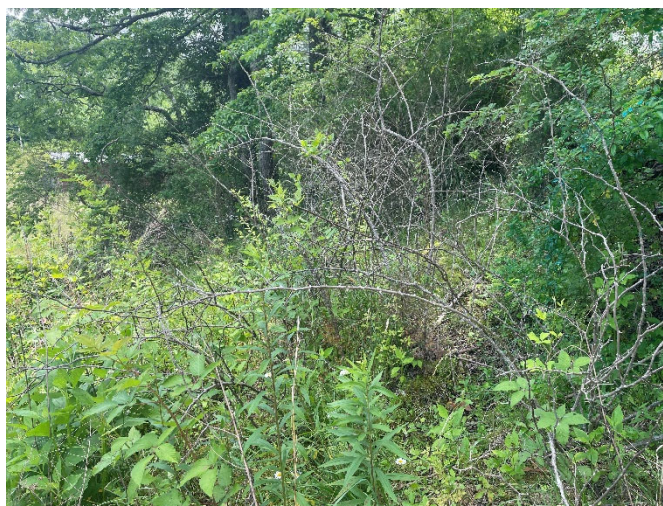
Invasive Treatment on R13 (June 14, 2023)

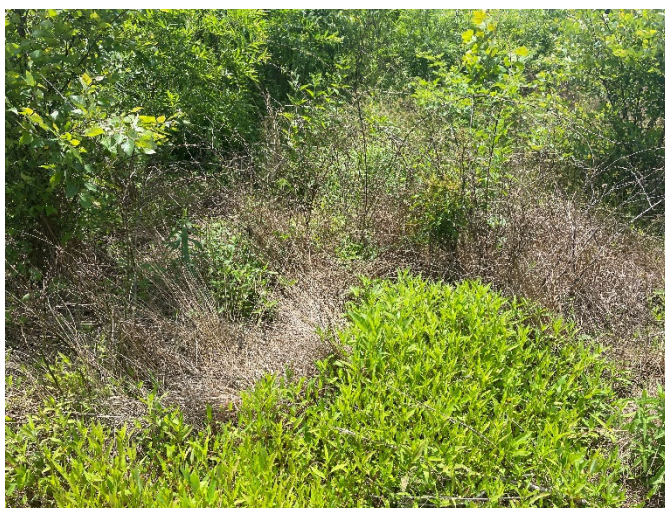
Invasive Treatment on R1 (June 14, 2023)

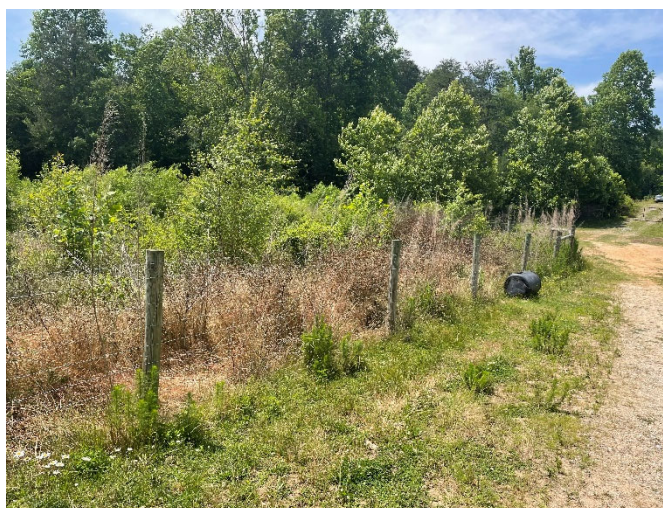
Invasive Treatment on R9 (June 14, 2023)

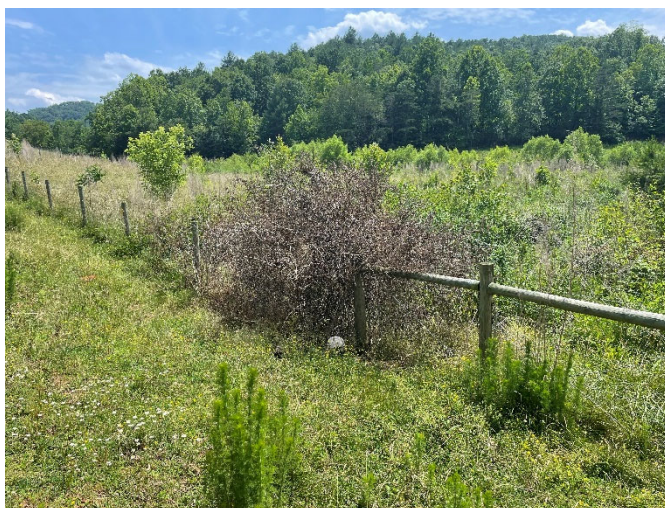
Invasive Treatment on R9 (June 14, 2023)

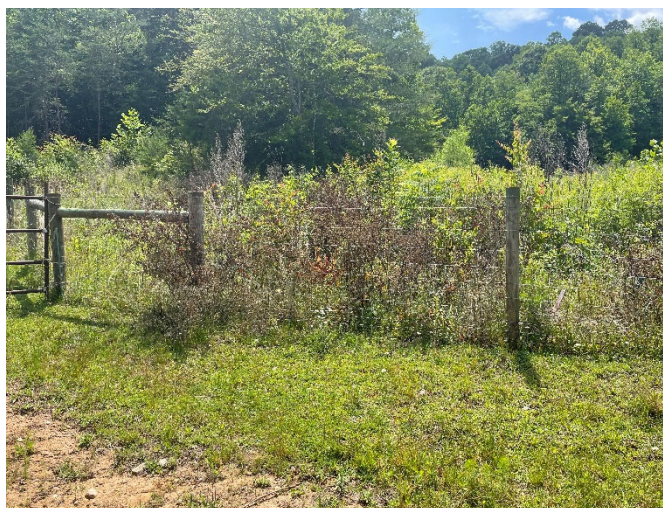
Invasive Treatment on R7 (June 14, 2023)
