SANDY CREEK

Durham County, North Carolina
EEP Project No. 322
Contract No. D08039S

2012 Annual Monitoring Report
(Measurement Year-7 – MY7 (2012) – 3rd year post-repair)
Site Constructed 2003/Repaired 2008-2009/Replanted 2011

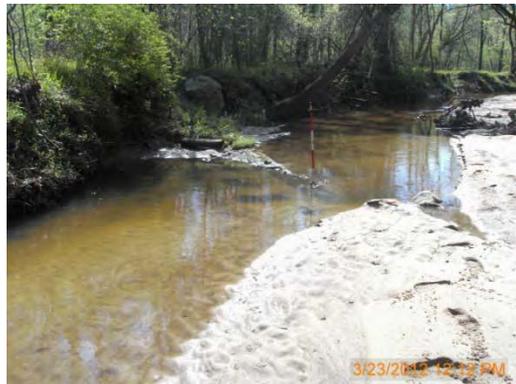
Photo Station 12: Log Vane #12 (Station 24 + 20)
Note exposed boulder, no change from previous year
