# Sink Hole Creek Mitigation Project

## Year 1 Monitoring Report

### Mitchell County, North Carolina

Contract Number: D06125-C, EEP Project Number: 92663

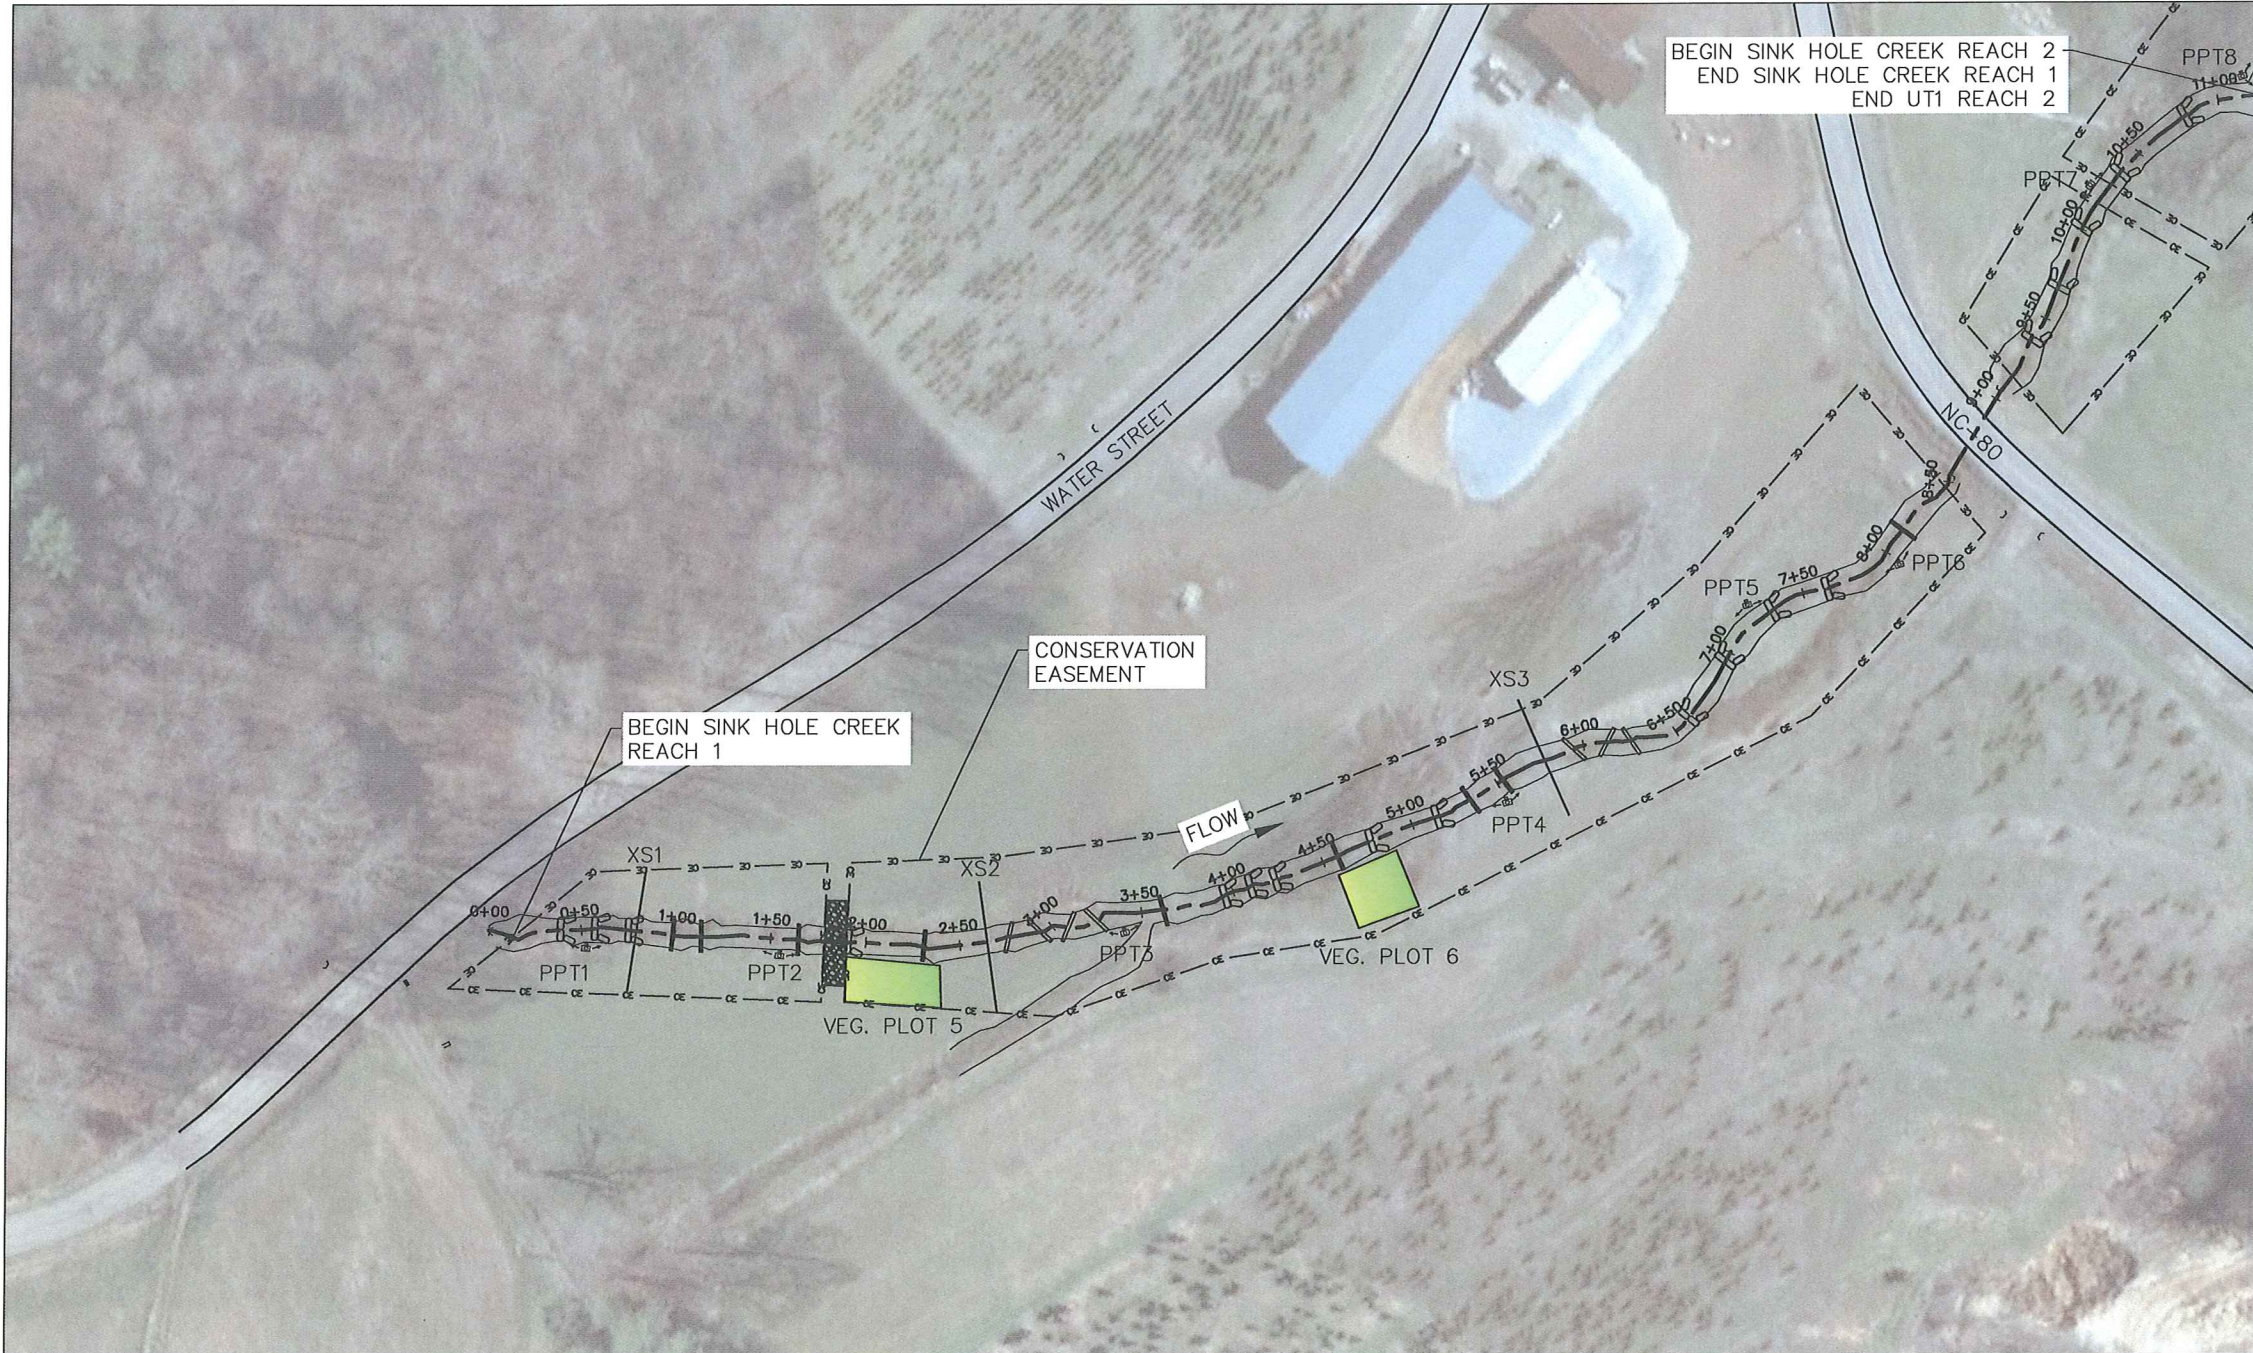
SINK HOLE CREEK  
 CURRENT CONDITION  
 PLAN VIEW  
 YEAR 1 MONITORING

The current conditions plan view depicts the monitoring features for the Sink Hole Creek Mitigation Project. The plan set also provides call outs at locations where stream and vegetation problem areas are present. With the exception of a few areas on UT2 and UT3 where the stream goes subsurface temporarily, there were no additional problems present. Figure 2 illustrates the project as it is delineated by reach.

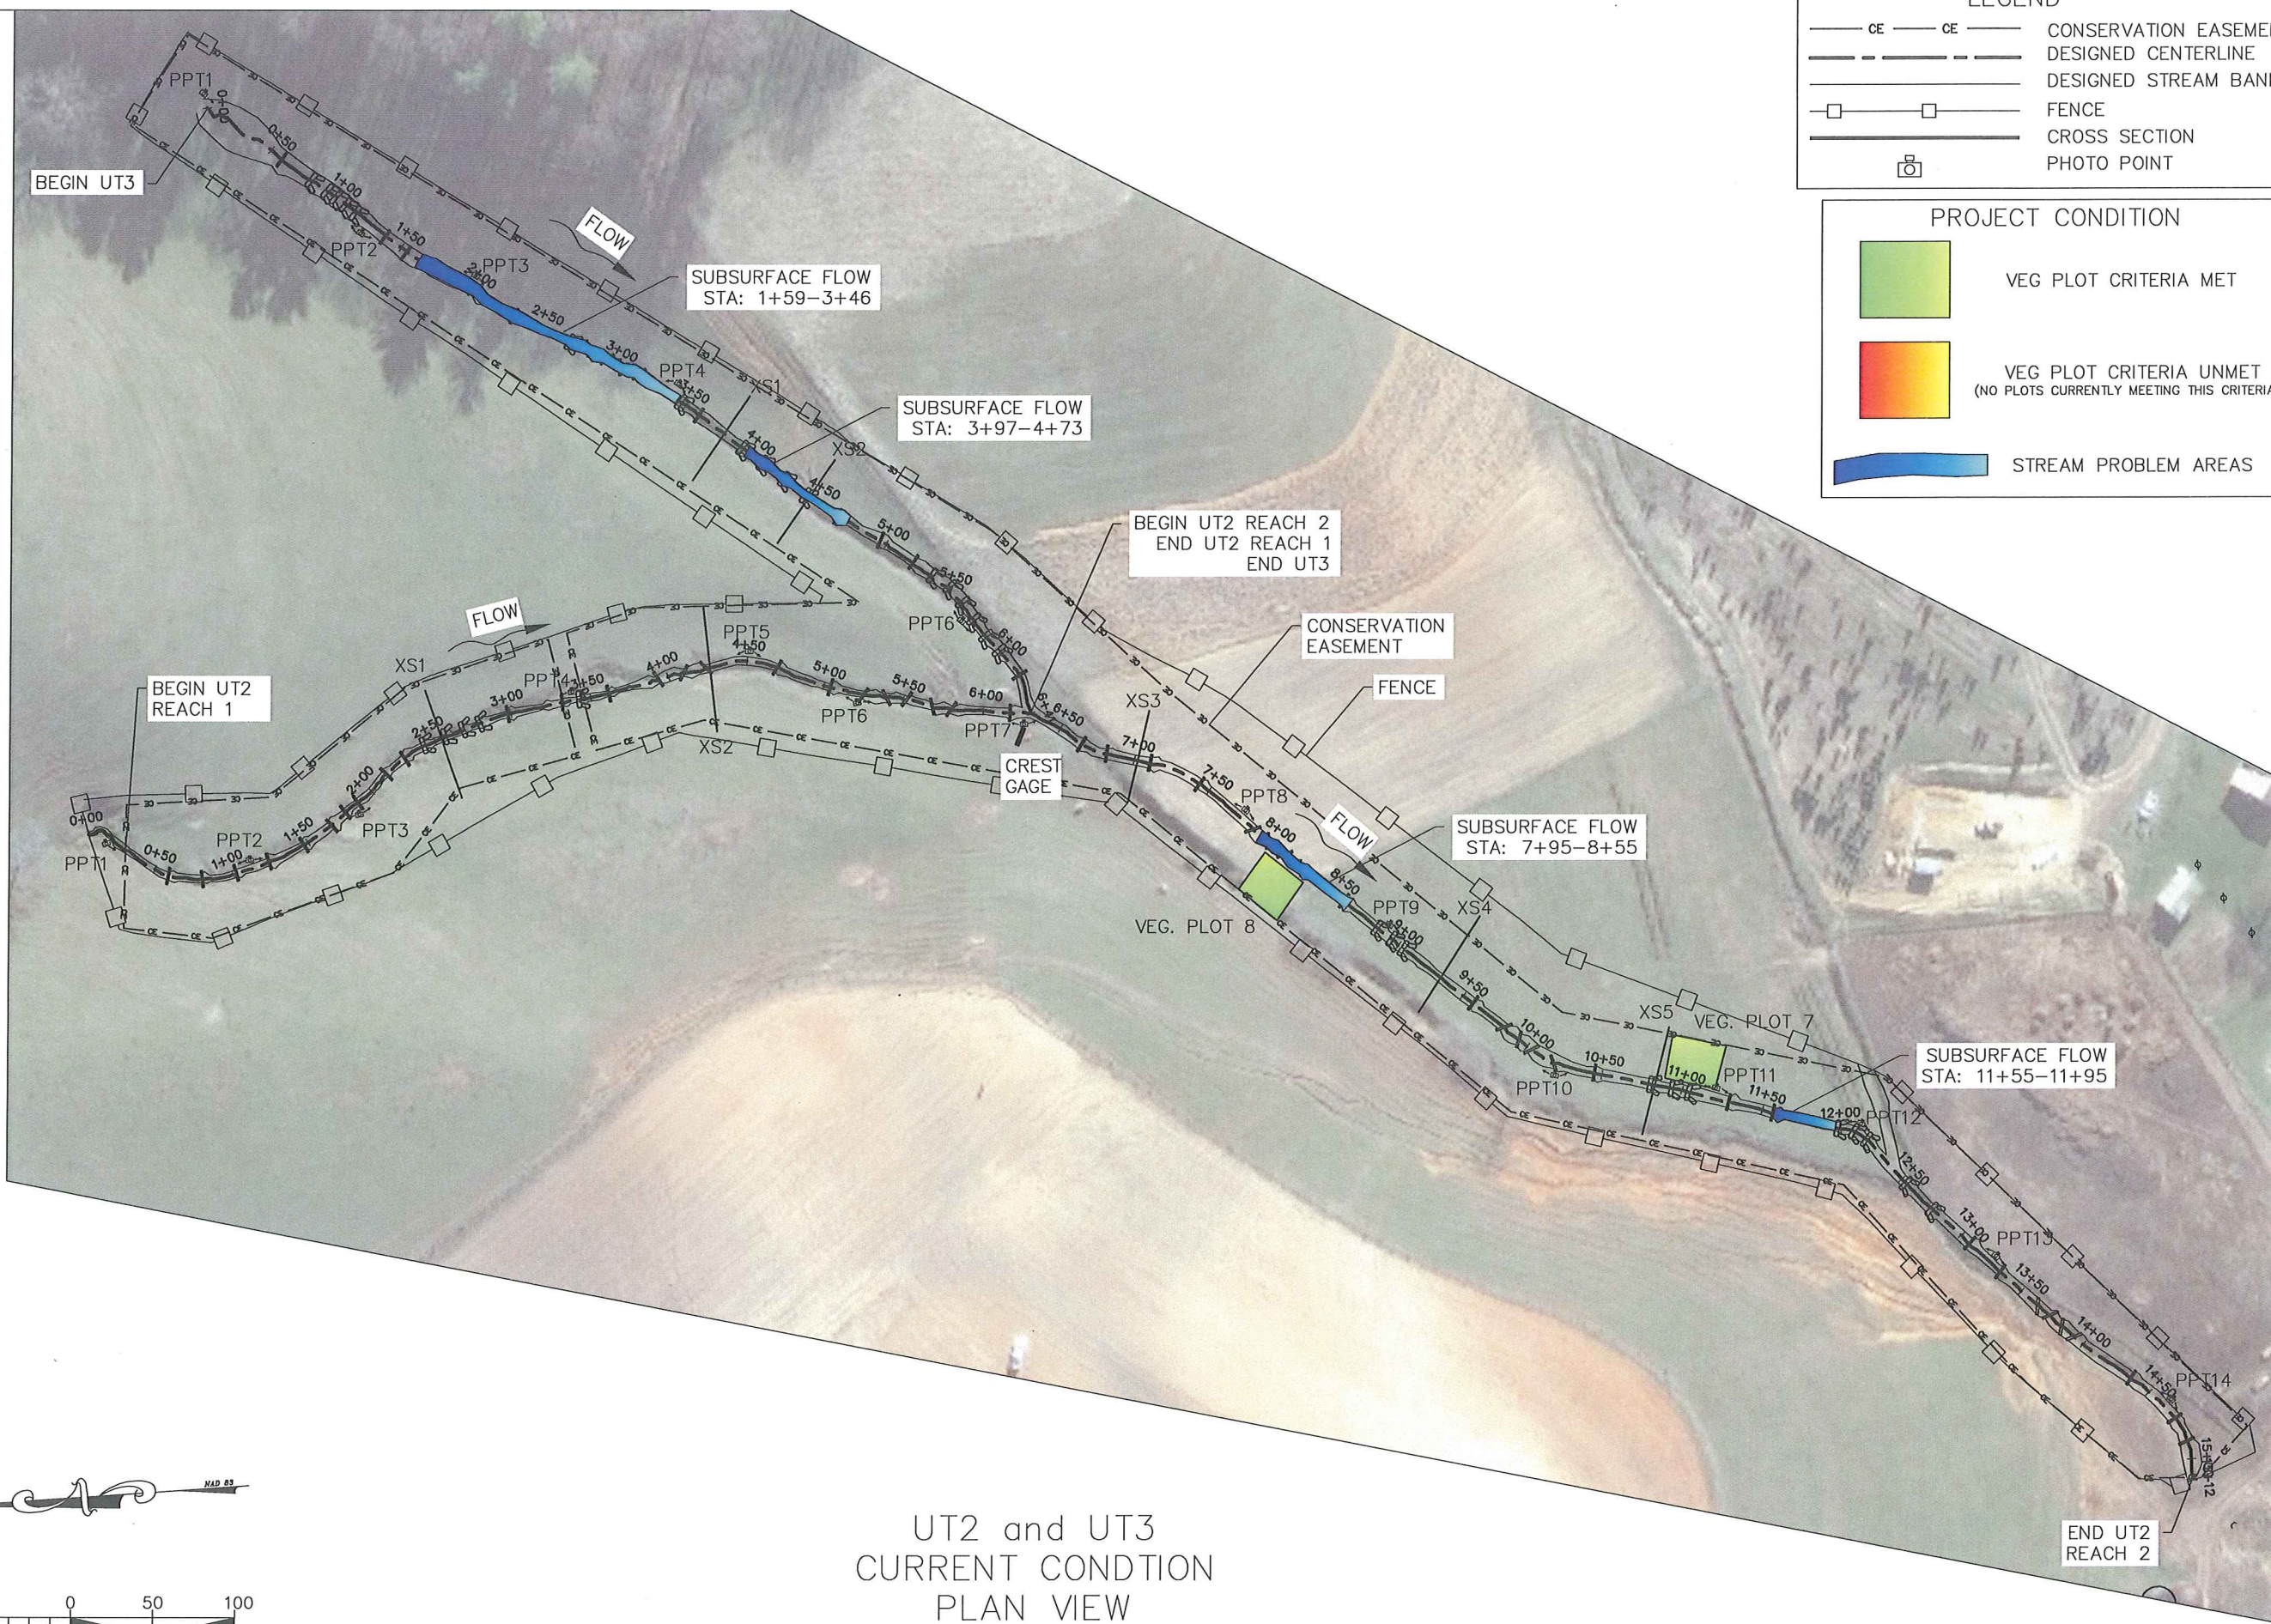
UT2 and UT3  
CURRENT CONDITON  
PLAN VIEW  
YEAR 1 MONITORING

The Year 1 longitudinal profiles for Reach 1 of UT2 and UT3 continue to exhibit profile adjustments. These appear to be lingering adjustments from a heavy downpour that occurred in July 2010 and resulted in a brief flash flood event in the project area approximately one month after the construction of these channels. Head-water systems are naturally degradational and the reconfiguration of bedform following extreme events (such as the August 2010 event in which over 4" of rain fell within one hour) is a natural occurrence. Adjustments are not of concern, unless they result in a loss of grade control in the channel, or severe erosion that cannot be repaired by natural vegetation processes. The results of that event, which was also noted in the Baseline Monitoring Report do not appear to have threatened the overall stability of these channels in the first year following construction of the project and do not present a concern at this time. Although the adjustments, which consist of shifted riffle and toe protection material and more closely spaced pools, are still present. However, closely spaced grade control structures have helped maintain the overall profile desired, no additional adjustments were noted, and there was no significant bank erosion observed because of the channel profile adjustments.

Although no areas of instability were noted in the project area during Year 1 monitoring, there are intermittent spaces on UT2 and UT3 where surface flow was lost. This is not completely unexpected given that stable, non-restored Aa to B-type streams are prone to such tendencies. Unnamed tributary 2 and UT3 are both Aa to B-type channels as they drain toward Sink Hole Creek. The stationing at which the stream goes subsurface is provided in Table 10 in Appendix B.

At this time, no areas of concern were noted in the project reaches. The steeper tributaries where flow tends to be intermittent in certain segments will continue to be monitored. Baker will notify the EEP of steps taken to encourage continuous surface flow if channel conditions do not improve by the end of the second monitoring year.
