**Year 2 Monitoring Report for Stream Mitigation of South Muddy Creek
Tributaries
(Queen Property)**

South Muddy Creek Tributaries
McDowell County, NC
SCO # D04006-01

Submitted: January 2008

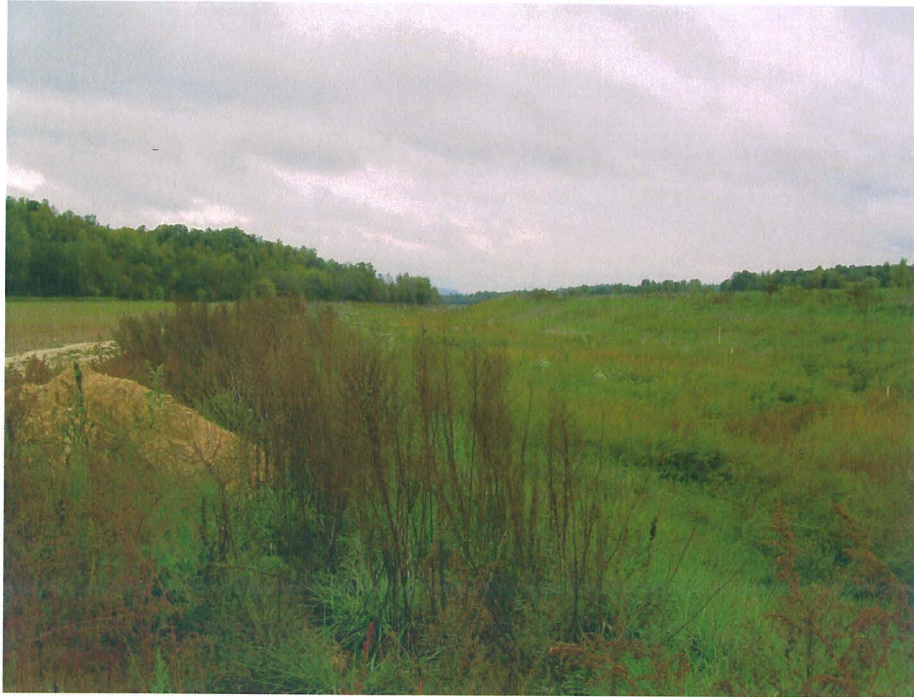
VPA 1

Feature/Issue	Station # / Range	Probable Cause	Photo #
Invasive Population	Throughout: See VPA Plan View	<i>Sericea lespedeza</i> : encroachment from pasture	VPA 1, VPA 2

Overview of the spread of *Sericea lespedeza* in the stream valley along Tributary A (lower), looking downstream from station 19+00.
(EMH&T, Inc. 10/23/07)

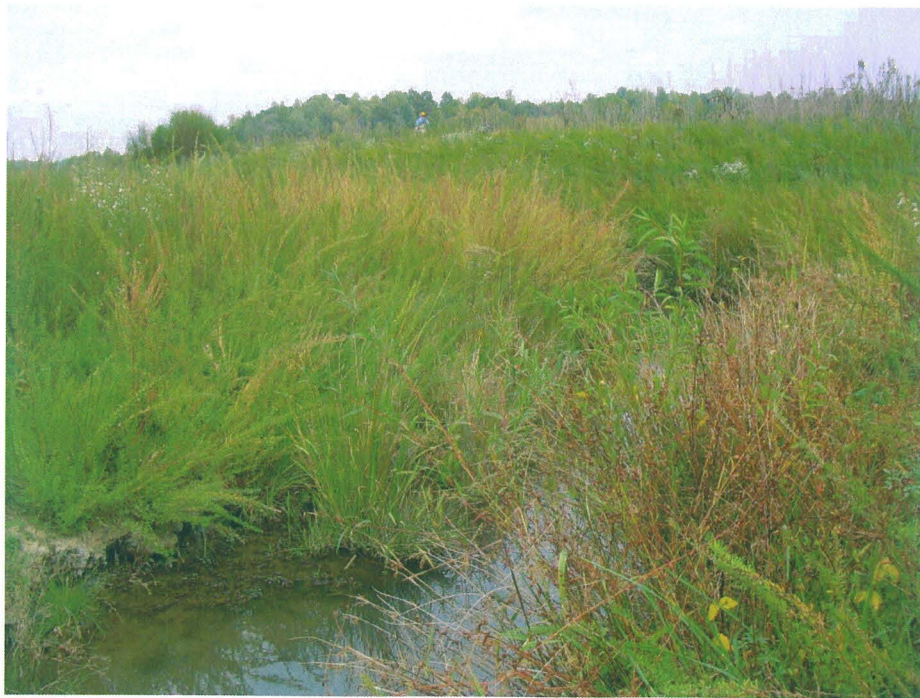
VPA 2

View of *Sericea lespedeza* growing along bank of Tributary A (middle) near station 85+64.
(EMH&T, Inc. 10/23/07)

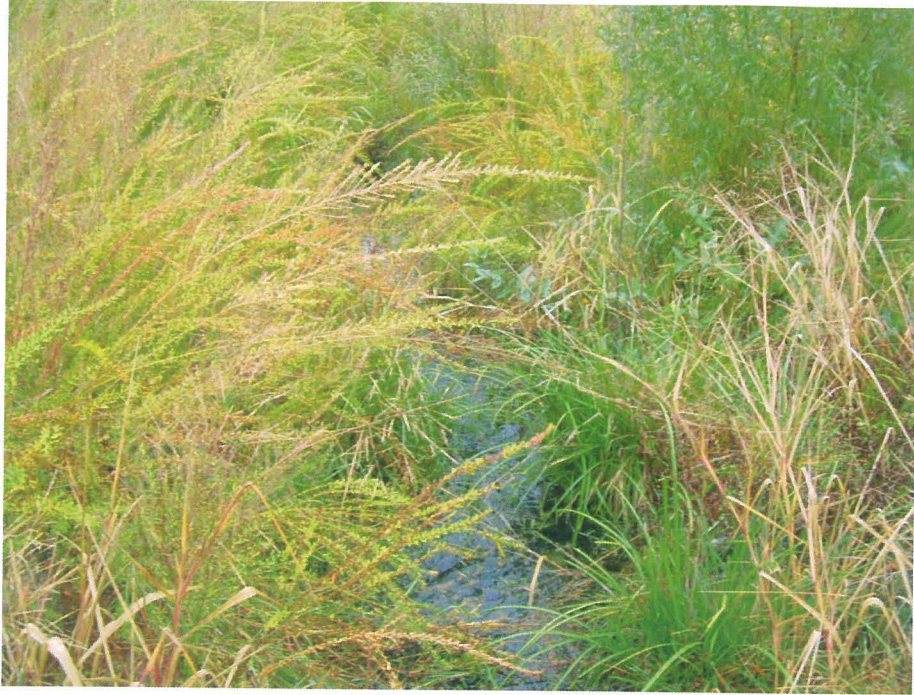
Table Xb. Stream Problem Areas – Year 2 South Muddy Creek Tributaries Restoration / EEP Project No. D04006-01			
Feature Issue	Station Numbers	Suspected Cause	Photo Number
Bank failure	12+10 (B)	Complete loss of riffle, bank recovering as a result of thick vegetation.	SPA 1
Bank scour	85+64 (A Middle)	Minor bank erosion	SPA 2
	15+70 (C)	Bank scour/ sloughing	
	4+50 (C)	Bank scour/ sloughing; heavily vegetated and stable

Bank failure along Tributary B at station 12+10. Buffer vegetation is obscuring the erosion.
(EMH&T, Inc. 10/23/07)

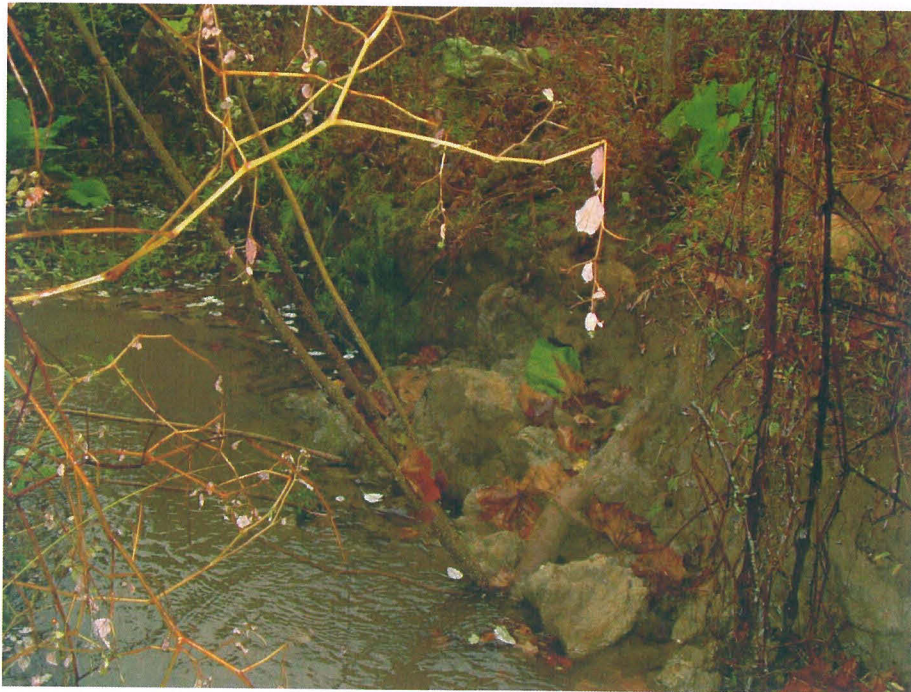
SPA 2

Bank scour along Tributary C at station 15+70.
(EMH&T, Inc. 10/23/07)

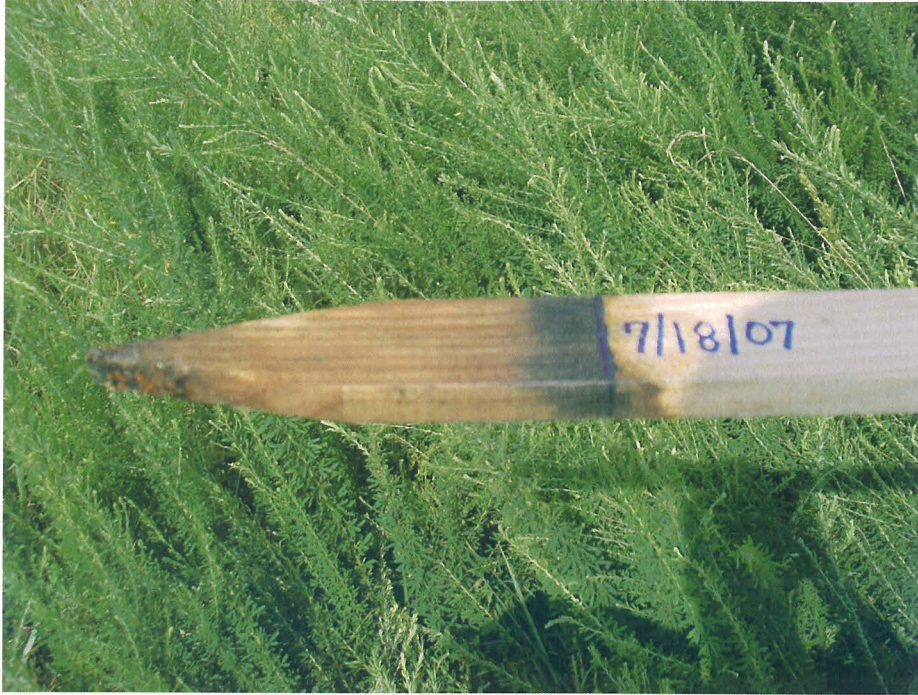
The height of the bankfull event was not measured for the crest gage on Tributary B. The crest gage on Tributary A (Lower) showed evidence of at least 3 separate events, with levels of 16.75, 24.75, and 33.25 inches above bankfull. In October 2007, the crest gage on Tributary A (Upper) registered a bankfull event at a level of 1.24 feet above bankfull elevation. Photographs of the crest gages are shown in Appendix B.

BF 1
Crest Gage at station 5+00 on Tributary B.
(EMH&T, Inc. 7/18/07)
