**Spring Valley Park Stream Restoration  
Guilford County, North Carolina  
Annual Monitoring Report**  
Monitoring Year: 2005

Monitoring Year: 2005  
Measurement Year 2  
As-Built Date: 2003  
Project Design by Kimley-Horn and Associates  
NCEEP Project Number: 354

**April 2006**

**SPRING VALLEY PARK STREAM RESTORATION  
2005 MONITORING REPORT**

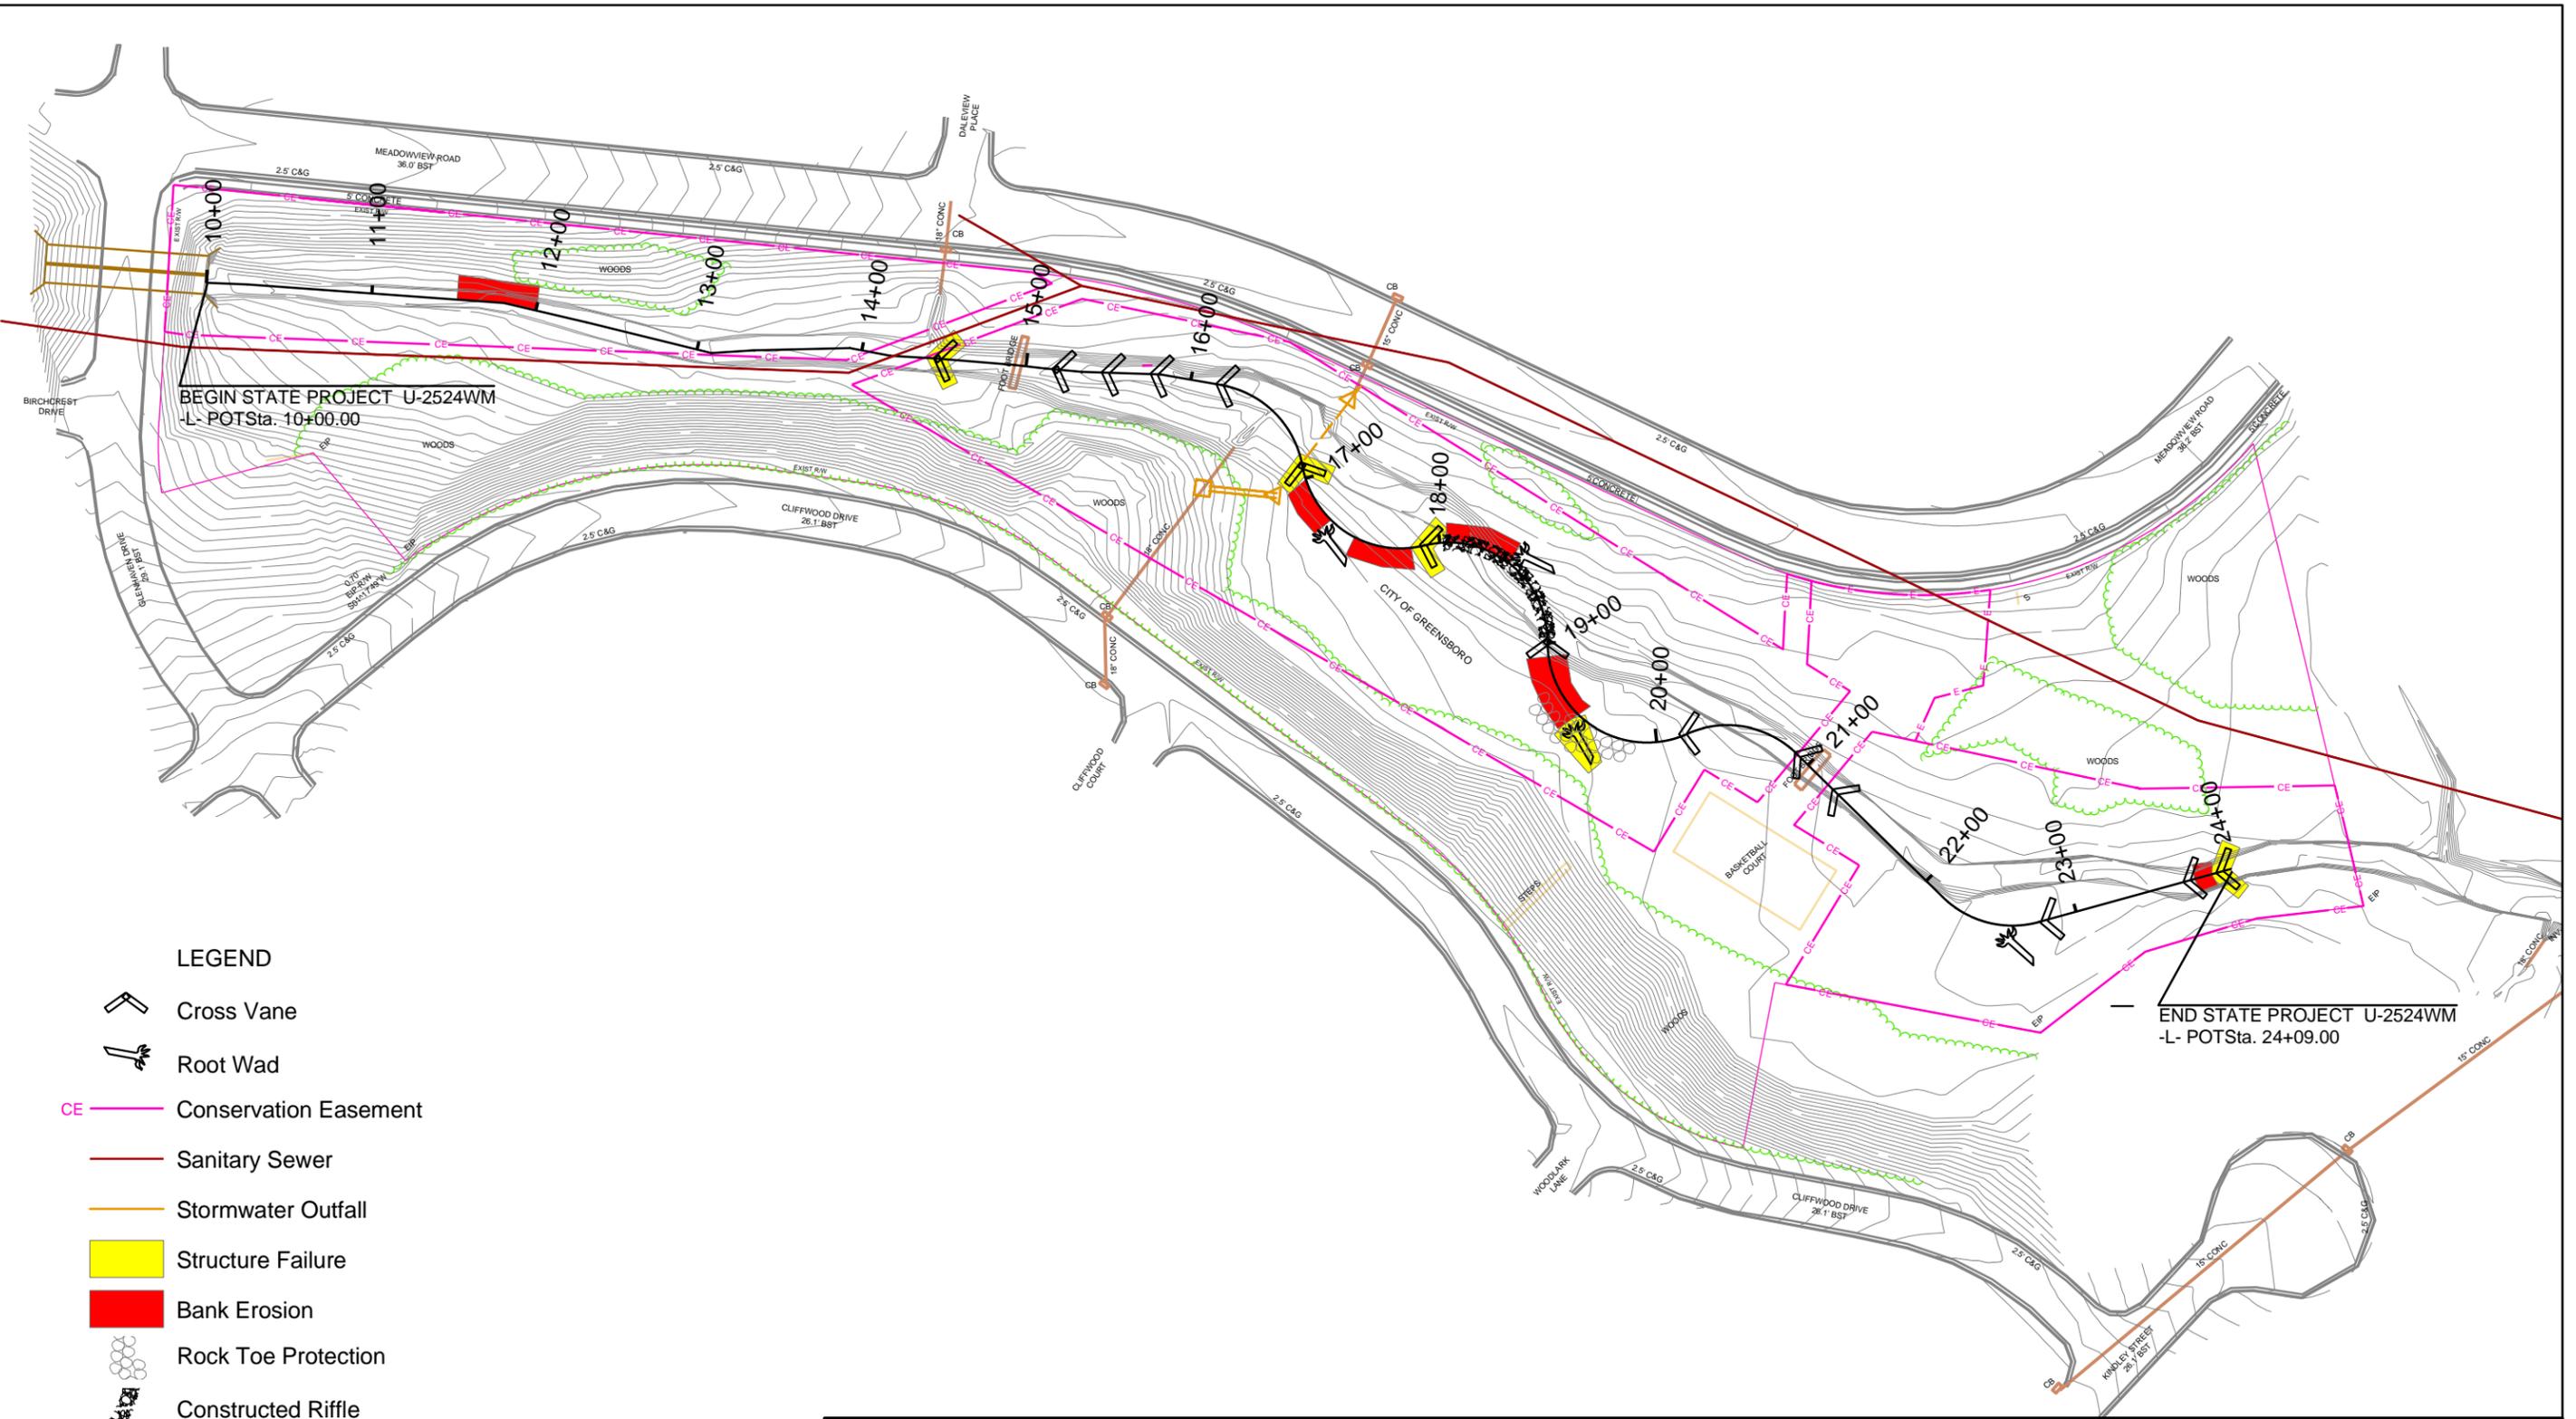
**APPENDIX B-1  
PROBLEM AREAS PLAN VIEW  
SPRING VALLEY PARK STREAM RESTORATION**

The project has some issues with piping around structures and areas of severe erosion. The following problem areas were observed:

At this time, repairs are recommended for the structures where water is flowing under them and for the eroded bank behind the rootwad at station 19+50. The other problem areas need to be watched and if the problems worsen over time, then the areas need to be evaluated a remedial plan developed.

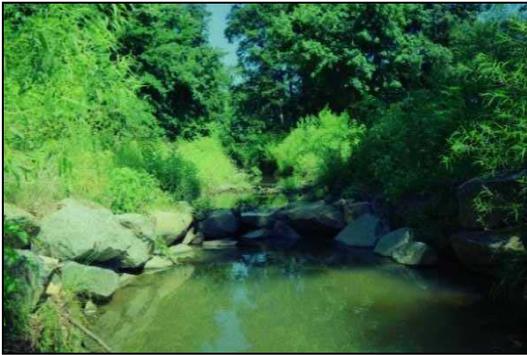
- At stations 11+50-12+00, the left banks have undercut behind the coir matting
- At station 14+25, water is not flowing over the center cross piece for the cross-vane, water is draining from the left bank down over the left arm also,

SPA1. Station 14+25 water not flowing over center piece in cross-vane.

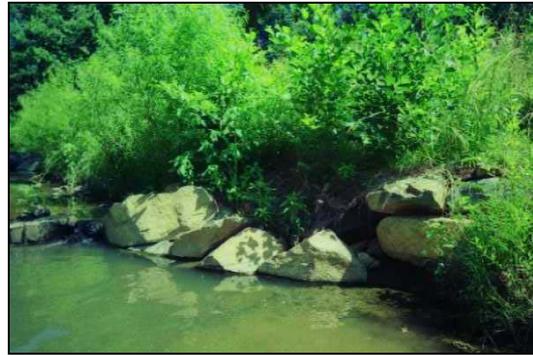
- At station 17+25, erosion on right bank in the direct flow pattern of water coming over the cross-vane upstream,
- At stations 17+50-18+00, along right bank, erosion from rootwad to cross-vane.

SPA2. Station 17+25 erosion on right bank from upstream cross-vane.

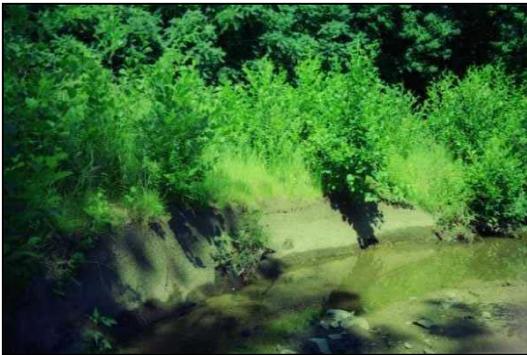
- At station 18+00, cross-vane arms are too high, water flowing underneath cross piece
- At stations 18+00-18+50, left bank eroding downstream of cross-vane,

SPA3. Station 18+00 left bank eroding downstream of cross-vane

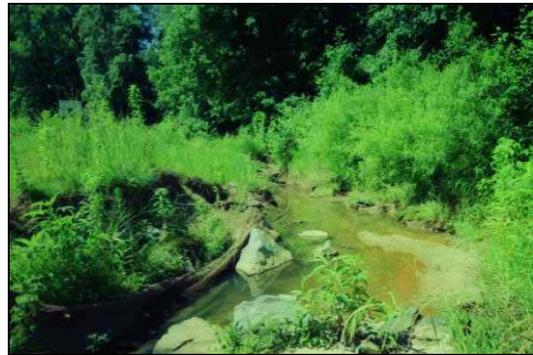
- At station 19+00, around a cross-vane 20 feet of erosion approximately 4 foot vertical banks,
- At station 19+50, completely washed out behind rootwad,

SPA4. 19+00 Erosion around and downstream of cross-vane.

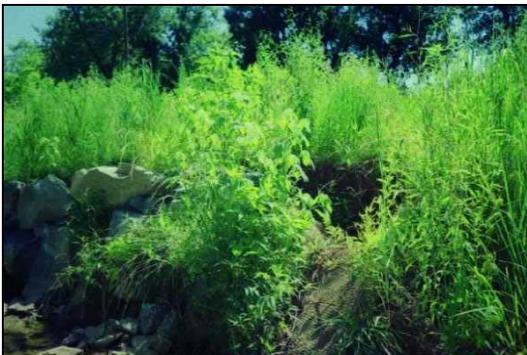
SPA5. Station 19+50 Erosion behind rootwad.

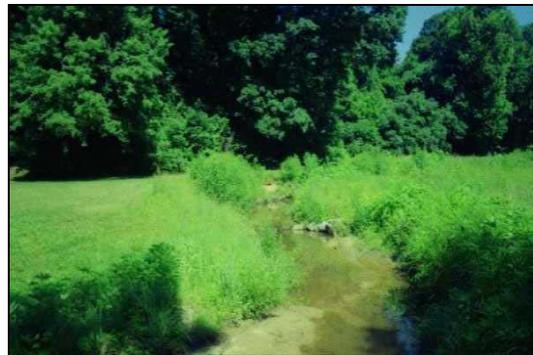
- At stations 20+50-21+50, mid channel sand bars,
- At stations 21+50-22+00, mid channel vegetated clumps in channel,
- At stations 23+75-24+00, erosion in between last two cross-vanes on both banks, and

SPA6. 20+50 mid channel sand bars.
