Monitoring Year 2 FINAL Monitoring Report
Stewarts Creek Tributaries Stream Restoration Project
Surry County, North Carolina
Yadkin River Basin, Hydrologic Unit Code (HUC) 03040101

Data Collection Period:
September 2021 – November 2021

Submission Date:
December 2021

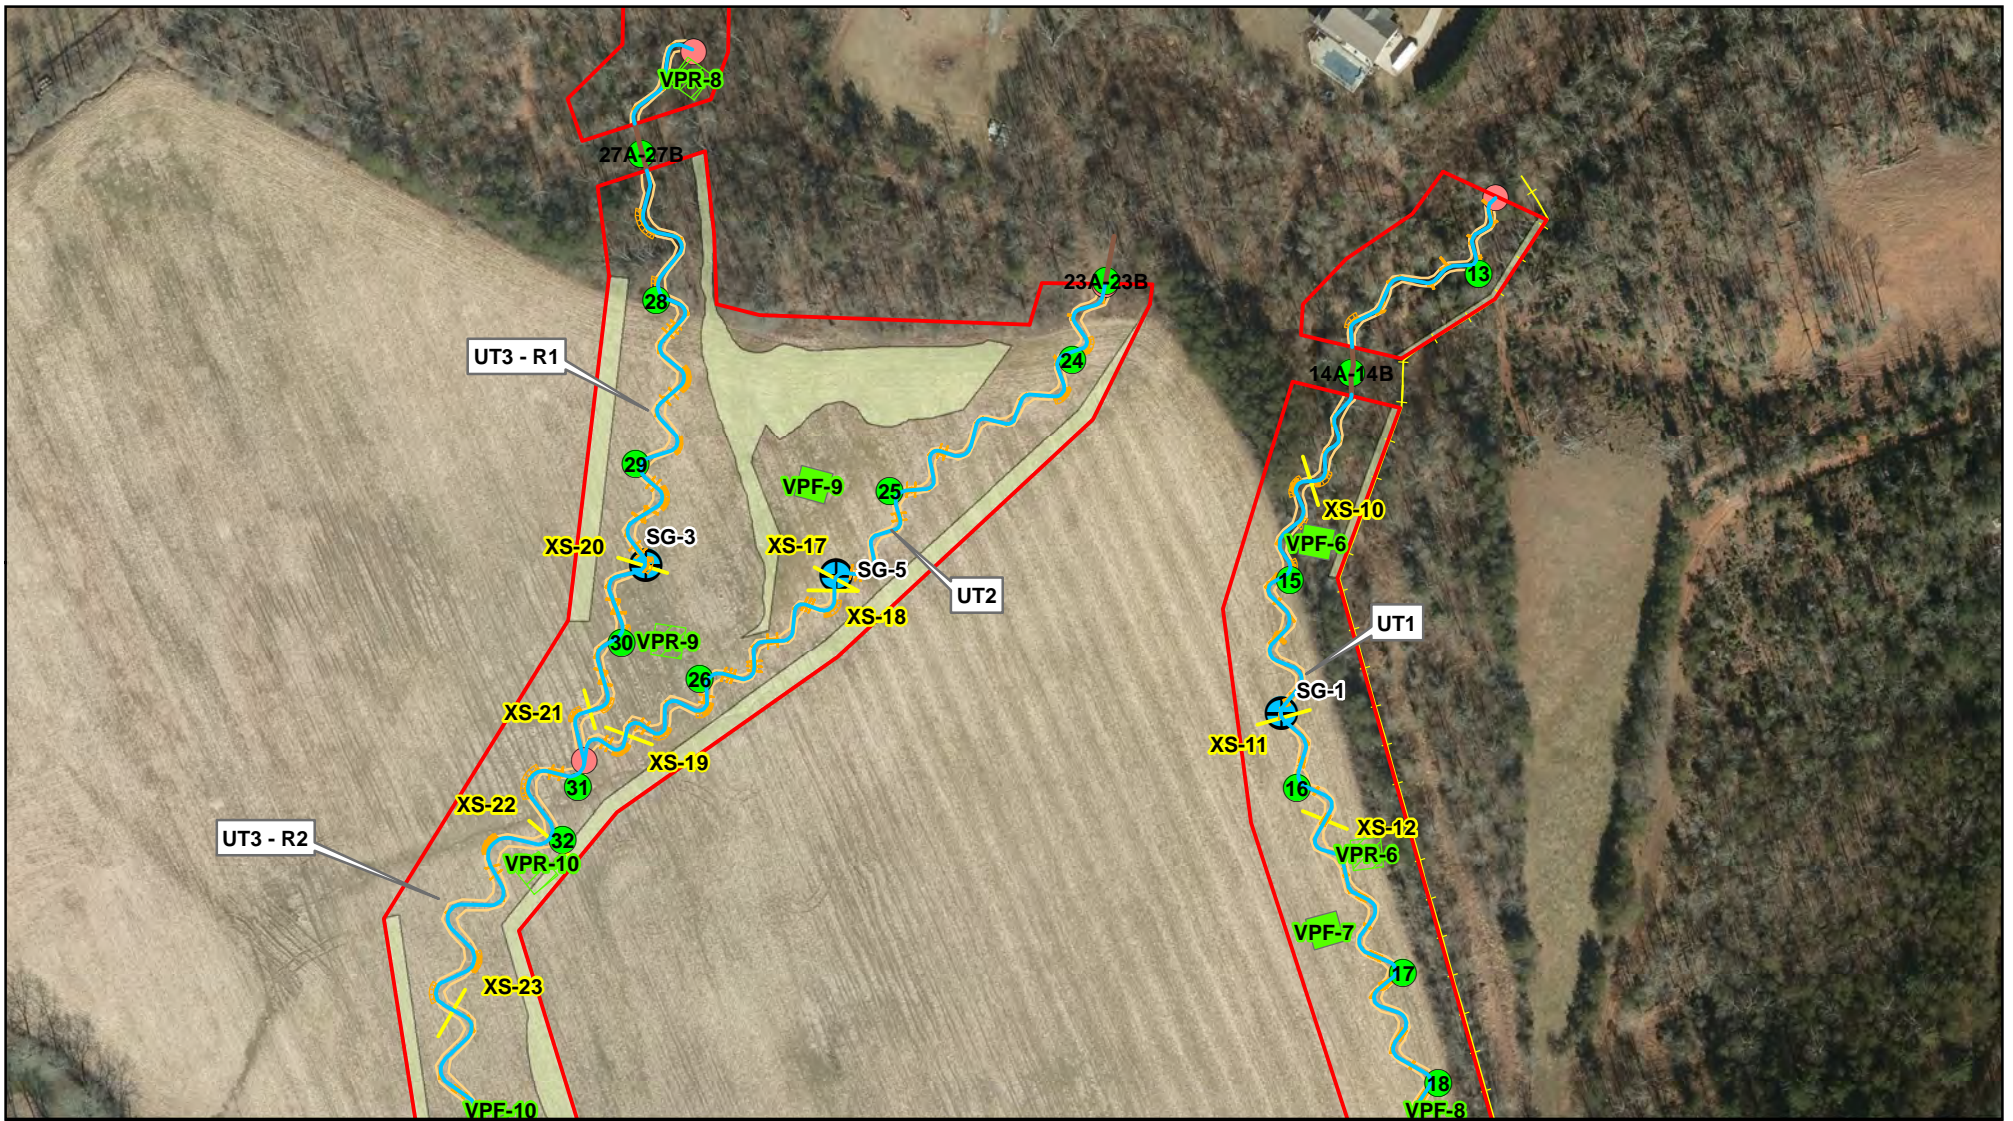
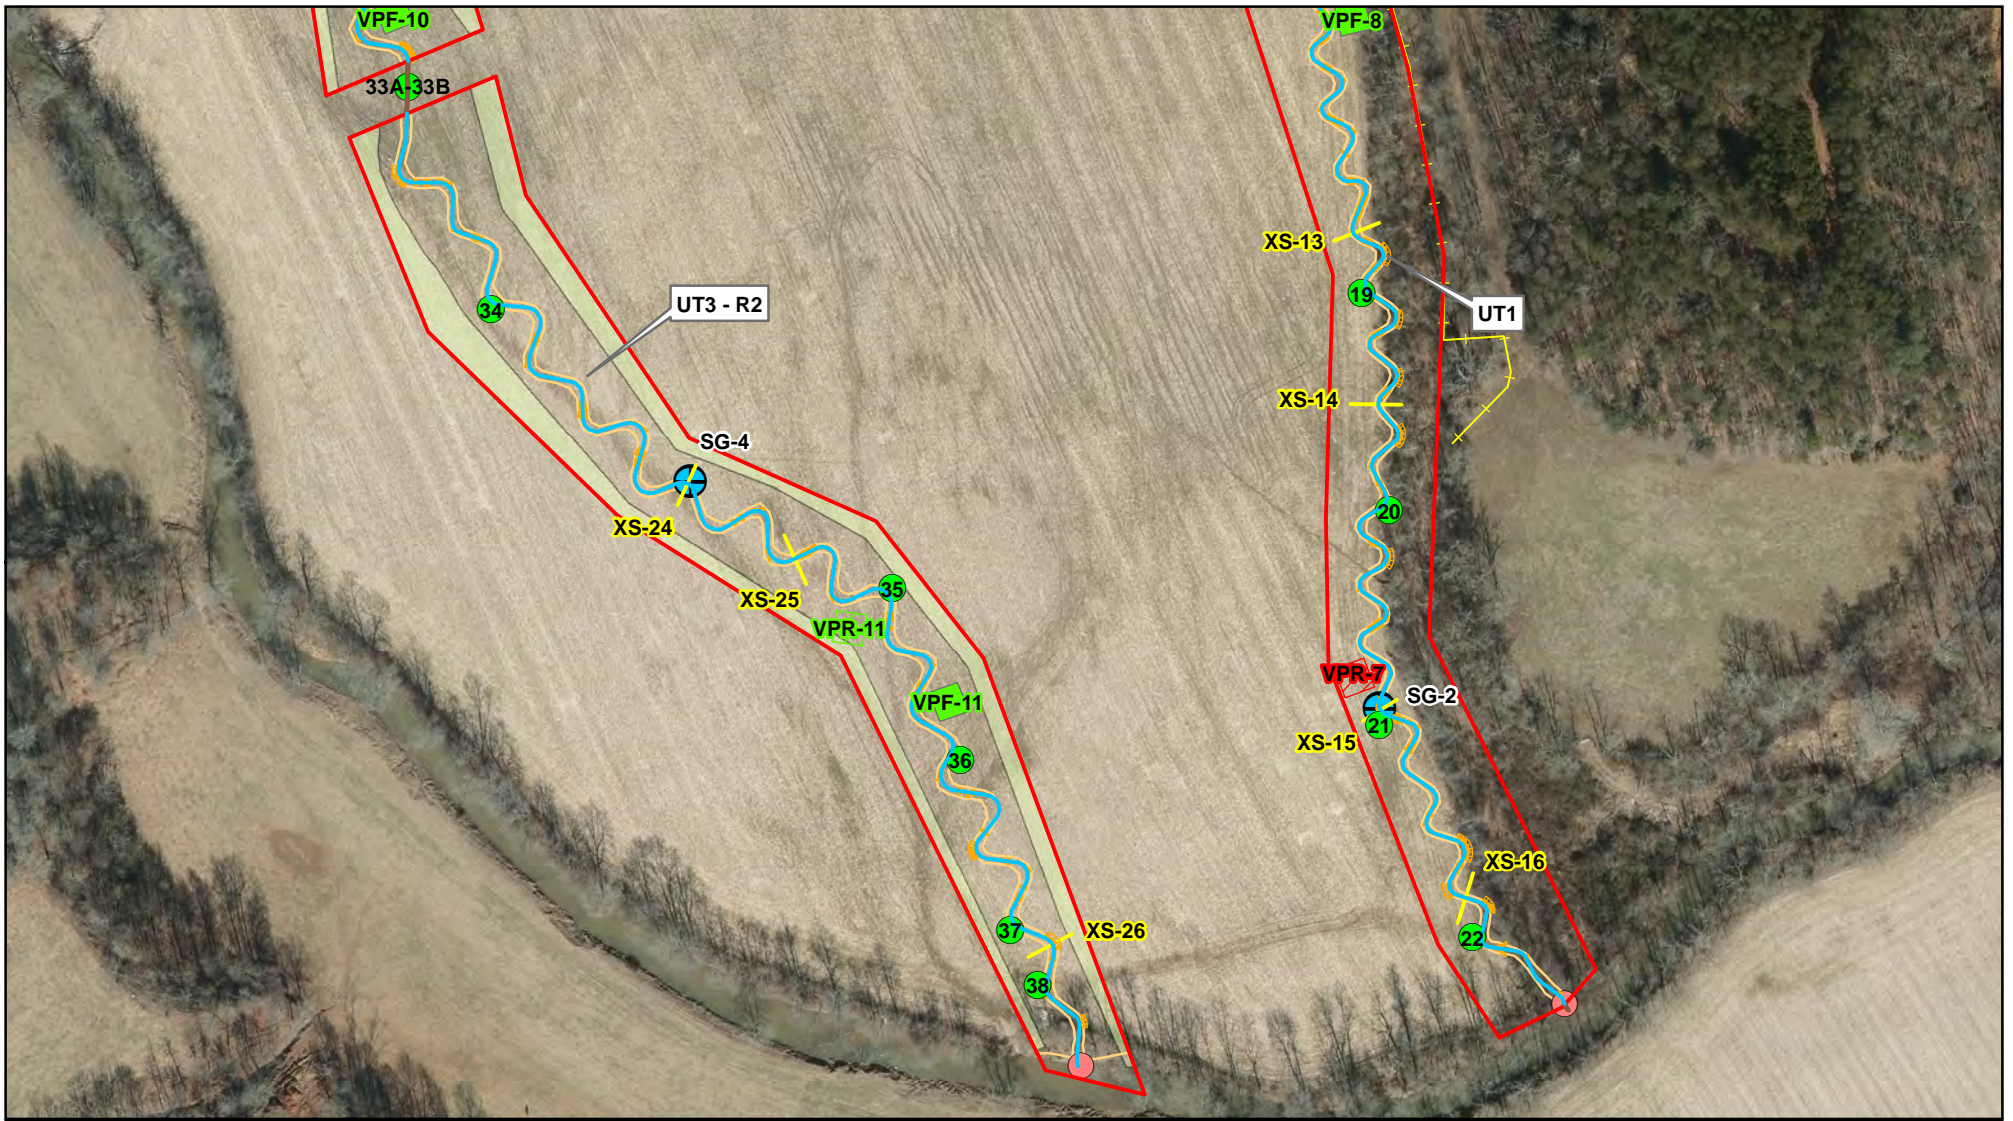
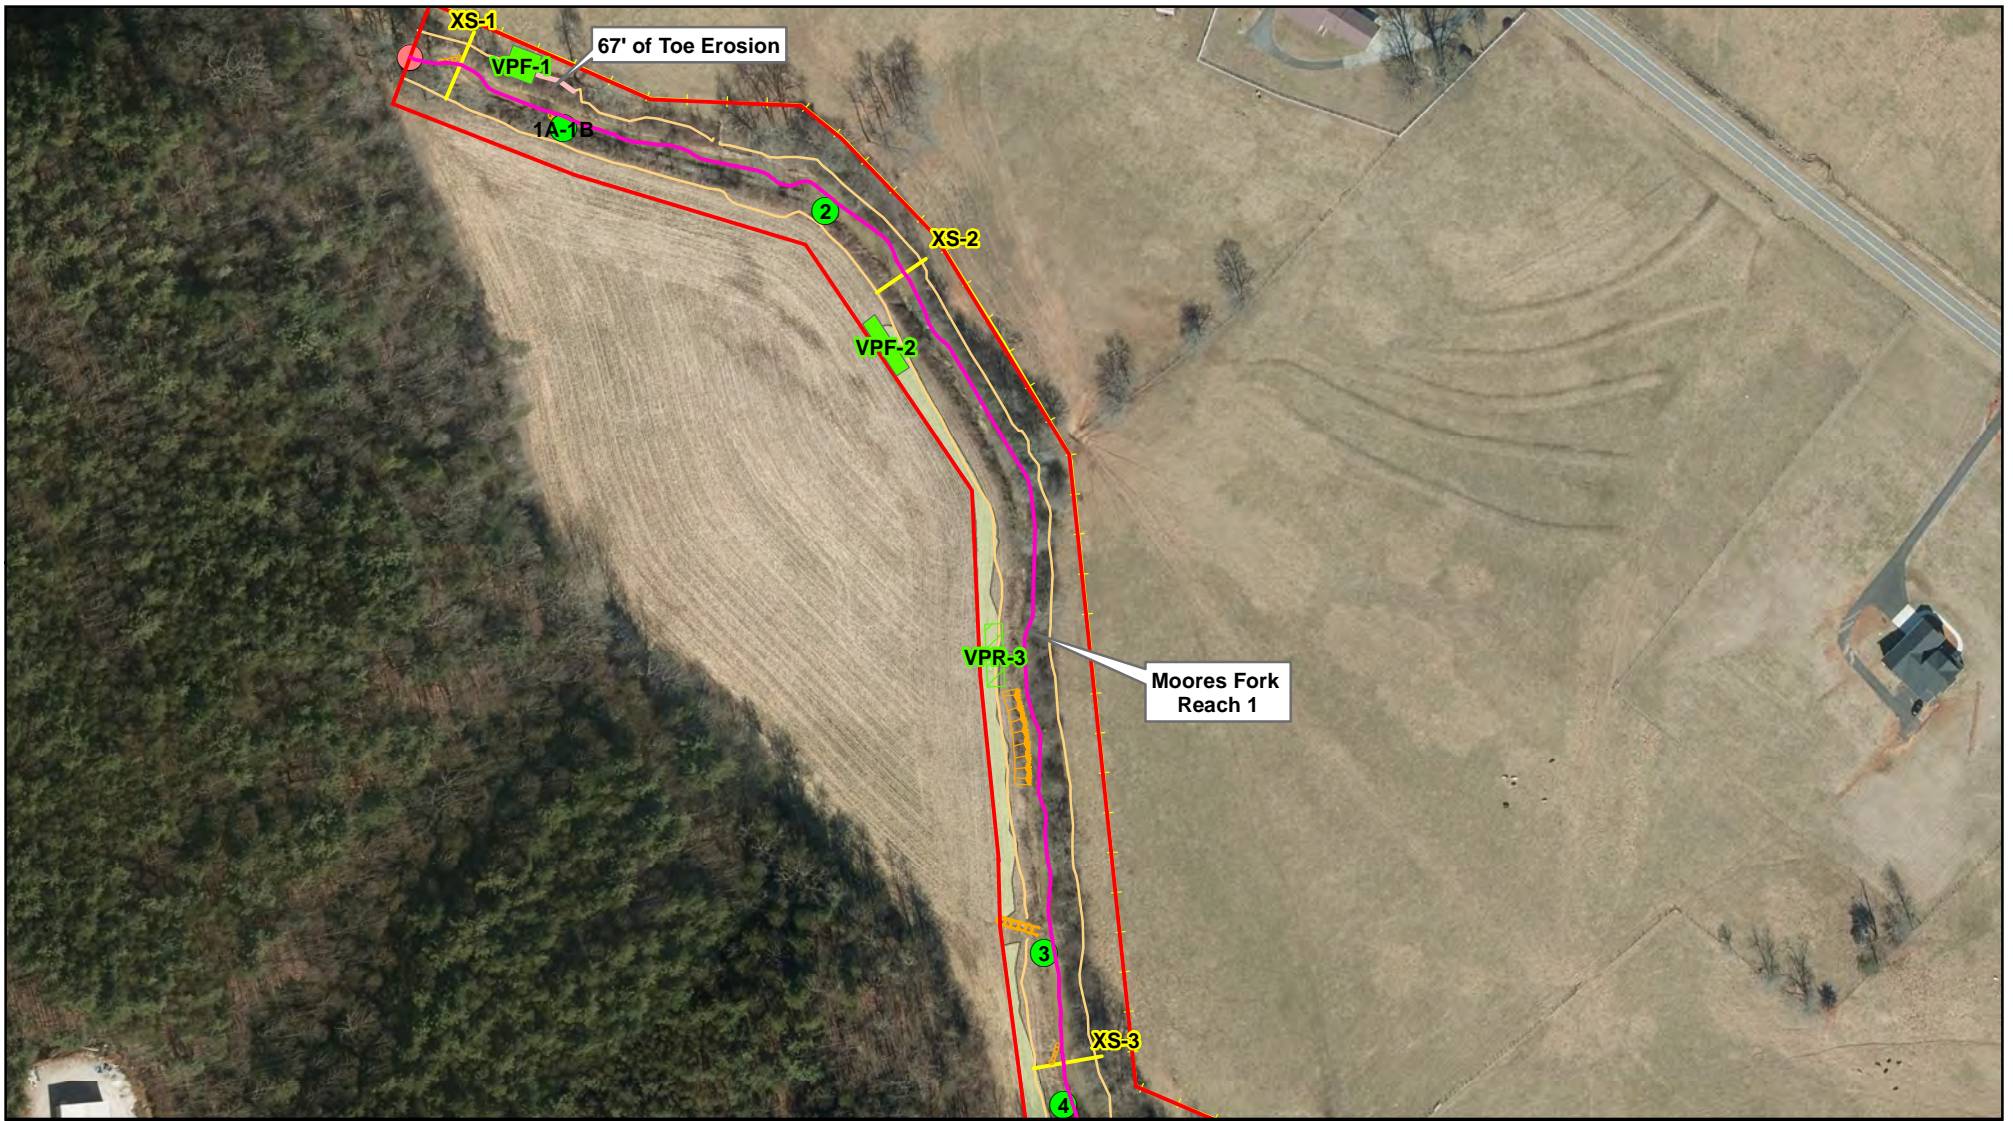
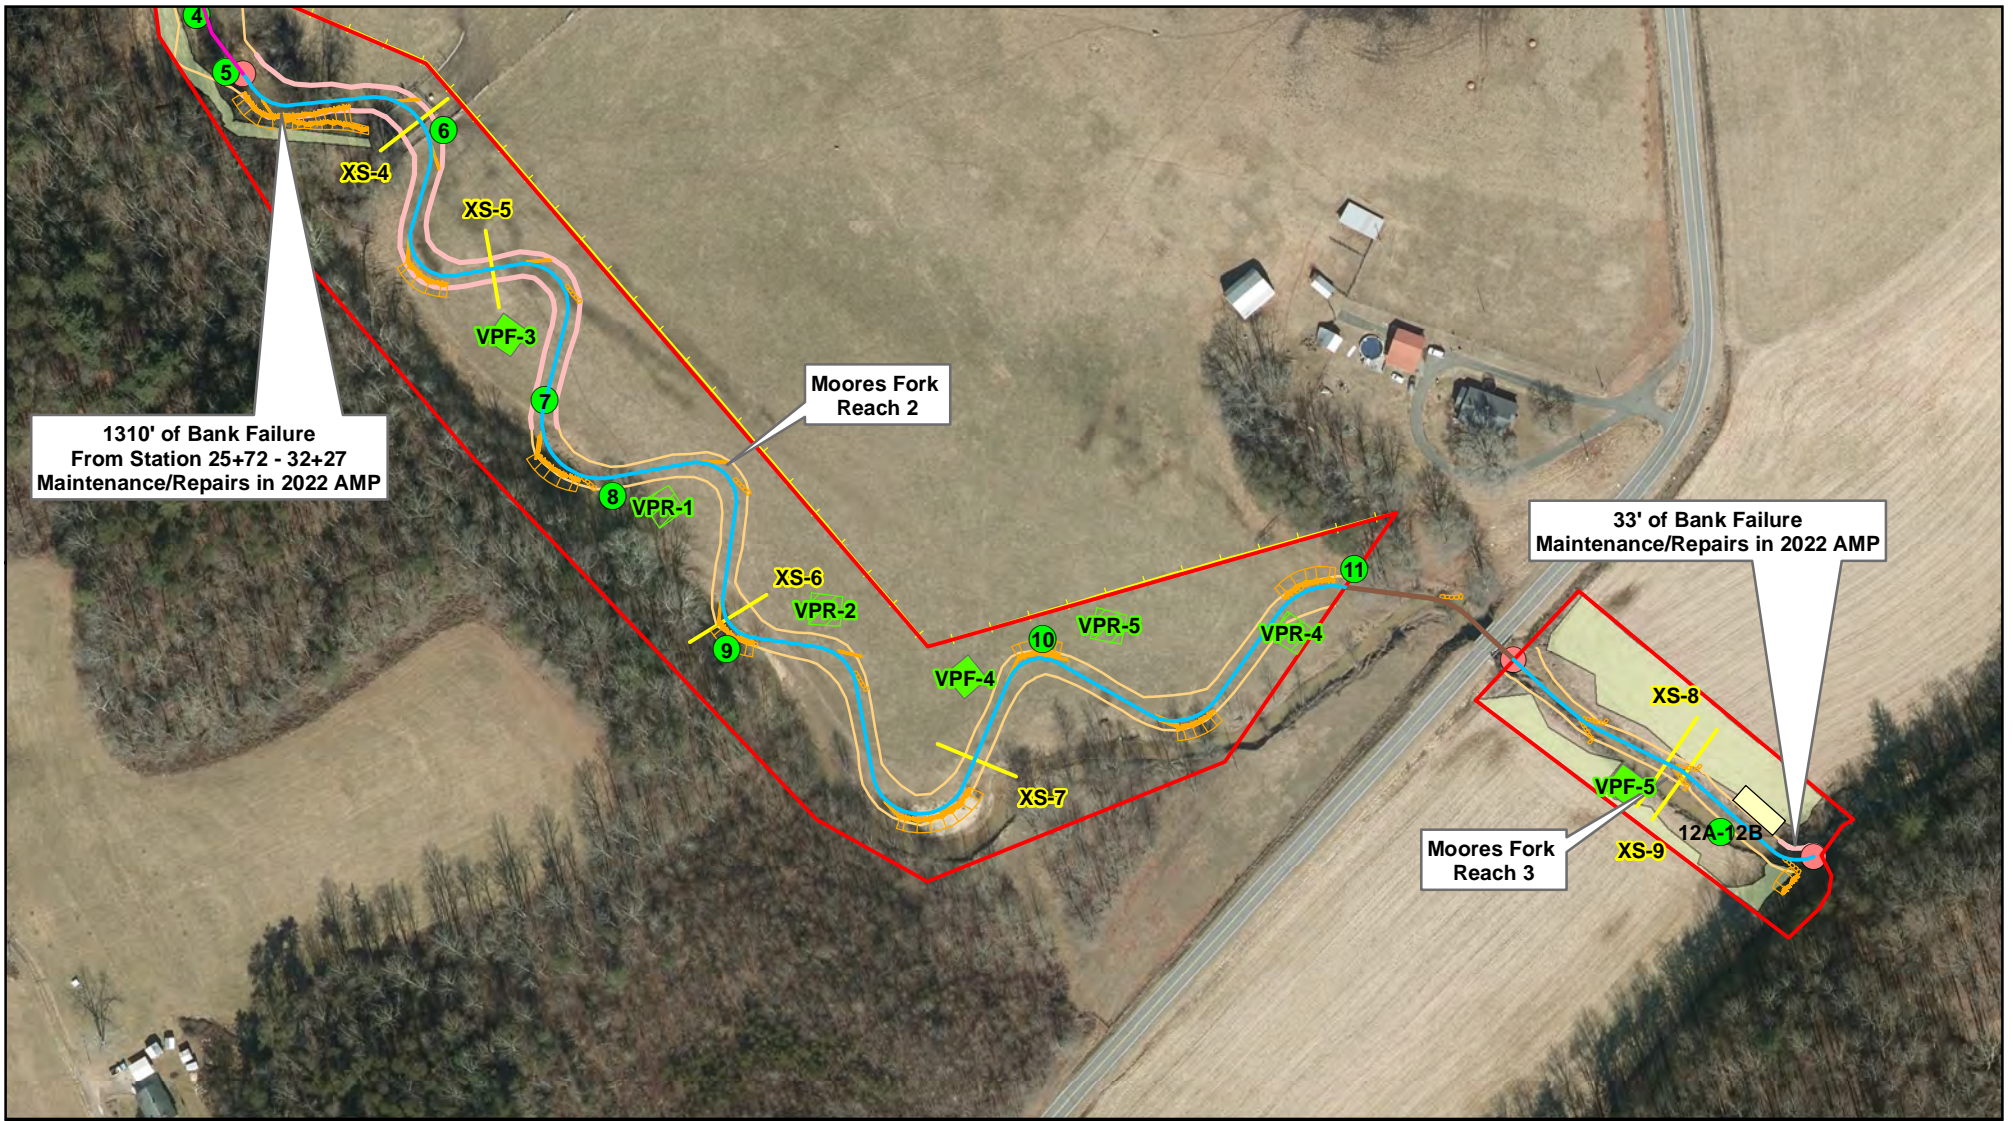
STEWARTS CREEK TRIBUTARIES
STREAM RESTORATION PROJECT
 CURRENT CONDITION PLAN VIEW: ASSET MAP
 MY2: 2021

- *Table 5. Vegetation Condition Assessment Table: The area of kudzu reported in MY2 is at the 0.1-acre mapping threshold. The area is shown on the CCPV maps. Please update table 5 to include the invasives reported and shown on the CCPV maps.*
 - **Updated.**

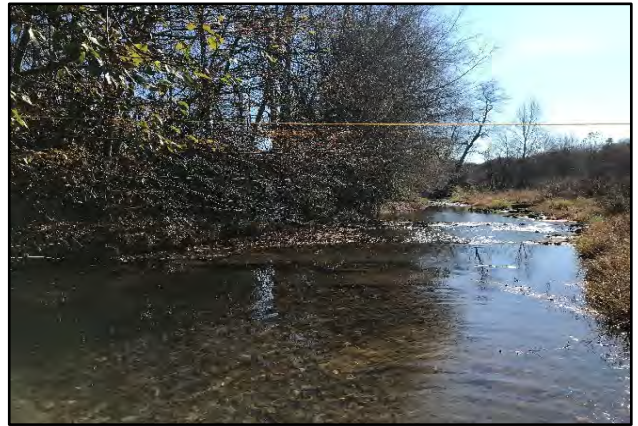
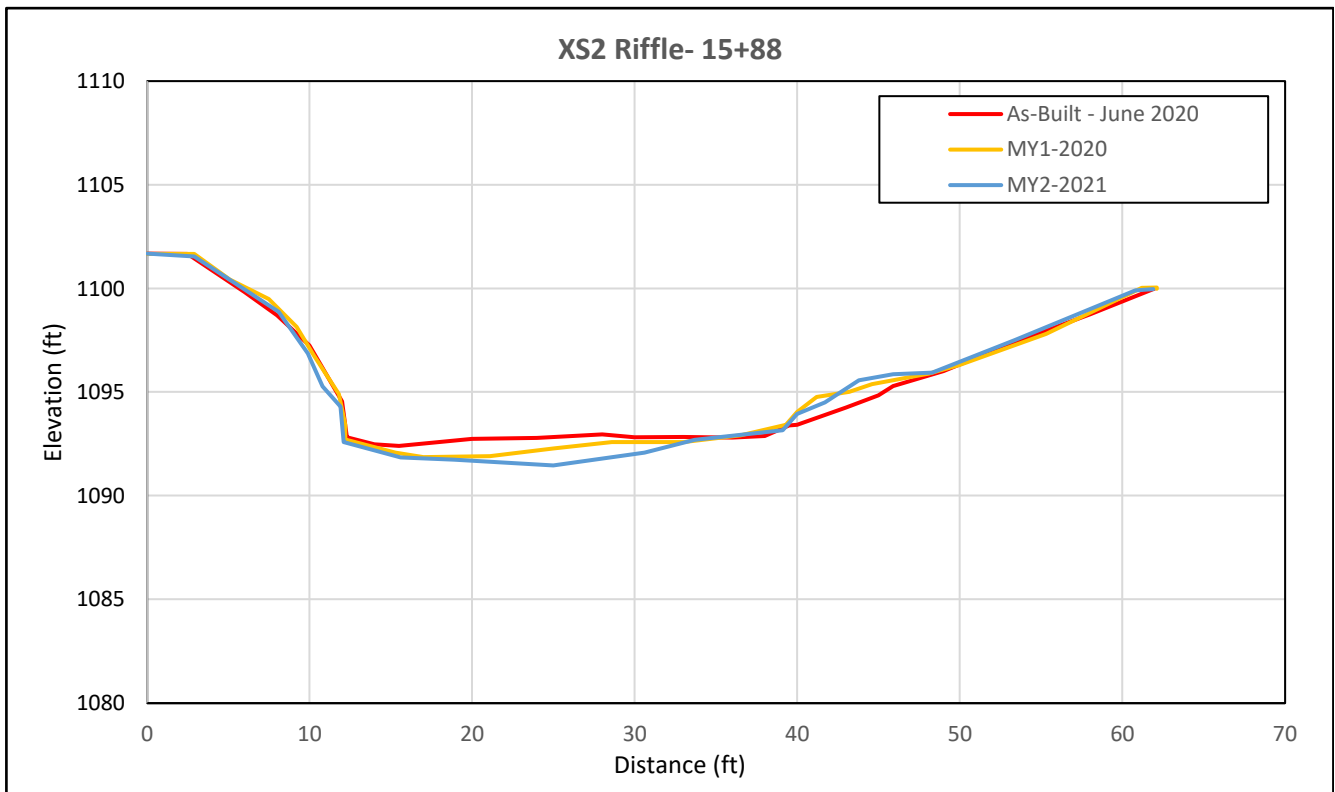
XS2 looking downstream

- Cross-section 2 on Moores Fork Reach 1 Enhancement shows an increase in bank-height-ratio. It is our professional judgement that this will fluctuate through the monitoring years and will not cut down any further due to it currently being cut down to bedrock.
- Cross-sections 4 and 5 are in the lower reaches of Moores Fork that show bank instability that will require maintenance/ repair. This will be addressed in the 2022 AMP.

MY0	MY1	MY2	MY3	MY4	MY5	MY+
Bankfull Elevation - Based on AB Bankfull Area	1094.84	1094.64	1094.32				
Bank Height Ratio - Based on AB-Bankfull Area	1.18	1.04	1.44				
Thalweg Elevation	1092.41	1091.86	1091.47				
LTOB Elevation	1095.28	1094.76	1095.57				
LTOB Max Depth	2.87	2.90	4.1				
LTOB Cross Sectional Area	75.98	65.20	100.49				
Entrenchment Ratio	1.29	1.54	1.49

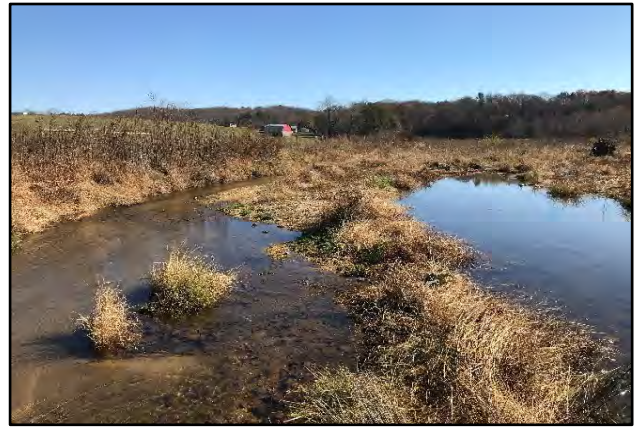
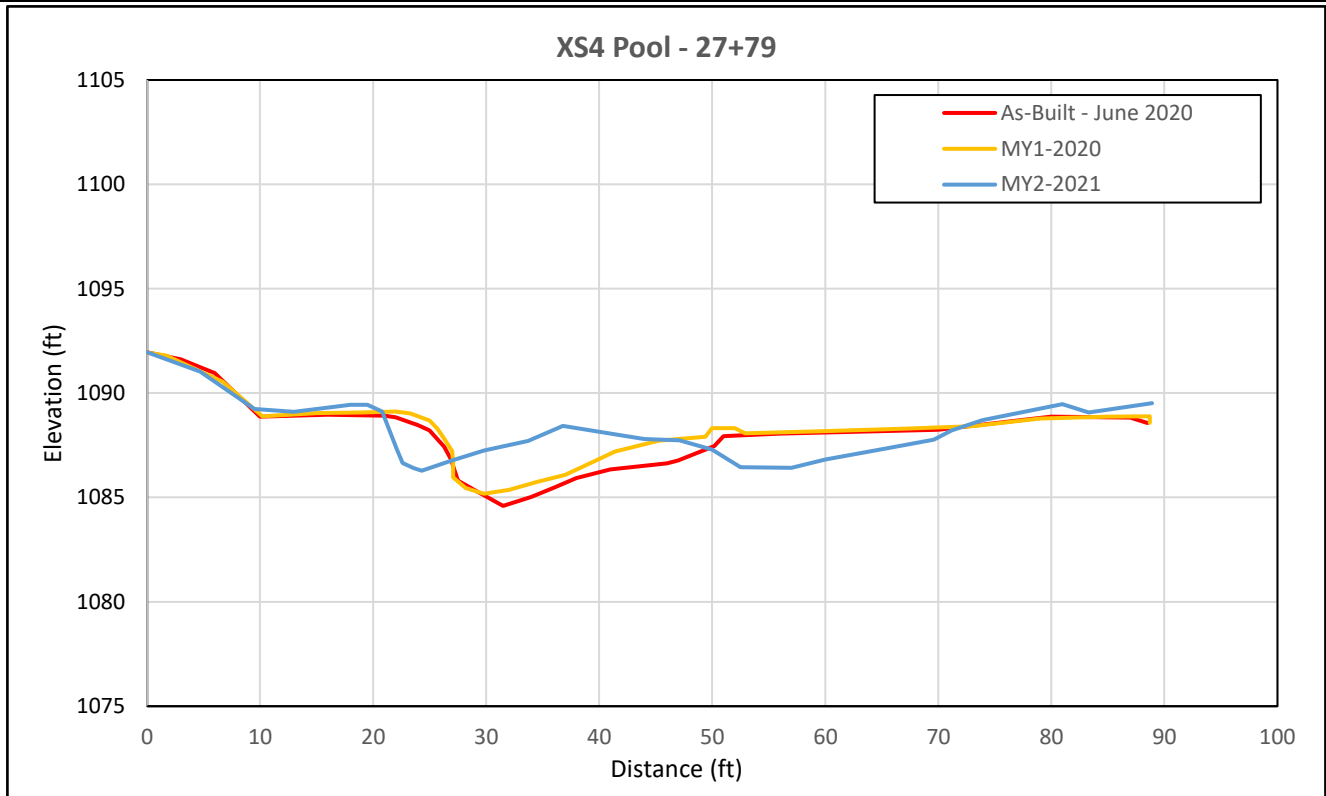
XS4 looking downstream

MY0	MY1	MY2	MY3	MY4	MY5	MY+
Bankfull Elevation - Based on AB Bankfull Area	1087.94	1088.59	1088.26				
Bank Height Ratio - Based on AB-Bankfull Area	1.00	0.80	1.61				
Thalweg Elevation	1084.60	1085.18	1086.29				
LTOB Elevation	1087.94	1087.91	1089.47				
LTOB Max Depth	3.34	2.73	3.18				
LTOB Cross Sectional Area	47.12	31.39	115.69				
Entrenchment Ratio	N/A	N/A	N/A
