STILLHOUSE CREEK STREAM RESTORATION – Project # 363
Orange County, NC

Mitigation Plan – As-built Report
FINAL

Table I. Project Restoration Components
Stillhouse Creek Stream Restoration – EEP Project #363

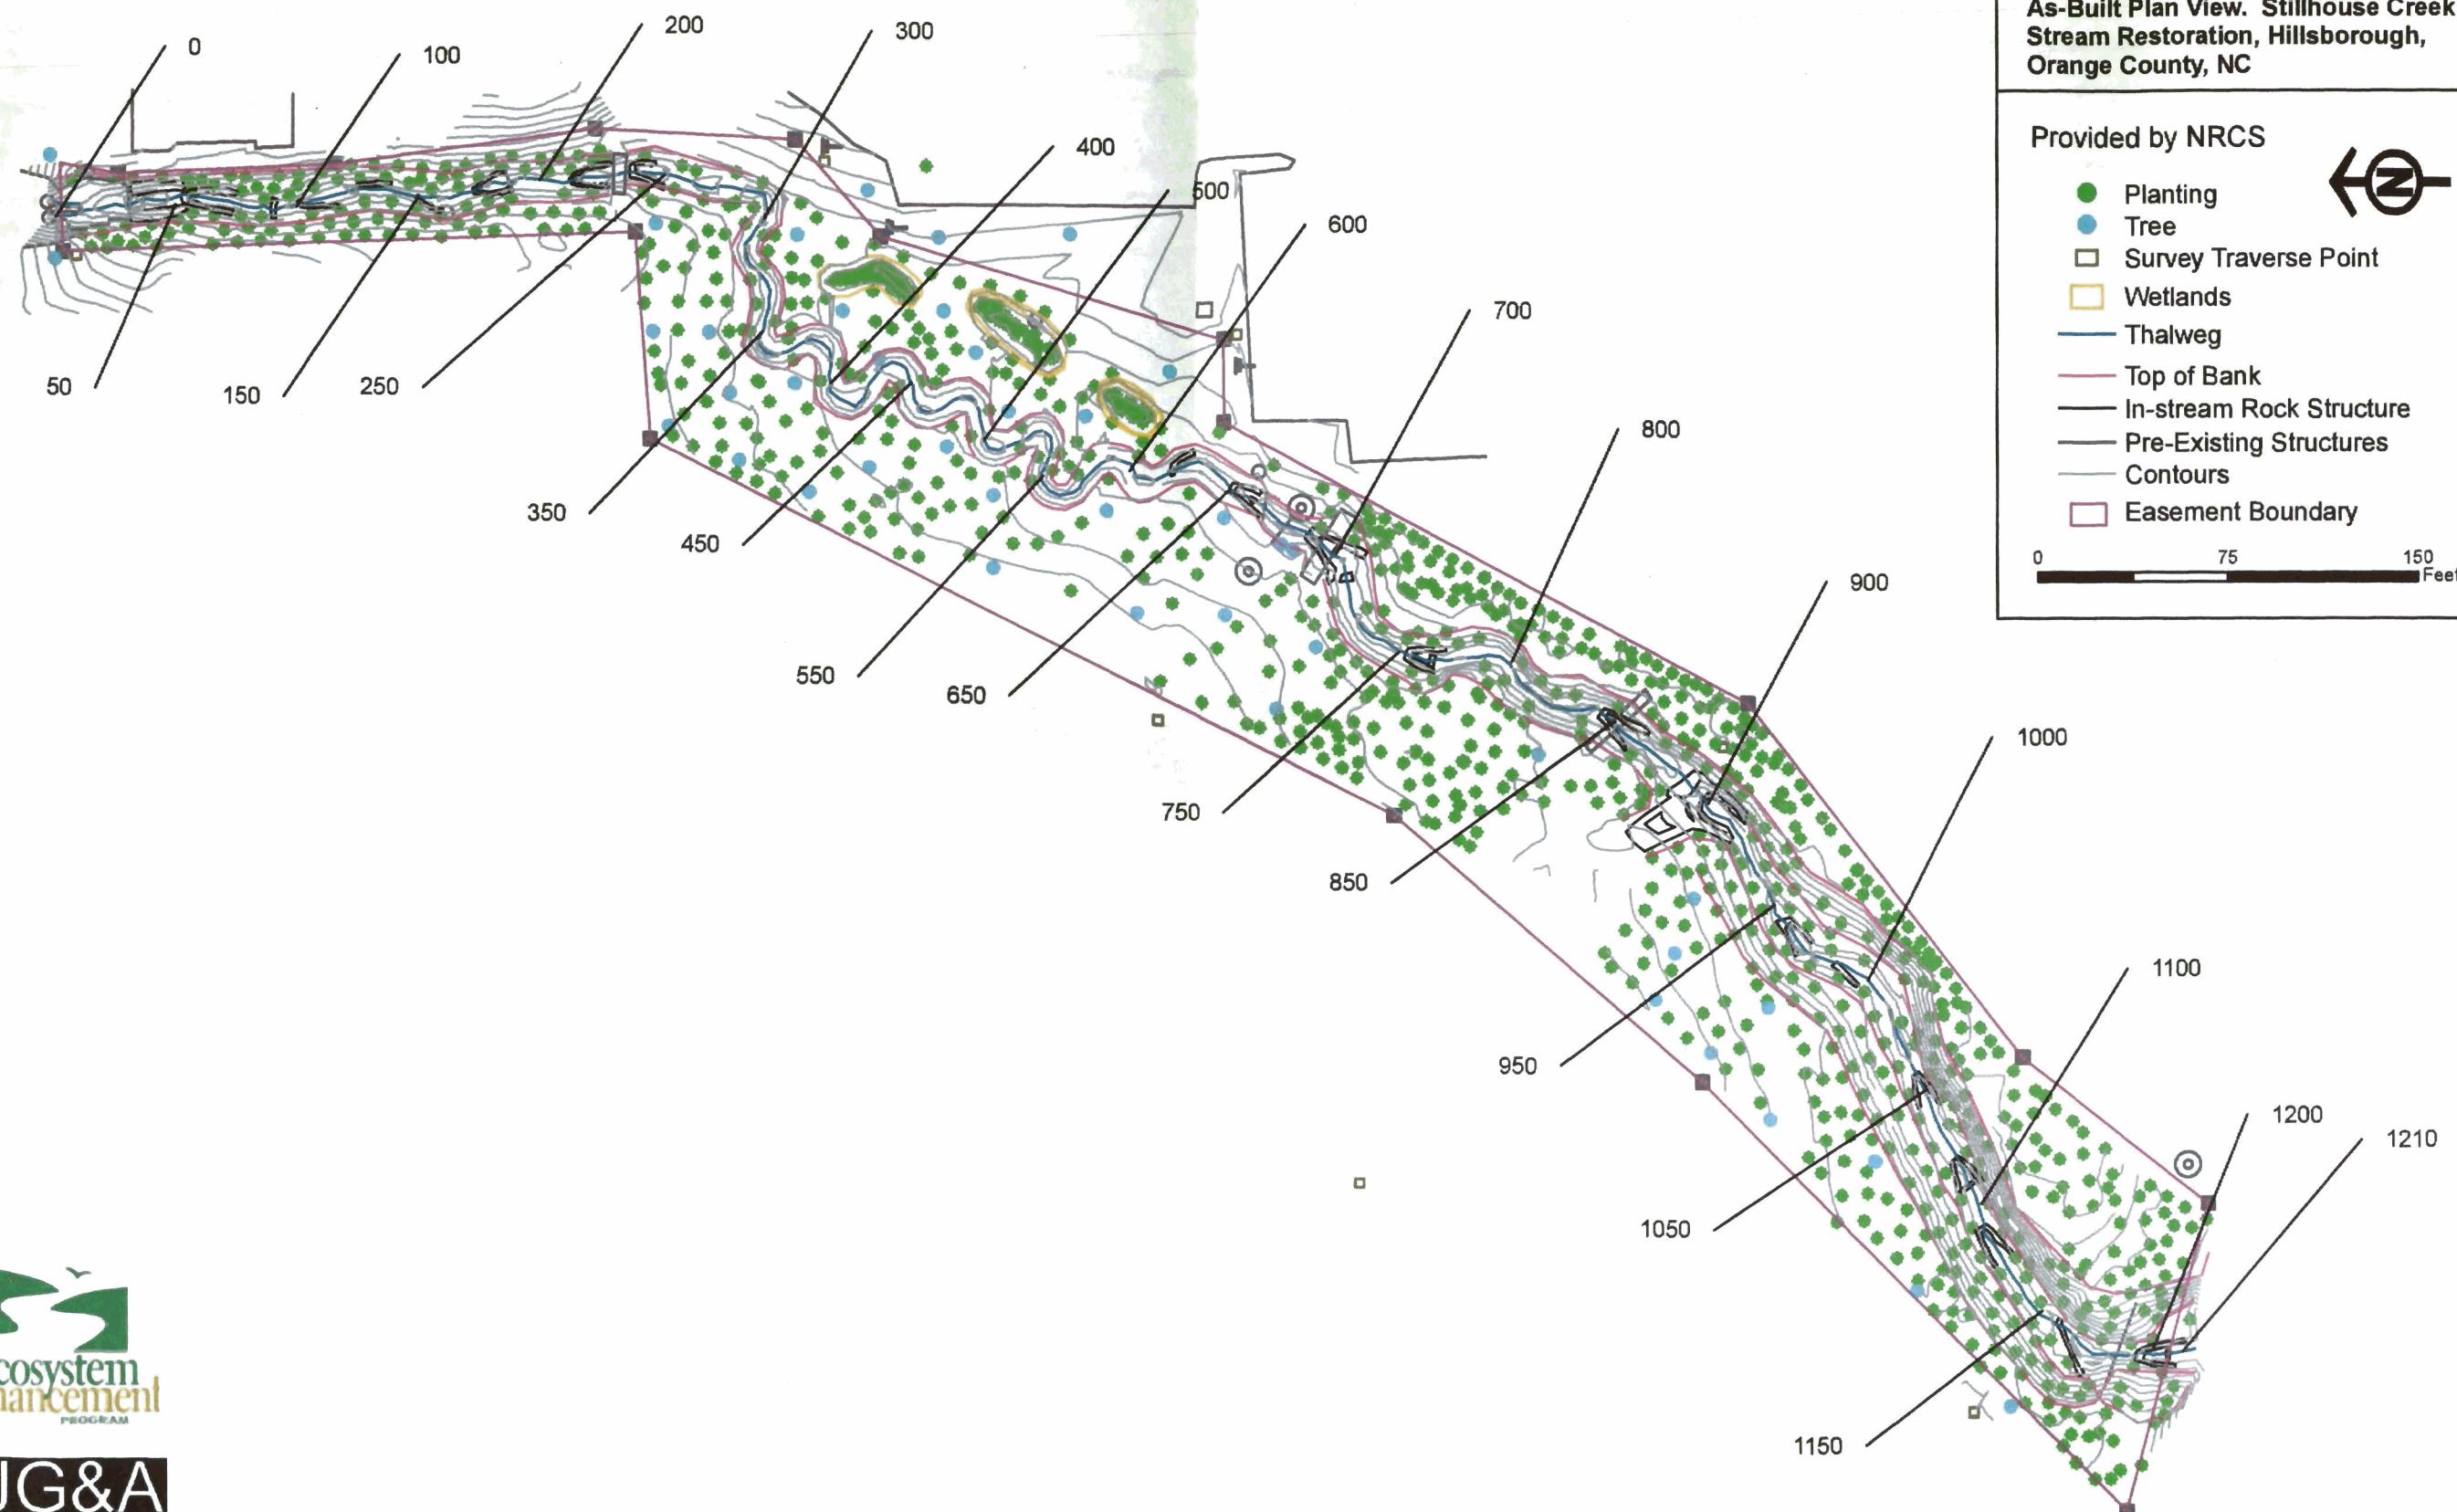
**As-Built Plan View. Stillhouse Creek
Stream Restoration, Hillsborough,
Orange County, NC**

A comparison of the design to as-built pattern parameters of Reaches 1-3 of Stillhouse Creek reveals a smaller average radius of curvature and meander wavelength in the as-built state, resulting in a shorter thalweg length. This may be due to the decrease in number and severity of meanders (Appendix A and F). Reach 4 parameters remain similar to those of the design.

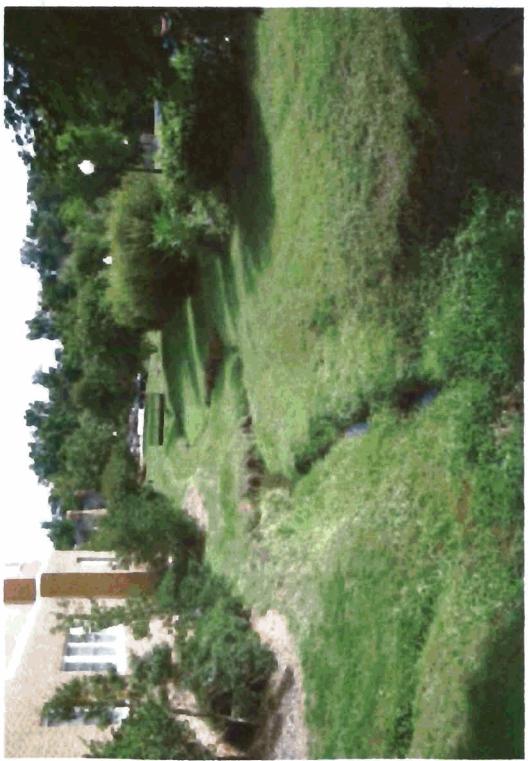
Pre-existing condition - August 2005

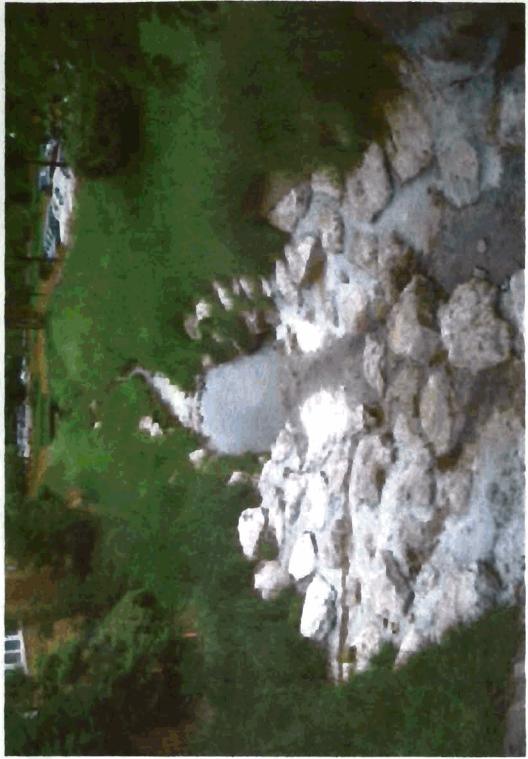
As-built state - May 2006

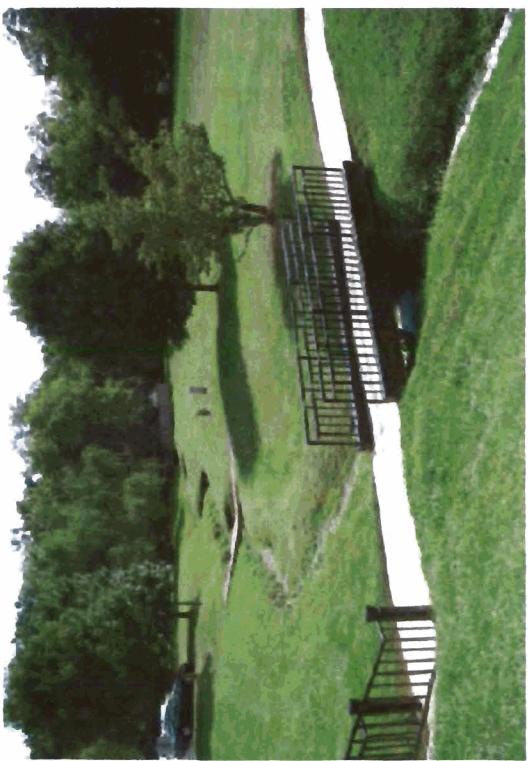
Pre-existing condition - August 2005

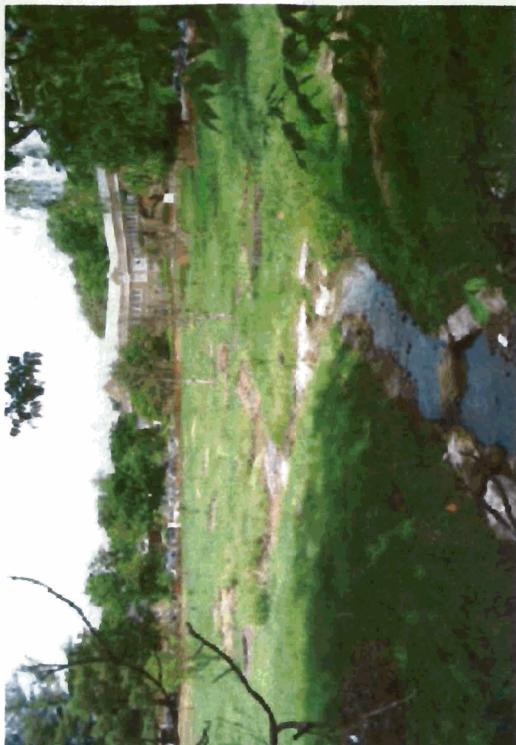
As-built state - May 2006

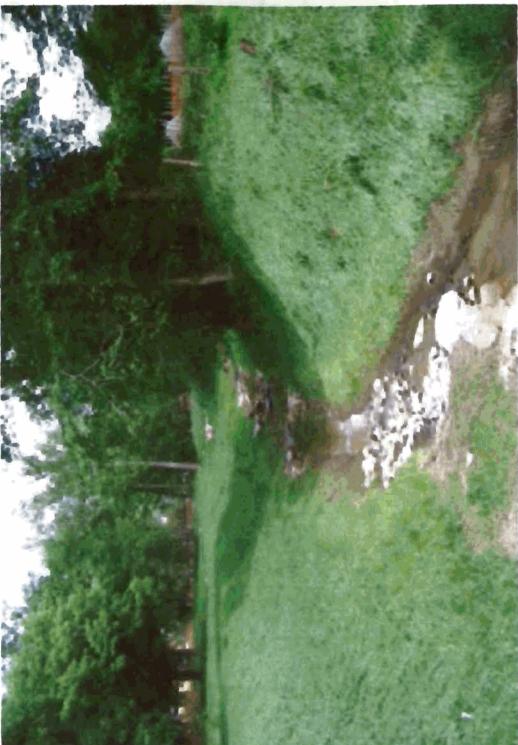
As-built state - May 2006

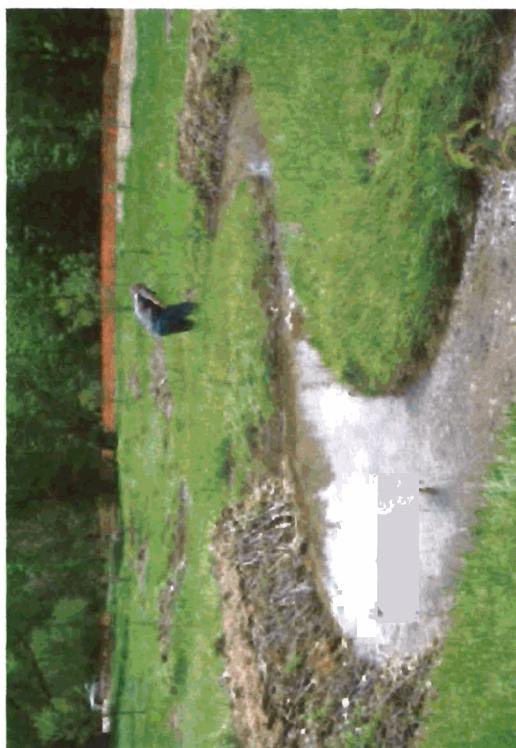
As-built state - May 2006

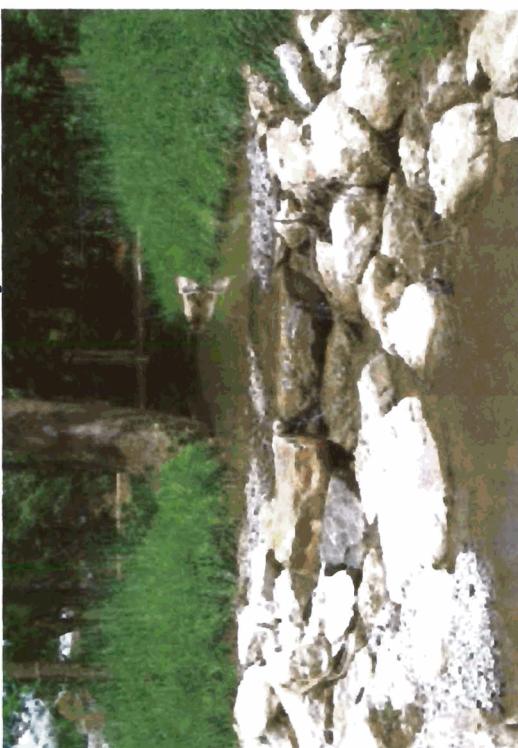
As-built state - May 2006

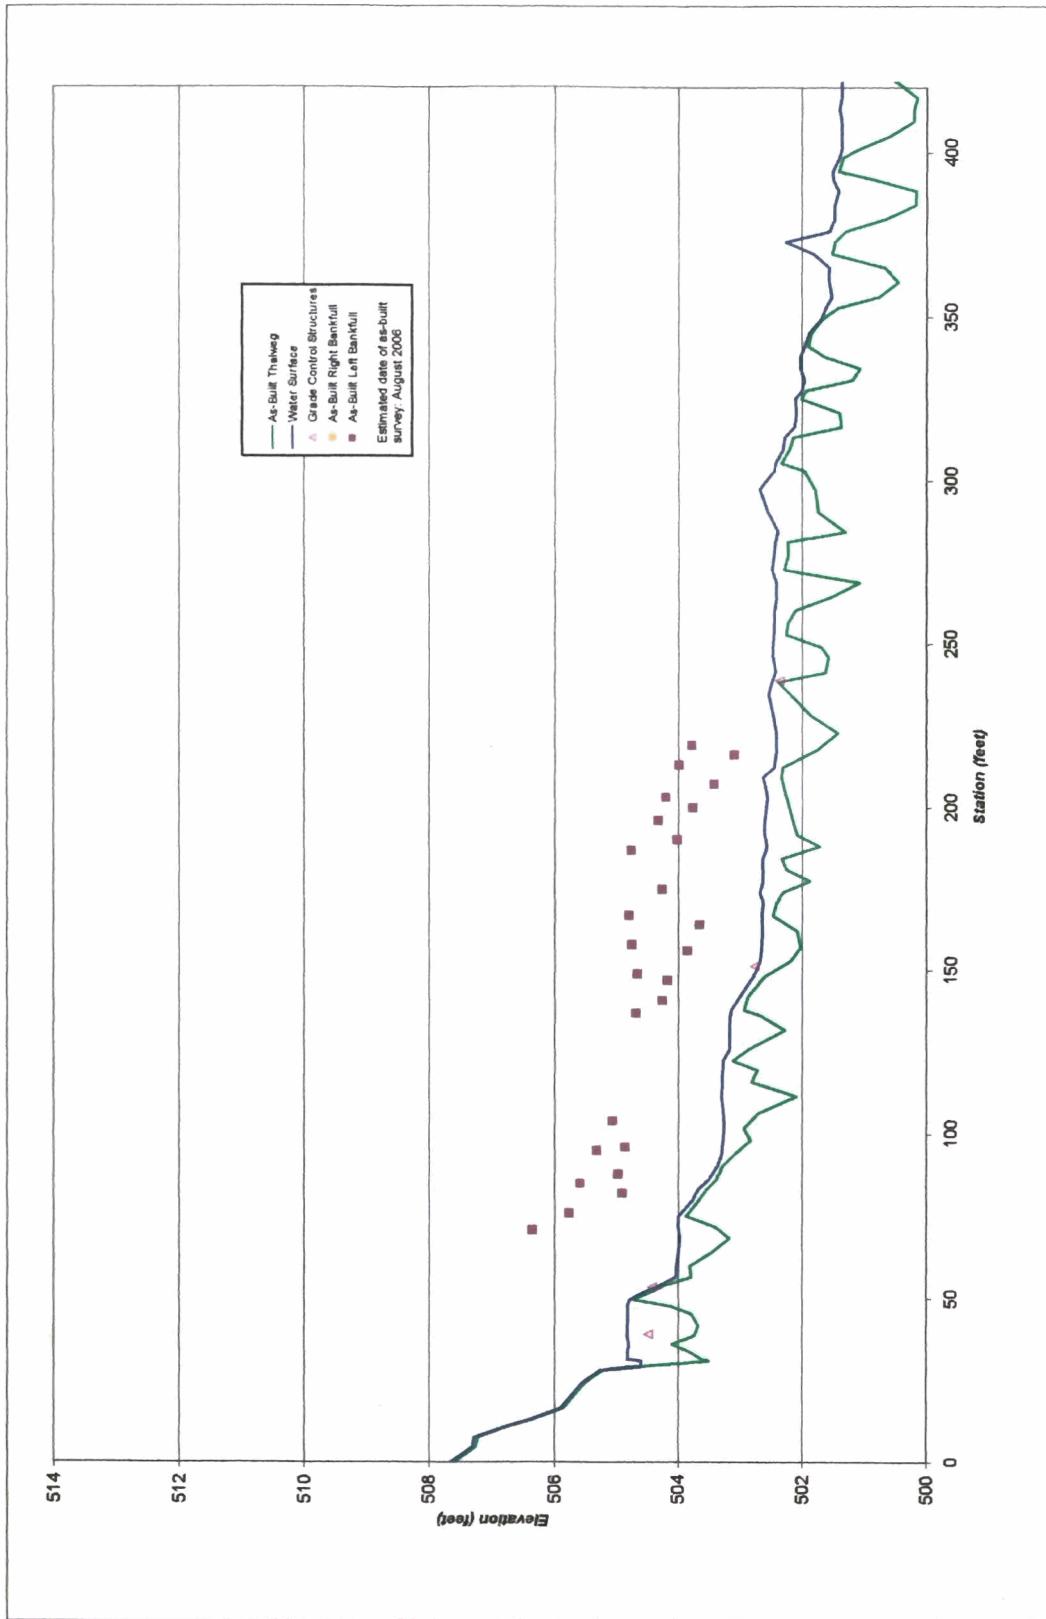
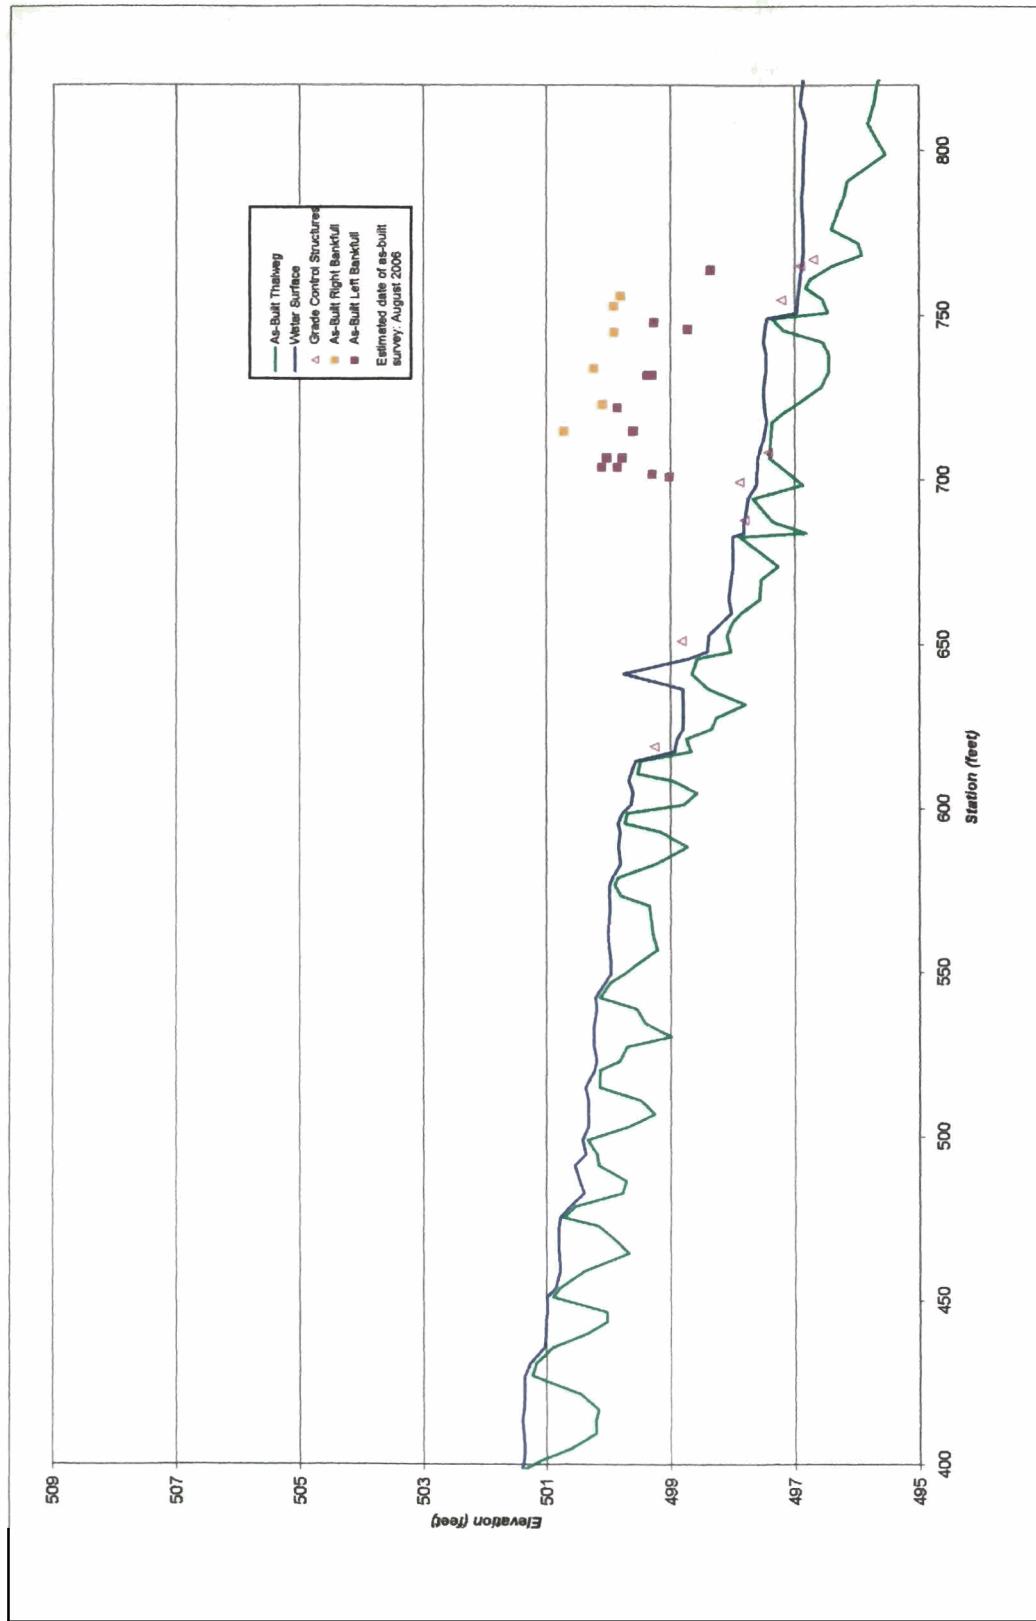
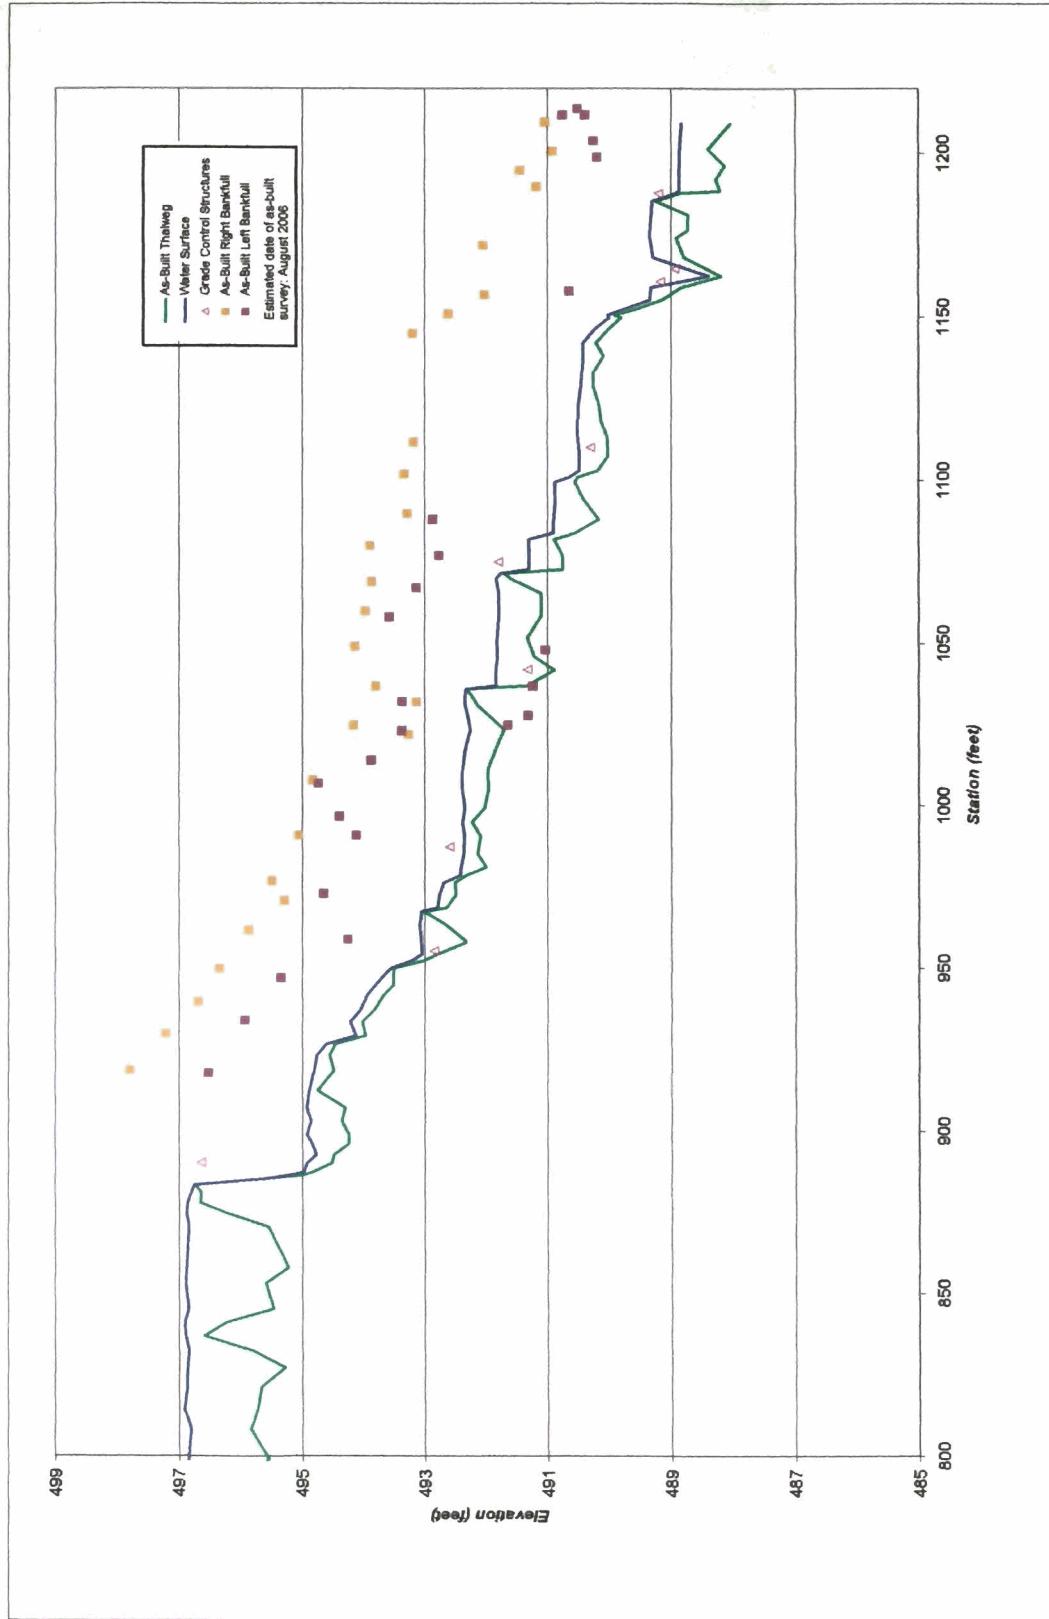
Longitudinal Profile - As-Built Survey - Stillhouse Creek Stream Restoration - EEP Project #363
Stationing 0 - 400

A comparison of the design to as-built profile parameters throughout Stillhouse Creek reveals an increase in average riffle slope and water surface slope in the as-built state, as well as a decrease in pool spacing. A steeper riffle may also result in a shorter riffle, and potentially a smaller distance between pools (Appendix B and F).
