STILLHOUSE CREEK STREAM RESTORATION – Project # 363
Second Annual Monitoring Report –Final
January 2009

STILLHOUSE CREEK STREAM RESTORATION – Project # 363
Second Annual Monitoring Report –Final

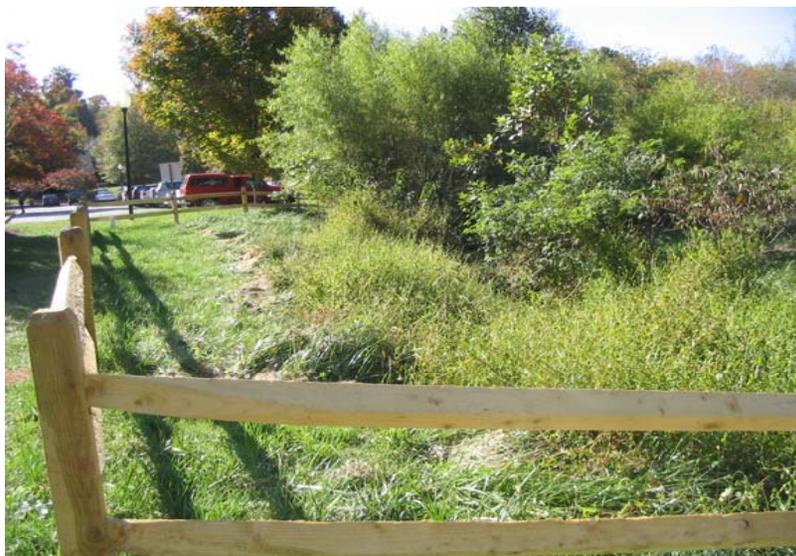
VP1 (10/28/2008)

Two vegetation problem areas were identified in Reach 2 (Figure B.1., Table 1). The area close to the first foot-bridge (Stations 235-300) was probably insufficiently planted at the time of construction. The second vegetation problem area in Reach 2 (Stations 320-530) has experienced poor survival of planted woody stems and continues to be dominated by fescue. At this point, no remedial action is recommended, but the areas should be observed and replanting may be necessary in the future.

Table 6. Vegetation Problem Areas – Stillhouse Creek Stream Restoration			
EEP Project #363			
Feature/Issue	Station/Range	Probable Cause	Photo #
Limited woody stem planting/survival	235-300	Planting oversight	VP1
Low planted woody stem vigor	320-530	Soil compaction and/or competition from fescue	VP2
Low planted woody stem vigor	1000-1060	Soil compaction	VP3

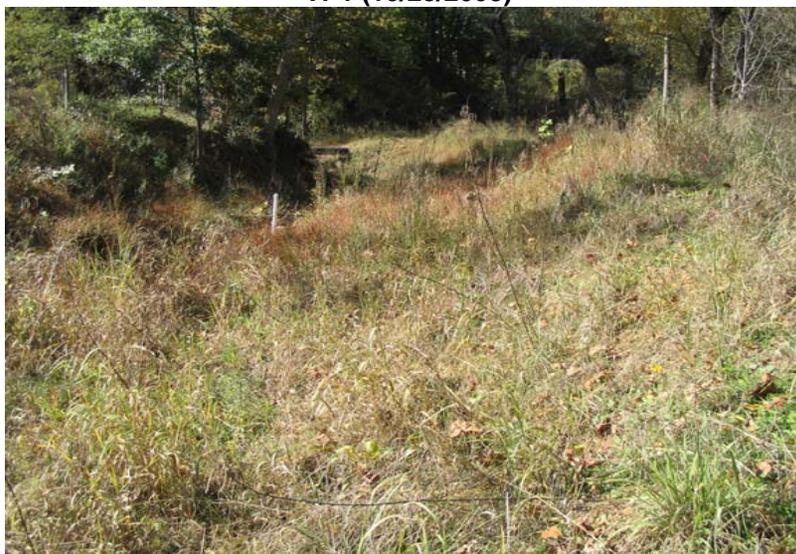
VP3 (10/28/2008)

In Reach 3 (Figure B.1.) the right top of bank area near cross-sections 4 and 5 (Stations 1000-1060) has a low survival of planted woody vegetation. Although, sedges and other non-woody vegetation are well-established in this area, it should be monitored in case remedial action is needed in the future. No remediation is recommended at this time.

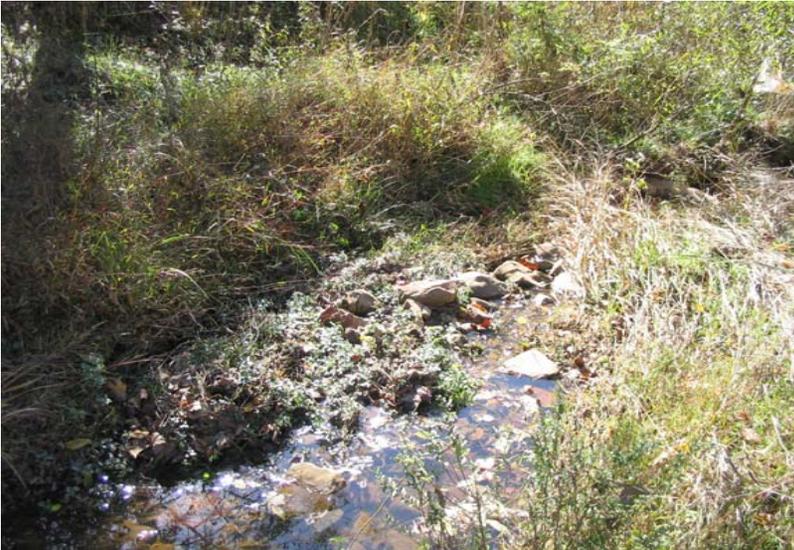
SP1 (10/28/2008)

Feature/Issue	Station	Suspected Cause	Photo #
Aggradation/bar	918	Insufficient flow	SP1
Aggradation/bar	1006	Insufficient flow	SP2
Piping	1047	Insufficient coarse backfill	SP3
Piping	1082	Insufficient coarse backfill	SP3
Vane not holding grade	1197	Height not appropriate	SP4
