East Prong of the Roaring River at Stone Mountain State Park Stream Restoration

Annual Monitoring Report

Monitoring Year: 2006

NCEEP Project Number: 364

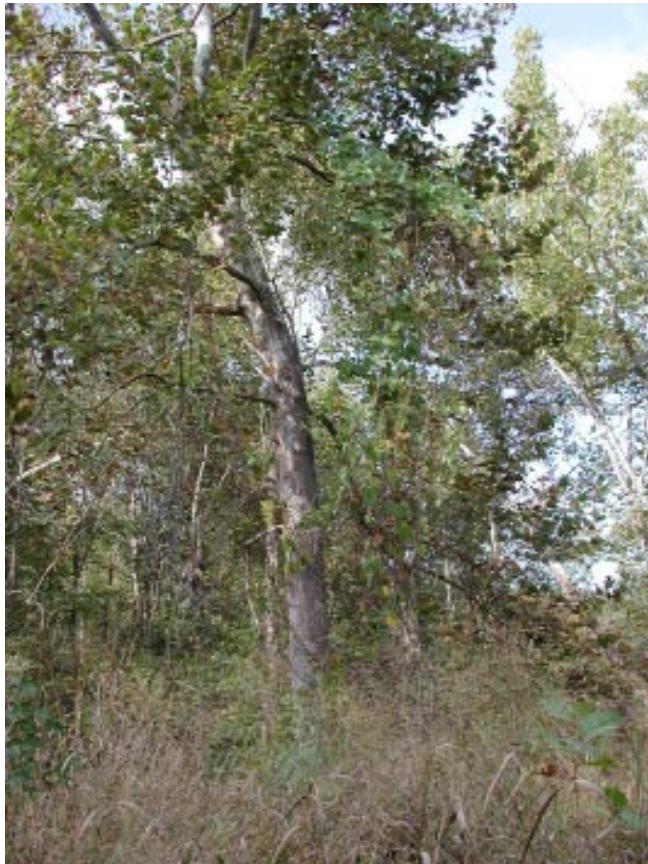
Invasive vegetation control was again not employed this growing season. Maintenance is highly recommended for next season. Kudzu (*Pueraria lobata*) was observed in large patches throughout the area and continues regaining a strong foothold in areas where it had been continually maintained and controlled in past years.

PA38 Stone Mt. Reach 4. Kudzu

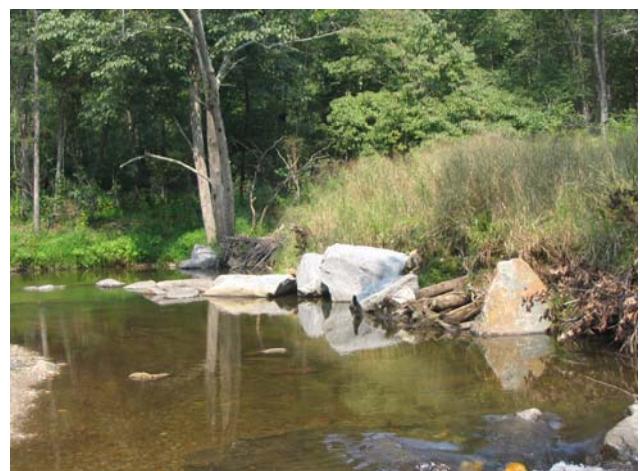
| Problem Number | Feature Issue | Station numbers | Suspected Cause | Photo number |
|---|--|---|---|---|
| PA 1 | Outside Meander Bend Erosion | 2+70 to 3+50 R2 | Poor deep rooting vegetation establishment Vane ineffective or improperly located | PA 1 |

PA1 Left Bank STA 3+50 Bank Erosion

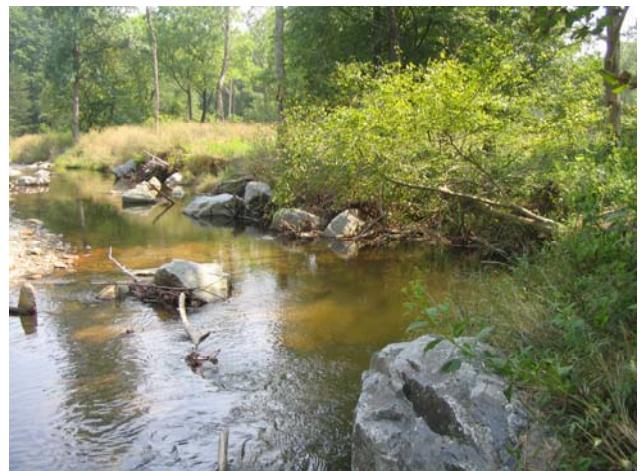
PA2 Looking Down stream STA 5+75 Right Bank Erosion

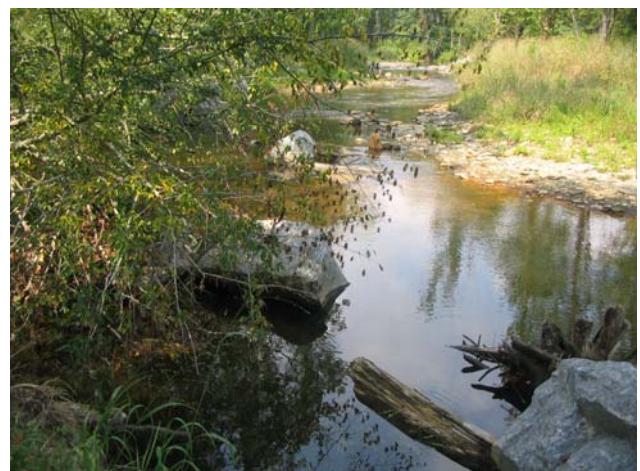
PA3 Looking Upstream STA 6+25 Right Bank Erosion

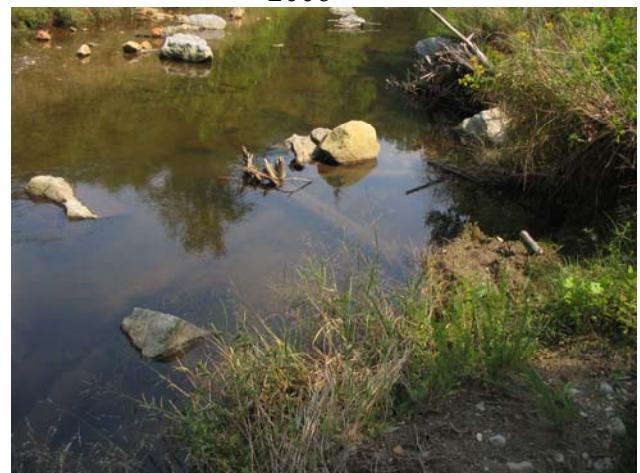
PA4 Look from Right Bank STA 6+50 Root Wads Bank Erosion

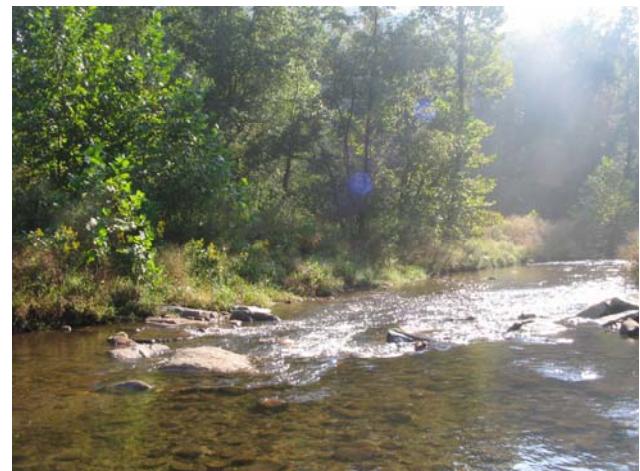
PA5 Looking Upstream STA 7+00 Rock Cross-Vane

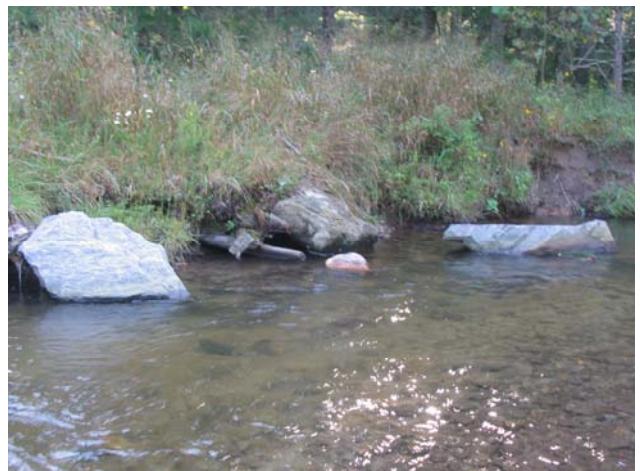
| Problem Number | Feature Issue | Station numbers | Suspected Cause | Photo number |
|---|--|---|---|---|
| PA 6 | Outside Meander Bend Erosion | 9+50 to 10+00 R2 | Poor deep rooting vegetation establishment Vane ineffective or improperly located | PA 6 and 7 |

PA6 Left Bank Root Wads and Boulders STA 10+00

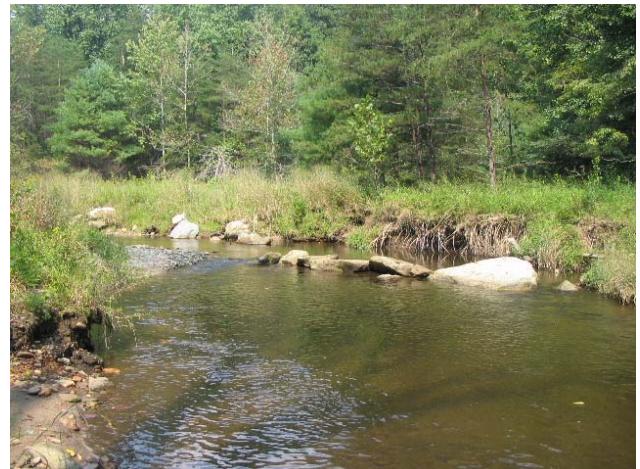
PA7 Looking Upstream STA 10+75 at J-hook and Left Bank Erosion

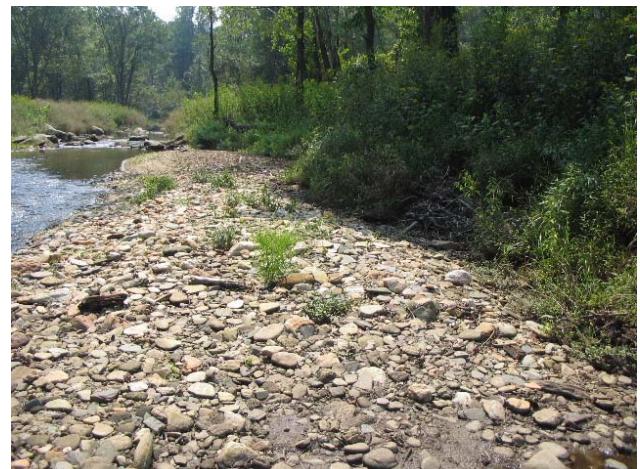
PA8 Looking Downstream STA 11+00 Lateral Channel Bar and Bank Erosion

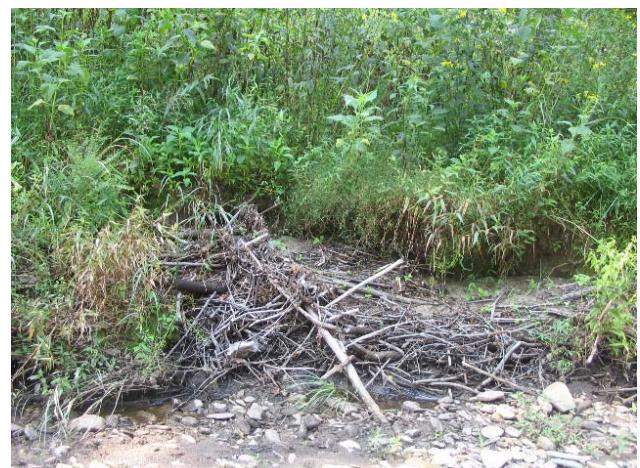
PA9 Right Bank Erosion STA 11+25

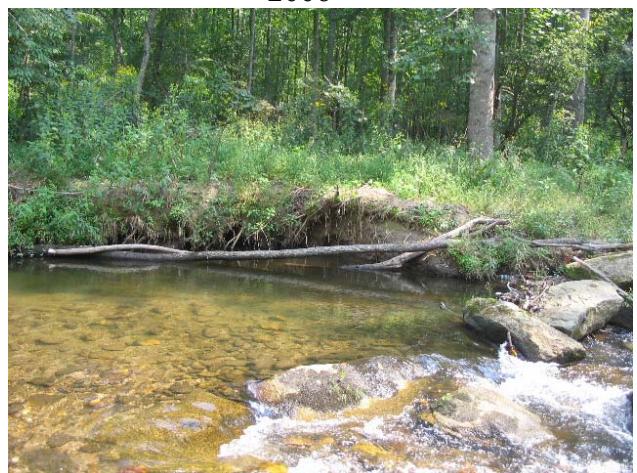
PA10 Left Bank STA 11+25 Erosion Behind Vane

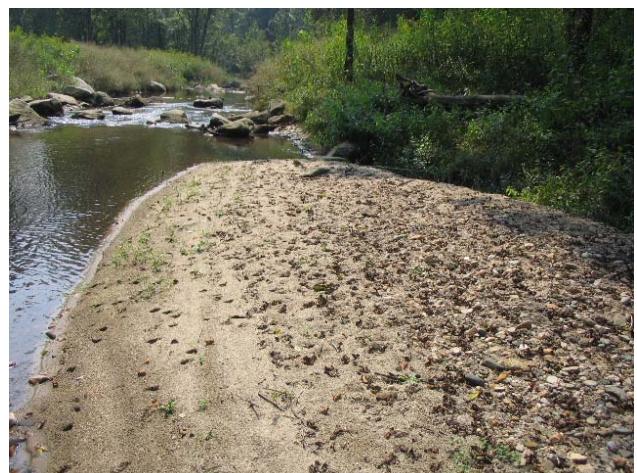
PA11 Looking Downstream STA 11+50 Lateral Bar

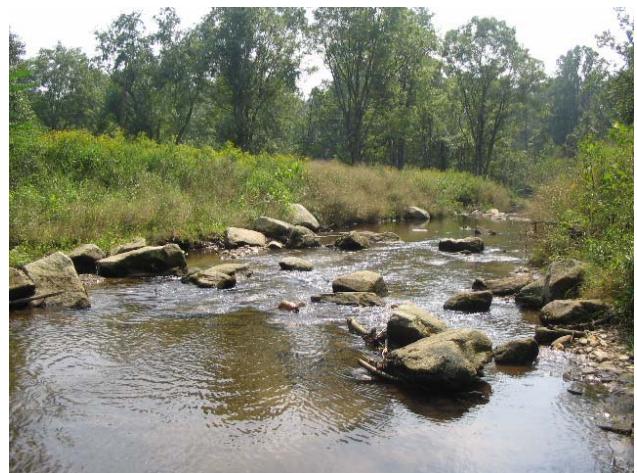
PA12 Looking Upstream STA 11+75 Random Boulder Cluster

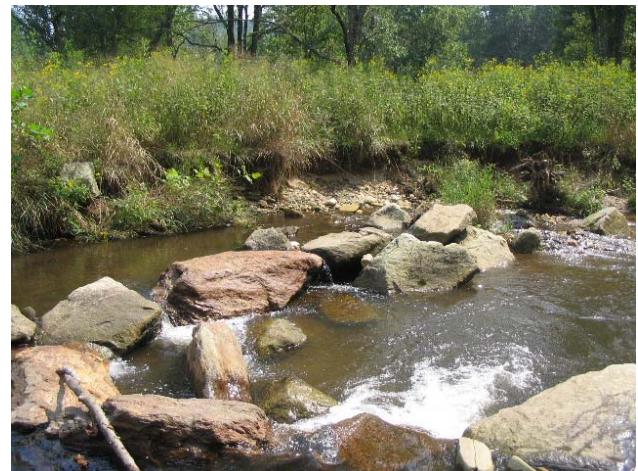
| Problem Number | Feature Issue | Station numbers | Suspected Cause | Photo number |
|---|--|---|---|---|
| PA 13 | Stream cutting around left arm of cross vane. | 13+30 - R2 | Lack of deep rooting vegetation Matting on repair area not adequately secured | PA 13 and 14 |

PA 13 Looking Downstream STA 13+00 Bank Erosion and Piping around Structure Arm

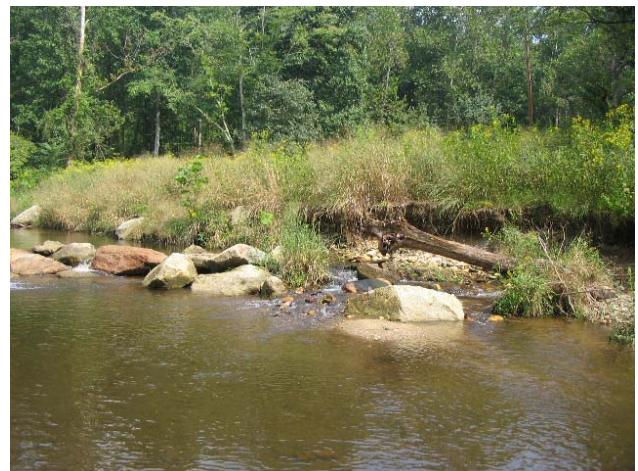
PA 14 Looking Upstream STA 13+75 Bank Erosion Left Bank

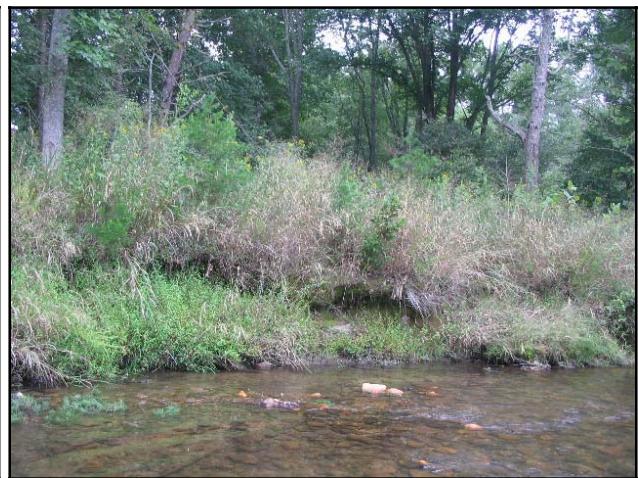
PA 21 Left Bank Erosion STA 19+00

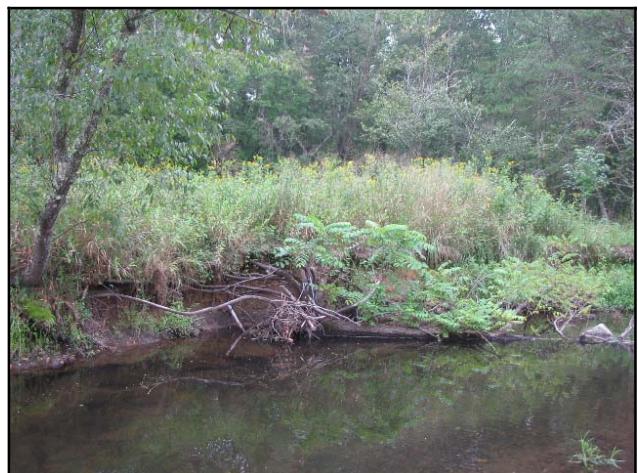
PA 22 Looking Downstream STA 20+25 Left Bank Erosion

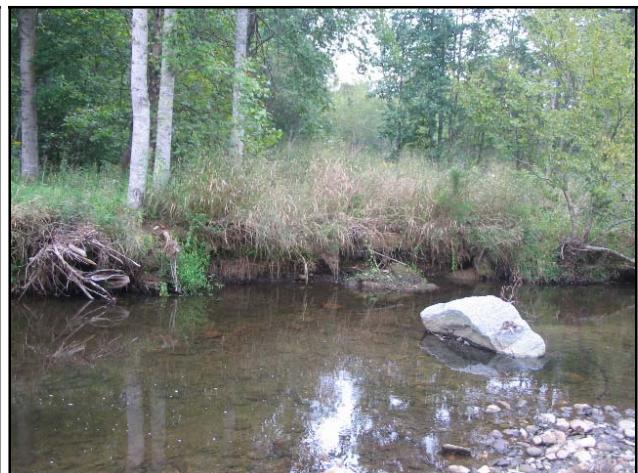
PA 23 Left Bank Erosion and Migration STA 20+75

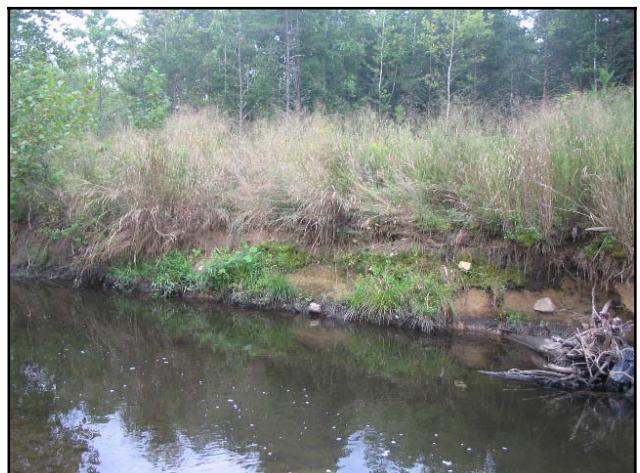
PA 27 Right Bank Erosion and Migration Lower Third of Meander STA 24+25

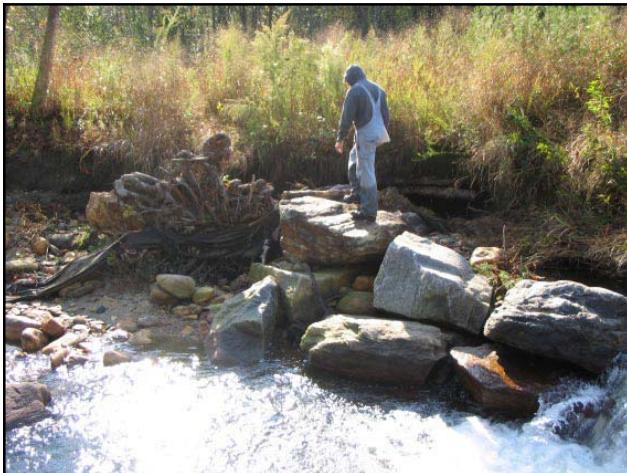
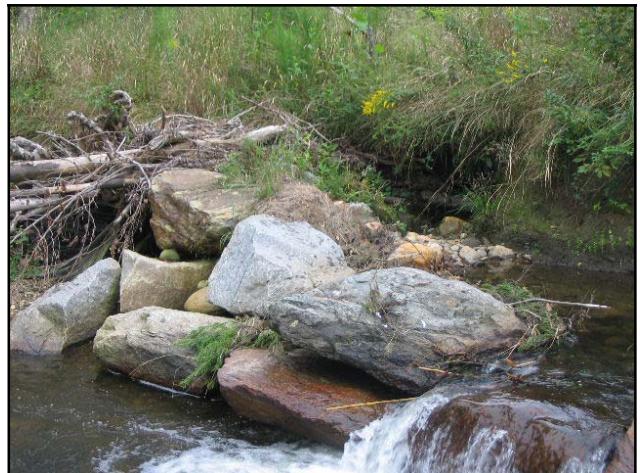
PA 28 Failed Rock Cross Vane Piping Behind Right Vane Arm STA 25+00

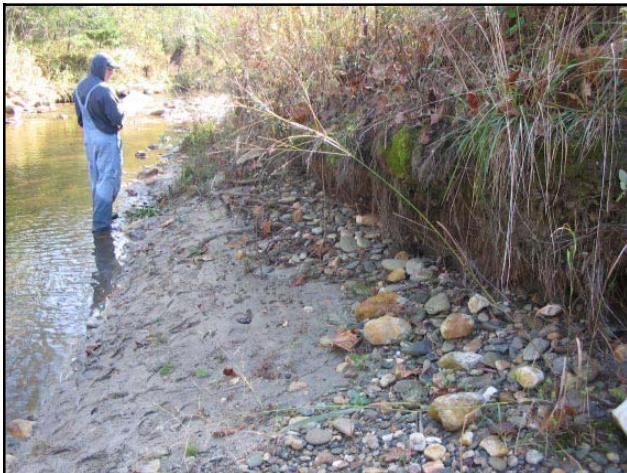
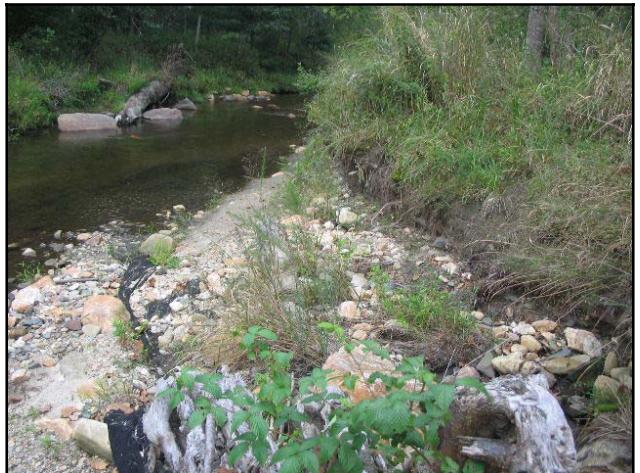
PA 29 Right Undercut Bank Below Rock Vane 25+25

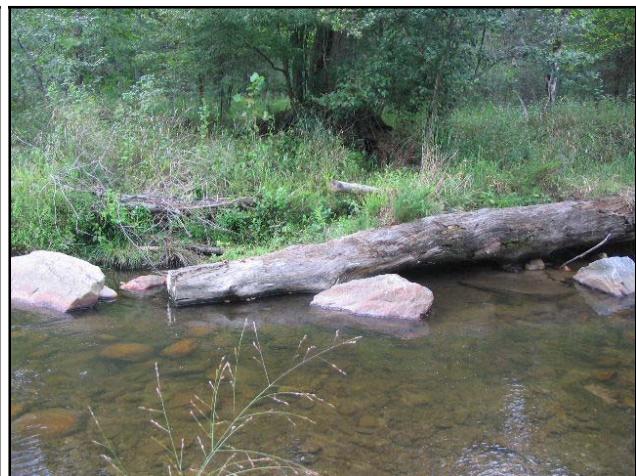
| Problem Number | Feature Issue | Station numbers | Suspected Cause | Photo number |
|---|--|---|---|---|
| PA 30 | Log vane piping and scour behind | 26+00 to 26+80 | Lack of deep rooted vegetation Improper placed vane | PA 30 |

PA 30 Failed Log Vane Left Bank 26+00

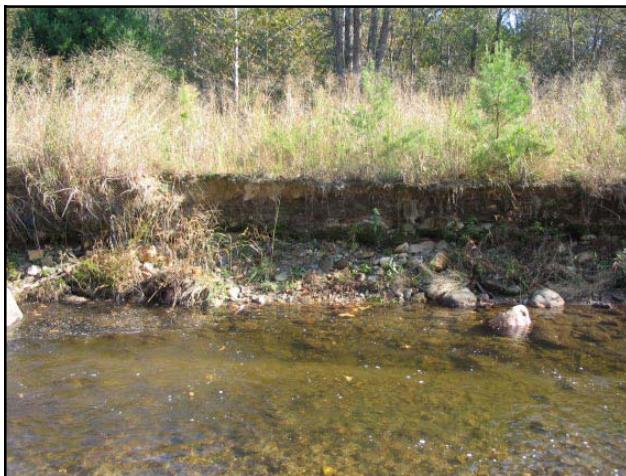
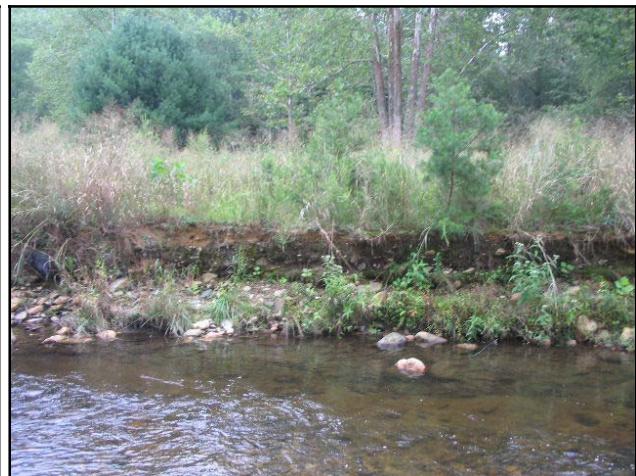
| Problem Number | Feature Issue | Station numbers | Suspected Cause | Photo number |
|---|--|---|---|---|
| PA 31 | Sever left bank erosion and J-hook cut around | 29+20 to 29+30 | Lack of deep rooted vegetation Improper placed vane | PA 31 |

PA 31 Failed Log J-Hook Left Bank Erosion and Migration STA 29+50

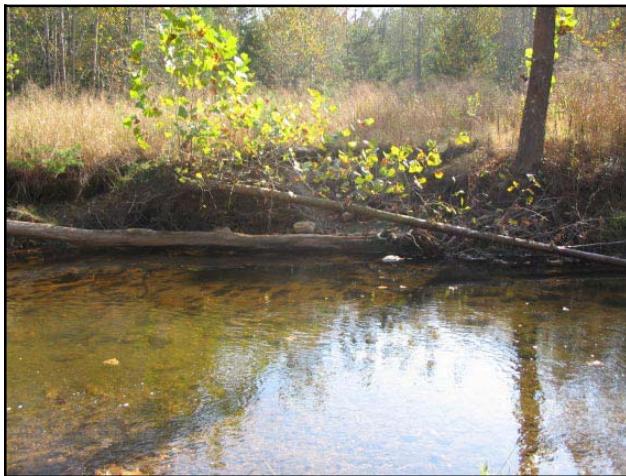
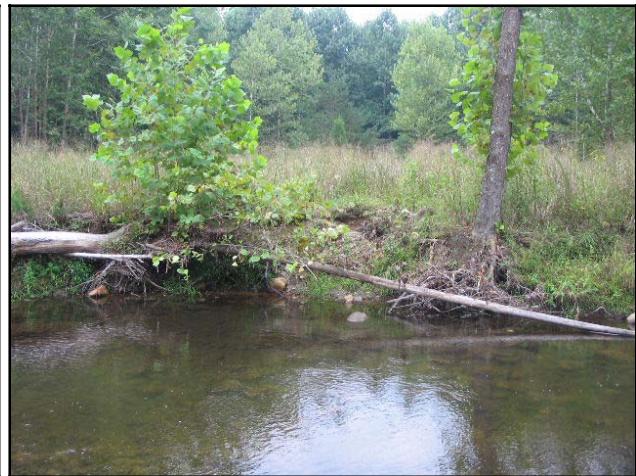
PA 32 Left Bank Erosion and Migration STA 29+75

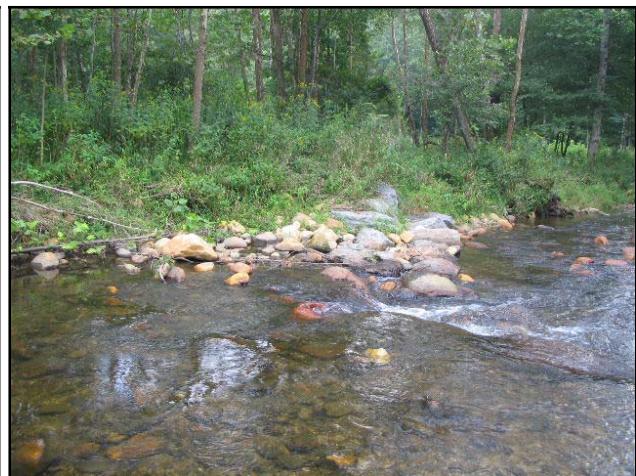
| Problem Number | Feature Issue | Station numbers | Suspected Cause | Photo number |
|---|--|---|---|---|
| PA 33 | Scour behind left vane are and piping | 30+40 to 30+80 | Lack of deep rooted vegetation Improper placed vane | PA 33 |

PA 33 Left Bank Erosion STA 30+50

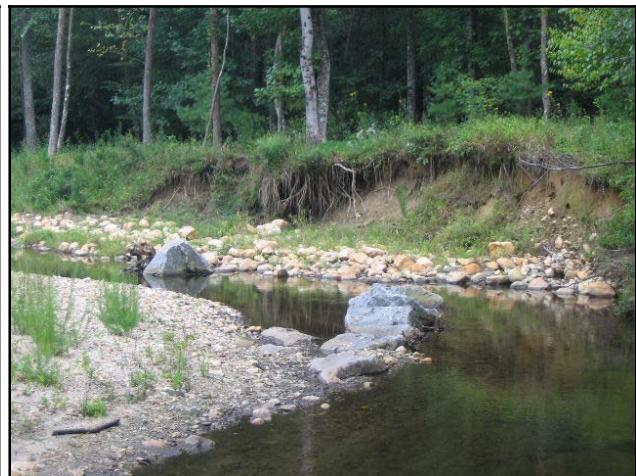
PA 34 Looking Downstream STA 32+50 Right Bank Erosion

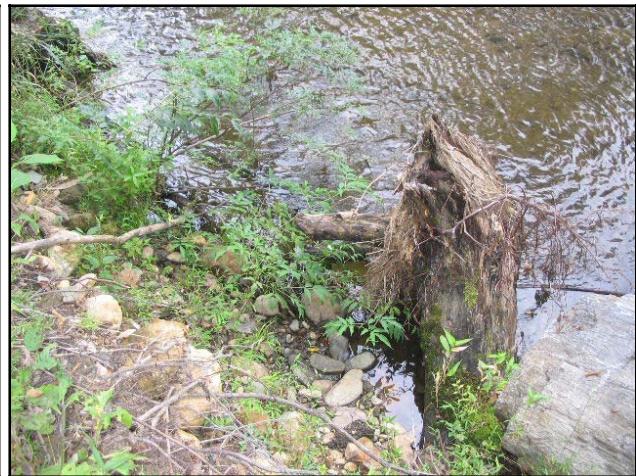
PA 35 Right Bank Exposed Root Wad STA 32+50
