ANNUAL MONITORING REPORT WILSON BAY (STURGEON CITY) PHASE II

WETLAND RESTORATION ONSLOW COUNTY, NORTH CAROLINA (EEP Project Number .00091)

Monitoring Year 3 of 5 (2006)

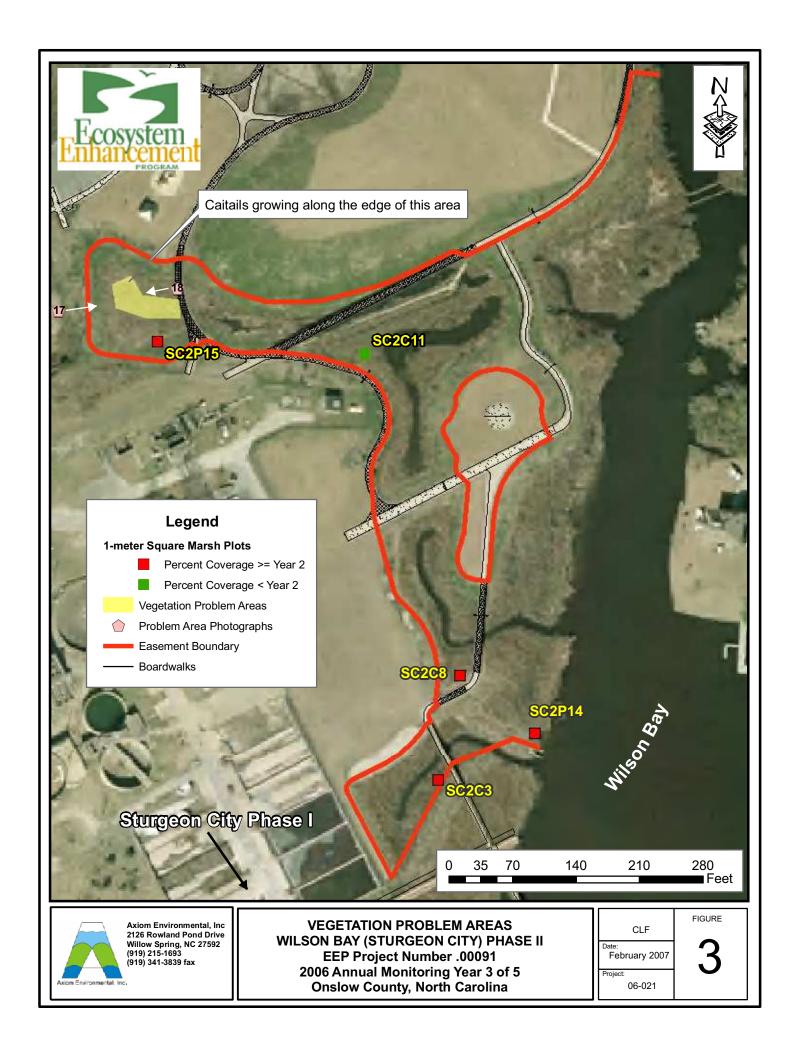
Vegetation problem areas within the Site are depicted on Figure 3 and are outlined in Table 6. An area along the northernmost and westward trending creek has a small colony of *Typha latifolia* growing within the area of *Spartina cynosuroides*. This may be a result of freshwater runoff from the adjacent parking area. This situation should be watched and control measures initiated, if necessary.

Mowing close the marsh edge has damaged a small number of desirable species, but this is a minor problem and this area is recovering naturally.
