FINAL MY2 (2023) MONITORING REPORT

SWAMP GRAPE STREAM AND WETLAND MITIGATION SITE

Robeson County, North Carolina Lumber River Basin Cataloging Unit 03040204

DMS Project No. 100115
Full Delivery Contract No. 7869
DMS RFP No. 16-007705
USACE Action ID No. SAW-2019-00904
DWR Project No. 2019-0675

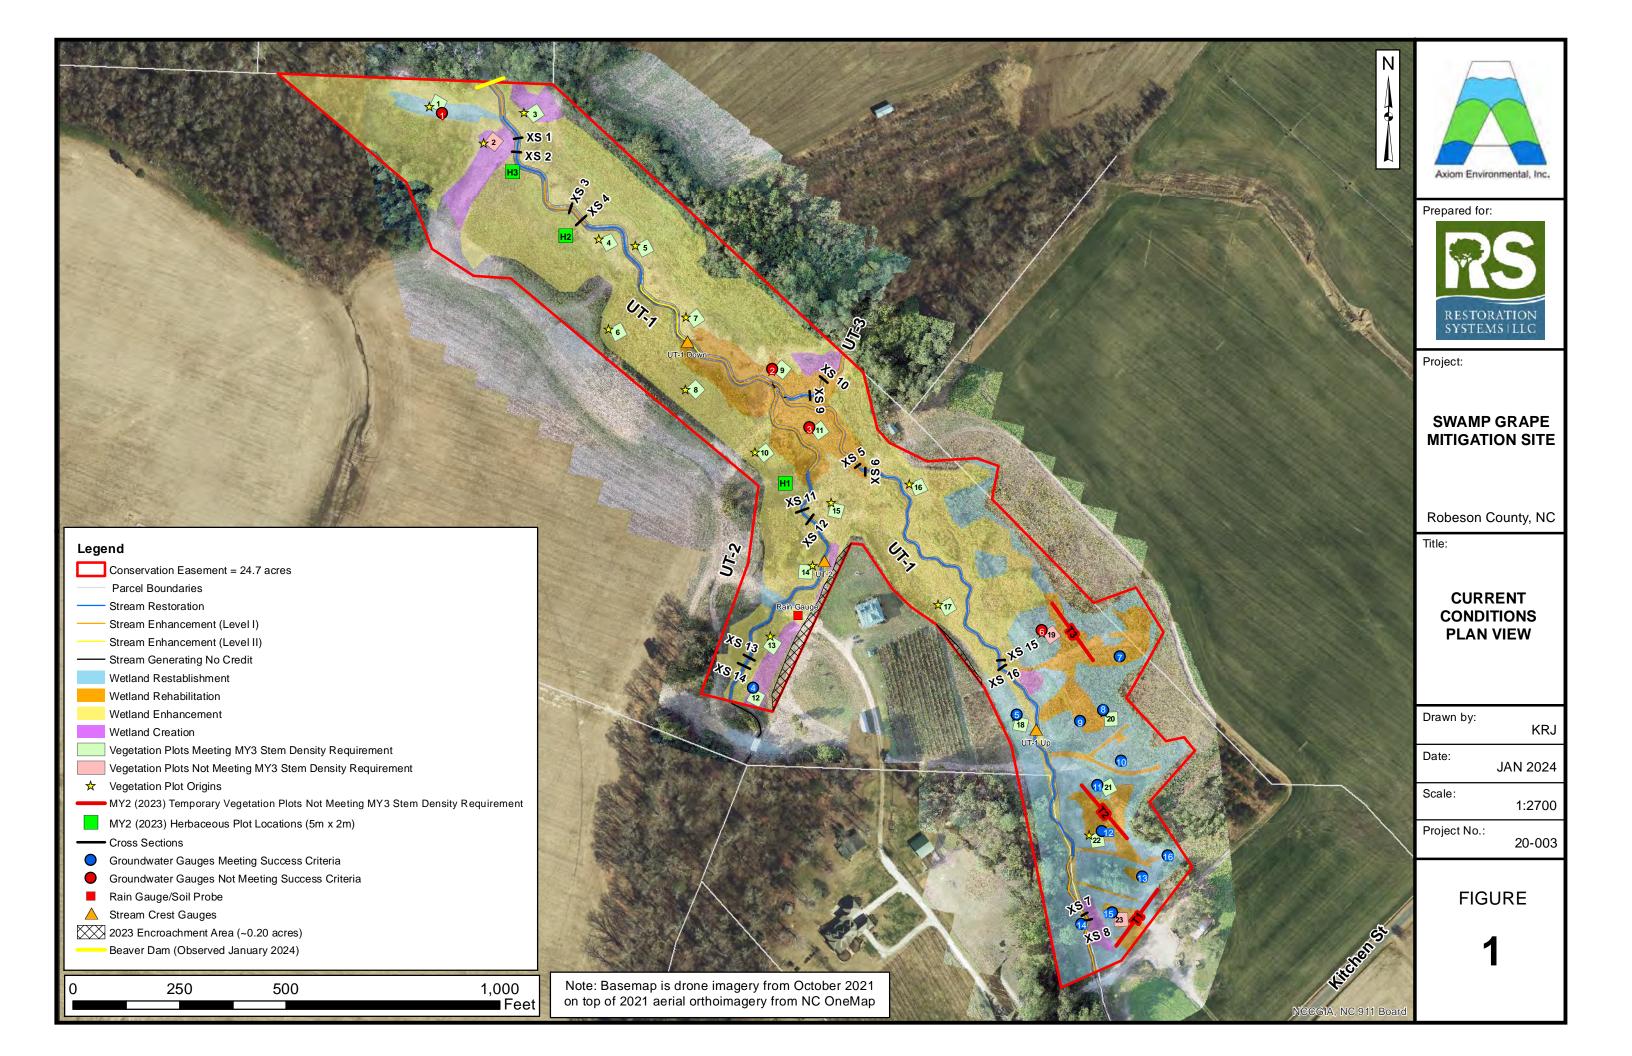
Figure 1. Current Conditions Plan View
Tables 4A-D. Stream Visual Stability Assessment
Table 5. Visual Vegetation Assessment
Vegetation Plot Photographs
Site Photo Log

1. During site visit a newly created beaver dam was observed on UT-1, on the downstream stream enhancement II reach, upstream of the conservation easement boundary. Overall, the site looked great. The location of the beaver dam was added to the report, CCPV, and digital submittal.

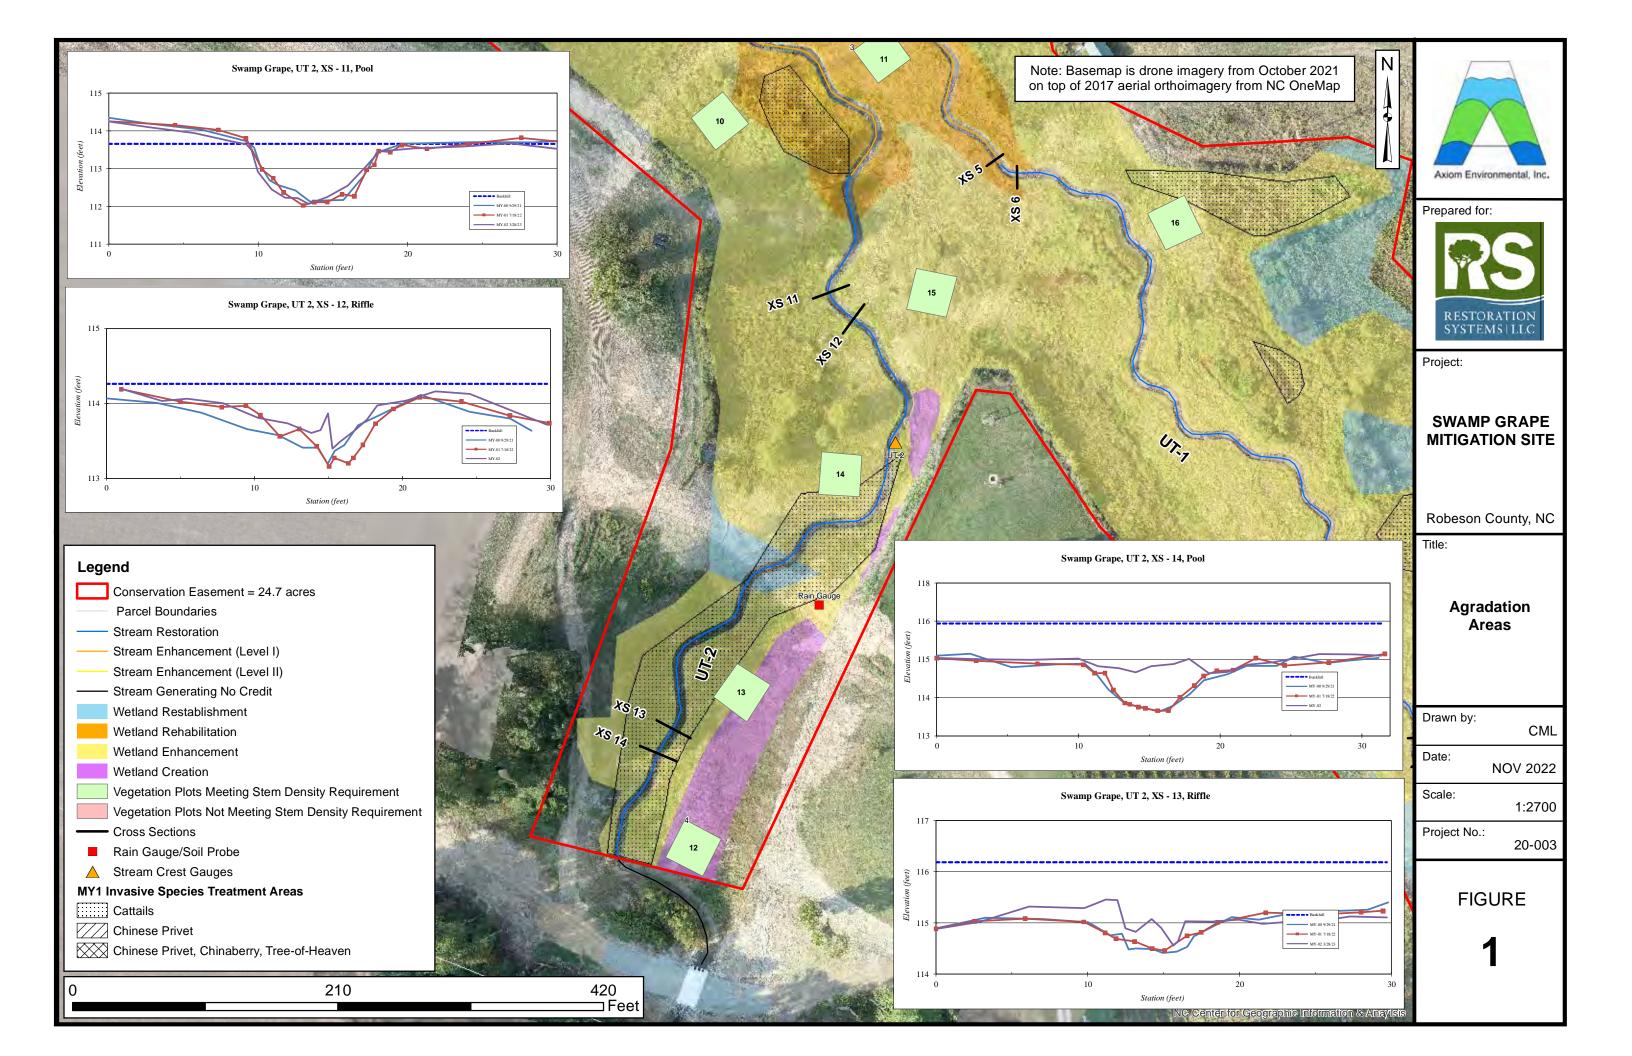
Swamp Grape Mitigation Site: MY2(2023) Observations of Aggregation, UT2 DMS Contract #: 7869; DMS Project ID: 100115; RFP # 16-007705

While conducting a quarterly site assessment walkthrough in May of Swamp Grape, Axiom Environmental Inc. (Axiom) noted that the upper reach of UT 2 has received excess sediment deposition. The aggregation begins above the UT2 vented-ford crossing, located outside the Site's conservation easement, and continues downstream through cross sections 14 (pool) and 13 (riffle). Minimal observance of aggregation was documented in cross-section 12 (riffle), and none was observed in cross-section 11 (pool).

Once the deposition was noted, Axiom conducted surveys of cross-sections 11-14 to ascertain the degree of aggradation. Cross sections are plotted in Figure 1, attached with photo documentation.
