Monitoring Year 5 (2016) Report

FINAL

Upper South Hominy Mitigation Site, South Hominy Creek, French Broad River Basin, Buncombe County, North Carolina

DMS Project Number: 92632

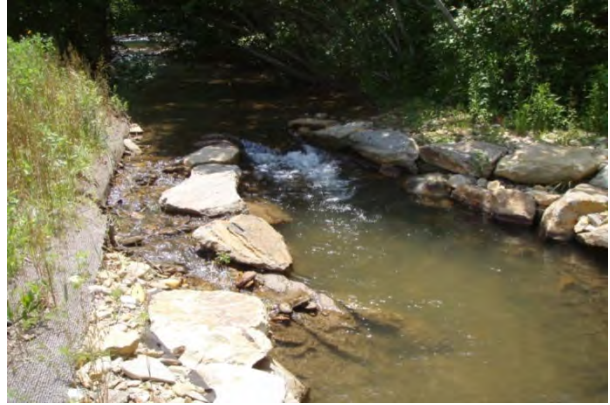
Rock vane after flood damage, sta. 1+50, facing upstream, 14 June 2012.

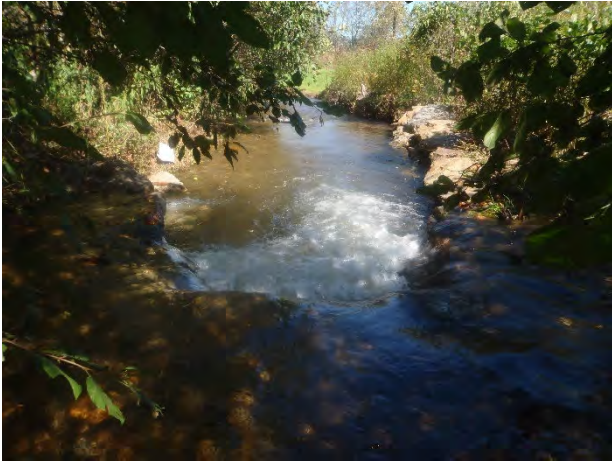
Problem Area 1

Repaired rock vane, sta 1+50 facing downstream 14 October 2015
No longer considered a problem during MY4 (2015) field surveys.

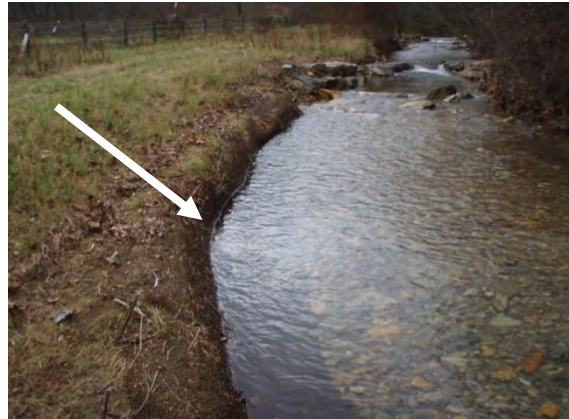
Problem Area 2

Right channel bank instability after flood damage, sta. 1+75 to 2+25, facing upstream, 5 December 2011.

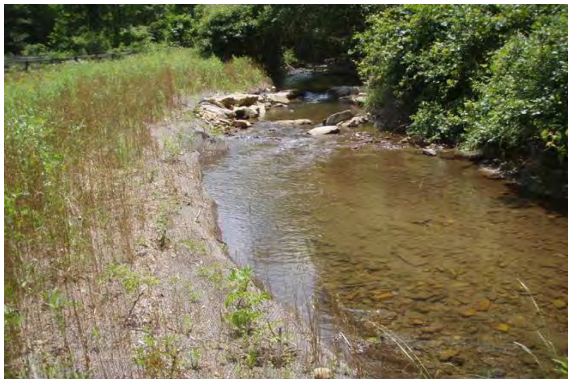
Right channel bank instability after flood, sta. 1+75 to 2+25, facing upstream, 14 June 2012.

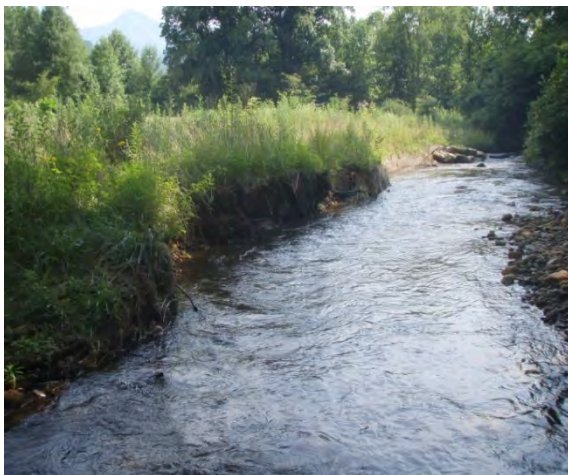
Right channel bank condition after 5 May 2013 flood, sta. 1+75 to 2+25 facing upstream, 18 July 2013.

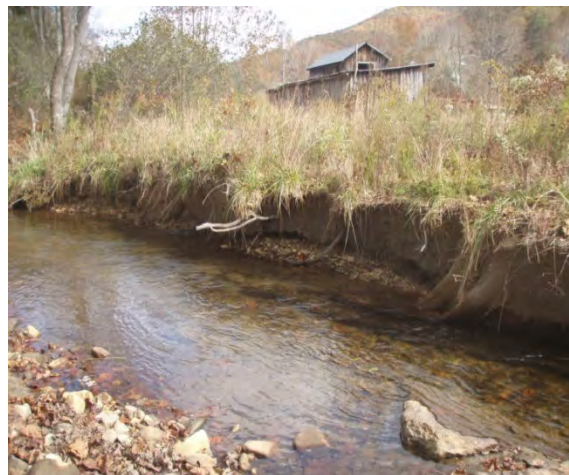
Right channel bank condition after 5 May 2013 flood, sta. 1+75 to 2+25, facing downstream, 29 October 2013.

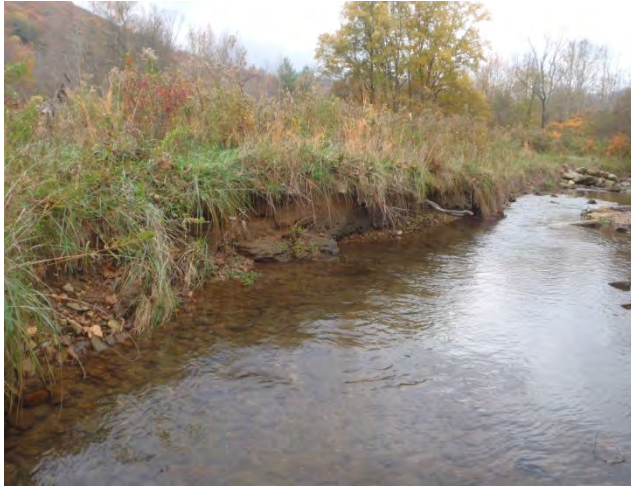
Problem Area 2

Right channel bank condition
sta. 1+75 to 2+25 facing upstream, 20 October 2014.

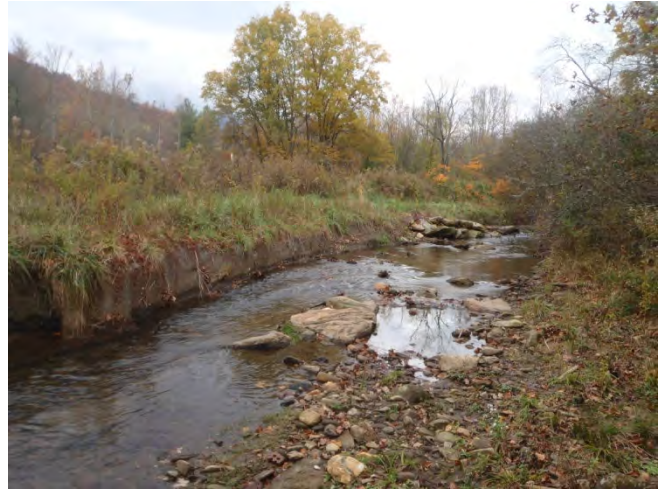
Right channel bank condition
sta. 1+45 to 2+75, facing upstream, 28 October 2014.

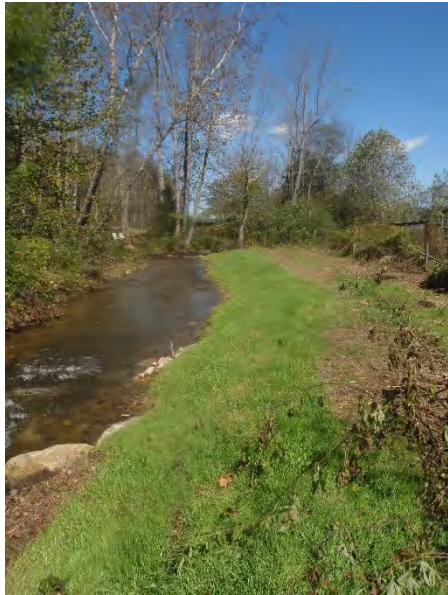
Right channel bank condition after 2015 repairs
sta. 1+75 to 2+25 facing upstream, 14 October 2015.
No longer considered a problem during MY4 (2015) field surveys.

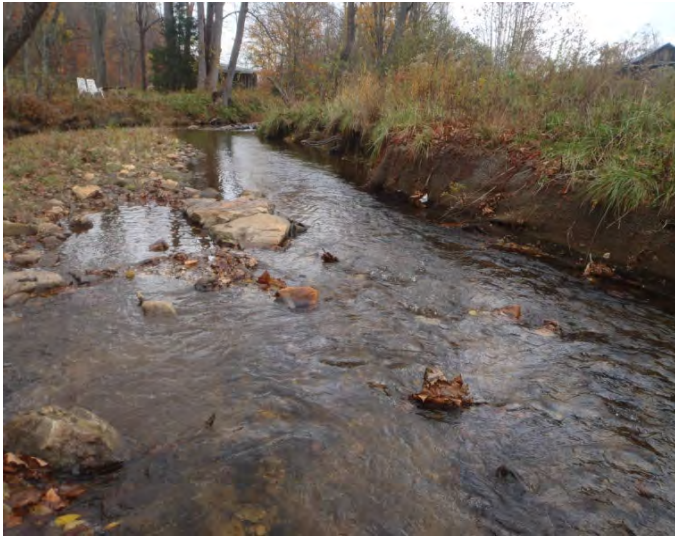
Problem Area 3

Aggradation below J-hook sta 2+50 facing downstream 28 October 2014

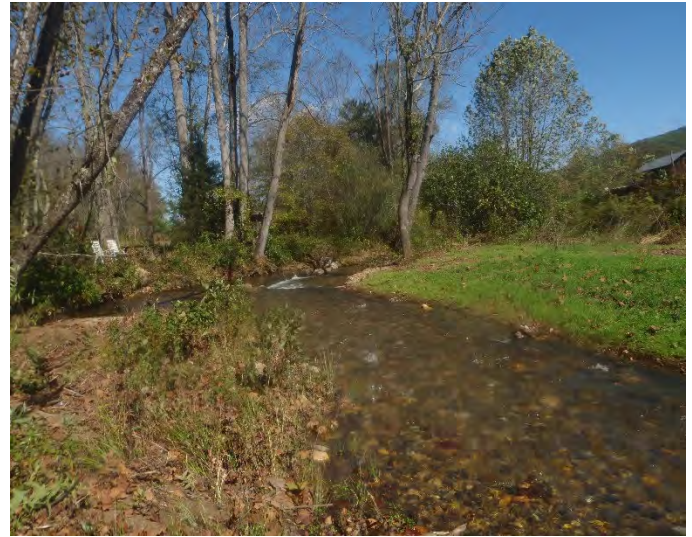
Meander below J-hook sta 2+50 after summer 2015 repairs facing downstream 14 October 2015
No longer considered a problem during MY4 (2015) field surveys.

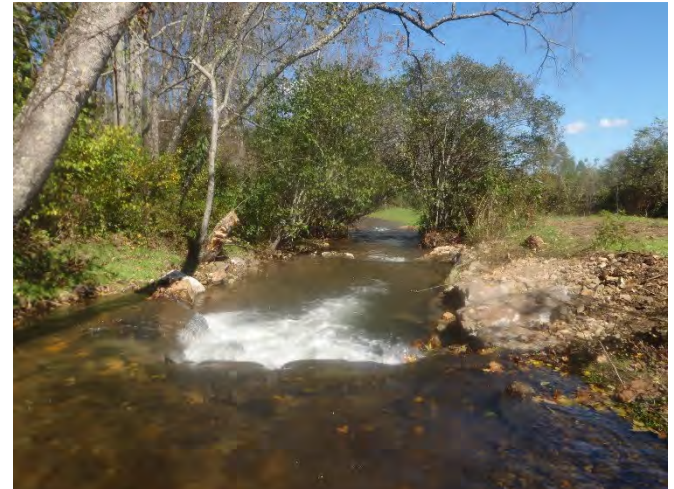
Crossvane after summer 2015 repairs, facing downstream, sta.
0+50, 14 October 2015

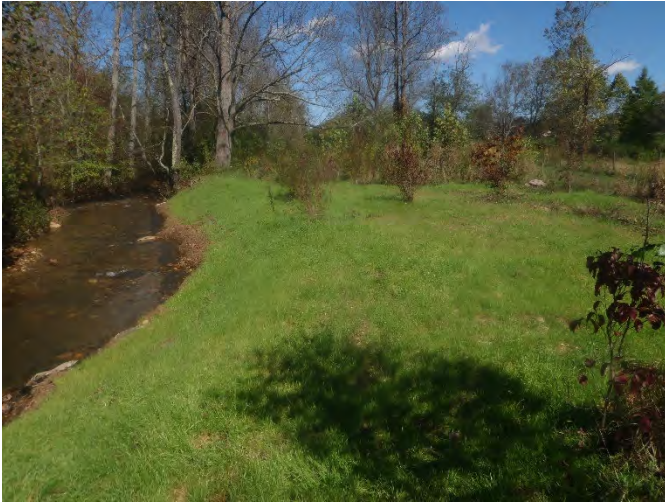
Problem Area 6

Right bank repairs performed summer 2015, sta. 6+25, facing downstream, 14 October 2015. No longer considered a problem during MY4 (2015) field surveys.

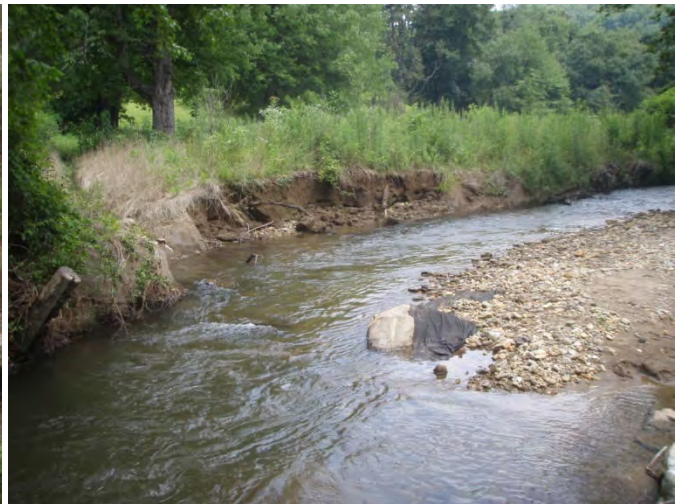
Right bank scour and erosion during 5 May 2013 flood event, facing upstream, sta. 12+50, 18 July 2013.

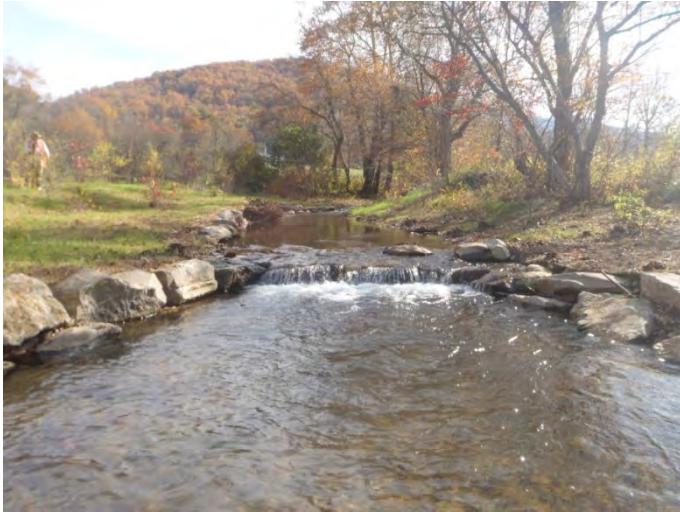
Problem Area 7

PA-7 station 12+75 facing upstream was repaired and is no longer considered a problem 28 October 2014

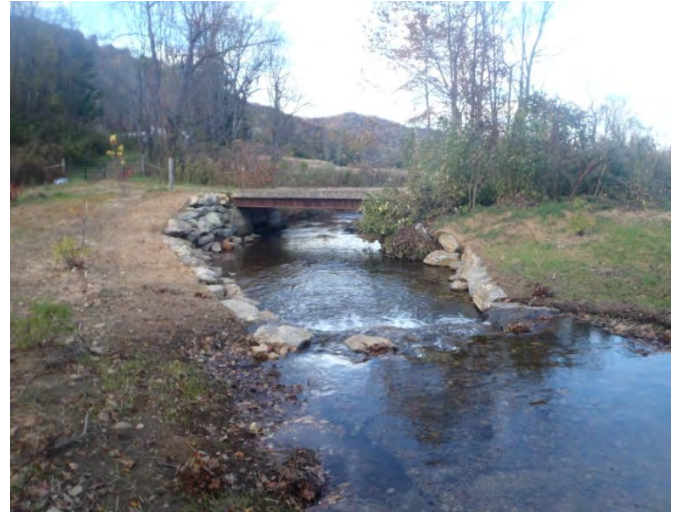
PA-7 station 12+75 facing downstream was repaired and is no longer considered a problem 28 October 2014

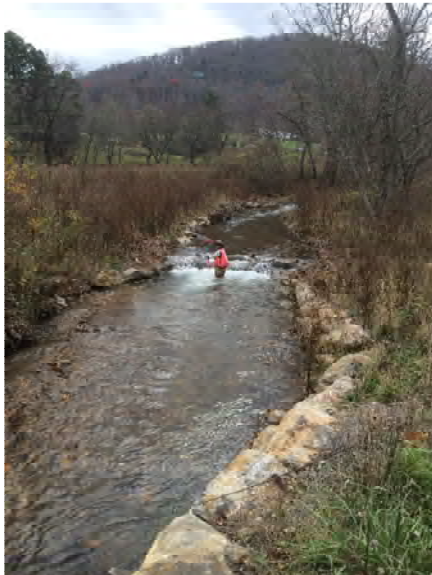
Repaired J-hook, sta. 12+75, facing upstream, 15 October 2015

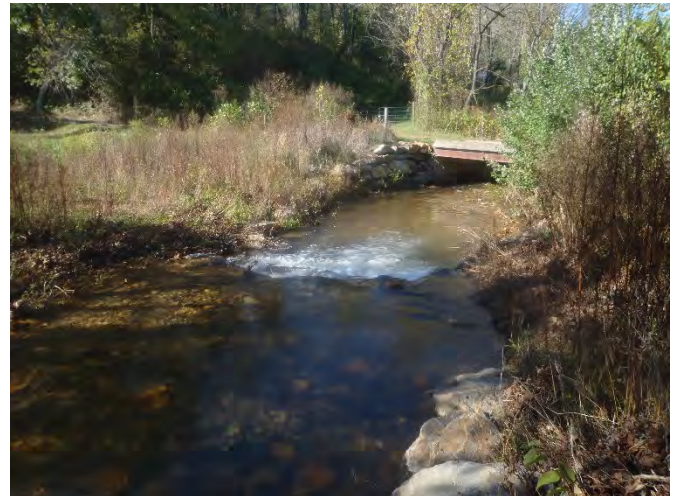
Repaired J-hook, sta. 12+75, facing downstream, 14 October 2015
