# **UT to Rush Fork Stream Mitigation Project Year 2 (2023) Monitoring Report FINAL**

DMS Project ID No. 100068, DEQ Contract No. 7535

Haywood County, North Carolina, French Broad River Basin: 06010106

MY2 Data Collection Period: May – November 2023

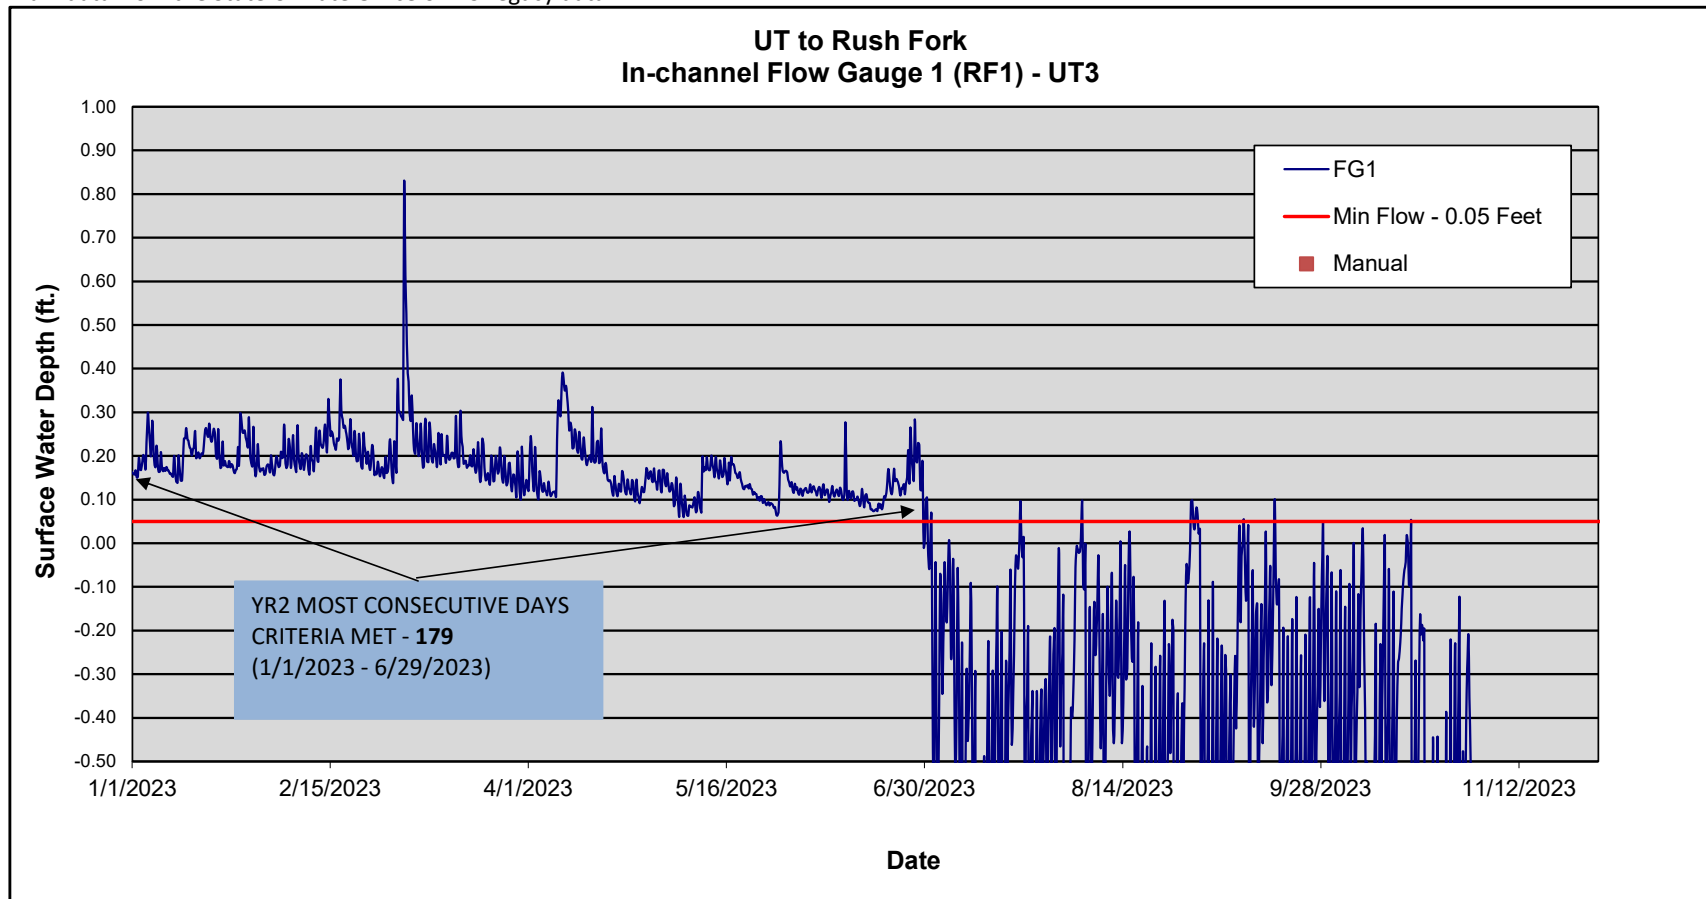
Figure 5 Flow Gauge Graphs

\*Surface water flow is estimated to have occurred when the pressure transducer reading is equal to or above 0.05 feet in depth.

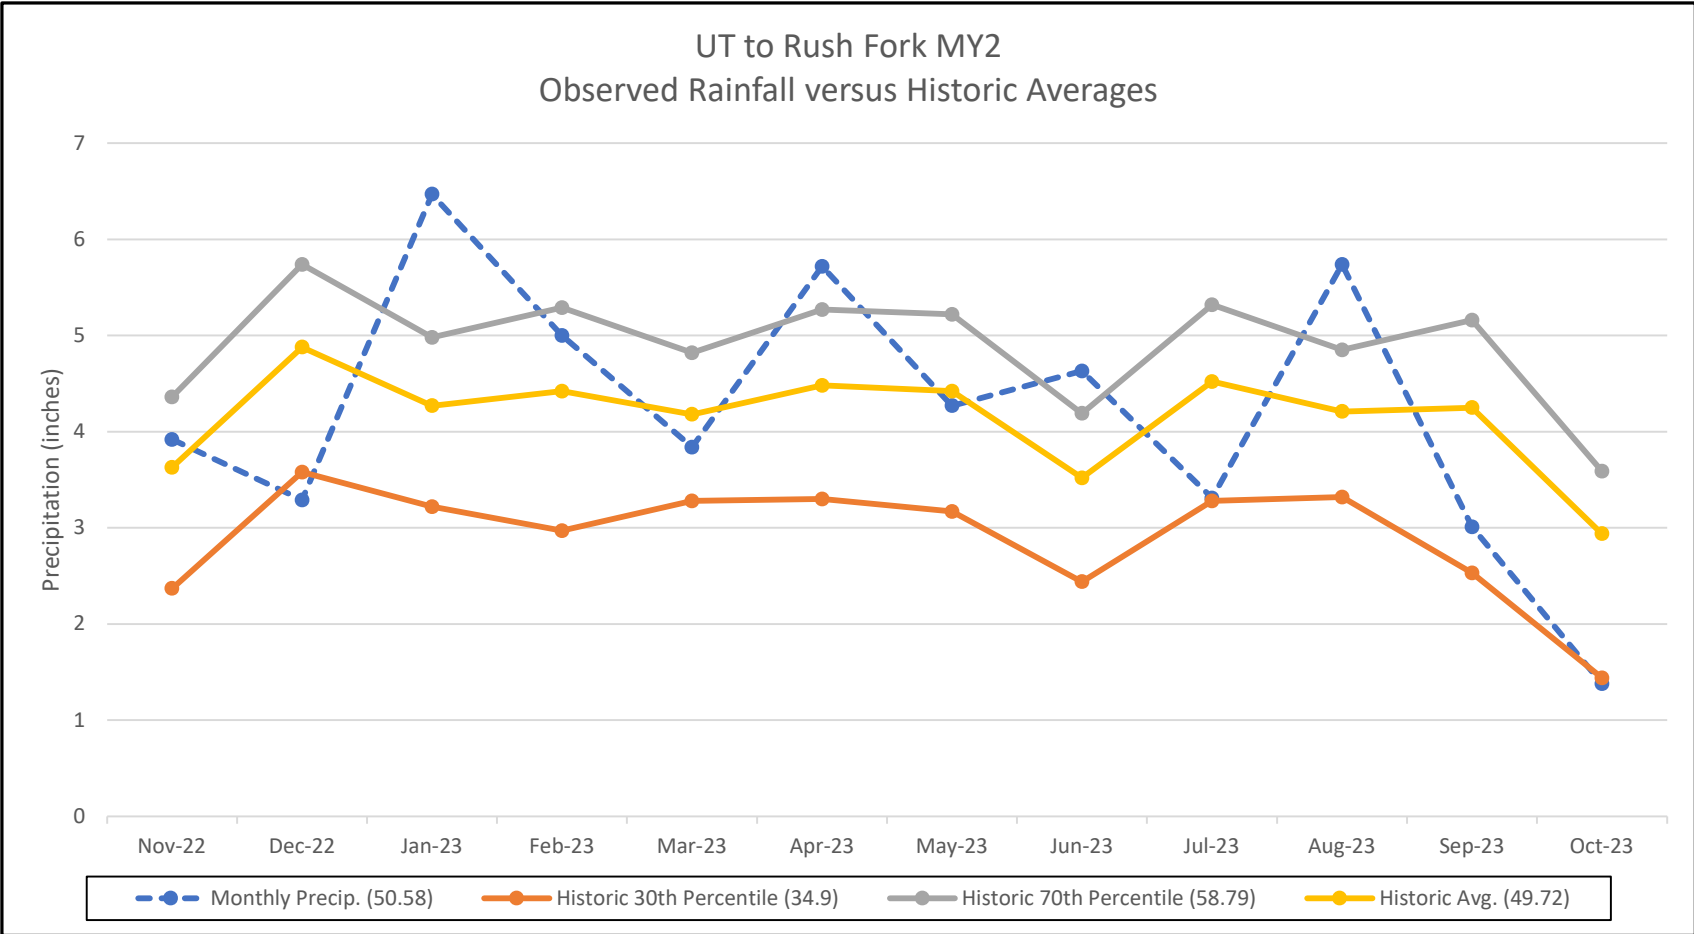
Figure 6. Observed Rainfall Versus Historic Averages

As the observed monthly rainfall data for the project presented in Figure 6, (Appendix E) demonstrates the total monthly rainfall has varied widely from the historic average precipitation. In an annual comparison the site experienced similar average annual rainfall during the monitoring year at 50.58 inches observed for the project site comparable to the county's 49.72 inches of rainfall. Observed project rainfall was collected from the North Carolina Climate Office Weather Climate Database Legacy system. This system uses a Multi-Sensor Precipitation Estimate (MPE) to combine radar-based precipitation values with surface gauges to generate site specific data based on project coordinates. The closest weather station (WAYN) is located approximately 11.4 miles southwest of the project at the Mountain Research Station on Test Farm Rd. in Waynesville, NC. Three automated channel flow gauges exceeded the minimum 30-day performance criteria during MY2. Summary information/data related to the Site and statistics related to performance of various project and monitoring elements can be found in the tables and figures in the report Appendices.

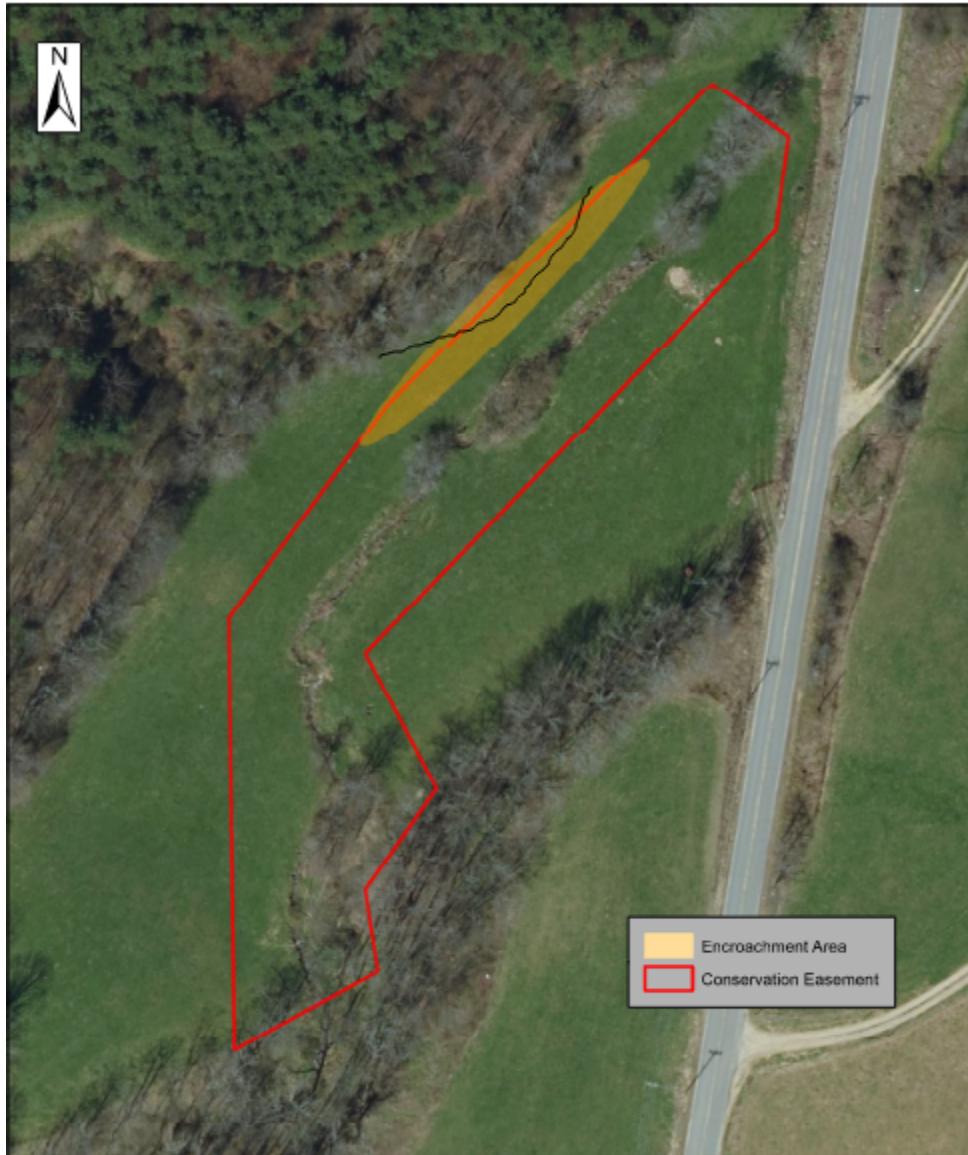
A minor Encroachment Area was observed during the completion of MY2 monitoring where a piece of farm equipment was driven through an unfenced portion of the easement on the right floodplain of UT1-R4 (shown on CCPV Figure 3C). It appears the equipment could not fit between the Conservation Easement boundary and the tree line. The area was not mowed and did not sustain any permanent damage. Baker has sent email and letter to the property owner to notify the farmer who leases the field that this is in violation of the terms of the conservation easement. This correspondence is included in Appendix F. Baker will work with the property owner and farmer to create a path for equipment, so this violation does not occur in the future.

The black line represents the path of the tractor.

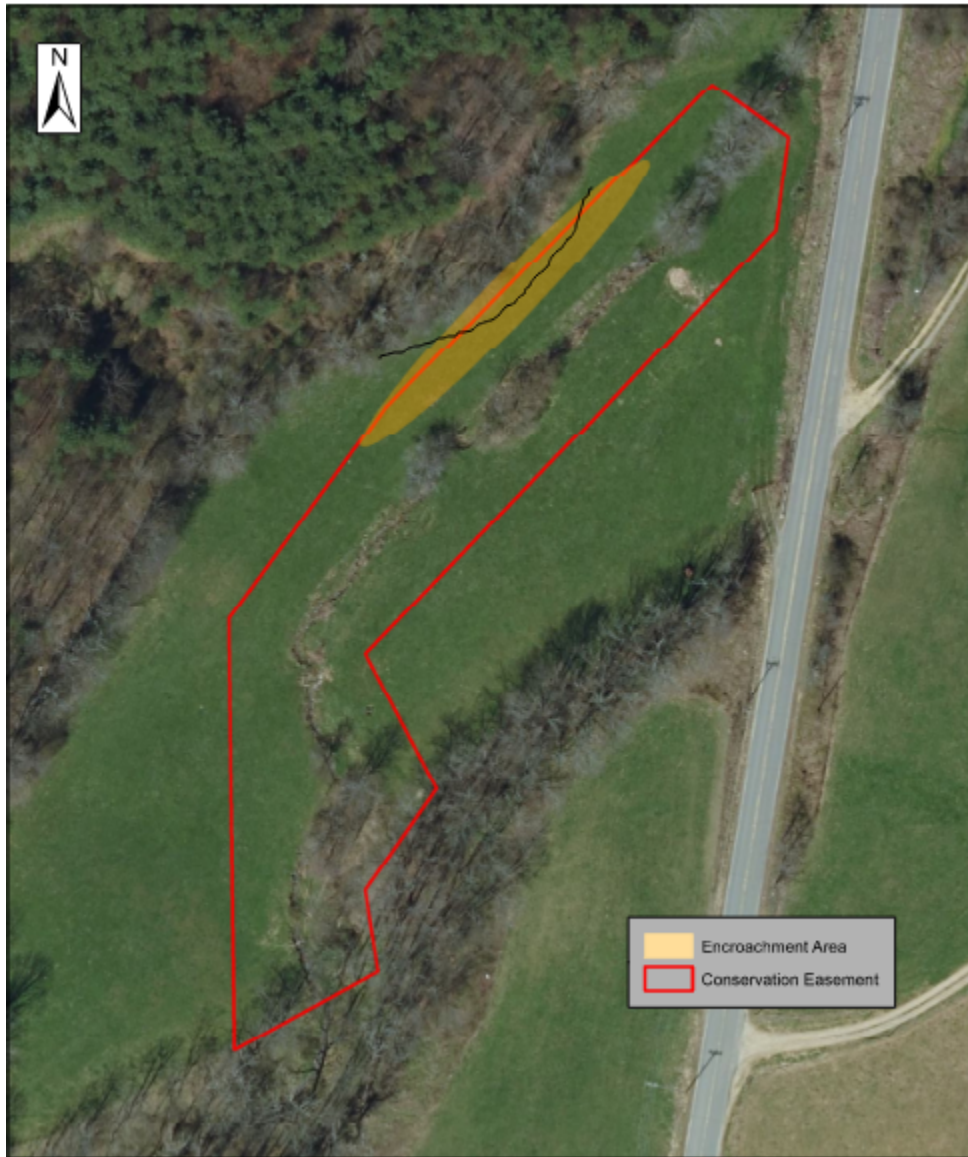
The black line represents the path of the tractor.
