FINAL
ANNUAL MONITORING REPORT
YEAR 3 (2014)
UT TO BALD STREAM/WETLAND RESTORATION SITE
YANCEY COUNTY, NORTH CAROLINA
(EEP Project No. 92596, Contract No. 4997)
Construction Completed December 2011

March 2015

Prepared by:
Axiom Environmental, Inc.
218 Snow Avenue
Raleigh, North Carolina 27603

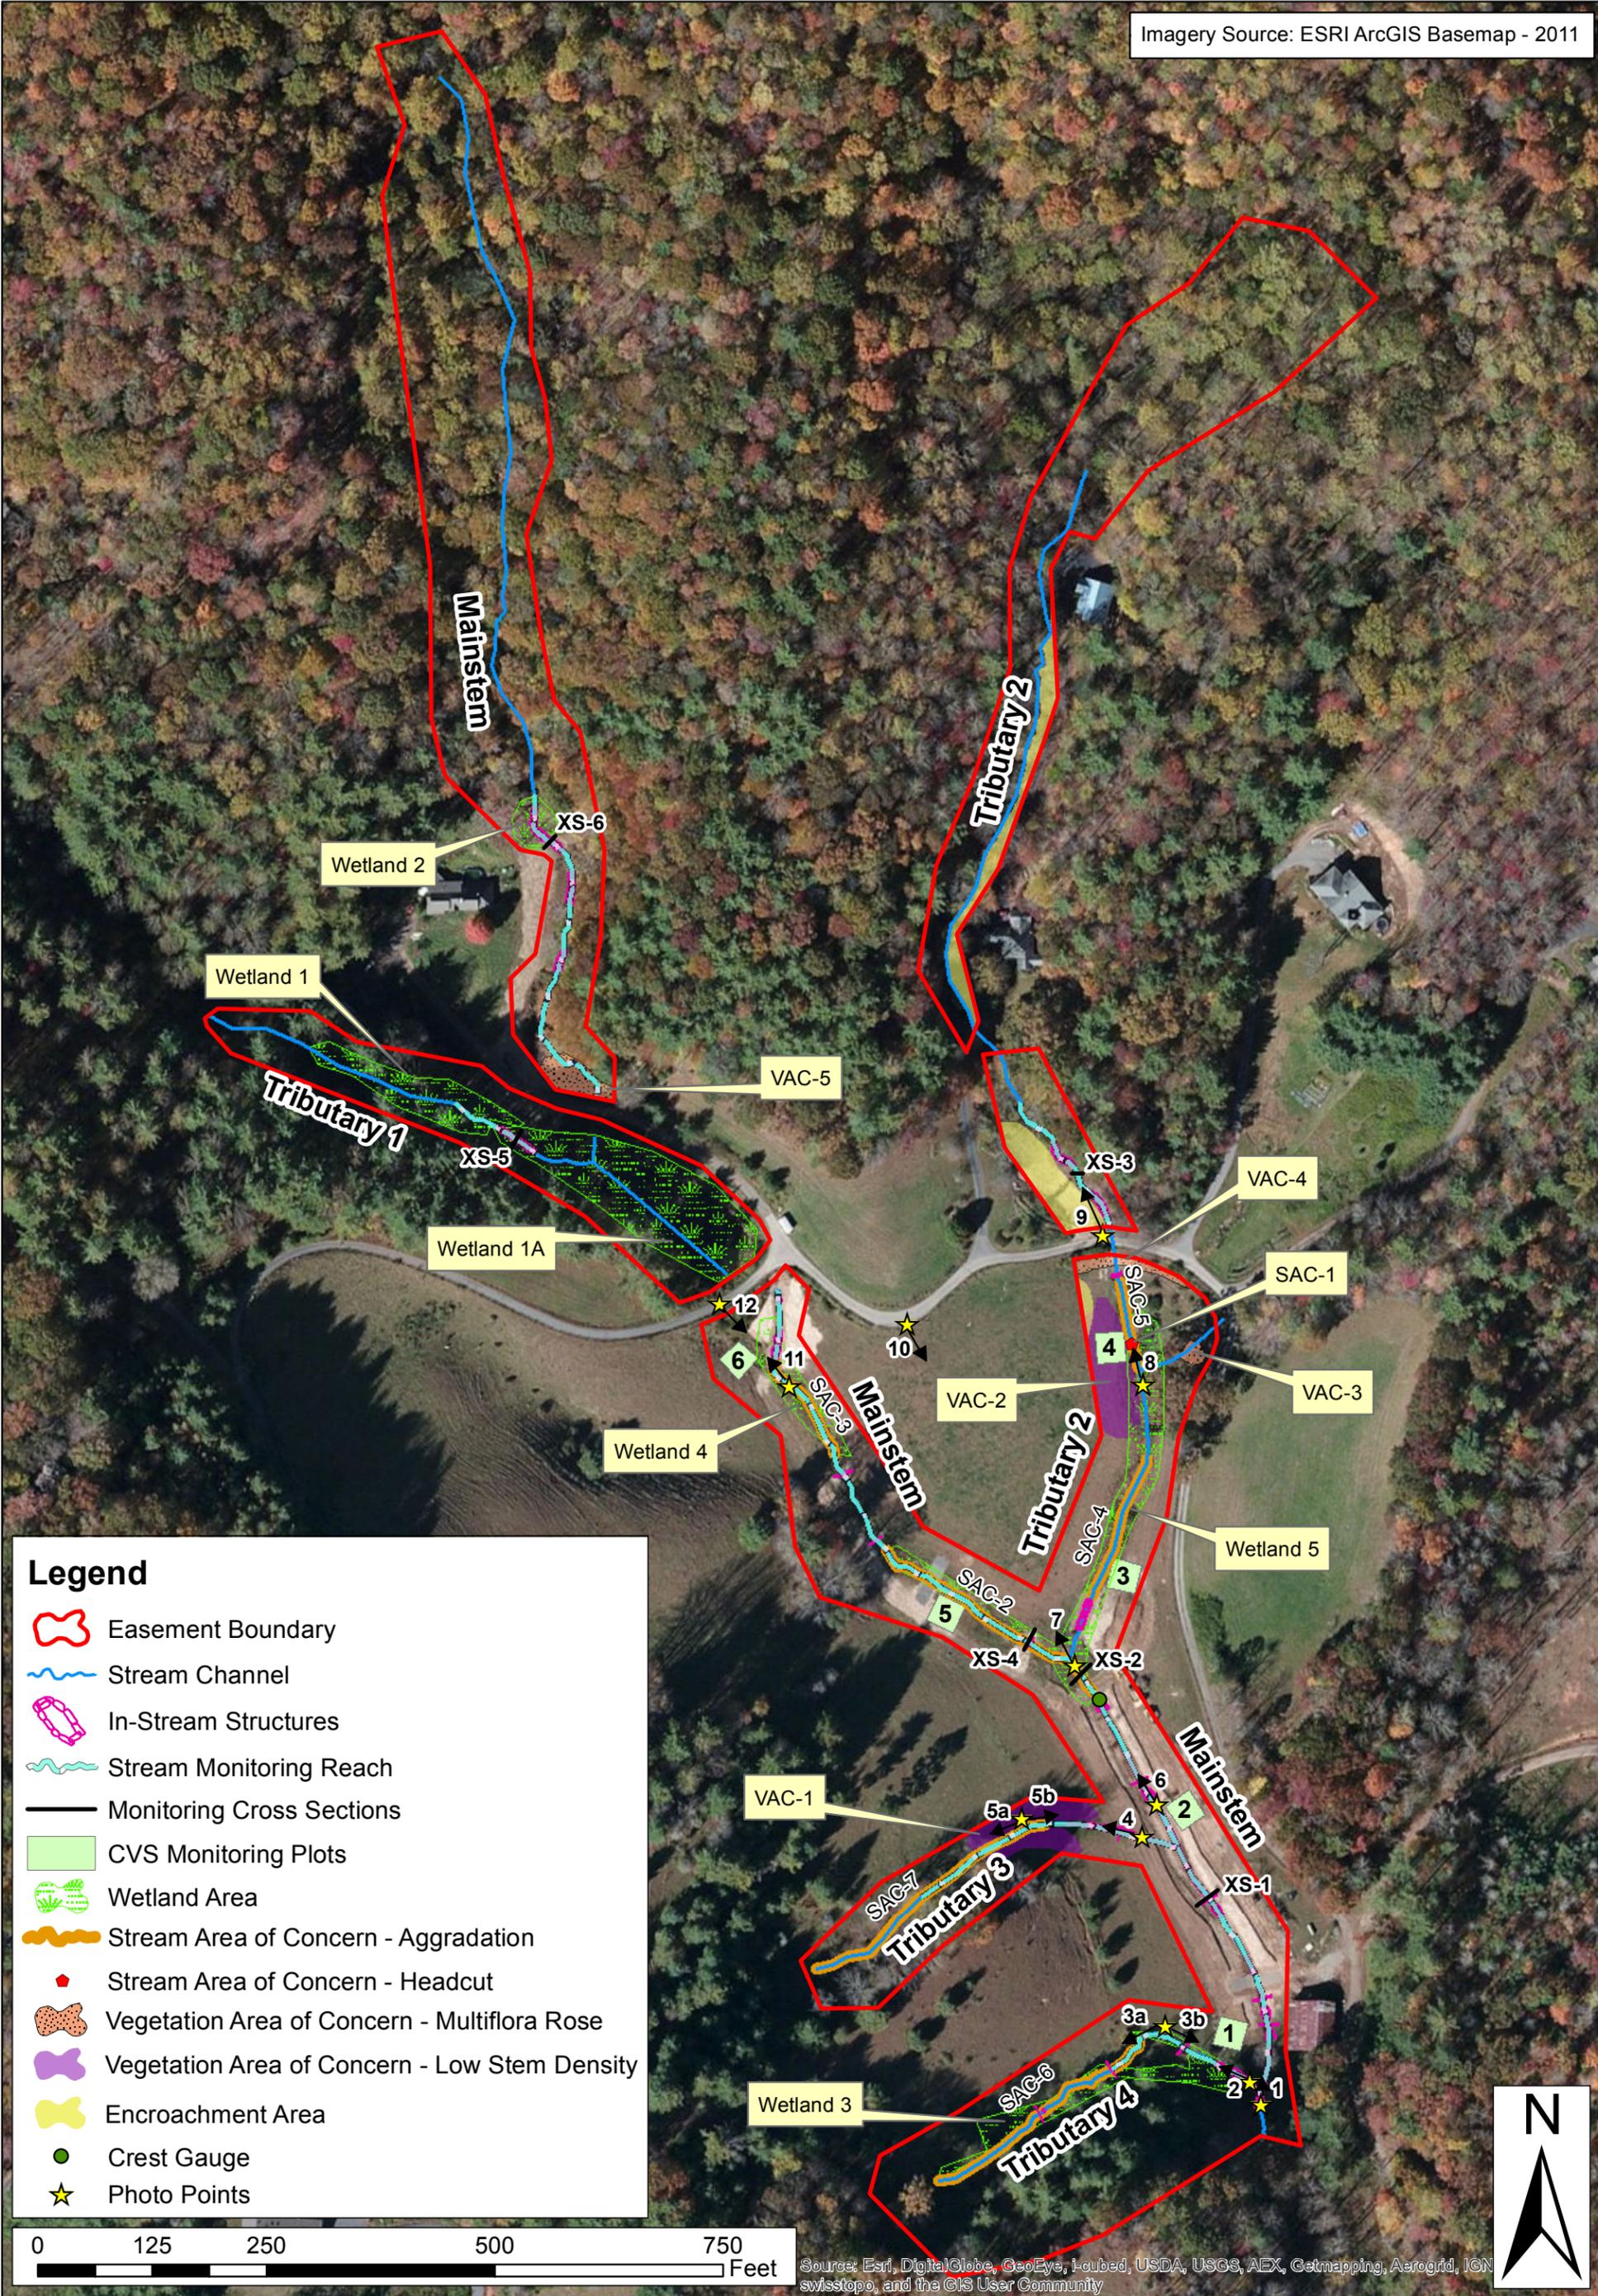
FIGURE
2

Map Identifier	Feature/Issue
VAC-1	Low stem density around Tributary 3
VAC-2	Low stem density in and around Veg Plot 4
VAC-3 to -5	Multiflora rose

Map Identifier	Feature/Issue
SAC-1	Headcut on Tributary 2
SAC-2 to 7	Aggradation on Mainstem, Tributary 2, Tributary 3, and Tributary 4

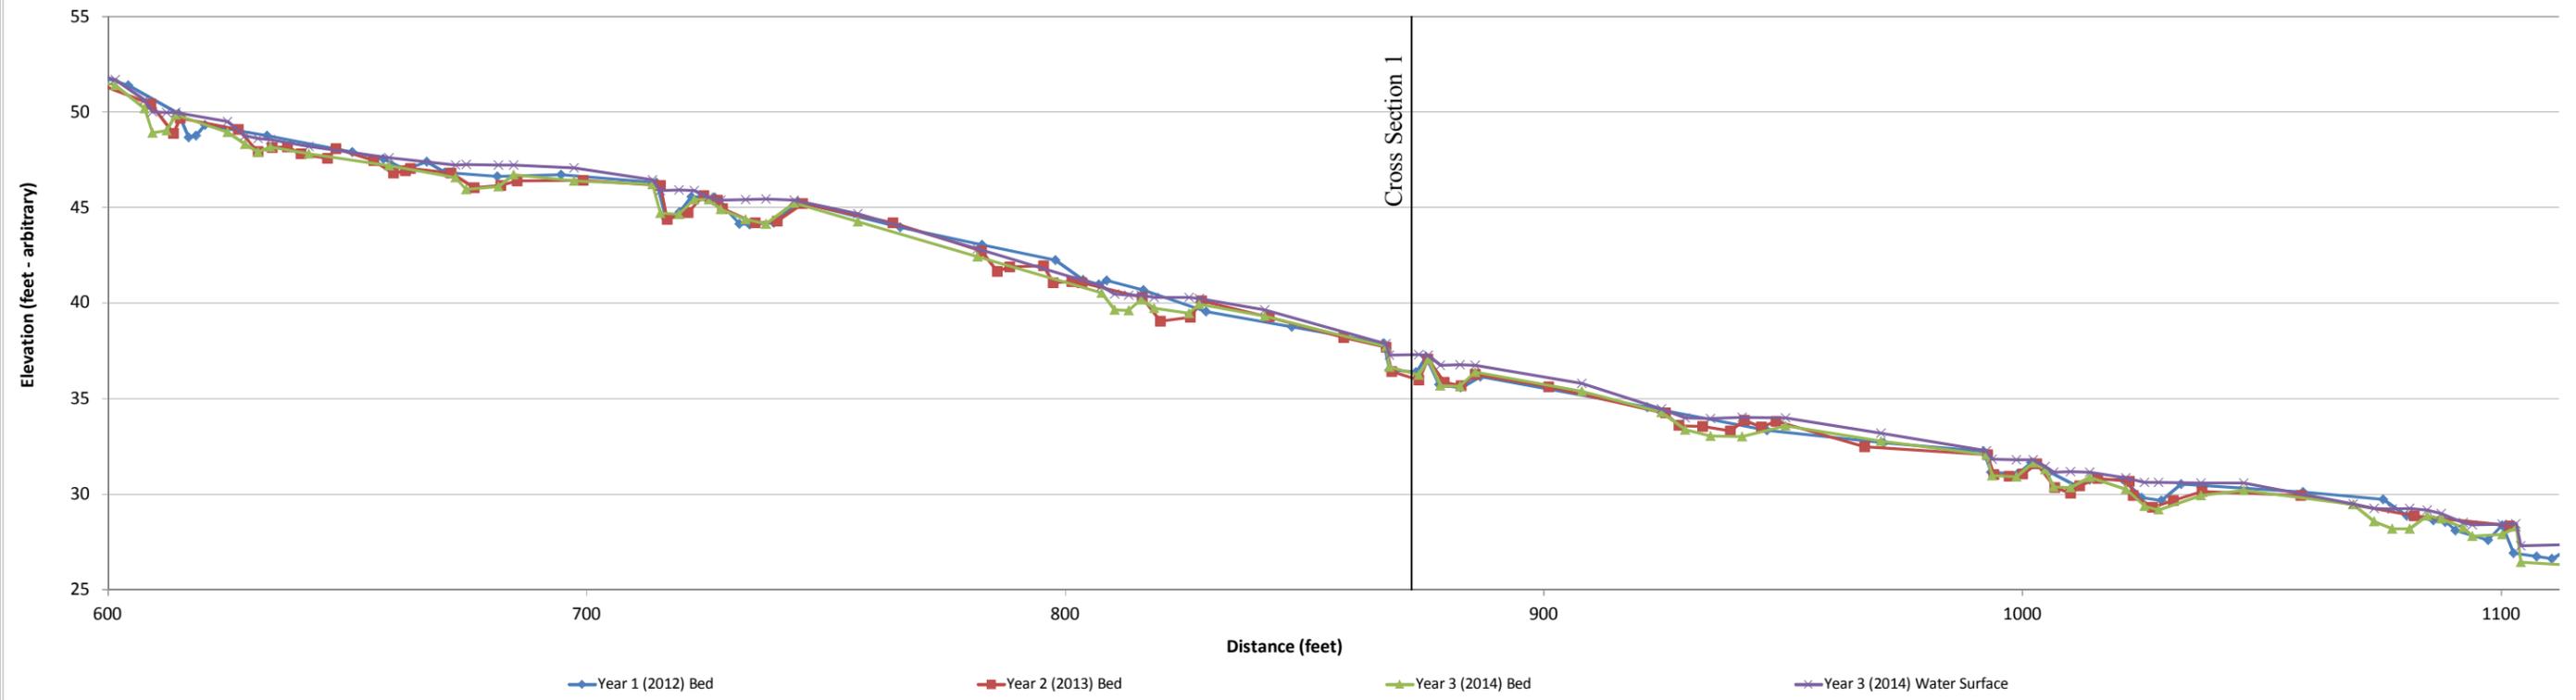
UT to Bald Creek Year 3 (2014) Profile - Mainstem, Station 06+00 to 11+12

2012	2013	2014	2015	2016
Avg. Water Surface Slope	0.0558	0.0540	0.0556		
Riffle Length	37	35	27		
Avg. Riffle Slope	0.0509	0.0609	0.0715		
Pool Length	13	12	17		
Pool to Pool Spacing	40	38	38

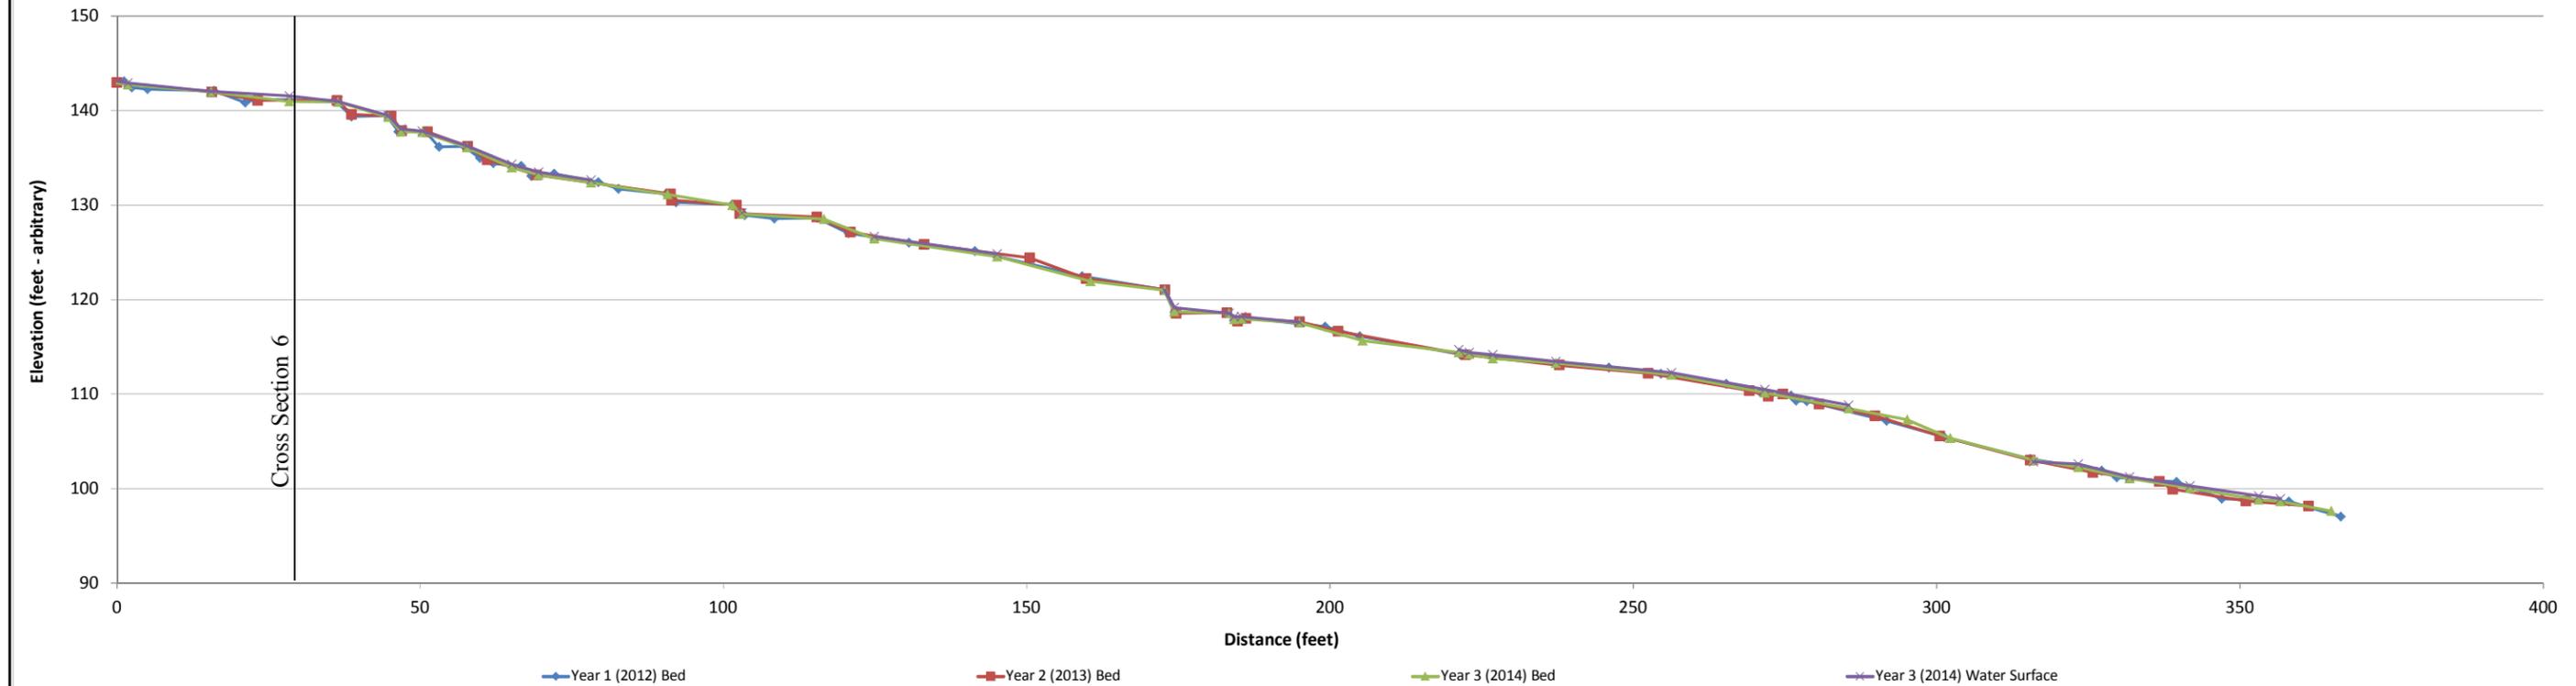
UT to Bald Creek Year 3 (2014) Profile - Mainstem Upstream, Station 00+00 to 04+00

2012	2013	2014	2015	2016
Avg. Water Surface Slope	0.1301	0.1313	0.1315		
Riffle Length	16	43	75		
Avg. Riffle Slope	0.0750	0.0846	0.0953		
Pool Length	5	2	6		
Pool to Pool Spacing	14	46	102

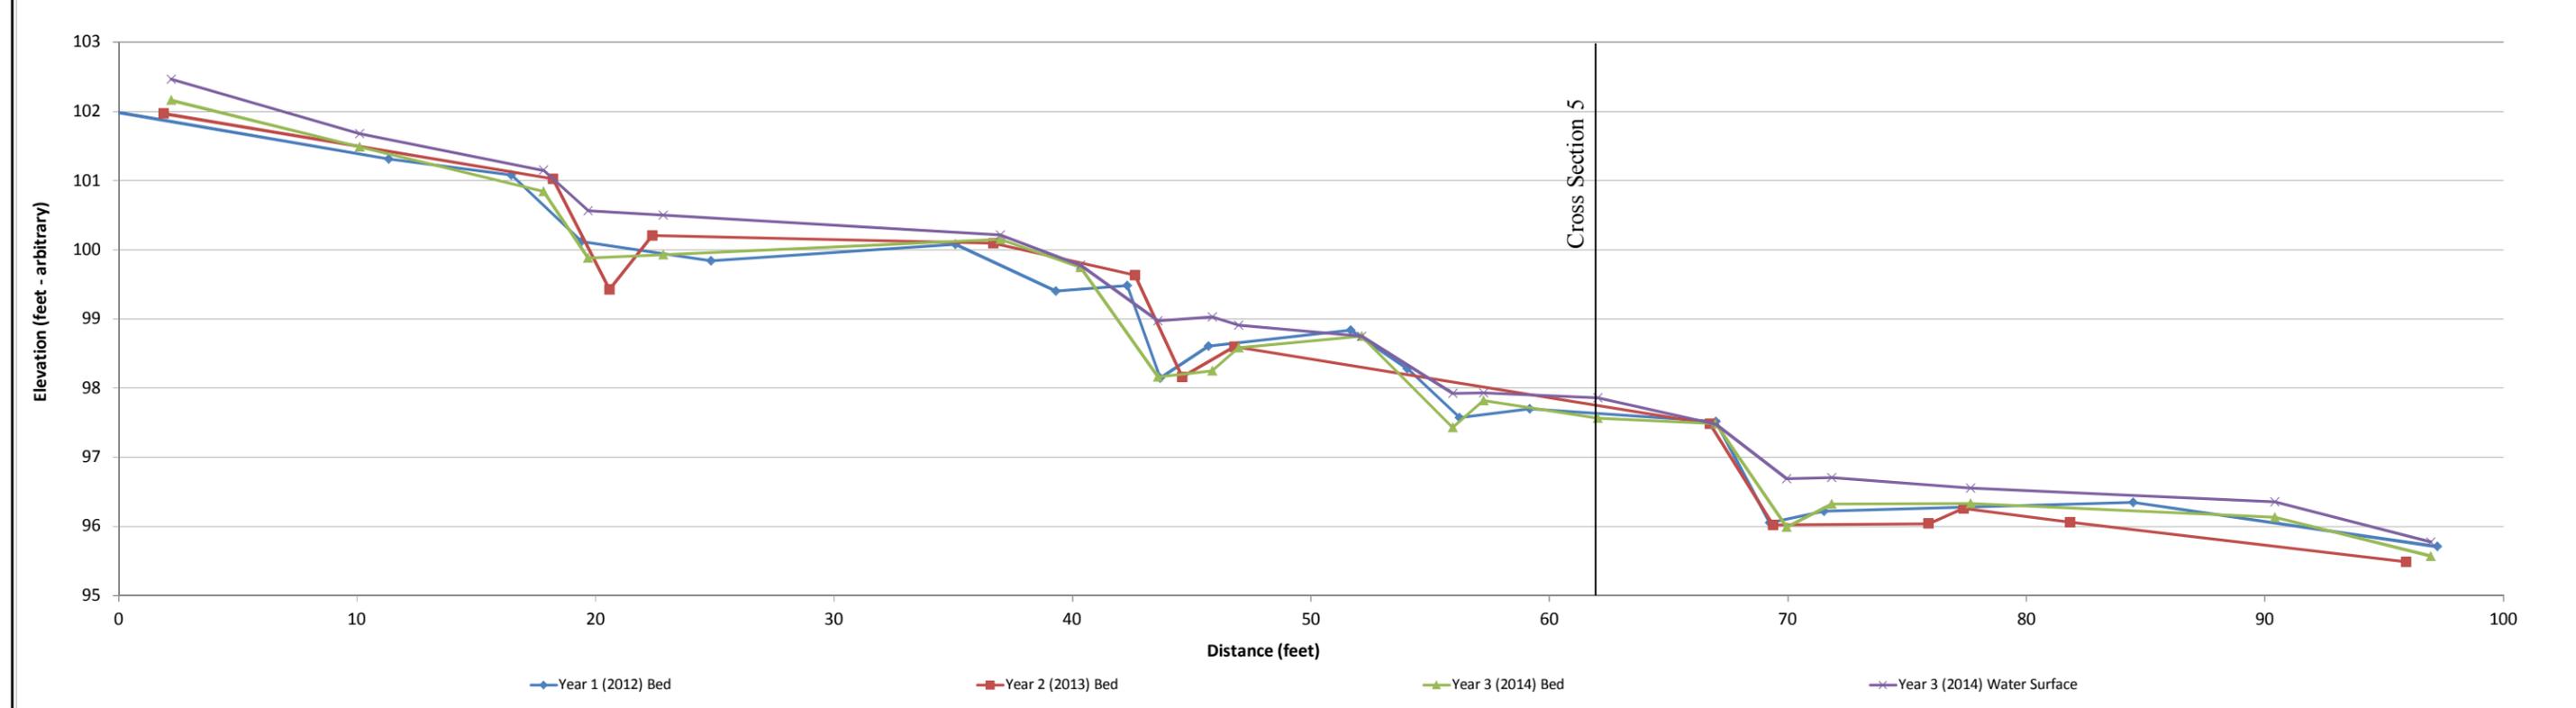
UT to Bald Creek Year 3 (2014) Profile - Tributary 1, Station 00+00 to 01+00

Avg. Water Surface Slope	2012	2013	2014	2015	2016
Riffle Length	0.0674	0.0782	0.0679		
Avg. Riffle Slope	7	19	14		
Pool Length	0.0418	0.0777	0.0391		
Pool to Pool Spacing	6	6	6		
	13	24	19
