UT TO BARNES STREAM AND WETLAND RESTORATION PROJECT

ANNUAL MONITORING REPORT FOR 2007 (YEAR 1)

Prepared by: Baker Engineering

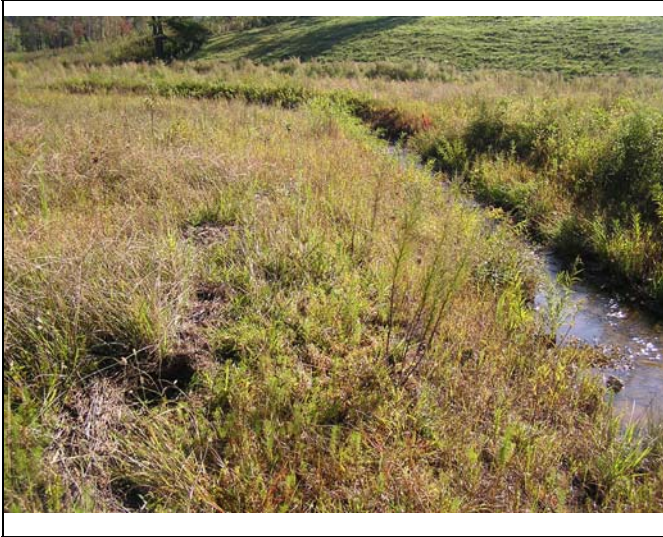
Bankfull Event Indicators 9/29/2006

The onsite crest gage documented the occurrence of two bankfull flow event during the first year (2006) of the post-construction monitoring period (Table 9). Inspection of site conditions during a site visit revealed visual evidence of out-of-bank flow, confirming the crest gage reading. The largest onsite stream flow documented by the CG #2 during Year 1 of monitoring was approximately 3.74 feet (44.88 inches) above the bankfull stage. Photos of the crest gage and bankfull indicators are located in Appendix A.

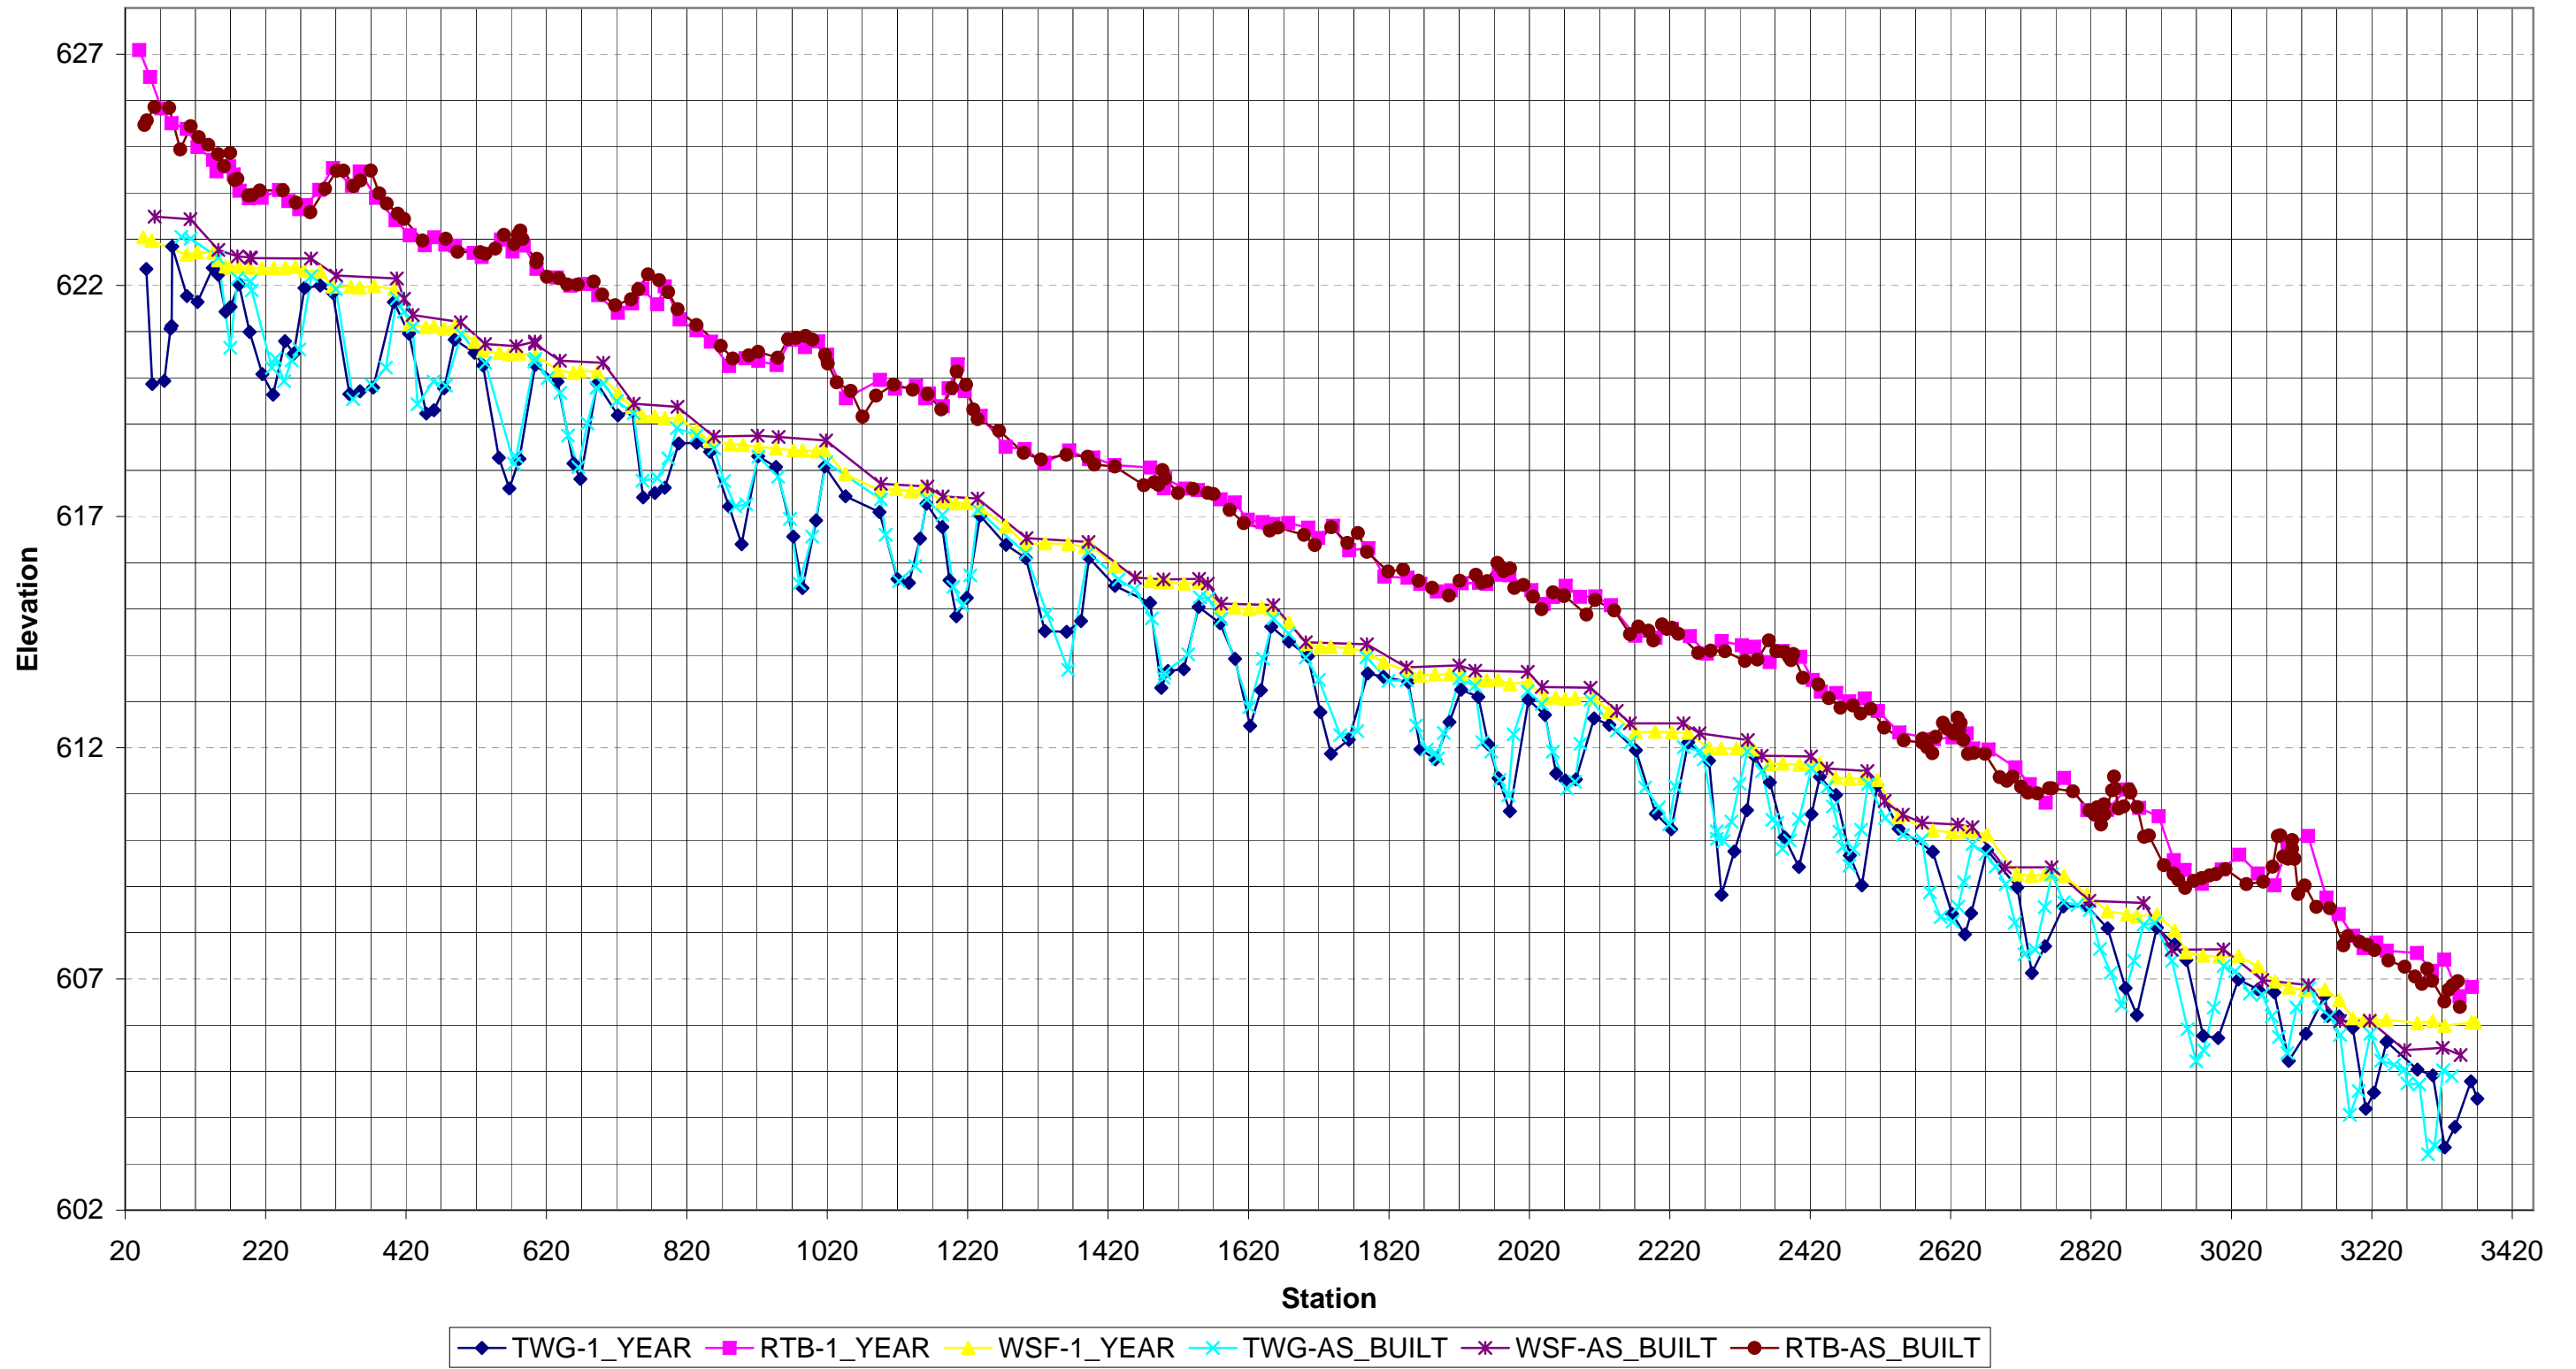
UT To Barnes Creek Year-1 Monitoring Profile vs. As-Built Profile (mainstem)

A comparison of the as-built longitudinal profile and the Year 1 longitudinal profile shows that bedform features are not significantly aggrading or degrading and that pool depths were deeper than riffle depths. This indicates a stable and properly functioning longitudinal profile. A plot of the profile comparison can be found in Appendix C.

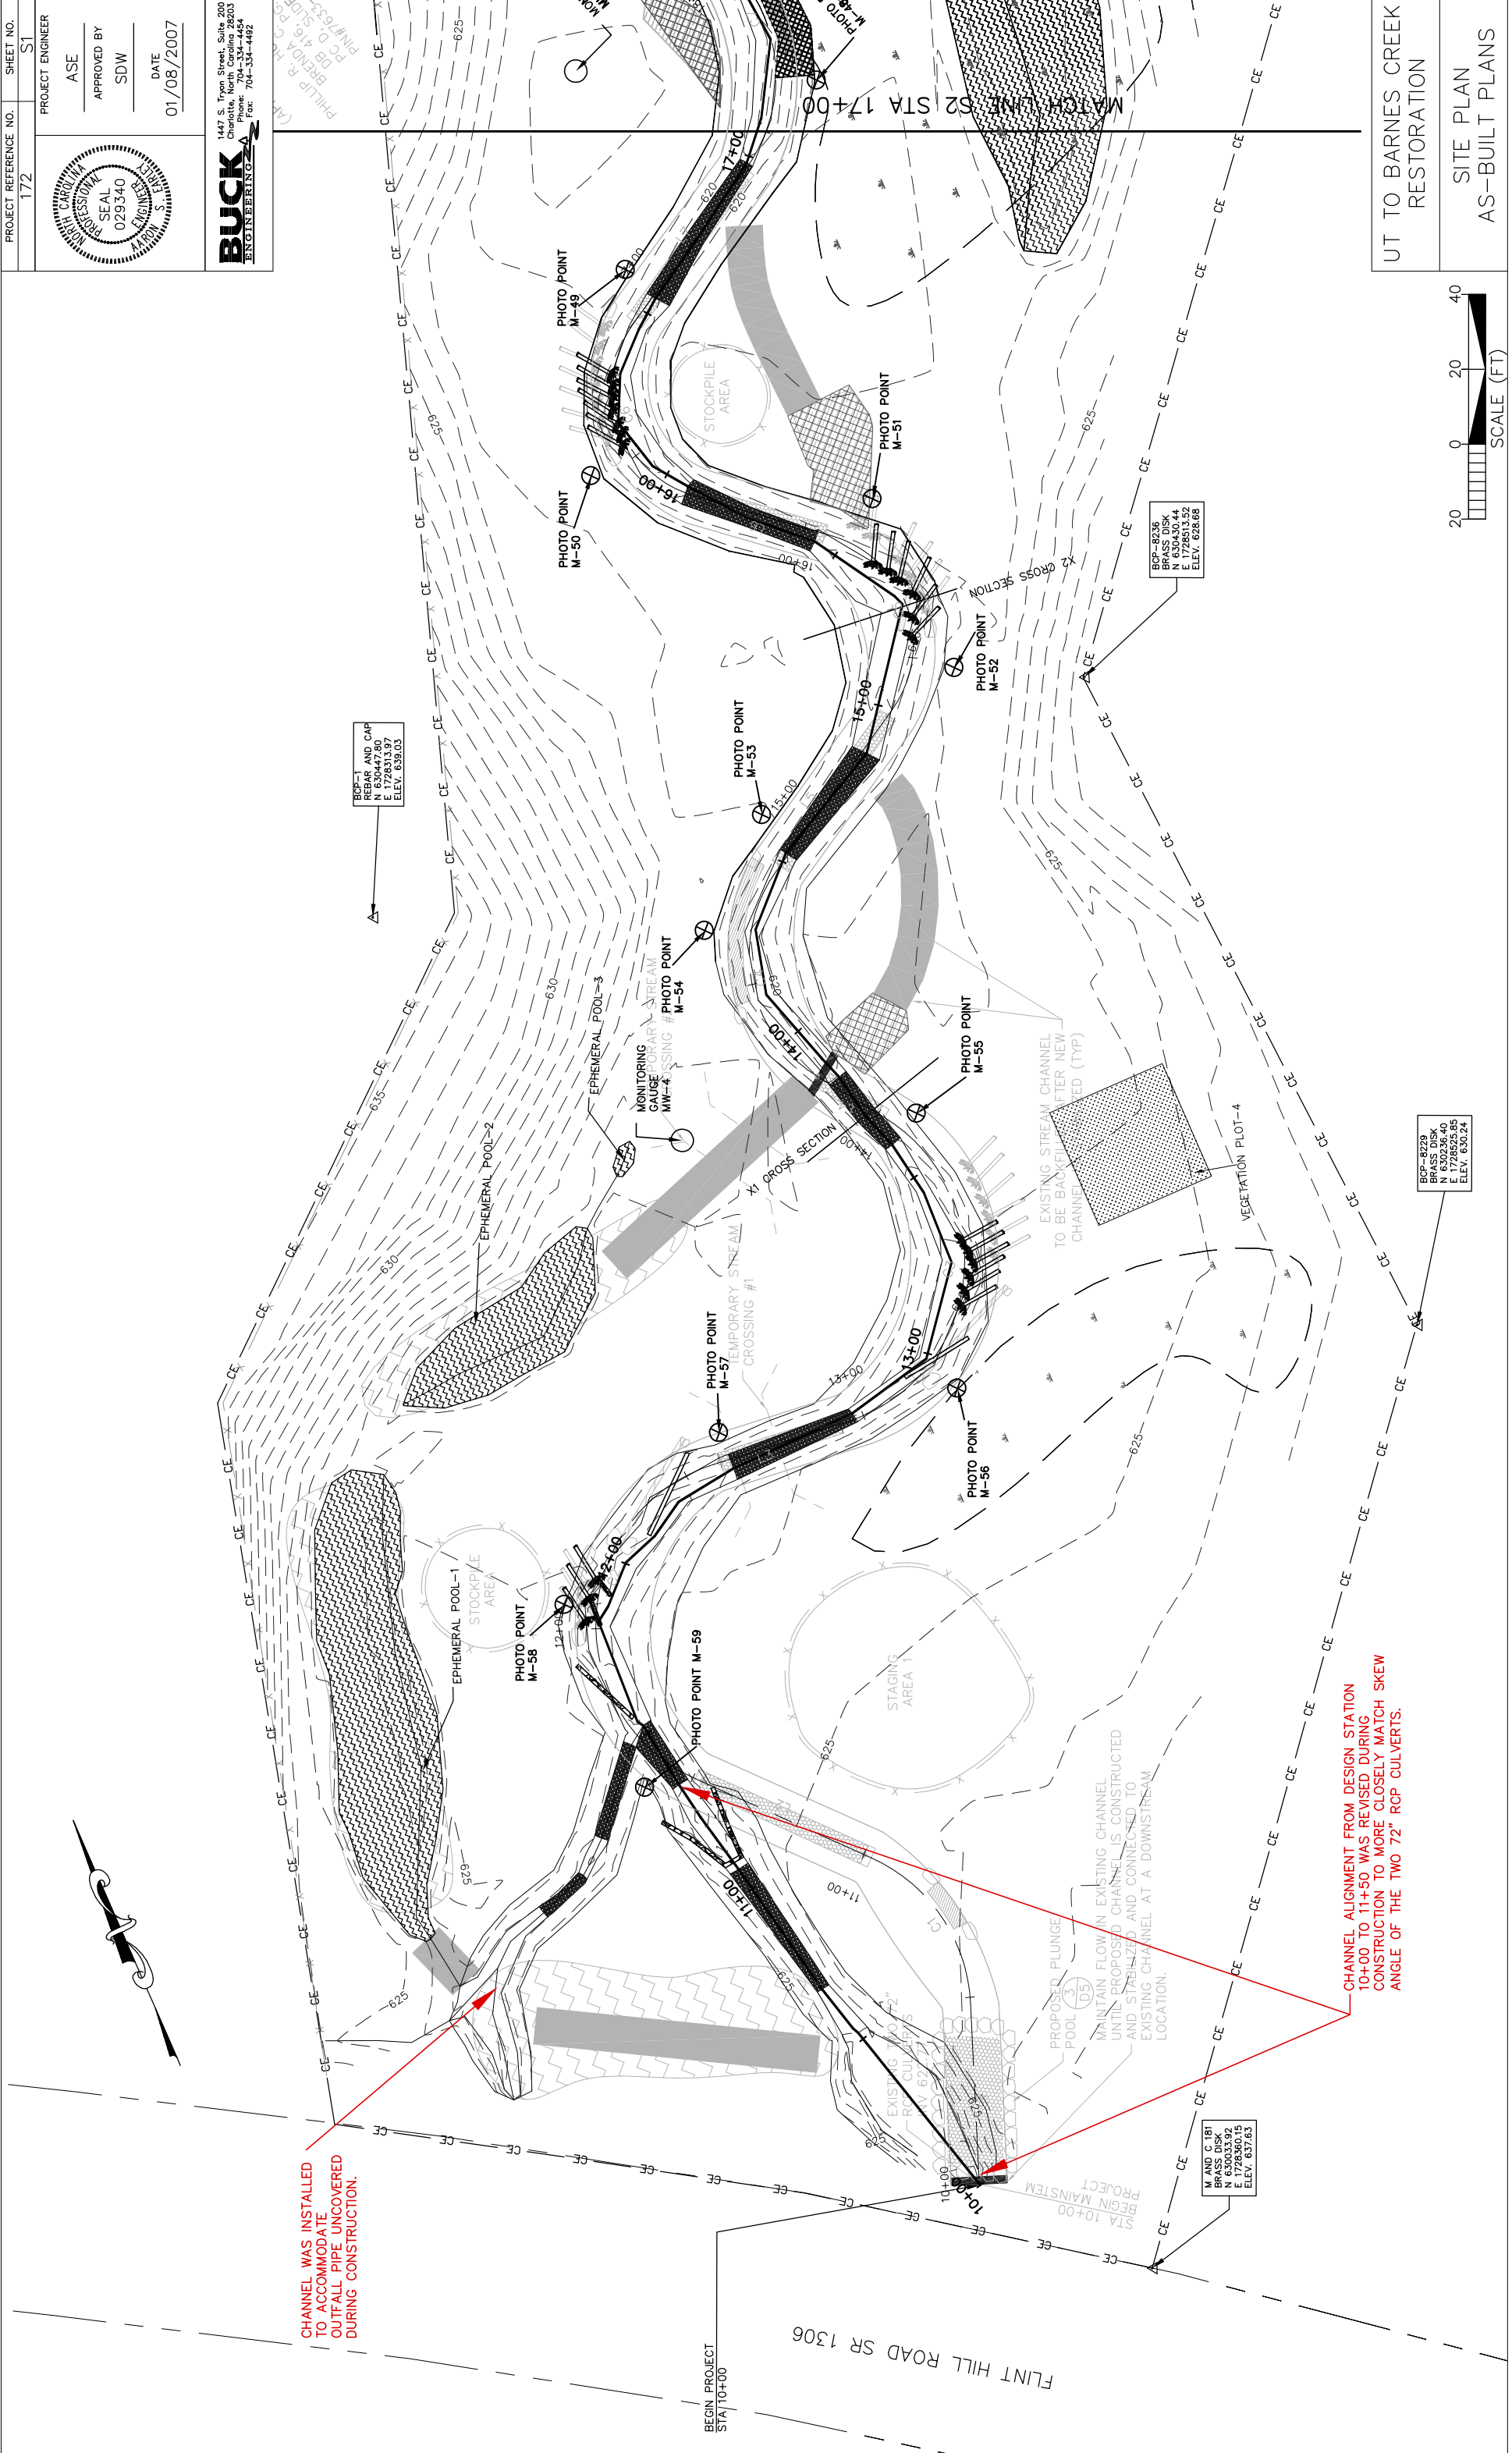
CHANNEL WAS INSTALLED TO ACCOMMODATE OUTFALL PIPE UNCOVERED DURING CONSTRUCTION.

CHANNEL ALIGNMENT FROM DESIGN STATION 10+00 TO 11+50 WAS REVISED DURING CONSTRUCTION TO MORE CLOSELY MATCH SKEW ANGLE OF THE TWO 72" RCP CULVERTS.

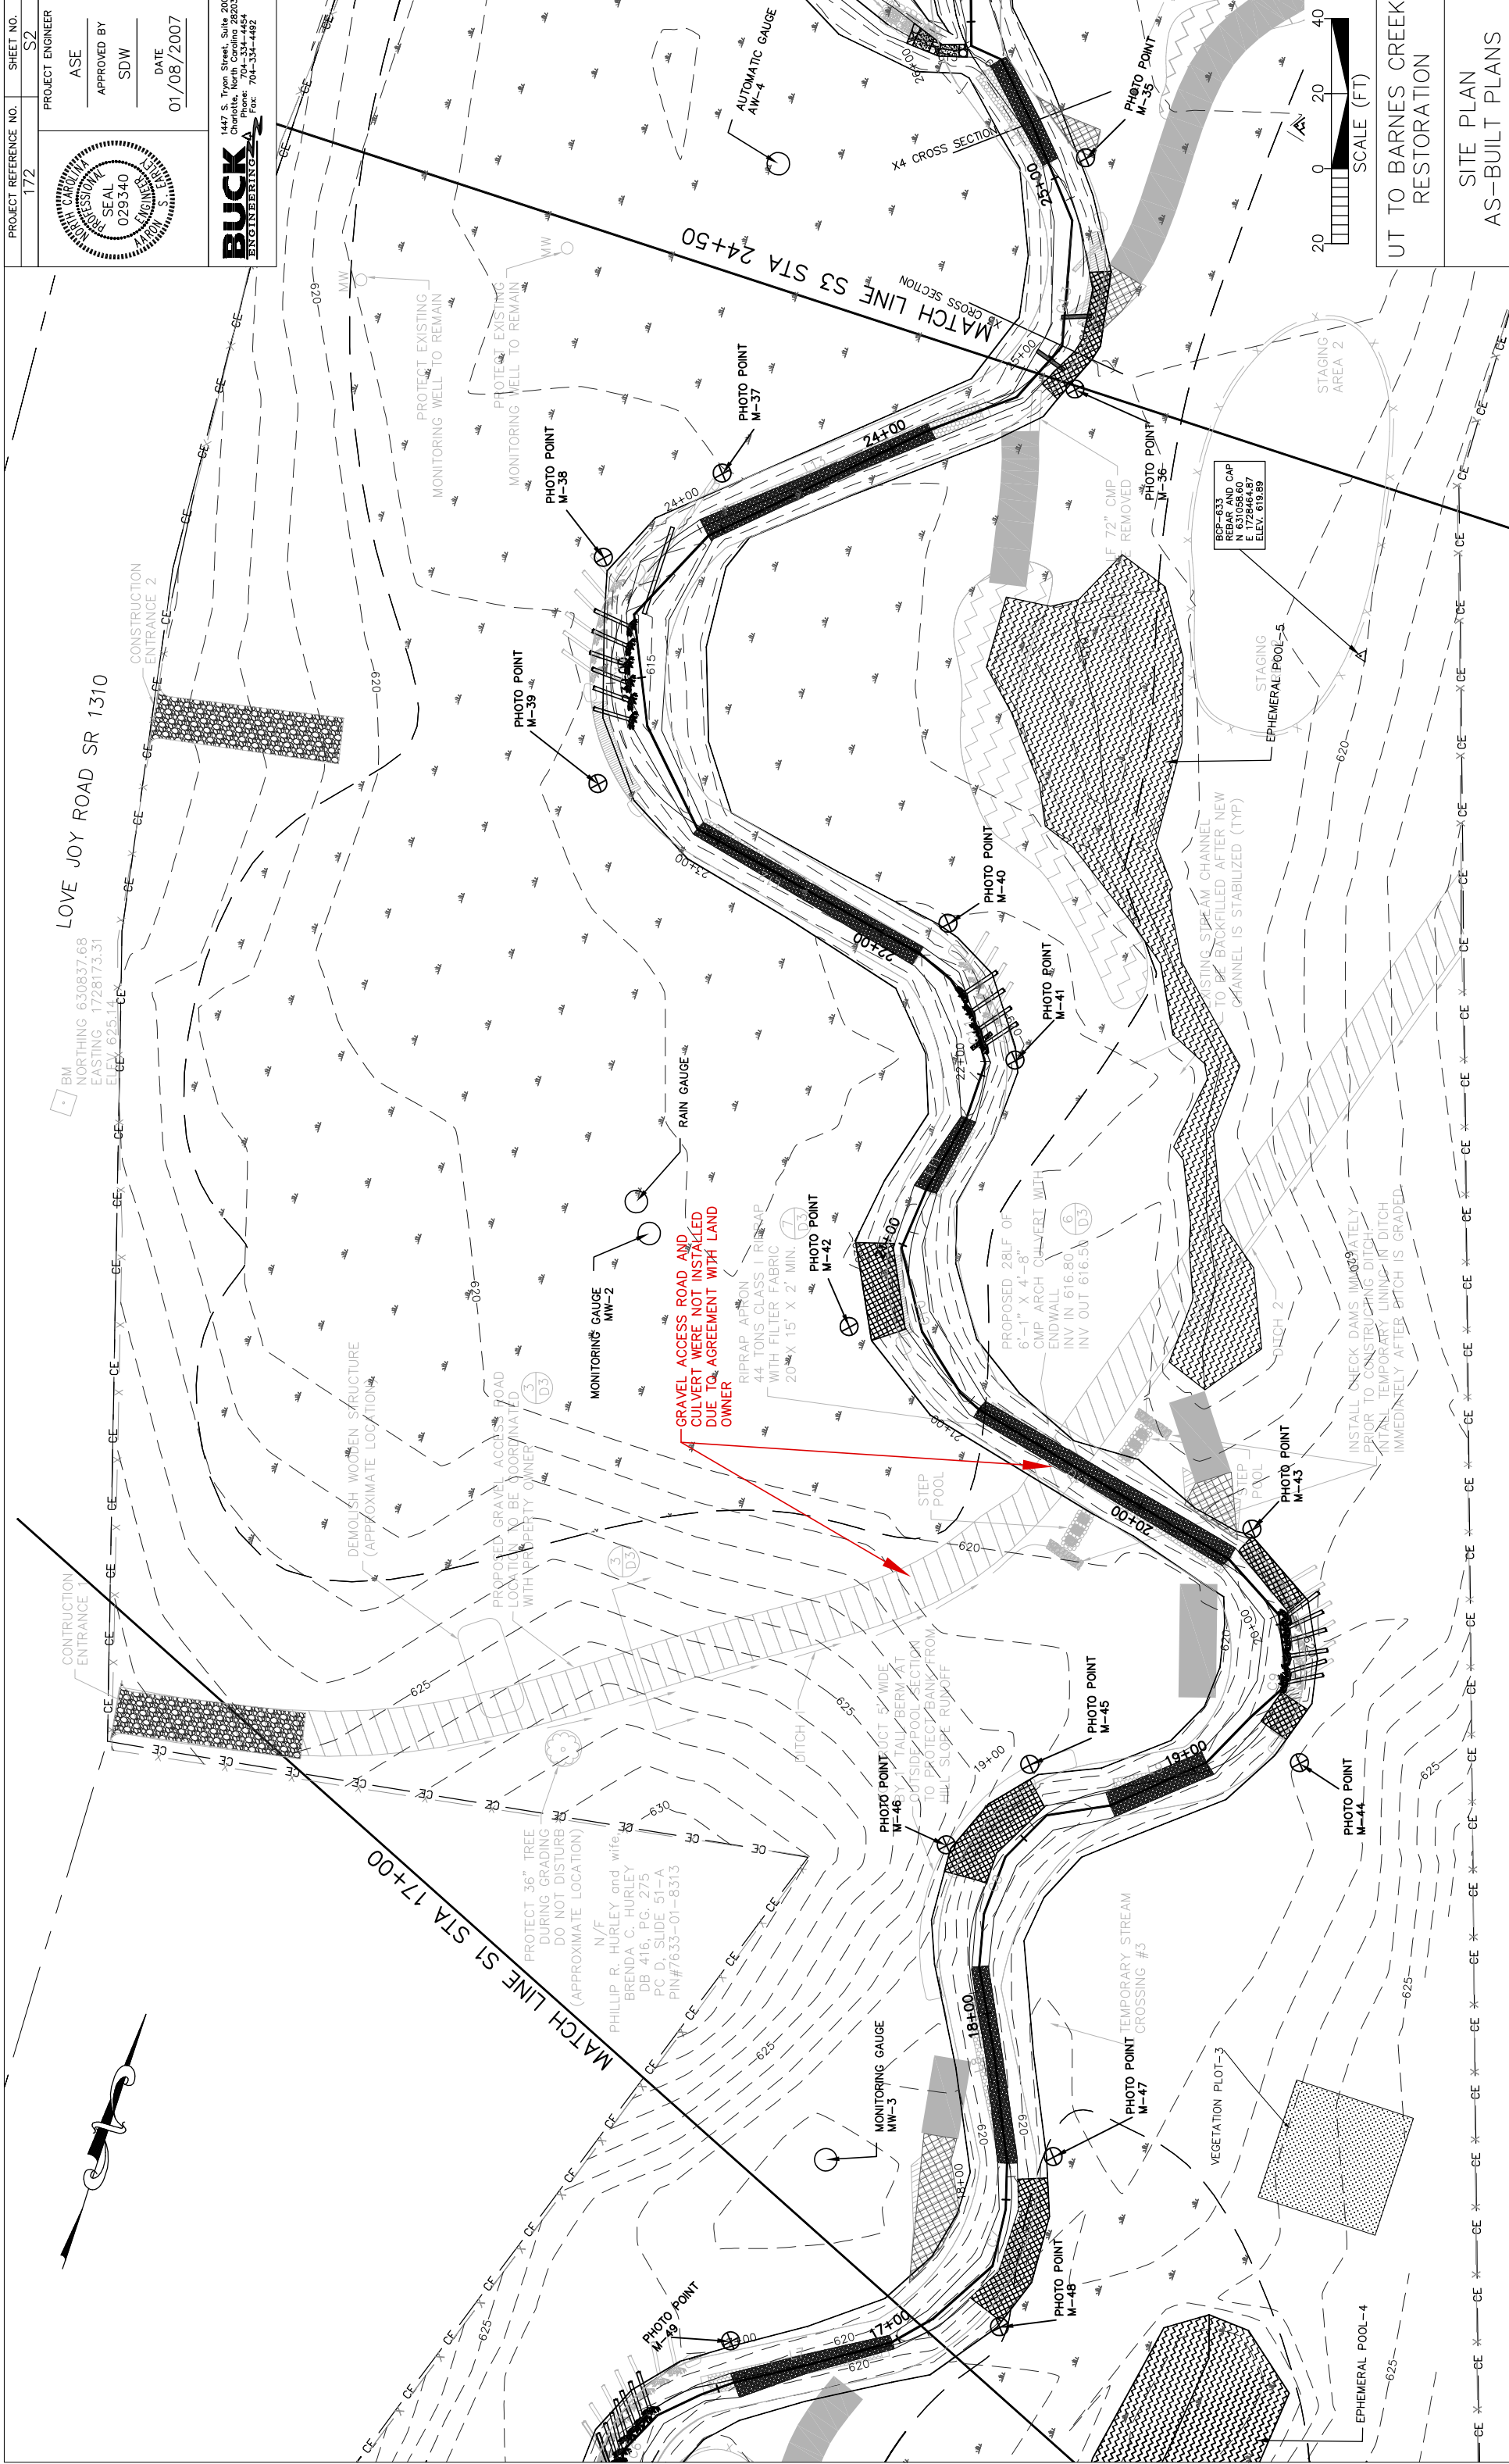
GRAVEL ACCESS ROAD AND CULVERT WERE NOT INSTALLED DUE TO AGREEMENT WITH LAND OWNER
