**UT Barnes Stream and Wetland
Restoration Project
Montgomery County
North Carolina**

**CU: 03040103
SCO# 040614201A
EEP Project No. 397**

**2nd Year Final Monitoring Report
March 1, 2008**

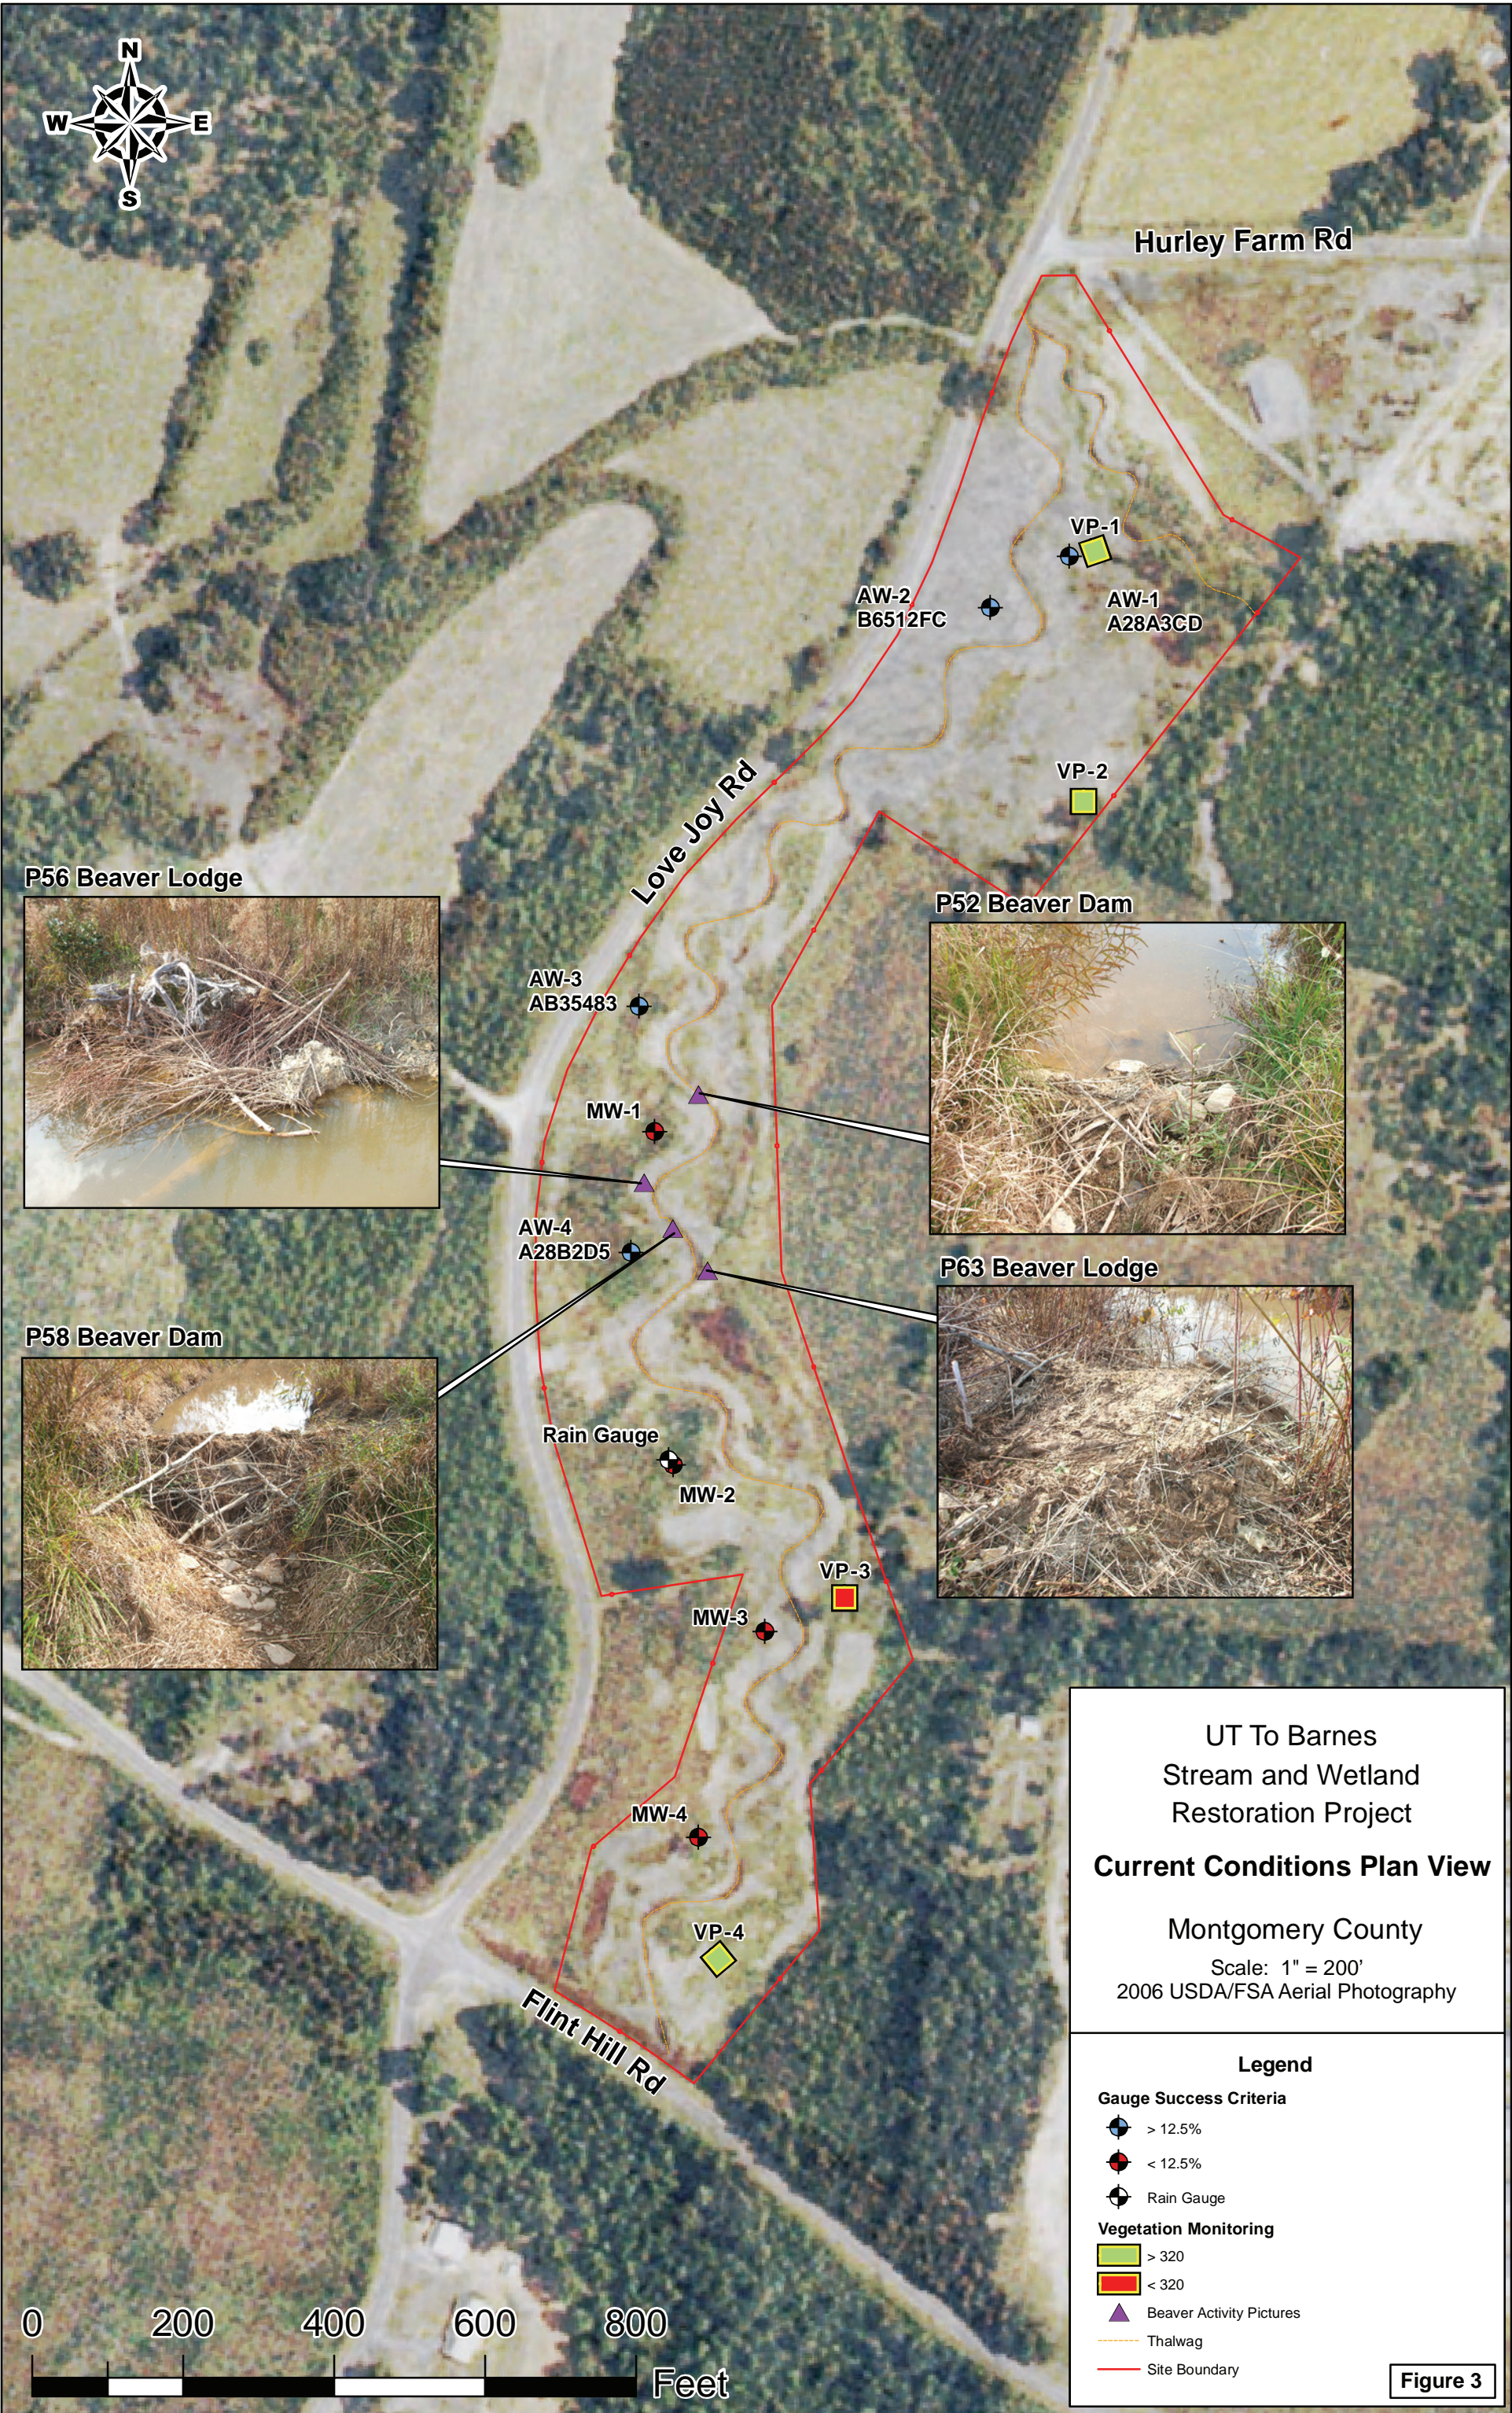
Figure 3

P56 Beaver Lodge

P52 Beaver Dam

P63 Beaver Lodge

P58 Beaver Dam
