UT to JUMPING RUN CREEK STREAM & WETLAND RESTORATION MONITORING REPORT (YEAR 1 OF 5)

Cumberland County, North Carolina EEP Project Number 92345

Status of Plan: Final Construction Completed: 2010 Data Collected: 2010 Submission Date: March 2011

Stantec Consulting Services Inc 801 Jones Franklin Road, Suite 300 Raleigh, NC 27606

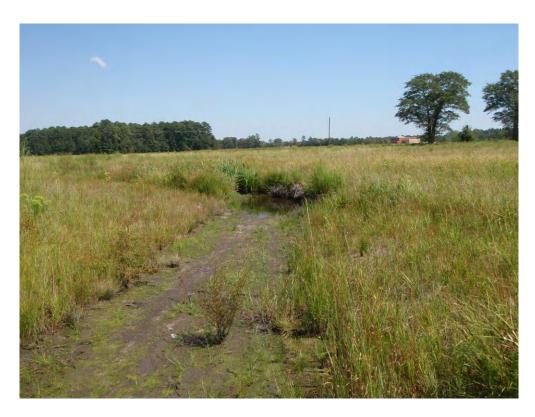
Photo B2 – (Photo Station 2) Cross-section 2 looking downstream at Station 54+30 (9/16/2010 Year 1)

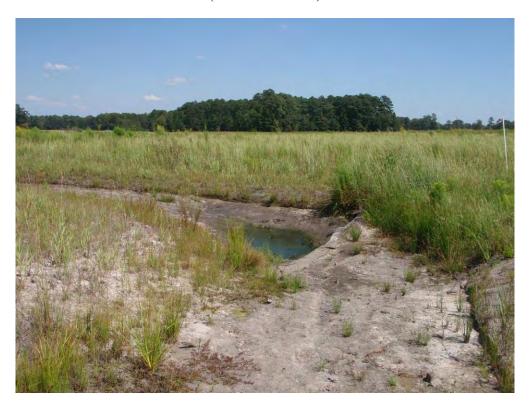
Photo B3 – (**Photo Station 3**) Cross-section 3 looking downstream at Station 54+98 (9/16/2010 Year 1)

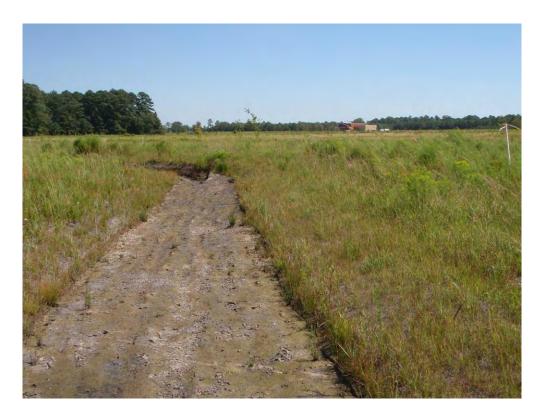
Photo B4 – (Photo Station S4) Cross-section 4 looking downstream at Station 59+09 (9/16/2010 Year 1)

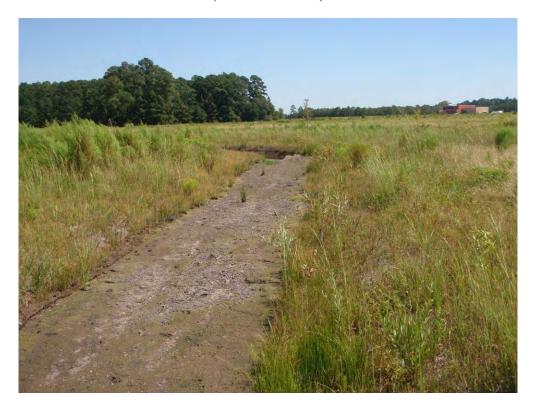
Photo B5 – (**Photo Station S5**) Cross-section 5 looking downstream at Station 62+87 (9/16/2010 Year 1)

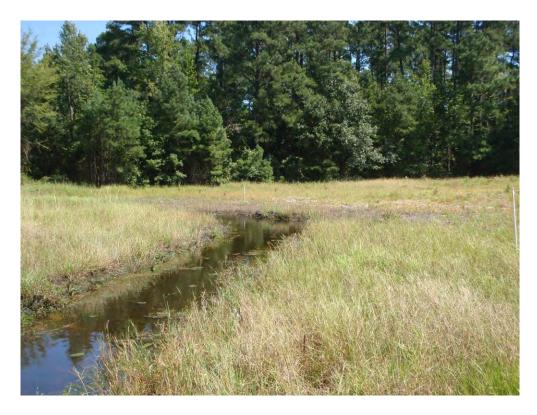
Photo B8 – (Photo Station S9) Cross-section 9 looking upstream at Station 75+30 (9/16/2010 Year 1)

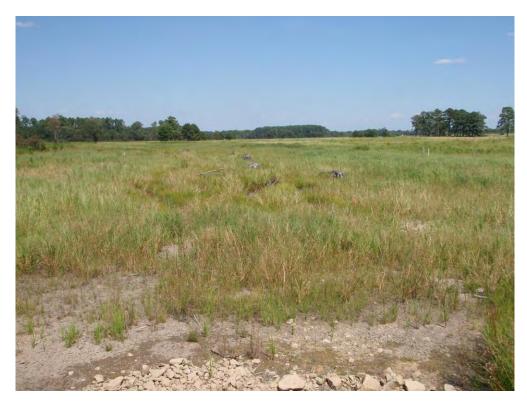
Photo B9 – (**Photo Station S10**) Cross-section 10 looking downstream at Station 80+45 (9/16/2010 Year 1)

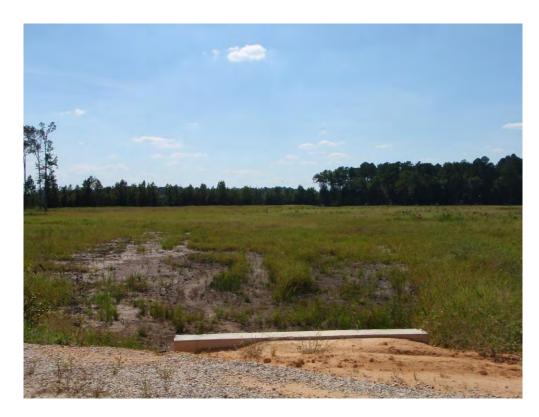
$\textbf{Photo B10-(Photo Station S11)} - \textbf{Stream channel looking downstream at upper road crossing } \\ (9/16/2010 \ Year \ 1)$
