UT to JUMPING RUN CREEK STREAM & WETLAND
RESTORATION
MONITORING REPORT (YEAR 3 OF 5)
Cumberland County, North Carolina
EEP Project Number 92345
Monitoring Contract Number D09085S

Status of Plan: Draft
Construction Completed: 2010
Data Collected: 2012
Submission Date: November 2012

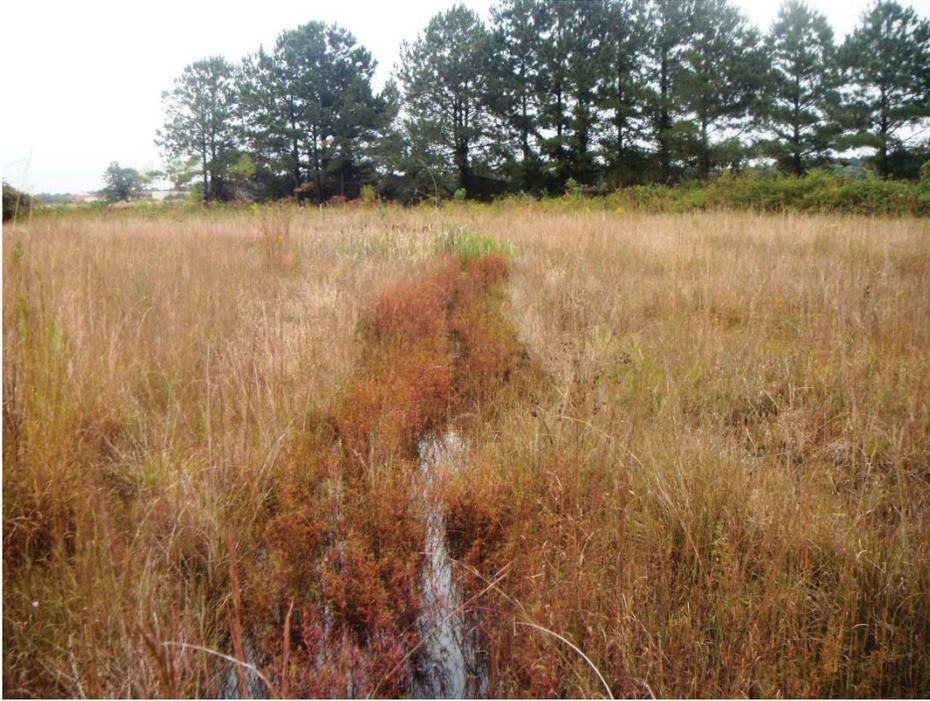
Photo B1 – (Photo Station 1) Cross-section 1 looking downstream at Station 48+81
(10/9/2012 Year 3)

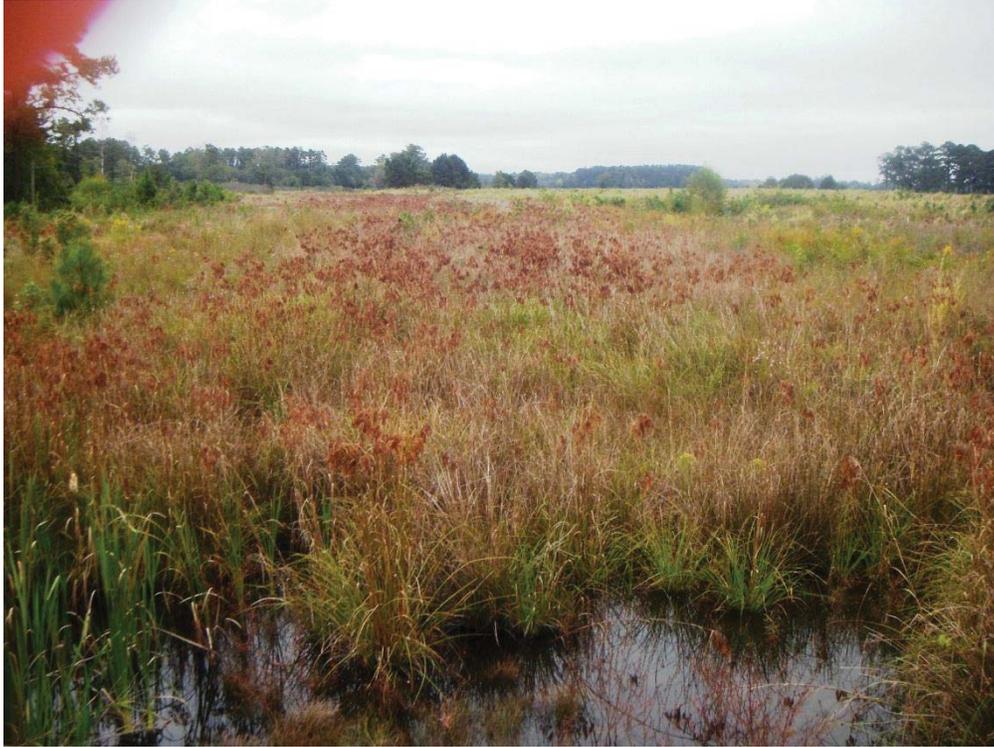
Photo B11 – (Photo Station S11) – Stream channel looking downstream at upper road crossing
(10/9/2012 Year 3)

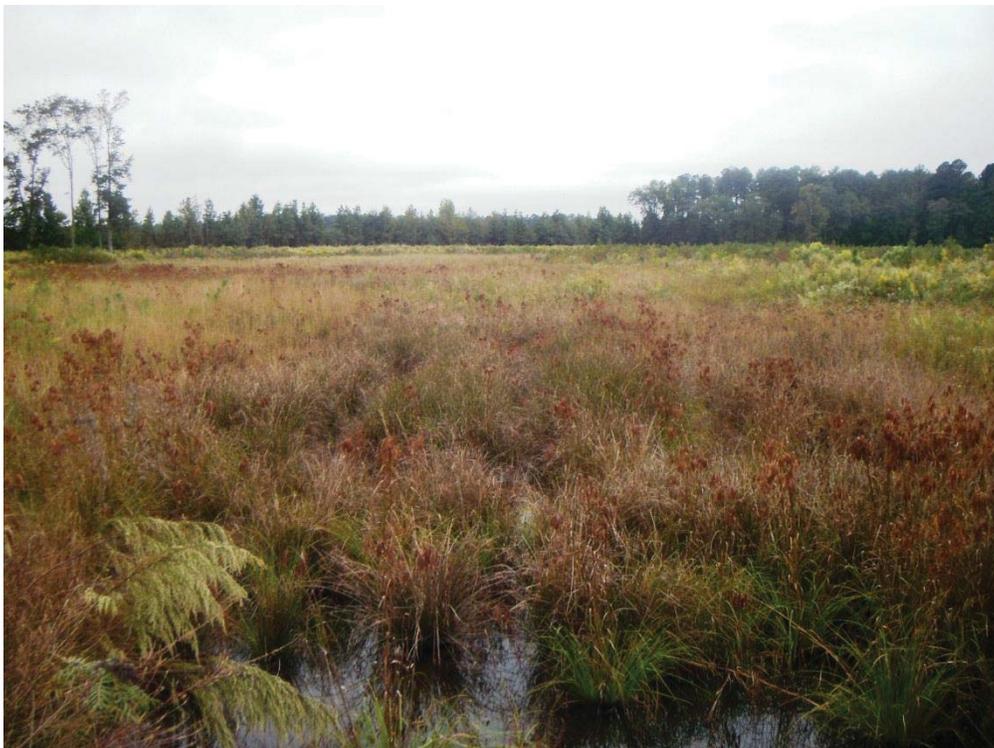
Photo B12 – (Photo Station S12) Stream channel looking upstream at upper road crossing
(10/9/2012 Year 3)

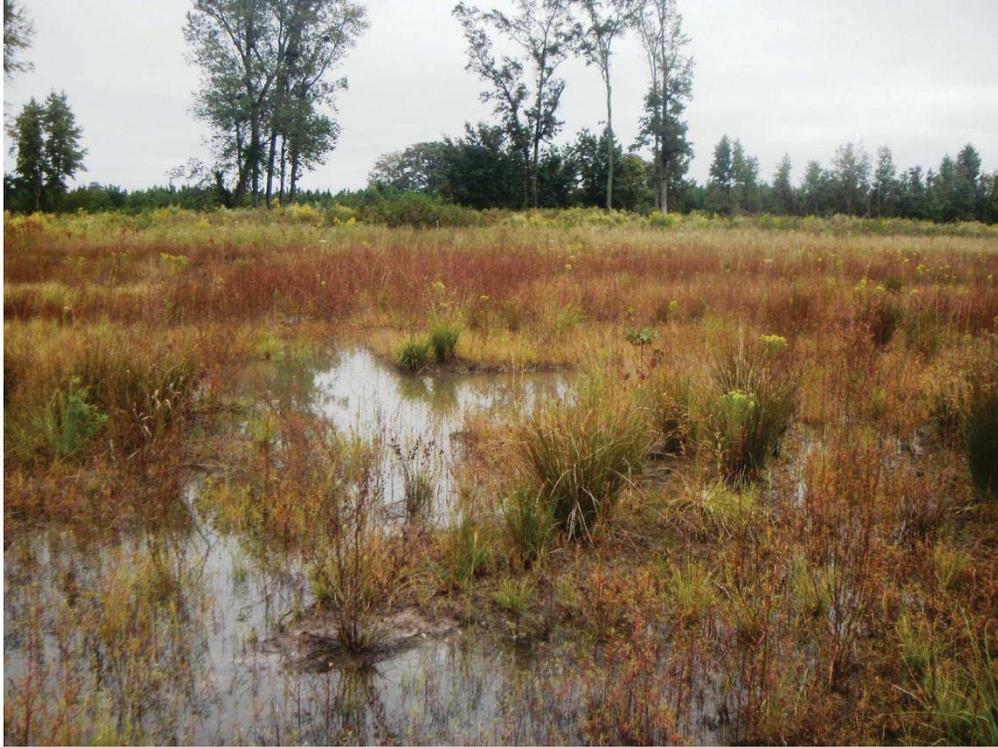
Photo B13 – Flow observed in headwater system UT1A (10/9/2012 Year 3)

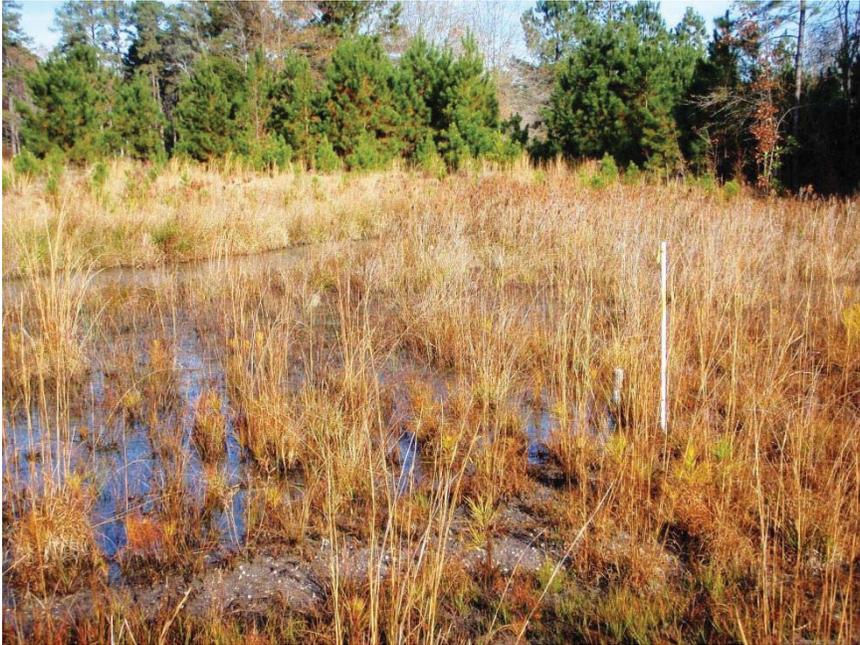
Backwater area looking downstream, well 15 located on the right side of the photo
